Professional Real Estate Inspector Sam Hestand TREC #24118

Date: 07/07/2023

# PROPERTY INSPECTION REPORT FORM

1011 Whitestone Ln, Houston, TX 77073

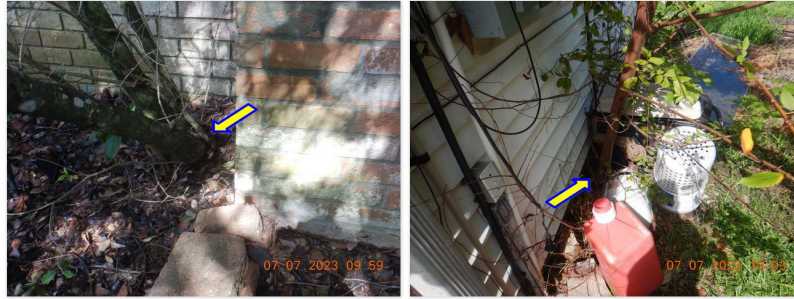
Trees and vegetation in close proximity around the dwelling

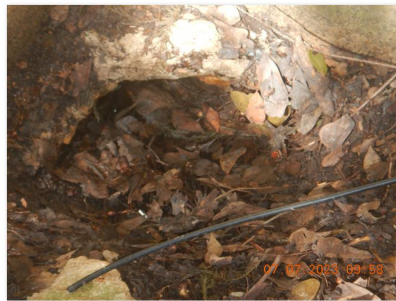
Evidence of ponding water was noted.

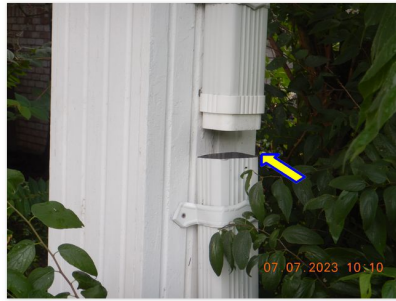
Gutter downspout pipe at the front right side of the home has a gap in it.

Splash blocks should be placed in areas where water can accumulate near the foundation edge. The discharging of the rainwater from the gutters needs to be directed away from the foundation edge.

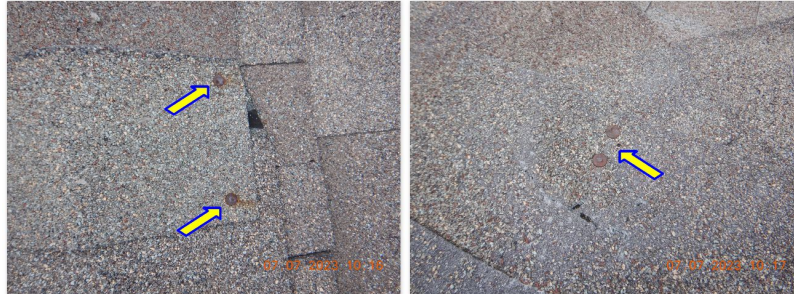
☑ Caulk face nailed ridge cap shingles where missing.

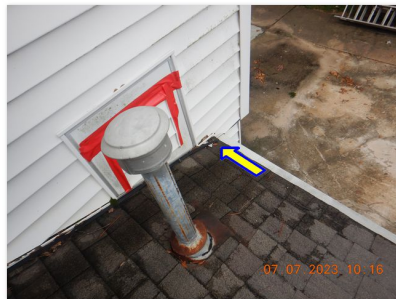
☑ Kickout flashing missing and or inadequate at some locations.

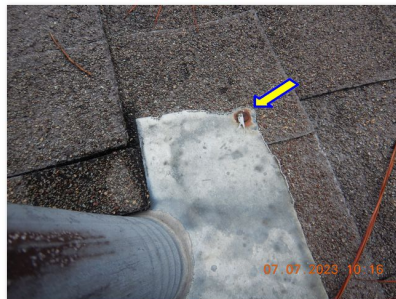
☑ Caulk face nailed roof jacks where missing.

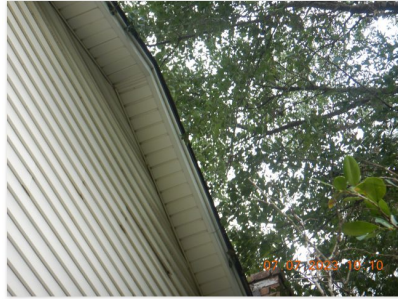
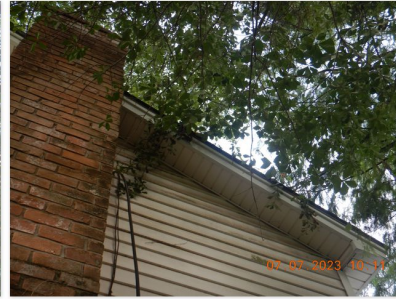
The roof has tree limbs coming in close contact with the roof covering. Tree limbs can cause damage to the covering and allow access to the roof for unwanted pest. I recommend trimming back all tree limbs away from roof.

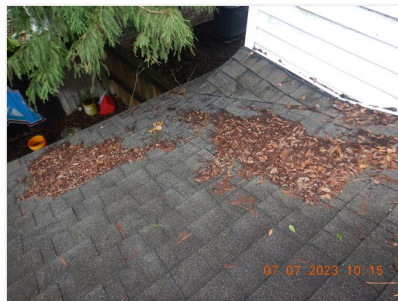
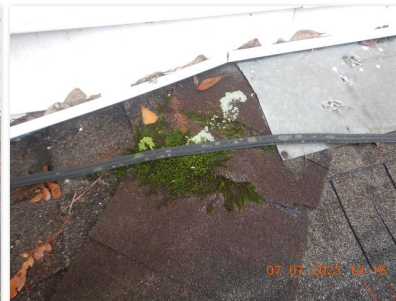
Leaves and debris observed at the roof covering.

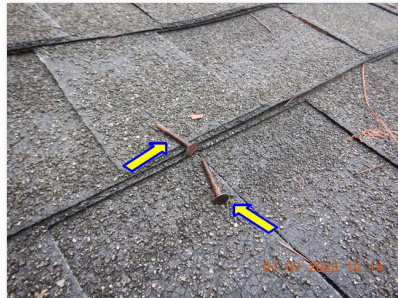
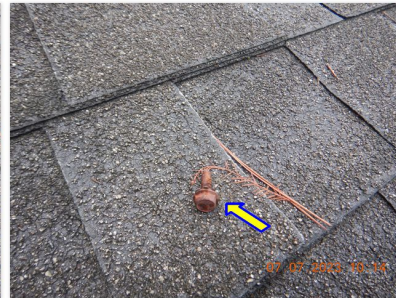
Loose nails observed at the roof covering.

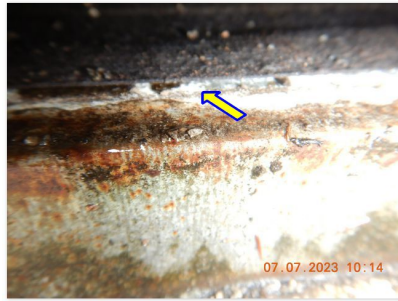
The roofing felt did not extend to the rakes or bottom of the roof deck in all of the areas that were inspected.

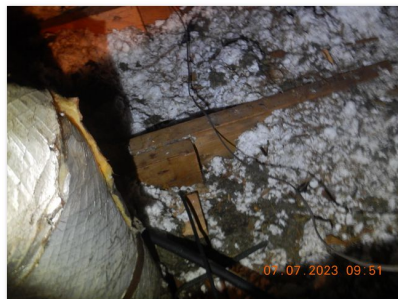
Redistribute insulation where missing or moved at the attic floor.

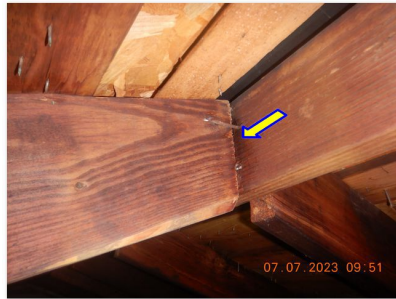
Rafters were secured to the ridge board with 0 nails on one side, versus the appropriate number on one side, the appropriate number on the other.

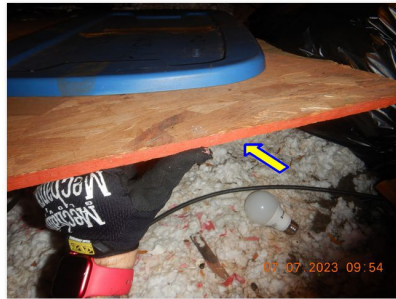
Service access flooring is not secured at some locations.

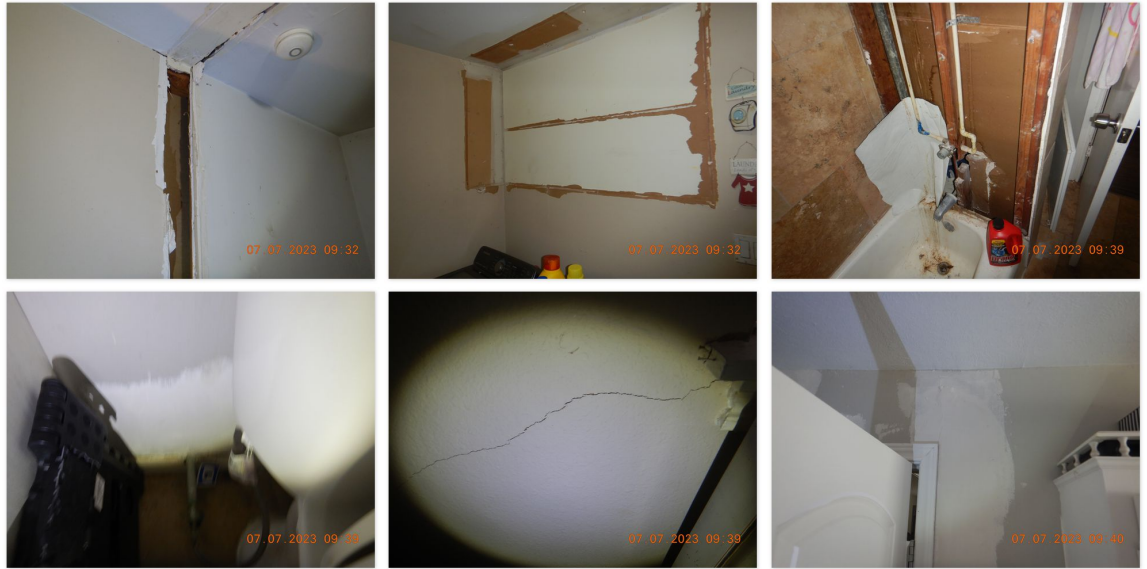
Cracks/damage/repairs in the drywall observed.

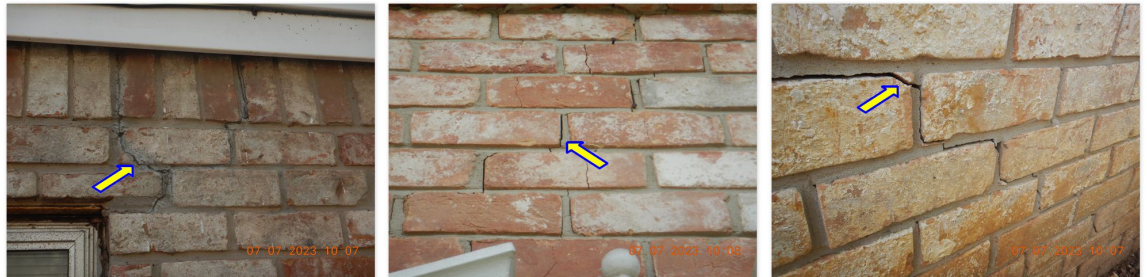
Cracks observed in the brick veneer and/or mortar were noted.

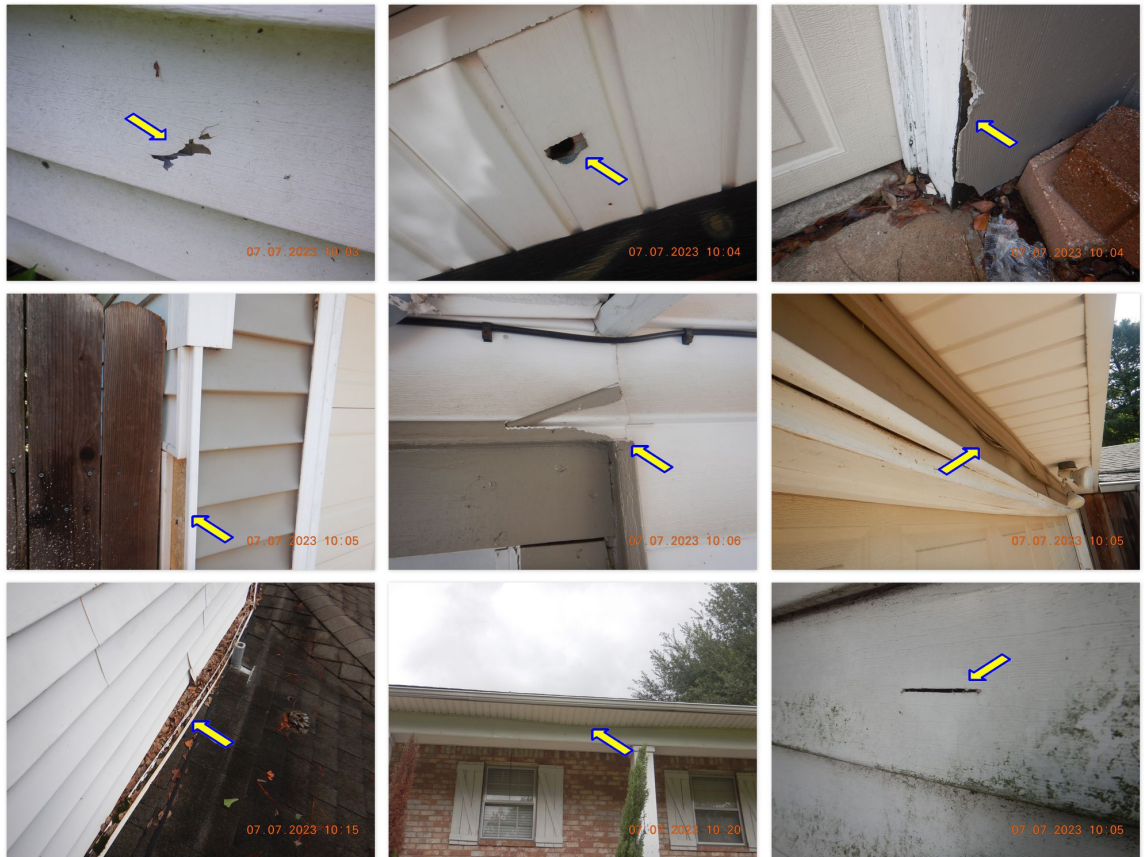
Damaged siding/trim was noted at various locations.

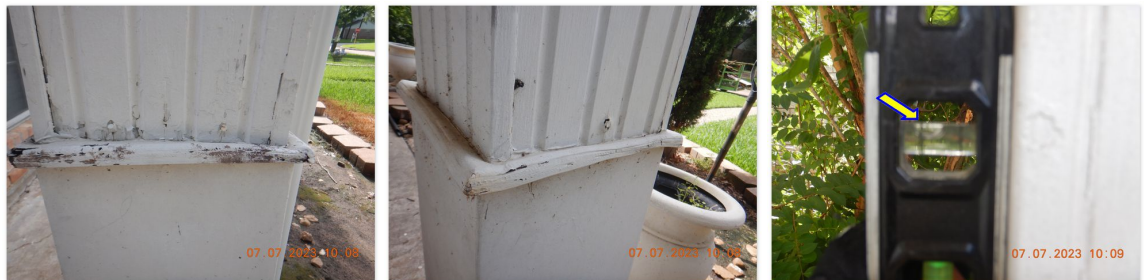
Front patio columns are deteriorated and some are no longer level.

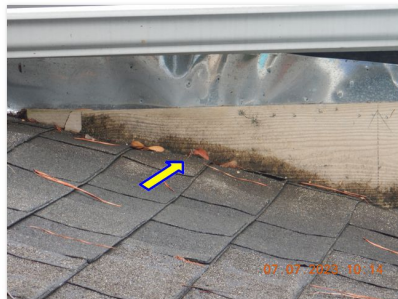
Exterior siding is in contact with the roof. Separation between the siding and roof covering will minimize moisture entrapment and deterioration of the siding.

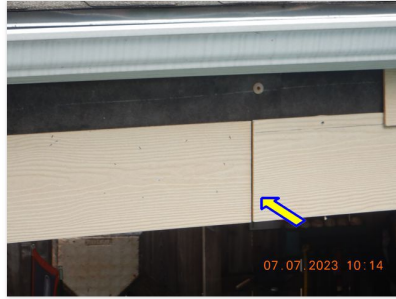
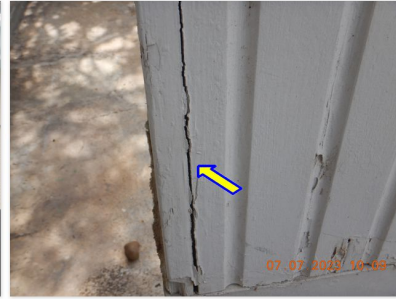
Caulking is needed at all joints and unsealed seams in the siding.

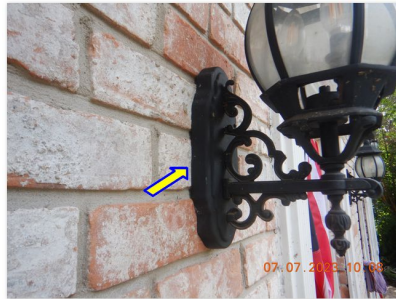
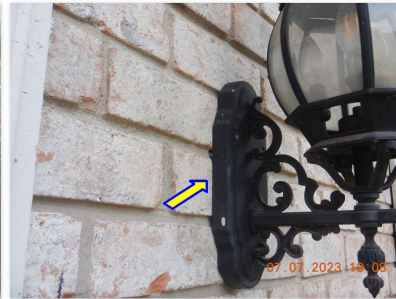
Caulking/sealant is missing around the exterior light fixtures where missing/deteriorated.

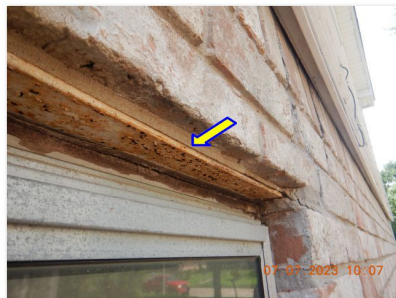
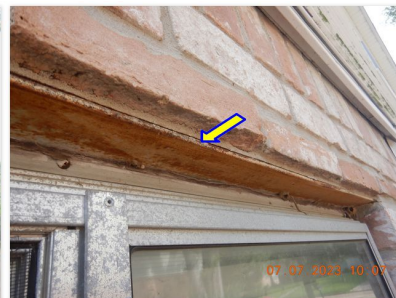
Metal lintels are rusting above the doors and windows.

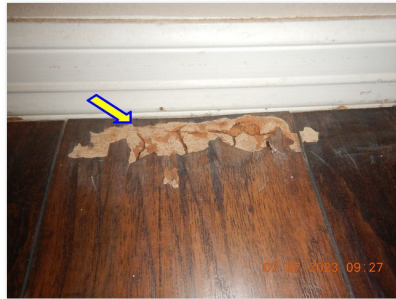
Evidence of moisture stains observed at the downstairs front right den.

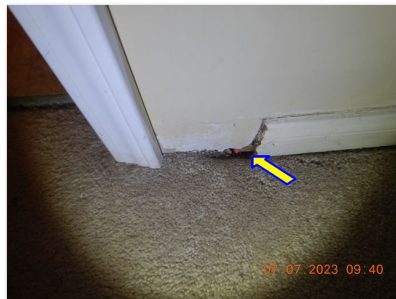
Floor trim is damaged/missing at some locations.

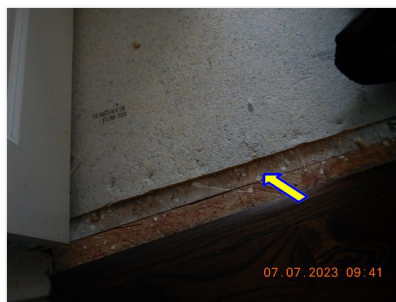
Flooring material is missing at the 2nd floor back right bedroom.

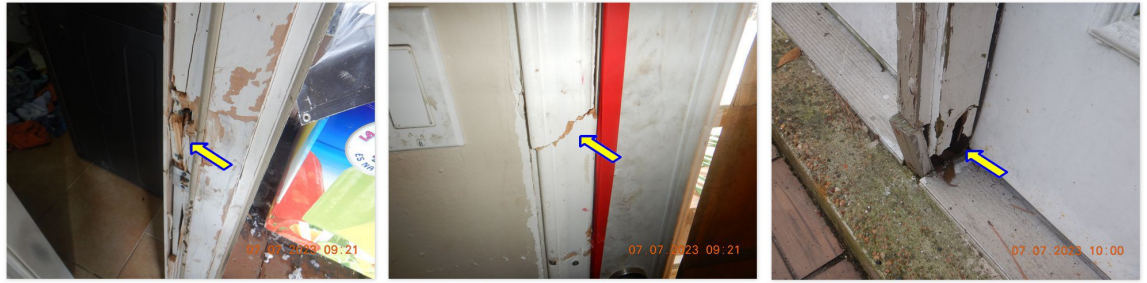
Door and/or door jam casing deteriorated/damaged at the following locations: Back patio, Right back patio.

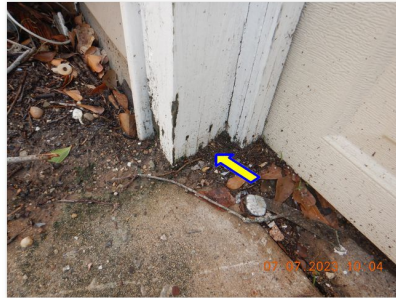
Garage door jambs in contact with the slab surface and are damaged at some locations.

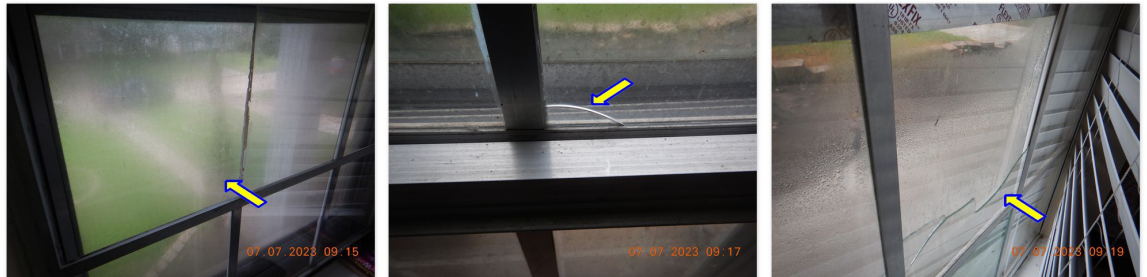
Broken windows observed at the following locations: Den, Dining room, 2nd floor front right bedroom.

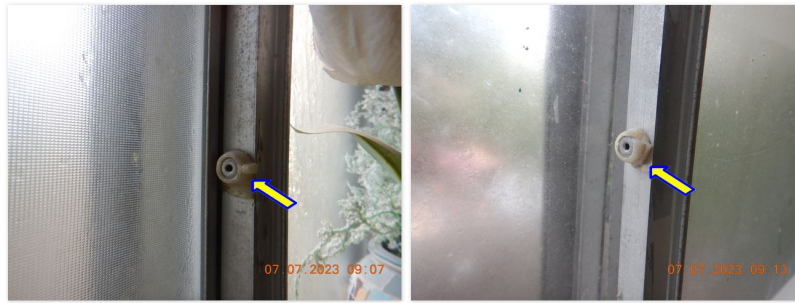
Window locks broken at some locations.

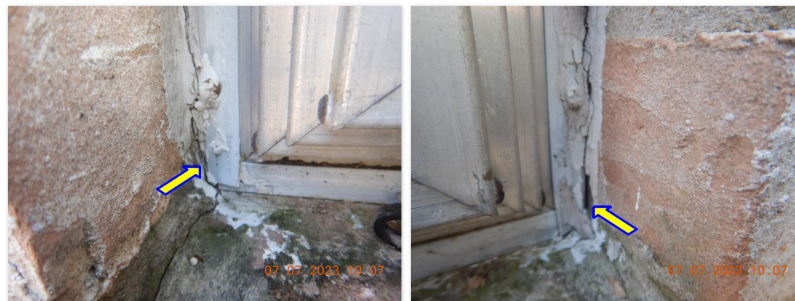
Caulking around exterior windows deteriorating.

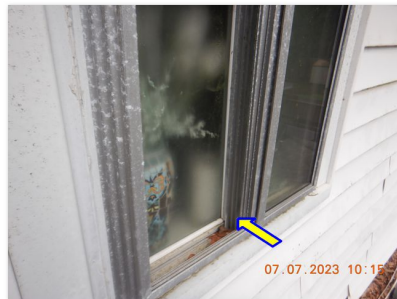
Window screens missing at some locations.

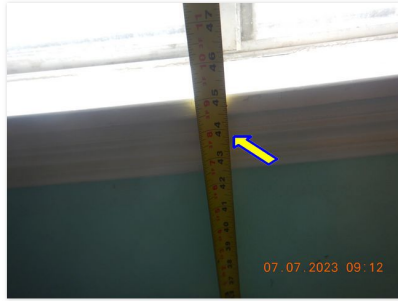
Window sill exceeds the allowable height (44") for egress in case of fire at the following bedrooms: 2nd floor back right bedroom.

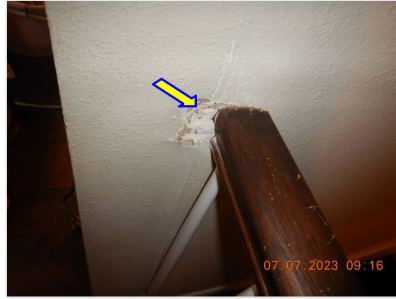
Handrail at the bottom of the stairs is no longer secured to the wall.

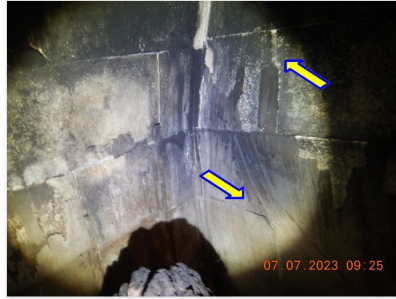
Missing or deteriorated grout between firebrick at the firebox.

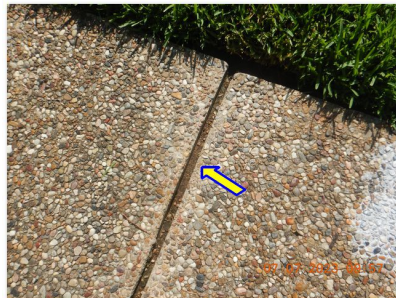
The expansion joints in the driveway and walk way are open. Open expansion joints can allow water to get under the concrete surface and expand or wash away the soil causing lifting or settling of the concrete. I recommend filling the expansion joints with an approved expansion joint material.

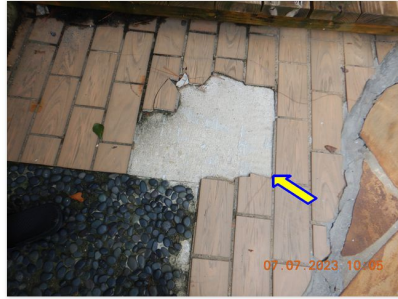
Back patio tile is damaged.

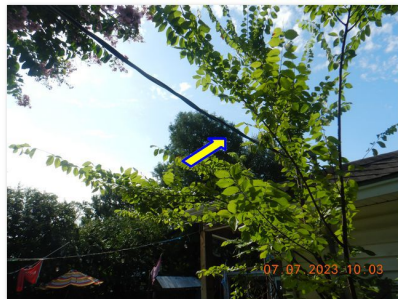
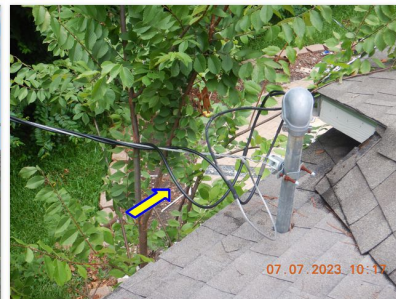
Service entrance conductor does not have proper clearance from the walking surface and roof covering.

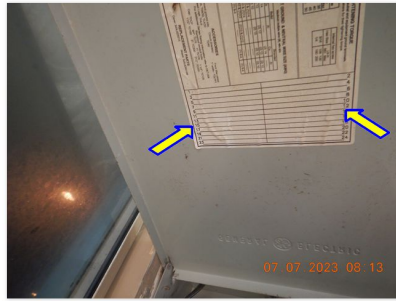
Branch circuit service locations were not all marked at the service equipment disconnecting means panel board enclosure dead front cover.

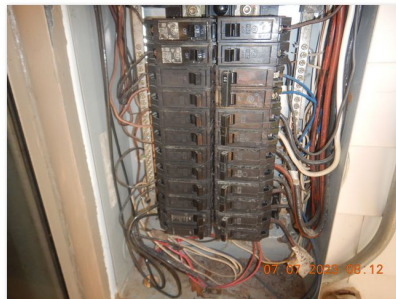
The service equipment disconnecting means panel board is missing a dead front cover.

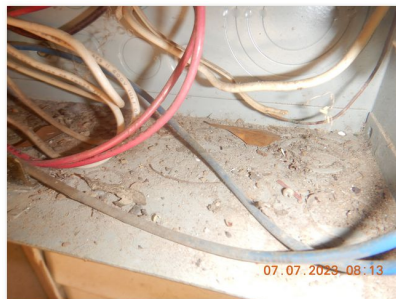
Debris observed at the interior of the service equipment disconnecting means panel board enclosure.

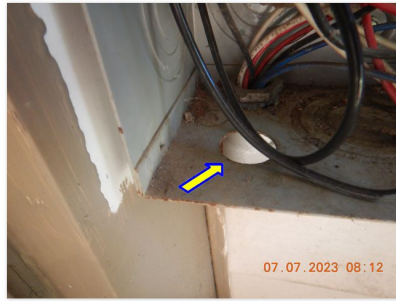
- ☑ One of the interior knockouts is missing at the bottom of the panel.

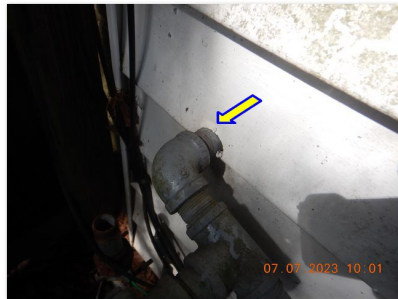
The metal gas distribution pipe entering the building should be bonded to the electrical system. The metal gas pipe is not bonded or could not be verified at the time of inspection.

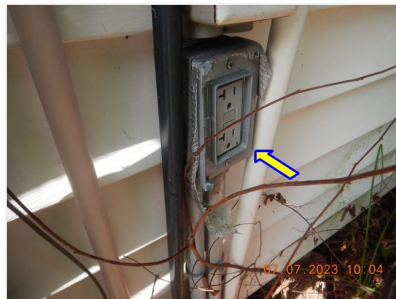
Exterior plug cover is damaged behind the garage.

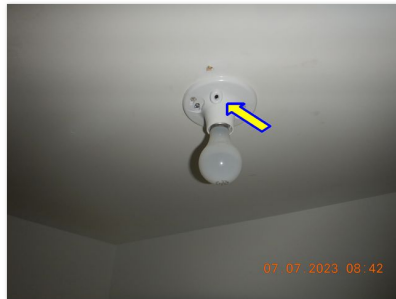
- ☑ The 2nd floor back right bedroom closet light pull chain is missing.

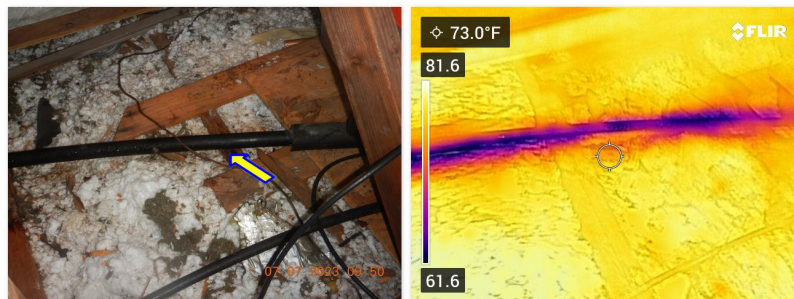
- Insulation is missing or deteriorated on the A/C suction line in the attic.

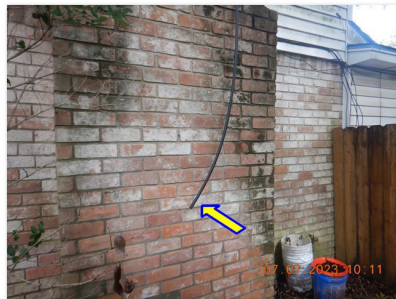
The auxiliary drain line should terminate above an easily observable.

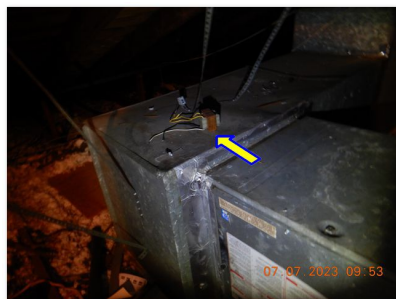
Debris should be cleared from the top of the HVAC equipment.

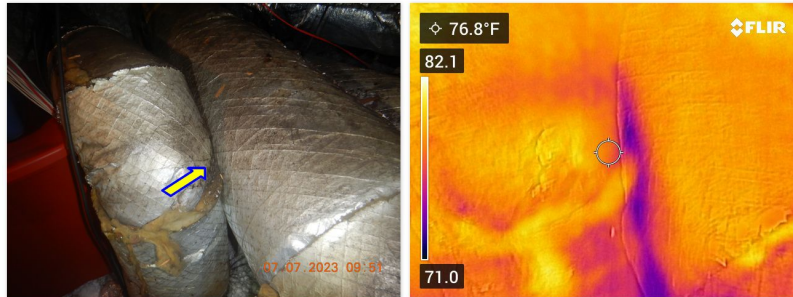
Separate ductwork where touching at attic to prevent thermal bridging. Thermal bridging causes condensation to form between the duct lines and can drip into the attic.

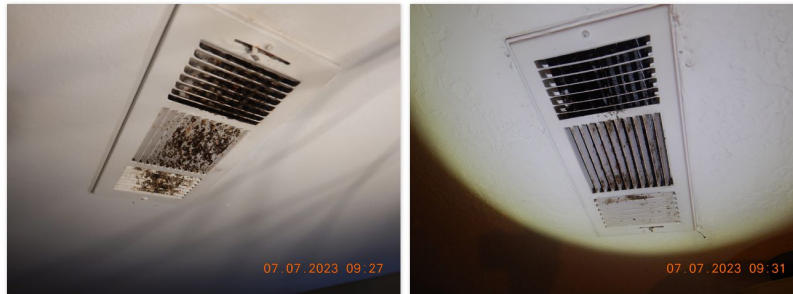
Organic growth was noted at some of the vent covers.

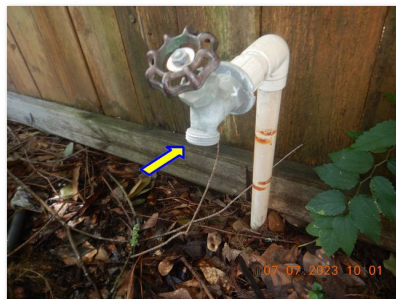
Exterior hose bibs not installed with anti-siphon devices at some locations.

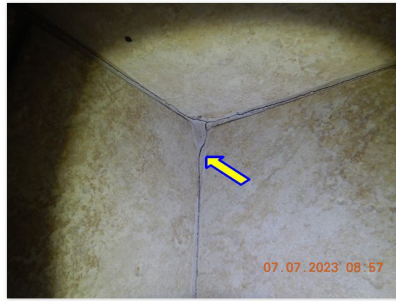
Mortar is cracked at the the master bathroom shower enclosure.

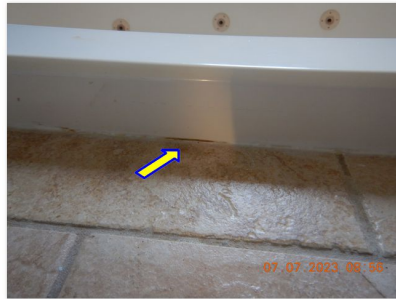
Caulk the bathtub/shower enclosures and around fixtures where missing or deteriorated.

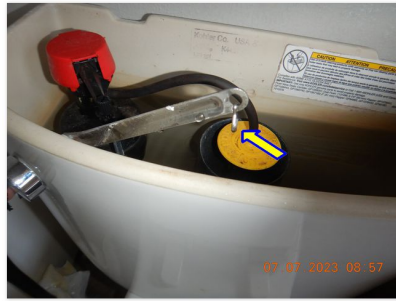
The master bathroom commode flushing mechanism is damaged and not flushing properly.

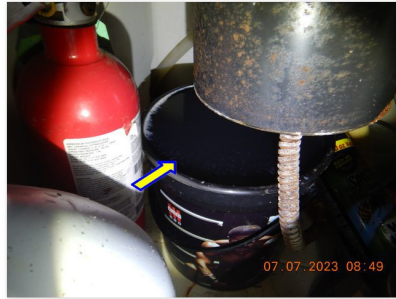
- ☑ An active leak was noted at the kitchen sink.

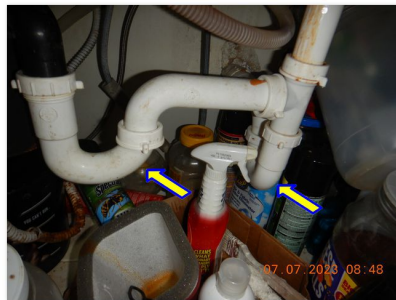
- ☑ A double P trap is installed at the kitchen sink. One P trap can pull water from the other trap and cause sewer odors to enter the home.

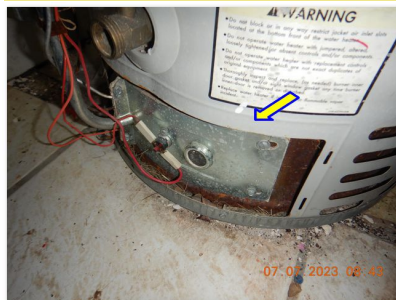
- ☑ Water heater control panel cover is missing.

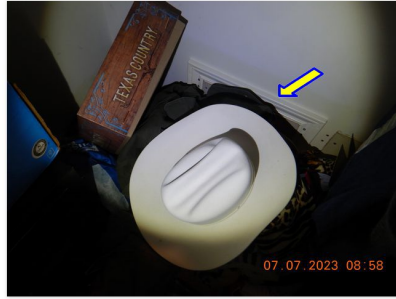
The hydro-massage therapy tub at the master bathroom appears to have an access panel but it could not be accessed due to stored items blocking it.

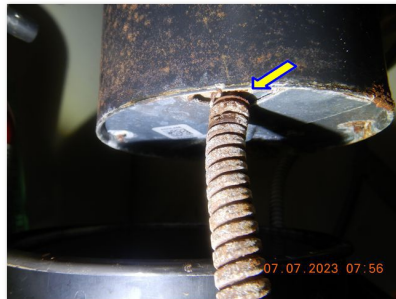
The food waste disposal whip cord is not properly secured at the clamp at the base of the food waste disposal.

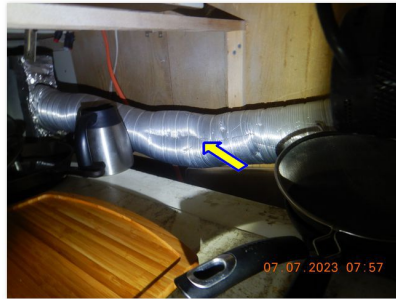
The range hood vent pipe is dented.

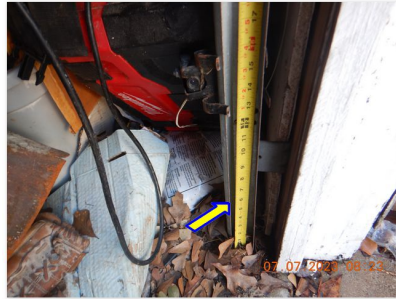
Photoelectric sensors are not properly installed at the base of the garage door. The sensors should not be installed more than 6 inches above the garage floor.

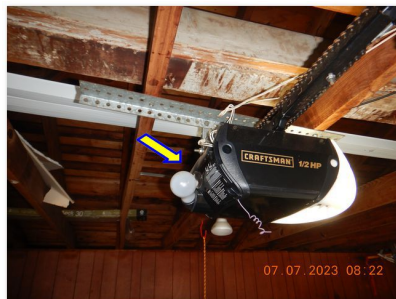
Light cover at the garage door opener is missing.
