NEW CONSTRUCTION FINAL INSPECTION

6126 Hazel Lake
Conroe, TX 77303

PROPERTY INSPECTION REPORT FORM

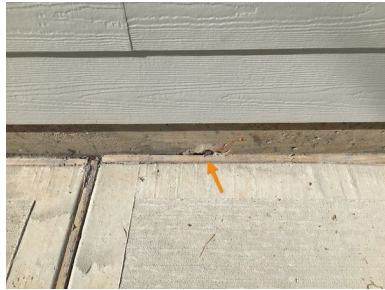
Rear

1: Slab: Exposed Post Tension Cables

Post tension cable(s) exposed along the perimeter of the foundation. Remedy as needed.

Recommendation: Contact your builder.

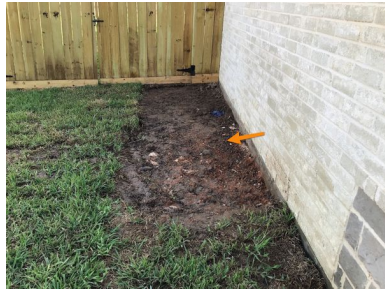
Left

1: Missing grass

Remedy as needed.

Recommendation: Contact a qualified professional.

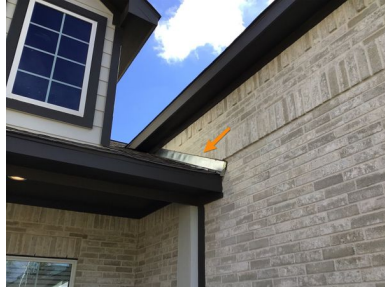
Unpainted/front

1: Flashing Deficiencies

Unpainted, Lifted, Neoprene boot inverted - Deficiencies with the flashings were present at the time of inspection. Evaluation and remediation is recommended.

Recommendation: Contact your builder.

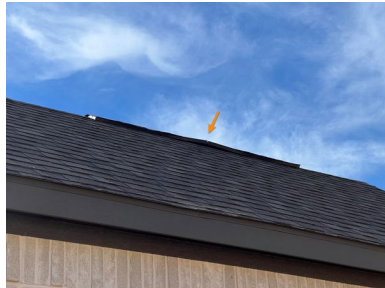
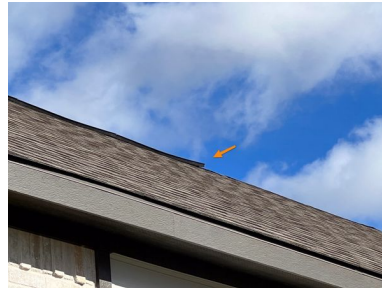
2: Lifted ridge vent

Remedy as needed.

Recommendation: Contact a qualified professional.

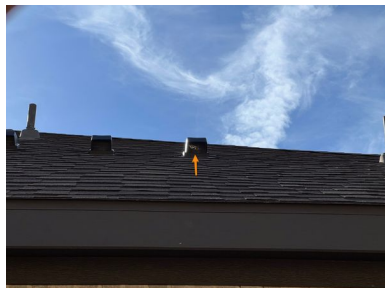
3: Debris inside Vent

Remedy as needed.

Recommendation: Contact a qualified professional.

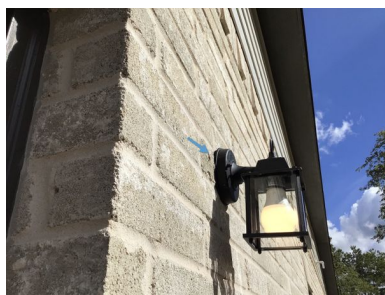
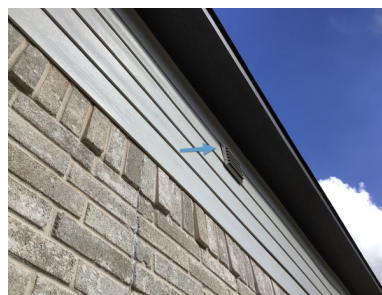
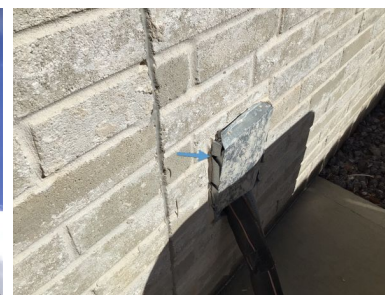
Right

1: Exterior: Seal Wall Fixtures

All Exterior Wall Penetrations, Light Fixture(s), Vent Cover(s) - Fixtures/Electrical boxes were not properly sealed. Remedy as needed.

Note: Modern building practices recommend sealing around components that are mounted on or pass through the exterior wall to limit moisture intrusion.

Recommendation: Contact your builder.

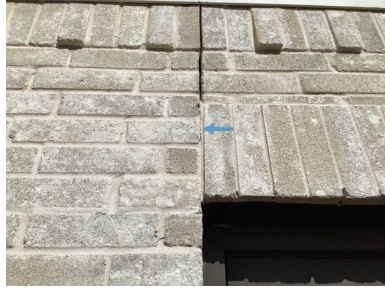
Right

2: Exterior- Masonry: Minor Brick Cracks

Cosmetic hairline cracks were observed in the masonry siding. Hairline cracks may be a result of thermal expansion of the veneer and/or normal structural movement. Monitoring is recommended.

Recommendation: Contact your builder.

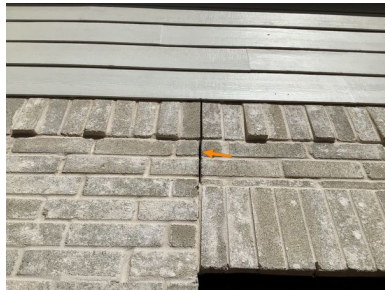
Right

3: Exterior- Masonry: Seal Expansion Joints

Sealant in the expansion joints is missing or has deteriorated. Evaluation and remediation is recommended.

Recommendation: Contact your builder.

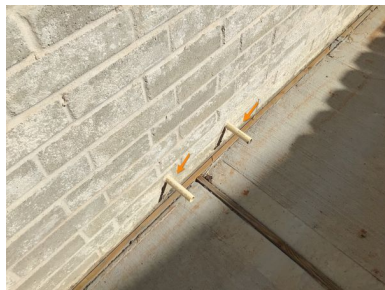
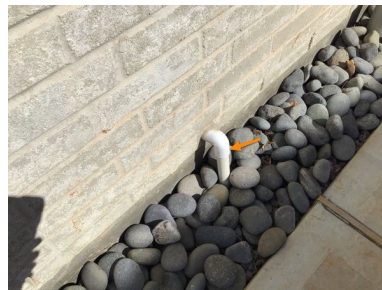
Right

4: Exterior: PVC Lines Unpainted

All exterior PVC line should be painted to prevent UV damage and deterioration. Evaluation and remediation is recommended.

Recommendation: Contact your builder.

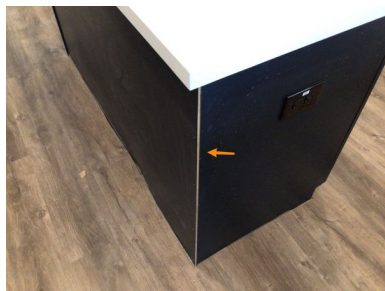
Kitchen

6: Missing cabinet trim piece

Remedy as needed.

Recommendation: Contact a qualified professional.

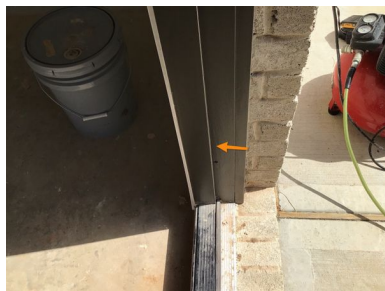
Garage exterior door

1: Doors: Weatherstripping Missing or Damaged

Door is missing standard weatherstripping. This can result in significant energy loss and moisture intrusion. Evaluation and remediation is recommended.

Recommendation: Contact your builder.

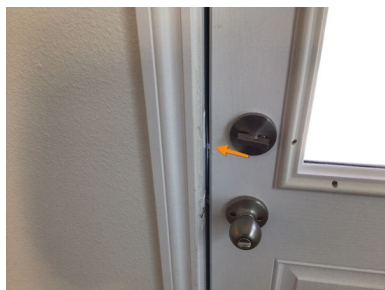
Right Rear Door

2: Doors: Noticeable Gap at Frame

Gaps were observed between the door and frame, which could result in energy loss. Evaluation and remediation is recommended.

Recommendation: Contact your builder.

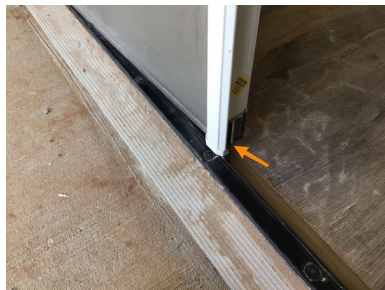
Right French door

3: Door Hardware: Doesn't Latch

Door did not latch properly. Evaluation and remediation is recommended.

Recommendation: Contact your builder.

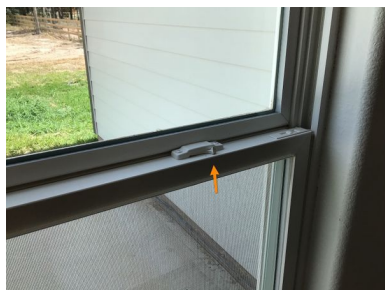
Breakfast Area

1: Hardware: Missing or Damaged

Window hardware was missing or damaged. Evaluation and remediation is recommended.

Recommendation: Contact your builder.

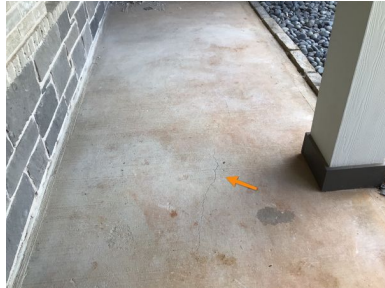
Front

1: Exterior Flooring: Cracked

Porch or balcony exterior flooring showed signs of foundation cracking. Evaluation and/or repair by a qualified concrete contractor is recommended.

Recommendation: Contact your builder.

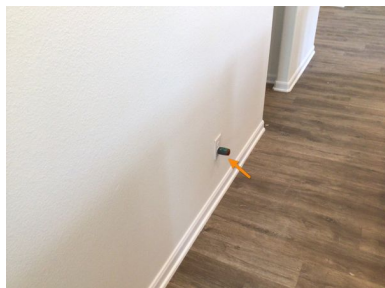
Kitchen

1: Receptacles: No Power

Receptacle had no power. Evaluation and remediation is recommended.

Recommendation: Contact your builder.

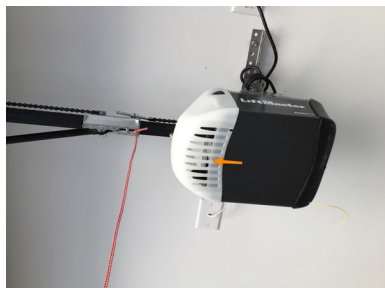
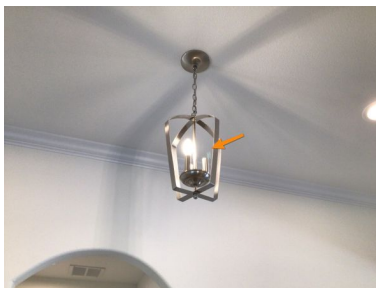
Entry

2: Light: Inoperable

One or more light fixtures were not operating at time of inspection. Cause was not determined. Evaluation and remediation is recommended.

Recommendation: Contact your builder.

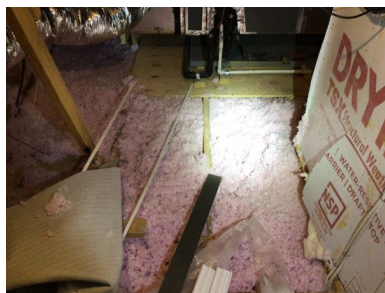
1: Accessibility: Inadequate Deck/Service Platform

Inadequate decking or service platform from attic entrance to the HVAC equipment was present. This is necessary for servicing, replacing, or inspecting the unit. Evaluation and remediation is recommended.

Recommendation: Contact your builder.

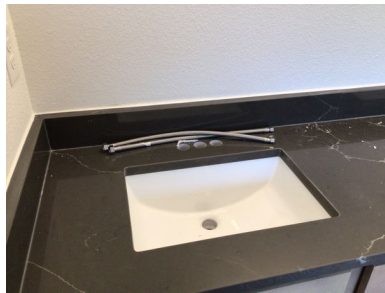
Left side of primary bathroom

Sink install not complete:

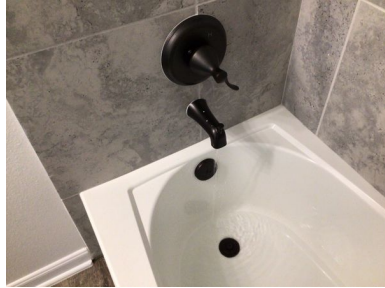
Right Hall Bathroom (cold side)

1: Fixtures: Poor Flow/Water Pressure

Evaluation and remediation is recommended.

Recommendation: Contact your builder.

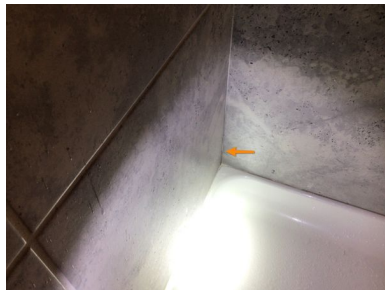
Left Hall Bathroom

2: Shower: Missing/Deteriorated Caulking or Grout

Evaluation and remediation is recommended.

Recommendation: Contact your builder.

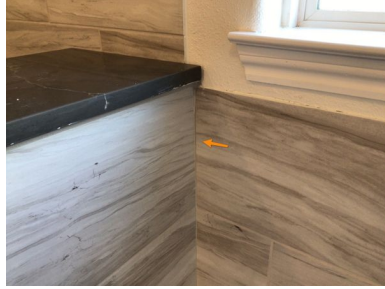
Primary Bathroom

3: Tub: Caulk Damaged/Missing

Evaluation and remediation is recommended.

Recommendation: Contact your builder.

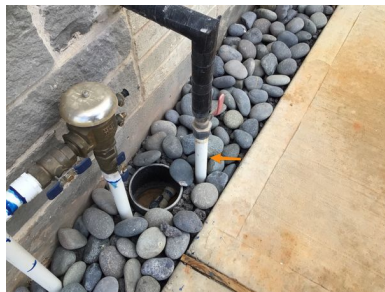
Right

4: Missing insulation around main water line

Remedy as needed.

Recommendation: Contact a qualified professional.

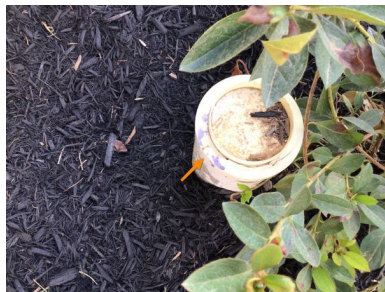
Front Left

1: Drain piping: Clean-out cap damaged/missing

Evaluation and remediation is recommended.

Recommendation: Contact your builder.

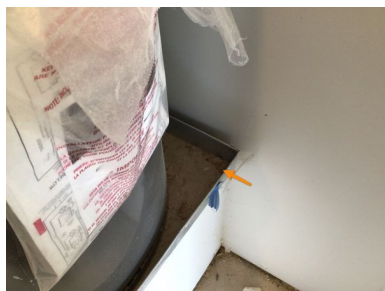
1: Tank: Insulation/debris in pan

Evaluation and remediation is recommended.

Recommendation: Contact your builder.

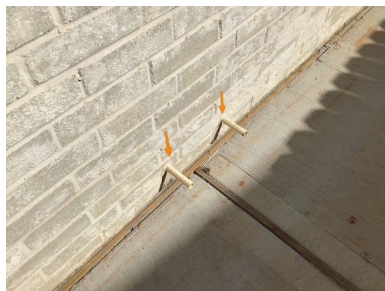
2: TPR Valve: Discharge tube poor termination

Water heater TPR discharge tube did not point towards the ground. The discharge tube should point towards the ground to prevent scalding injuries or damage to property. Evaluation and remediation is recommended.

Recommendation: Contact your builder.

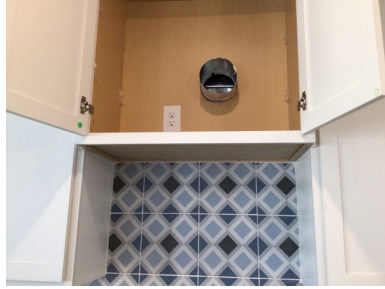
Range hood installation not complete:

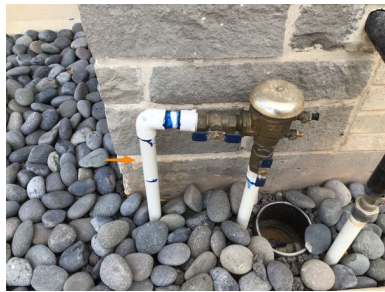
Right

2: Missing insulation for backflow

Remedy as needed.

Recommendation: Contact a qualified professional.

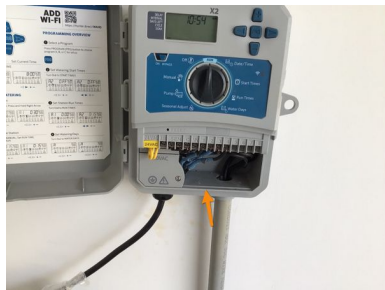
3: Missing control panel cover

Remedy as needed.

Recommendation: Contact a qualified professional.
