MECHANICAL INSPECTION

505 Jackson Hill St Unit 203 Jacksons Place
Houston, TX 77007

PROPERTY INSPECTION REPORT FORM

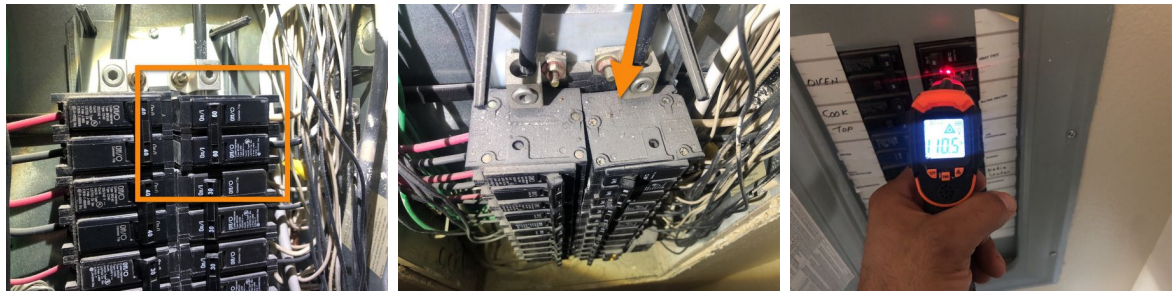
1: Breaker - Loose

The breaker for the furnace was not seated properly causing it to protrude. A loose breaker will cause the breaker to overheat. It is recommended that an electrician be contacted to repair the breaker and any secondary damage.

Recommendation: Contact a qualified professional.

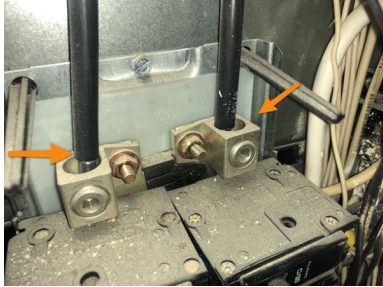
The aluminum conductors were not coated with an anti-oxidation solution. Per the standards set forth by The Texas Real Estate Commission, we are compelled to recommend that the wires should be coated with an anti-oxidation solution, however this is not required by the current building codes.

Obtain cost estimate

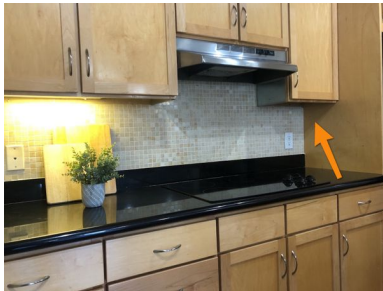
Kitchen cabinet

A light fixture that was non-functional when the switch was on was observed. The problem may be a burned out bulb, defective light fixture, or defective switch.

Further investigation is recommended

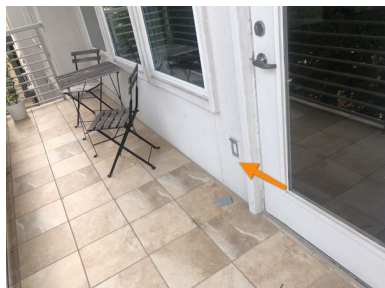
Balcony

3: Exterior Switch - No water tight cover

Recommendation: Contact a qualified professional.

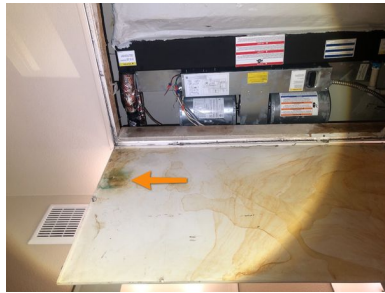
3: Green discoloration - possible leak

A green colored staining was observed on the evaporator coil possibly indicating a current or previous refrigerant leak. Further investigation is recommended with a service company.

Obtain cost estimate

Recommendation: Contact a qualified professional.

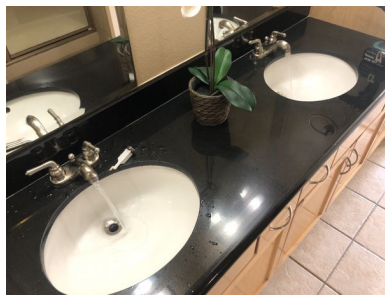
Master Bath Both Sinks

The drain stopper was not operating properly and needs to be repaired.

Obtain cost estimate

Recommendation: Contact a qualified professional.

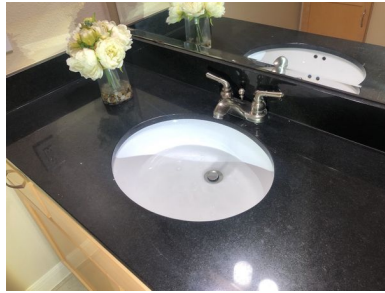
Guest Bath

2: Sink Drains Slow

A sink that was draining slower than normal was observed. Have a plumber find the source of the problem and make any necessary repairs.

Obtain Cost Estimate

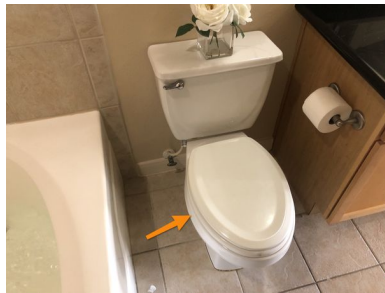
Master Bath

3: Toilet - Loose on floor

The toilet was loose on the floor and needs to be reset and secured to the floor.

Obtain Cost Estimate

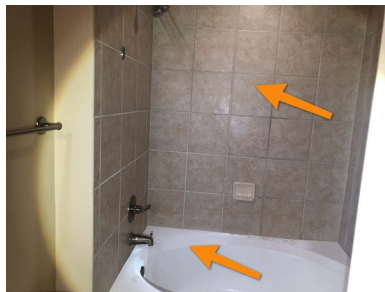
Guest Bath

4: Tub/Shower - Water leaks past diverter

The diverter valve was leaking water past the valve when the valve was turned to the shower.

Obtain Cost Estimate

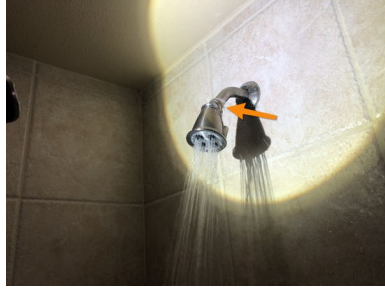
Master Bath

5: Shower/Tub - Shower head leak

The shower head was leaking at the connection and needs to be repaired.

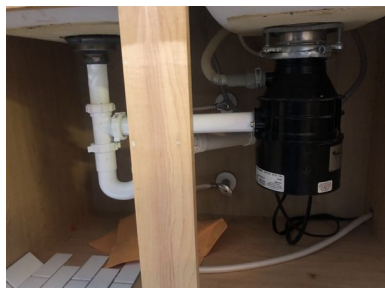
1: Noisy - Determine if repairable

Have the unit checked by a service company, who should make any necessary repairs.

Obtain Cost Estimate

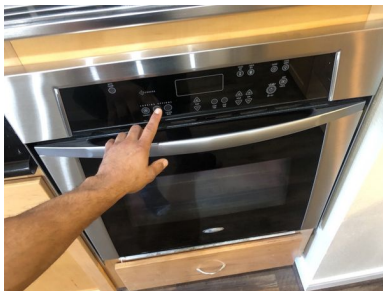
1: Oven - Nonfunctional

The oven was nonfunctional at the time of the inspection. The reason for the condition was not determined and further investigation is recommended with a service company.

Obtain Cost Estimate

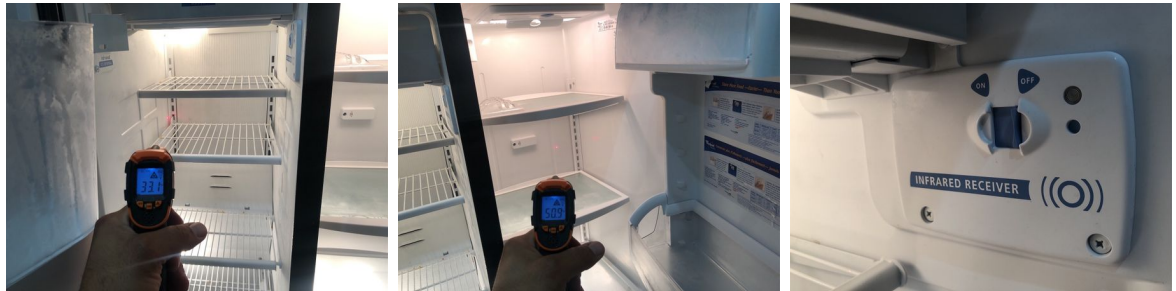
The refrigerated equipment did not appear to be functioning properly. The equipment was operating, however the temperature inside was only 00 degrees when checked with an infrared thermometer. Have a service company find the source of the problem, and make any necessary repairs.

Obtain Cost Estimate
