Goodspeed Inspection Services, Inc.

Alison McGallion

1725 Ave N 1/2
Galveston TX 77550

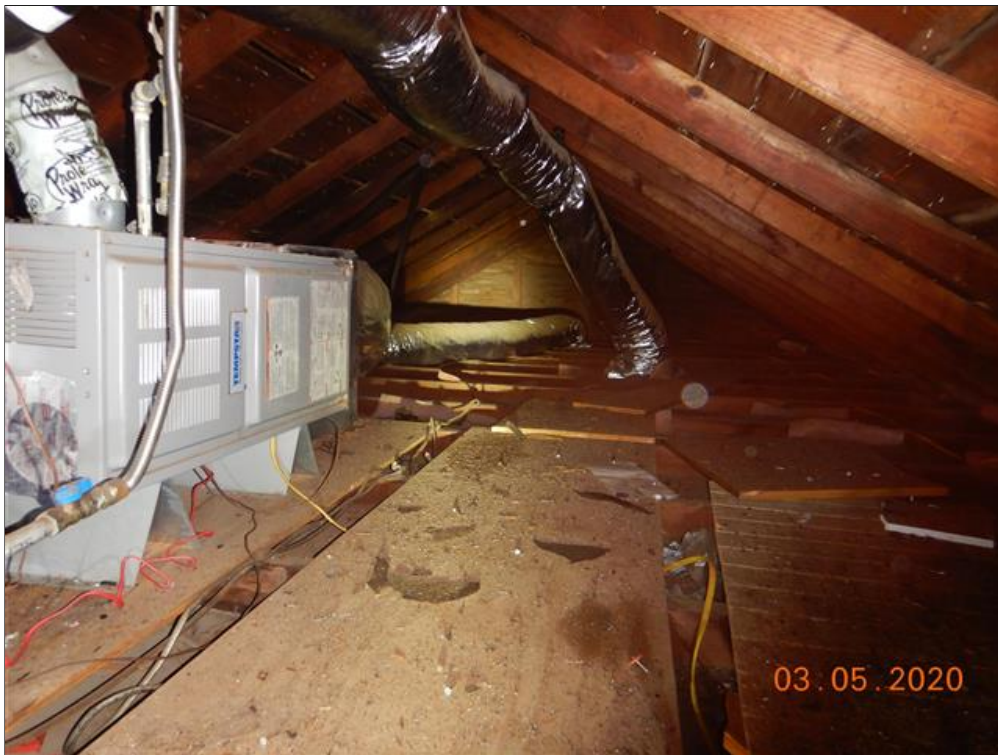
4.0 Item 1(Picture)

D - Purlins walls undersized throughout attic - this may lead to roof framing sagging. Although this may have been normal construction practice at the time of construction it may be advisable to add additional structural support to reduce the amount of potential roof structure sagging or member failure.

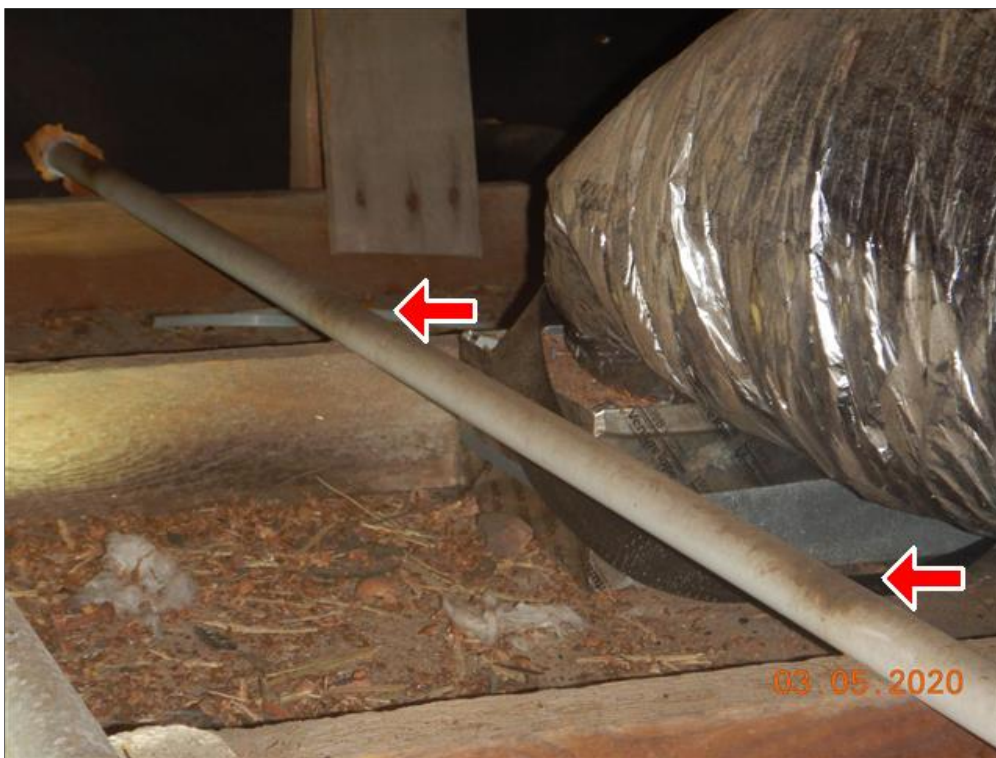
4.2 Item 2(Picture)

(4) D - Soffit vent have been sealed - There appears to be insufficient roof ventilation. This condition will lead to premature aging of roofing surfaces and excessively high utility bills.

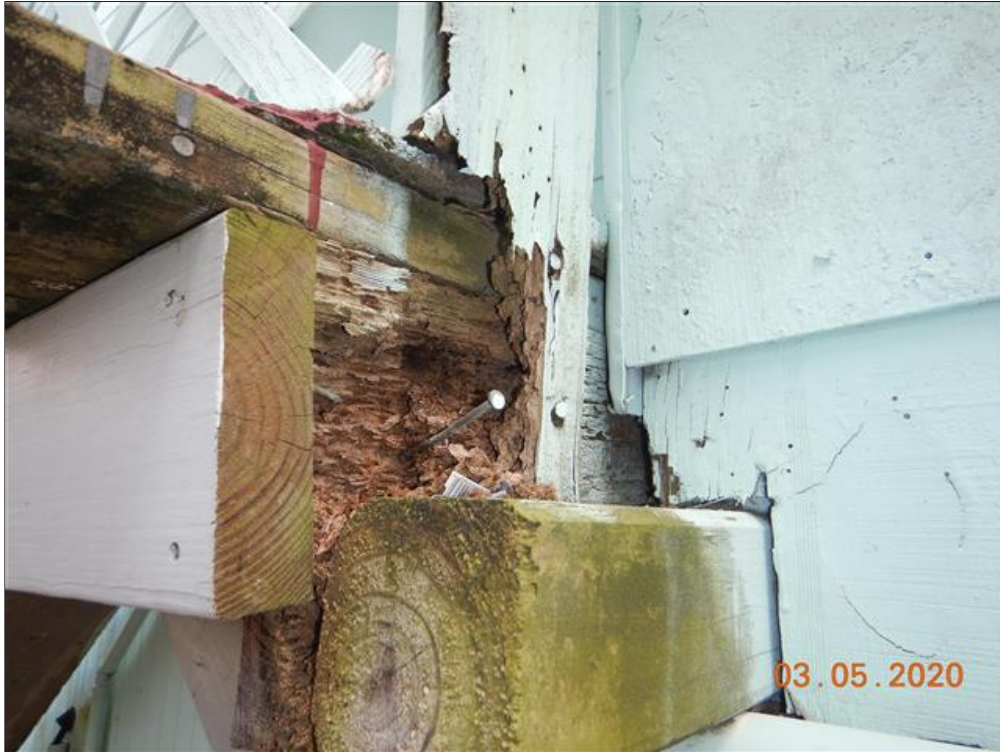
5.2 Item 7(Picture)

(3) D - Damaged siding along the right side. This condition may lead to or have lead to moisture intrusion, mold, wood destroying insect infestation and water damage. It is recommended that an independent moisture intrusion analysis be conducted by qualified specialist due to visible and known moisture problems with this type of siding systems. No water intrusion testing or inspection was conducted by this inspector.

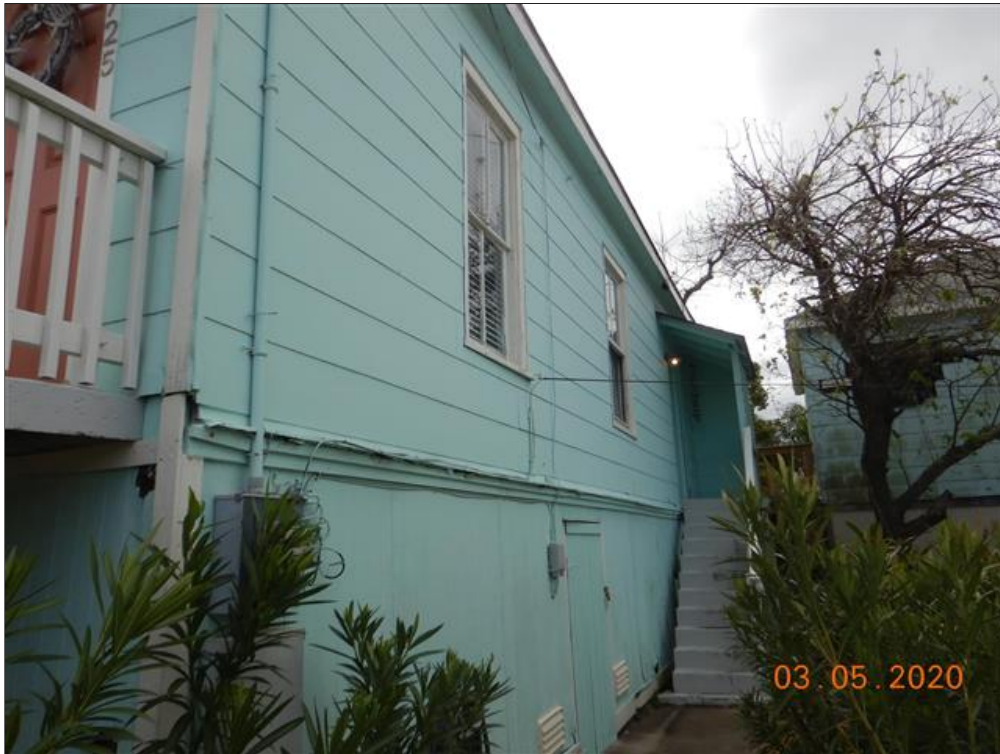
5.2 Item 12(Picture)

(4) D - Damaged siding along the rear side. This condition may lead to or have lead to moisture intrusion, mold, wood destroying insect infestation and water damage. It is recommended that an independent moisture intrusion analysis be conducted by qualified specialist due to visible and known moisture problems with this type of siding systems. No water intrusion testing or inspection was conducted by this inspector.

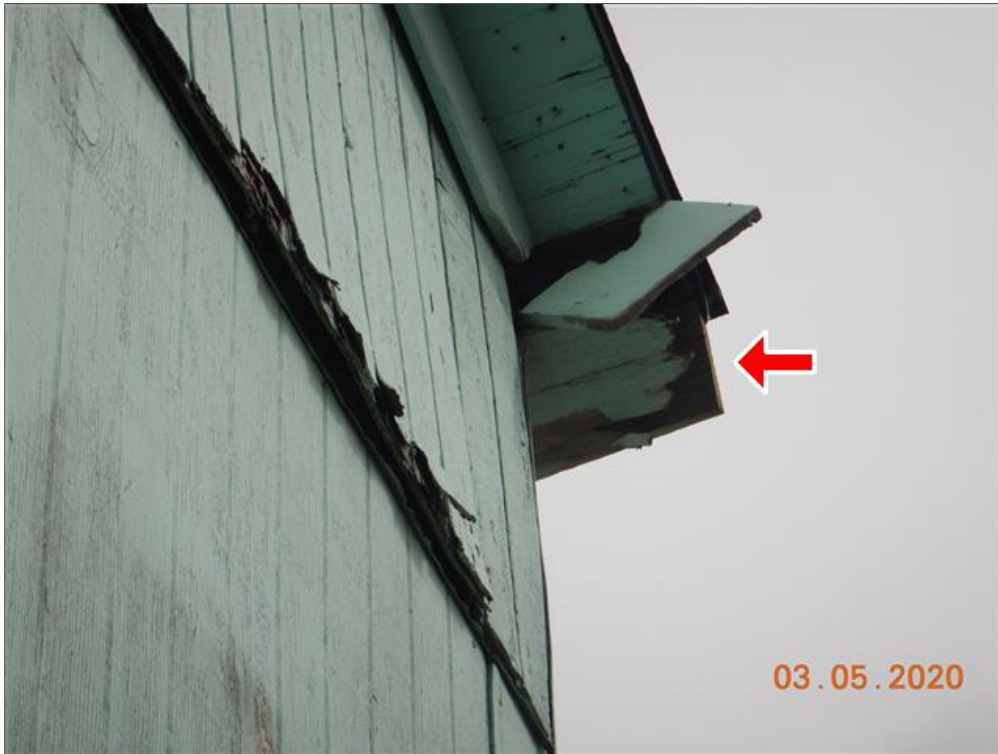
6.7 Item 1(Picture)

D - Wood rot to fascia, soffit and trim at rear side(s) of house.

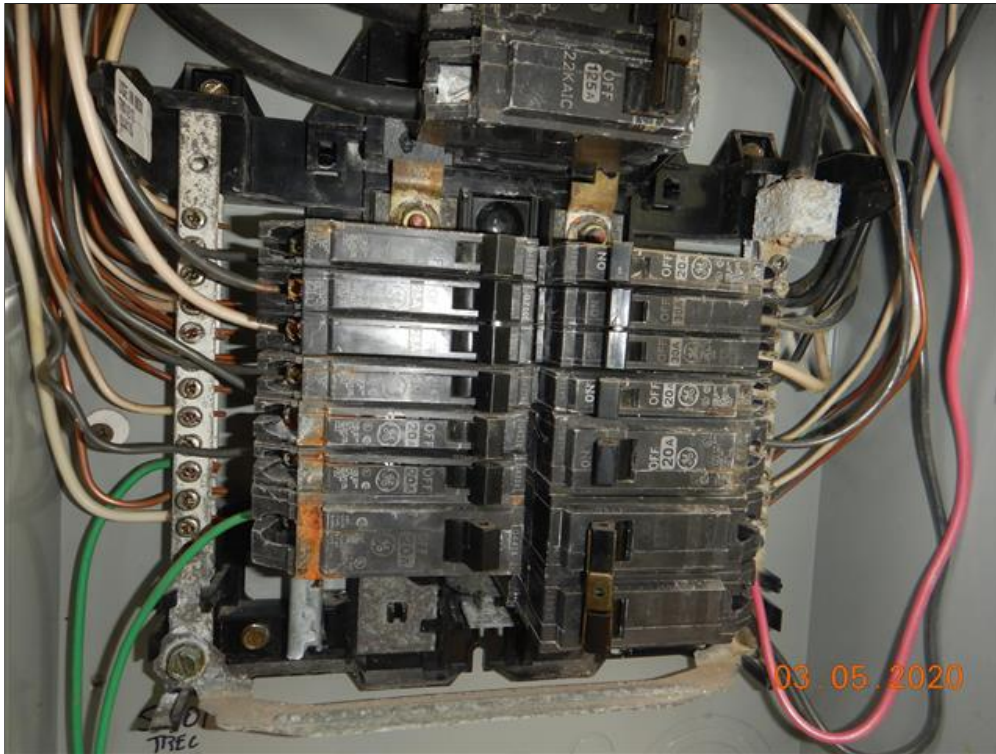
9.1 Item 1(Picture)

- (2) D - 240 Volt electrical wires inside the breaker box - White hot legs are required to be designated (wrapped with black electrical tape or marked black) black as Hot - Electrical shock hazard.
- (3) D - Missing dead-front screw(s) - Electrical Shock Hazard.
- (4) D - Excessive corrosion on main grounding lug.

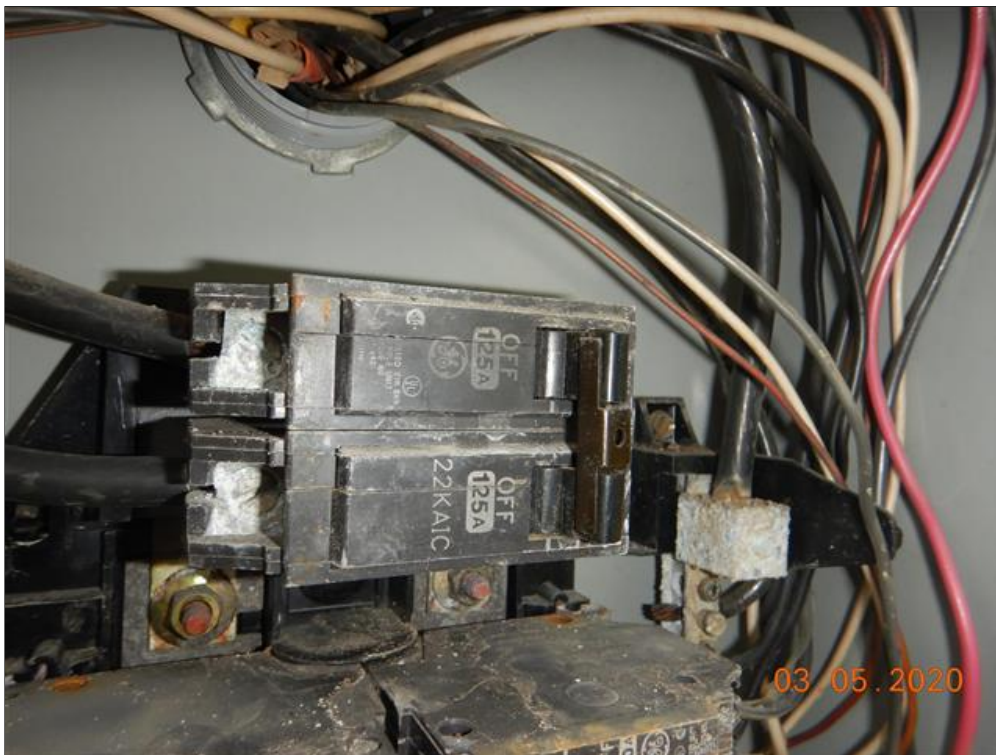
9.2 Item 1(Picture)

- (2) D - No visible anti-oxidants on aluminum conductor terminations as required by current codes and T.R.E.C. Standards of Practice required disclosure.

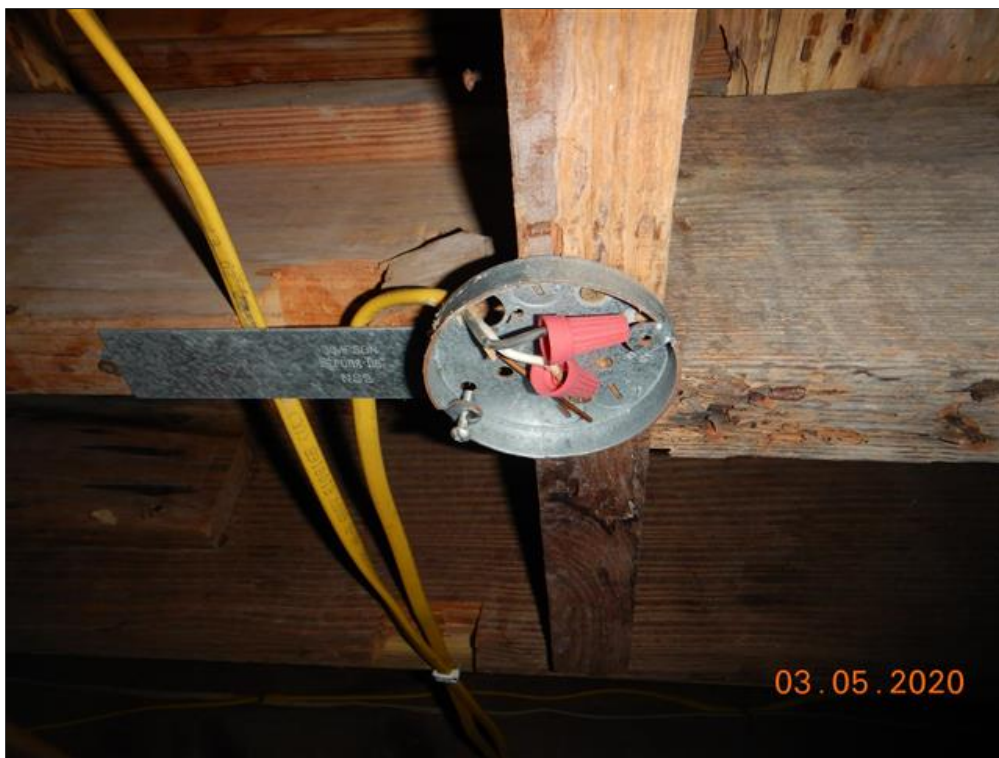
10.0 Item 2(Picture)

(3) D - Open wire splices in attic above kitchen, Electrical Fire Hazard.

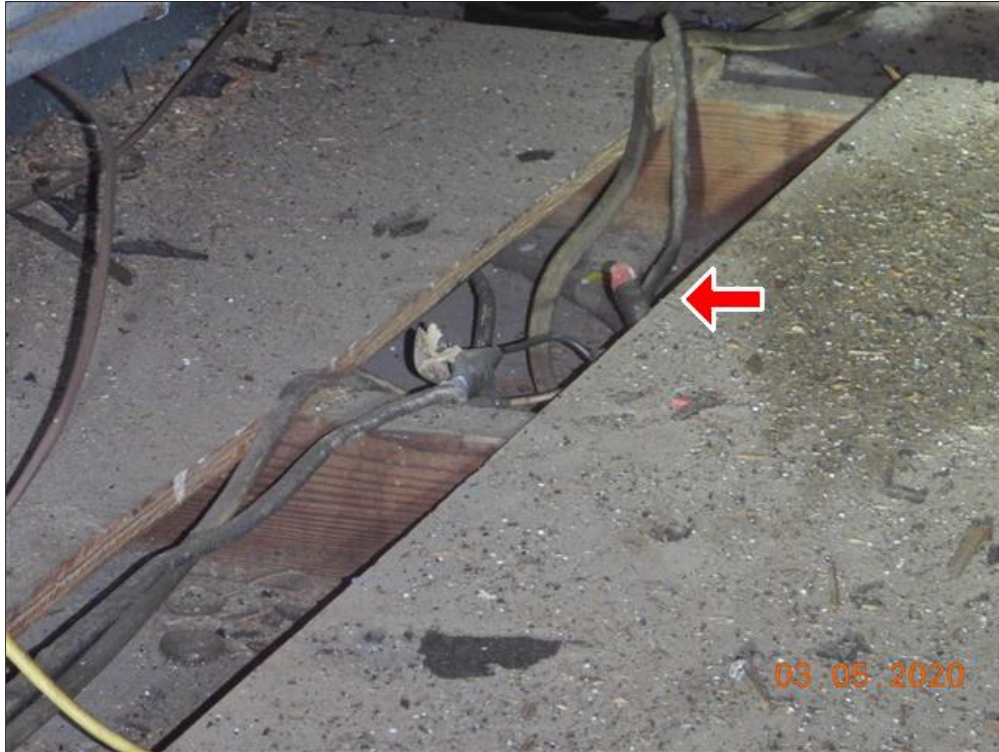
10.0 Item 3(Picture)

(4) D - Live knob-n-tube wiring in garage and house attic, evidence of some updating to "Romex" type wiring is visible in garage and house attic. Percentage of updated newer wiring and older style knob-n-tube is not determine as part of this limited inspection. This is an antiquated type electrical wiring system and is an electrical shock and fire hazard compared to current standards that should be repaired or replaced by a qualified electrician prior to closing of escrow.

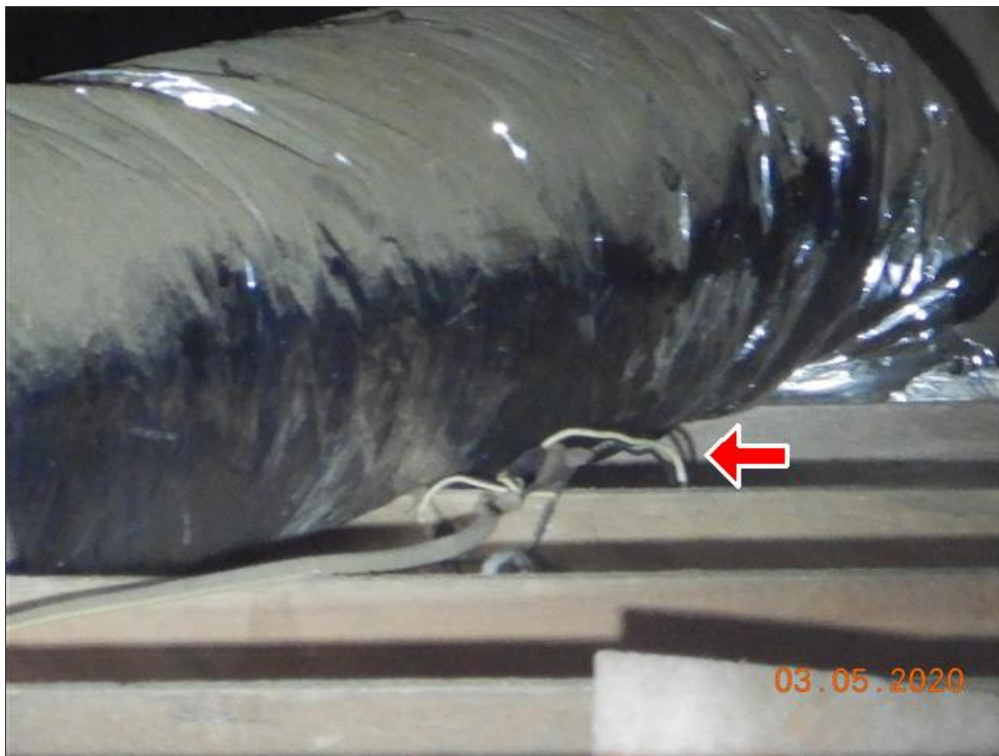
10.0 Item 6(Picture)

(6) D - Open ended live wire splices/open ended wires/loose or non secured junction box(s) , this is an

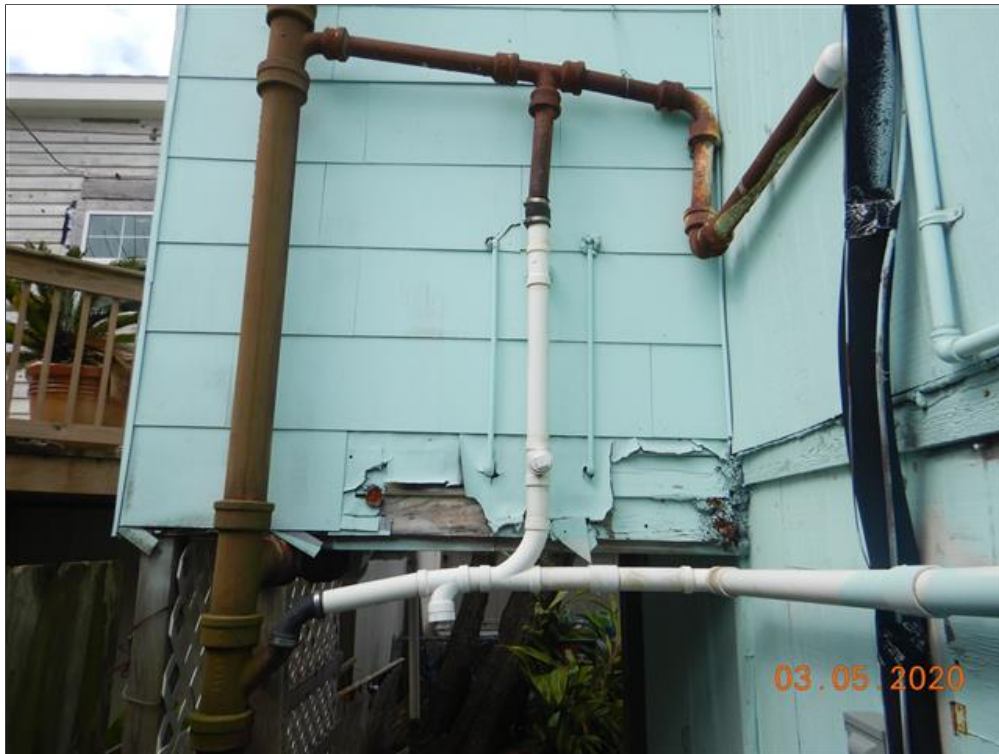
15.0 Item 1(Picture)

(1) C - Complimentary photo (if found) of the main sewer clean-out cap.

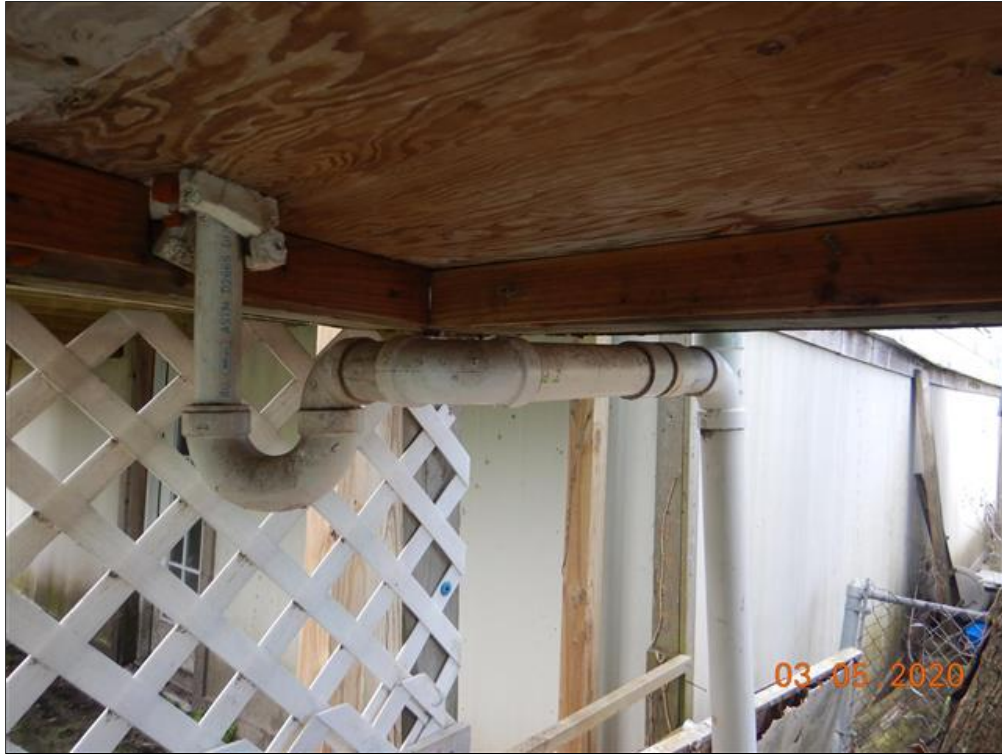
15.0 Item 2(Picture)

(2) D - Kitchen drain pipe is leaking in multiple locations. Recommend full evaluation by qualified plumber prior to closing

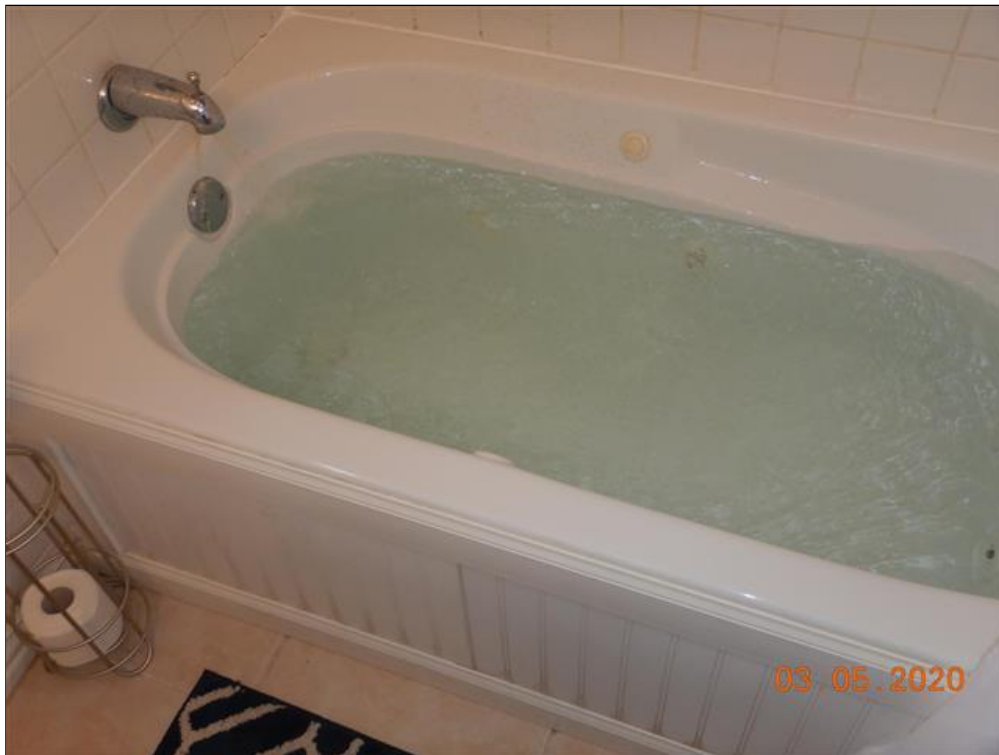
17.0 Item 1(Picture)

(1) D - Unit is not functioning. It is recommend that shower/tub enclosure be fully evaluated or tested by qualified professional prior to closing of escrow.

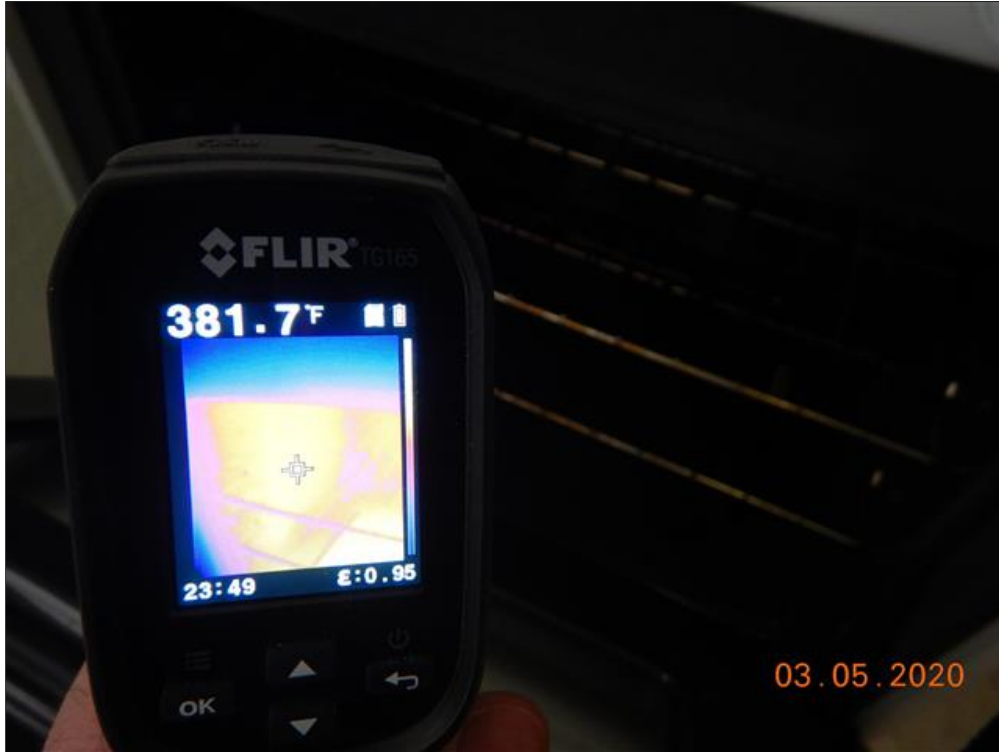
18.3 Item 2(Picture)

(2) D - No anti-tip device installed as required by most current code and Texas Real Estate Commission Standards of Practice. This device when installed properly will help prevent freestanding stove/oven from tipping forward causing a crushing accident.
