Home Inspection Report

6102 Seawall Blvd Unit 158, Galveston , TX 77551

Inspection Date:

Sunday March 21, 2021

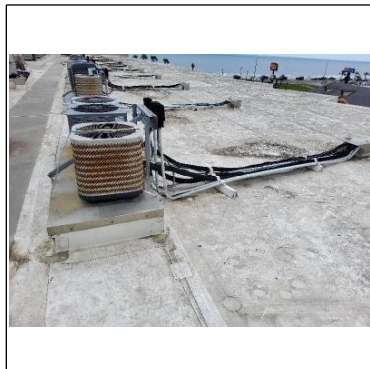
*Comments:*The roof covering materials are typically beyond the scope of inspection for a condo, this is usually the responsibility of the HOA or building representatives.

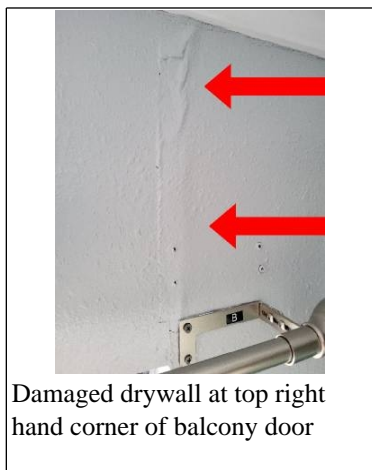
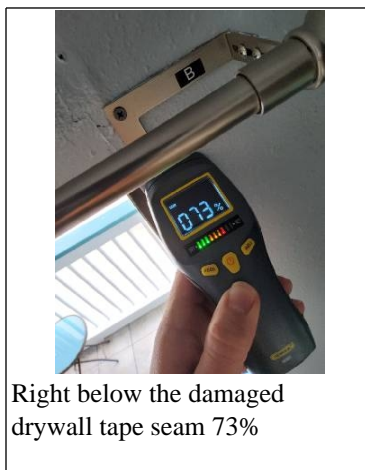
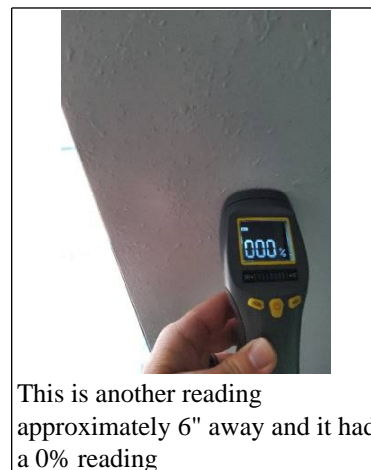
There was damage at a drywall tape seam above the balcony door at the top right side. The area also had a higher moisture reading than the surrounding areas. It is not uncommon for the balconies above to have minor leaks, recommend that further investigation be done and repairs be made as needed.

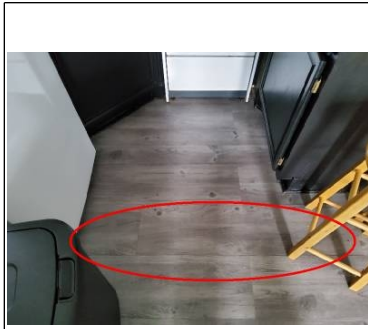
The laminate flooring had a few uneven areas however it is believed that the flooring may have been layed over the top of parts of the previous flooring creating the unevenness. An example of this can be felt at the kitchen threshold.

Unevenness at the kitchen threshold

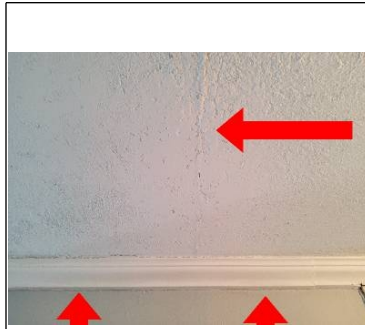
The ceiling was in pretty good shape, there were a few minor issues that need addressed. There is one small crack in the drywall ceiling next to the return air, these are typical and recommended to be patched.

There is also separation of the crown molding throughout various areas of the condo, recommend that these areas be caulked.

Minor crack in ceiling next to return air and example of crown molding separating

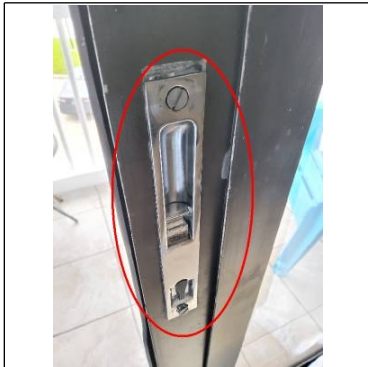
Hardware is loose

Comments: The hardware on the sliding glass door is loose, recommend that it be tightened. The rubber gaskets used to secure the glass are also starting to come loose in various areas, recommend that the gaskets be evaluated for repair. It is recommended that a lubricant such as WD40 or food grade silicone be used to keep the track lubricated so the door slides freely. The locking mechanism for the bathroom door to the hallway did not function properly, recommend that it be repaired. The strike plate on the door to the bedroom needs minor adjustment as the door will not stay fully closed, recommend that it be repaired.

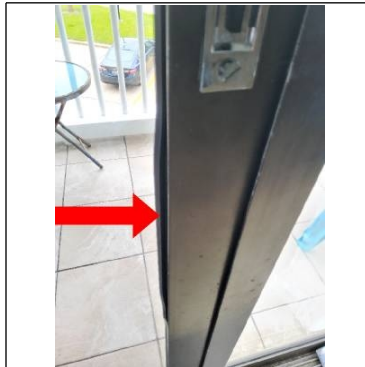
Rubber gaskets are coming loose

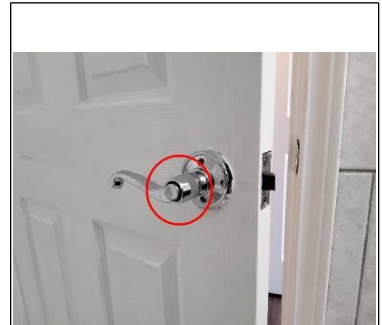
Lock doesn't work in bathroom to hallway

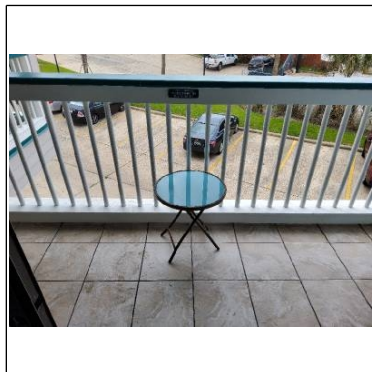
Comments: The balcony on a condo is typically beyond the scope of inspection, the HOA or building representatives usually maintain them as they like to keep the uniformity of the building. The balcony appeared to be in good shape and functioning properly on the day of the inspection. It had secure railing with the proper spacing between the pickets as to not allow an object or sphere 4" or greater to fit between.

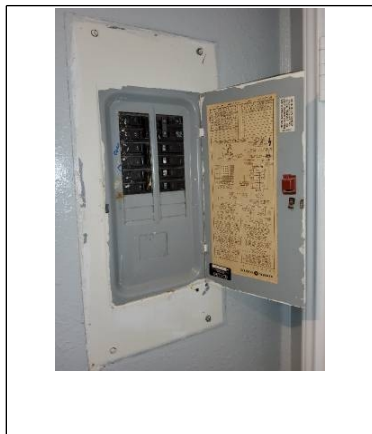
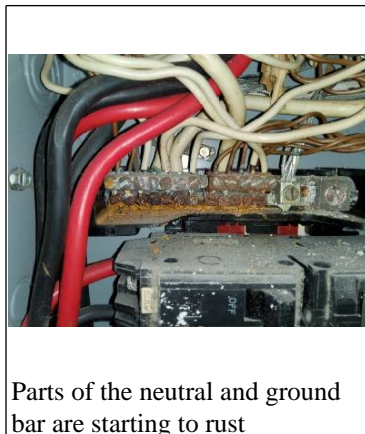
Comments: The breaker box located in the of the condo is a 100amp rated General Electric brand subpanel Box. There is a main breaker located at a service trough on the premises to shut the power off to each condo. The neutral and ground bar were starting to show signs of rusting, recommend that a qualified electrician further evaluate for repair/replacement.

Parts of the neutral and ground bar are starting to rust

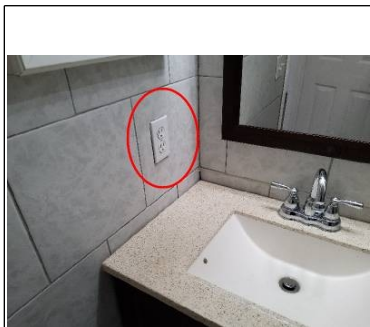
Comments:The outlet in the bathroom next to the sink is recommended to be under the protection of a GFCI since it is in a wet location and is a shock hazard. It is recommended that a qualified electrician place the outlet on a GFCI.

Outlet is near a wet location and needs to be under the protection of a GFCI

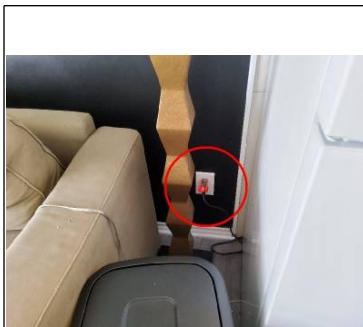
The outlet to the left of the refrigerator near the floor on the northwest wall is wired reverse polarity (hot/neutral backwards), recommend that the outlet be properly rewired.

Outlet to the left of the refrigerator is wired reverse polarity

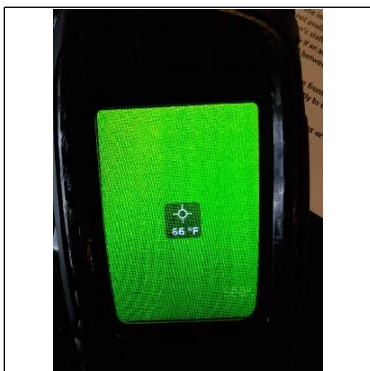
*Comments:*The electrical heating components were functioning properly on the day of the inspection. The supply vent had a temperature reading of 95° while the return air temperature had a reading of 66°giving the system a heat rise of 29°.

Return air temperature reading was 66°

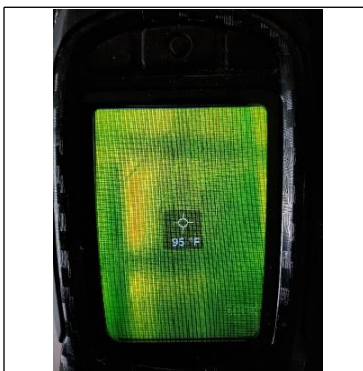
Supply air temperature was read at 95°

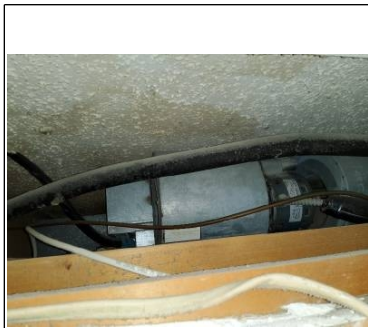
Interior portion of a/c located above the bathroom ceiling

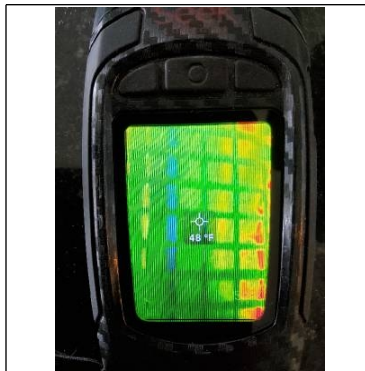
Supply air temperature was 48°

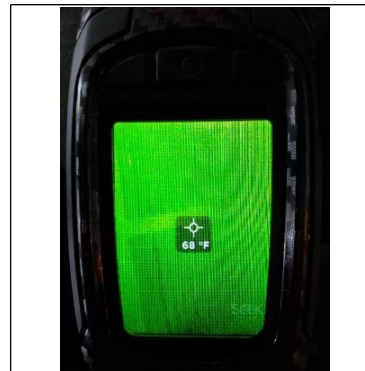
Return air temperature was 68°

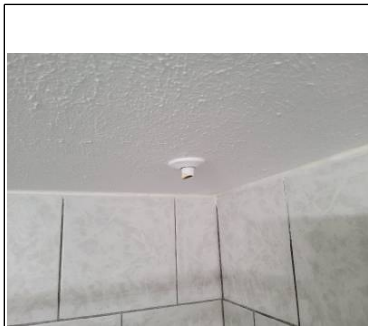
Secondary drain pan overflow above bathtub

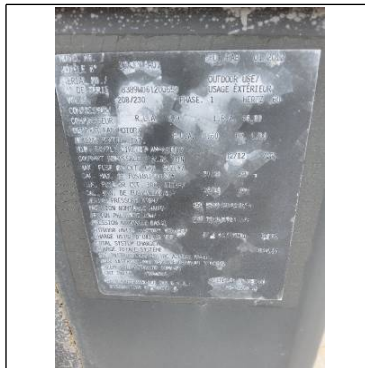
*Comments:*The exterior unit was manufactured in 2012(interior unknown), is rated at 1 1/2 tons and uses the new refrigerant R410A. The cooling system was found to be functioning properly on the day of the inspection and had a temperature differential of 20° between the return(68°) and supply(48°) air. The recommended temperature split is between 16 and 22 . The exterior unit was showing its age as it had a significant amount of rust and corrosion. Exterior air conditioning units typically last 7-12yrs and the current unit is in this age range at 9yrs old, one cannot predict the remaining life expectancy however it is recommended that it be budgeted for replacement in the near future.

Exterior unit was manufactured in 2012, is rated at 1 1/2 tons and uses the newer refrigerant R410A

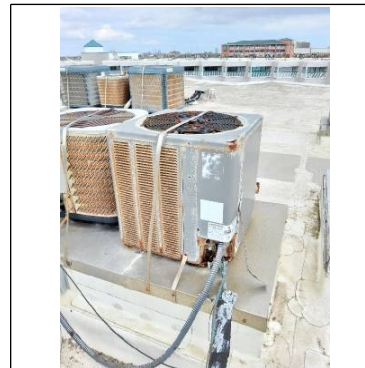
Exterior unit was showing signs of age with rust and corrosion

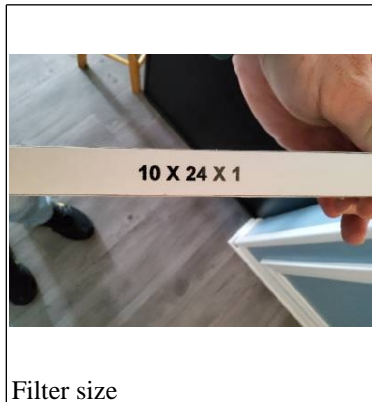
The filter does need to be replaced, filter size is 10x24x1.

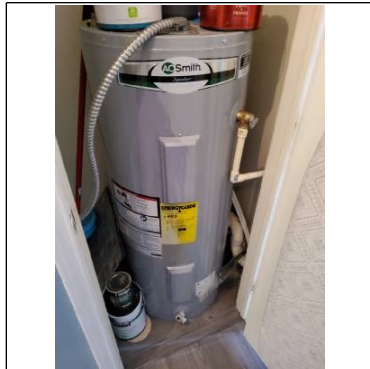
AO Smith brand unit

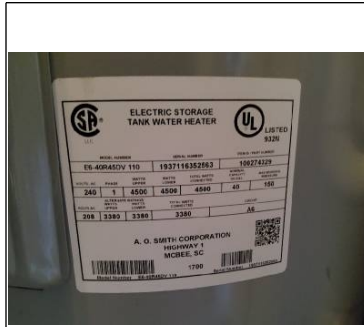
Water heater was manufactured in 2019 and is rated at 40 gallons

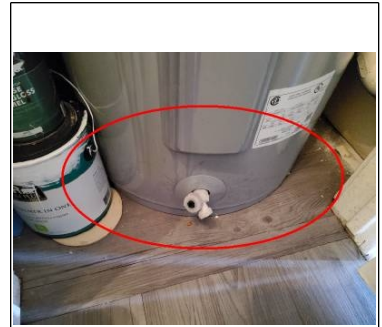
Comments: The AO Smith brand water heater was manufactured in 2019 and is rated at 40 gallons. The unit was functioning properly on the day of the inspection however it is missing a safety pan. It is recommended that a qualified contractor place a safety pan under the appliance with an alarm attached to the pan. A safety pan provides protection against a leak and the alarm will alert the occupant that there is an issue.

No safety pan

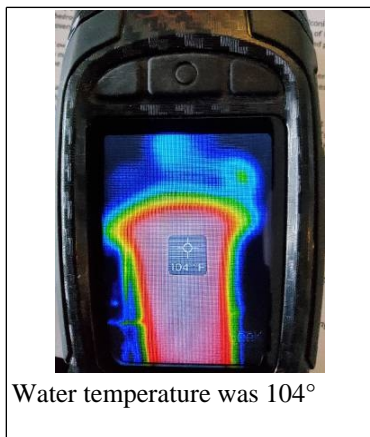
Water temperature was 104°

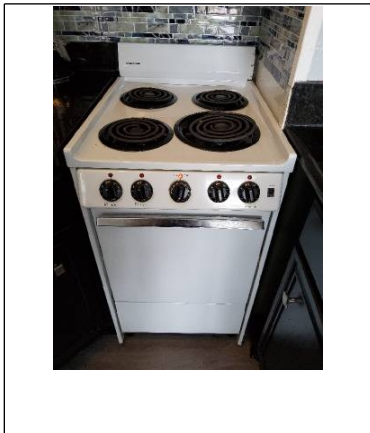
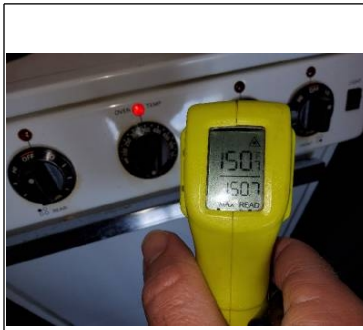
Comments:The GE brand oven was set to 350 and when the temperature was read it was 476°. The oven thermostat likely is not functioning properly. The appliance was also allowing a lot of heat to escape as the oven knobs had a 150° reading coming from them, the oven likely is in need of replacement.

Oven knobs were hot and read 150°

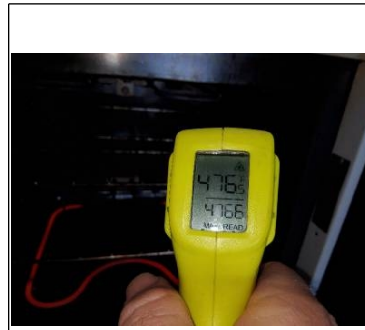
Oven temperature read 476° on the side of the unit, too hot

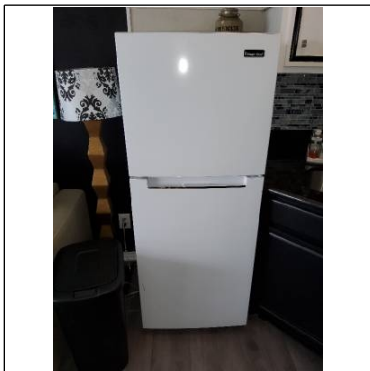
Comments: The Magic Chef brand refrigerator was functioning properly on the day of the inspection and had the proper temperature readings for the cooling(43°) and freezer(13°) sections.
