Inspection Report

Property Address:
8 Howell Ct
Beaumont TX 77706

PROPERTY INSPECTION REPORT FORM

Subash Behara	8/31/2023
<i>Name of Client</i>	<i>Date of Inspection</i>
8 Howell Ct, Beaumont, TX 77706	
<i>Address of Inspected Property</i>	
Joe Askew	TREC# 0010495
<i>Name of Inspector</i>	<i>TREC License #</i>
<i>Name of Sponsor (if applicable)</i>	<i>TREC License #</i>

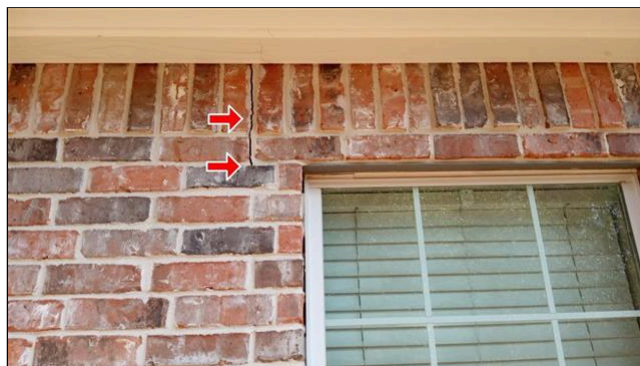
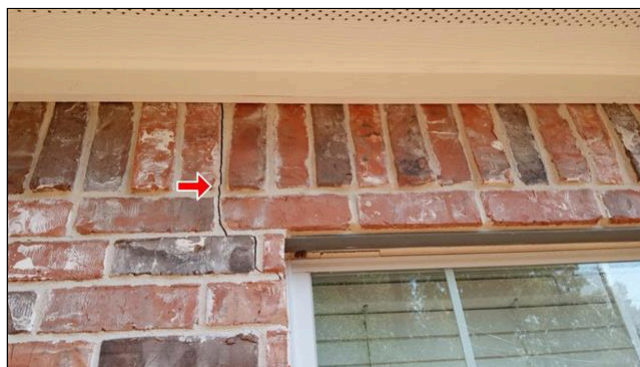
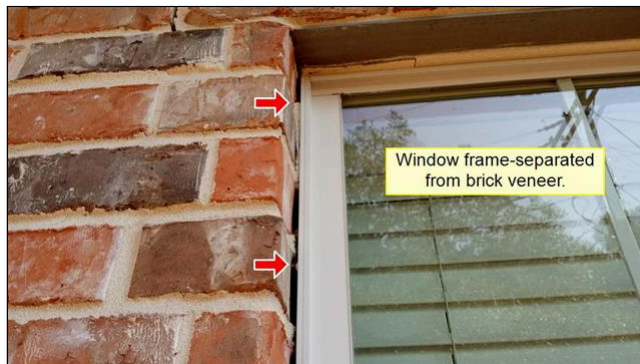
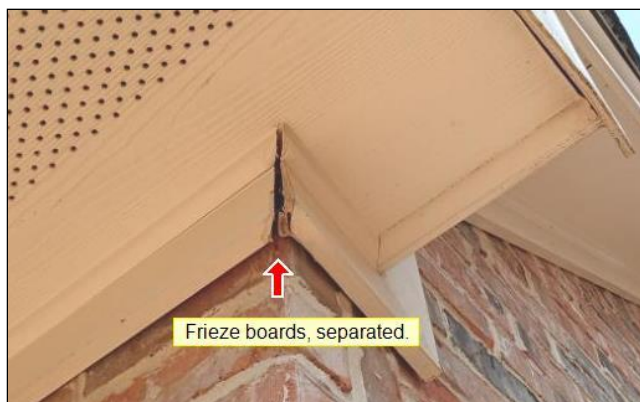
(1) Some evidence of settlement was noted at the right side of the home.

-Brick veneer cracking was observed above two windows.

-Cracked tile were noted near the front of the primary bathroom (also on right side of home).

-The frieze boards at the rear right corner were separated.

It is not unusual to find evidence of settlement in homes of this age in the area. Client may wish to have checked to determine if stabilization/repair is needed.

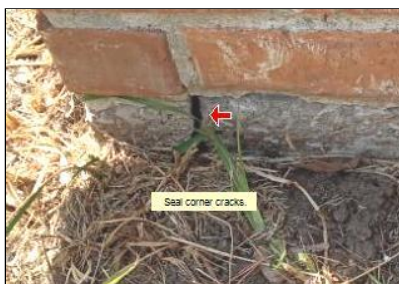
A. (Picture 5)

(2) Cracks were detected on the corners of the concrete slab-(commonly referred to as "corner cracks"). These cracks are common in "post-tension" and monolithic concrete slab foundations. The cracking is mostly due to the properties of the concrete and how it dries after pouring. Expansion properties in the brick veneer can also cause these cosmetic blemishes. As these cracks can continue past the finish grade, it is recommended to caulk or seal these cracks to prevent insect infestation.

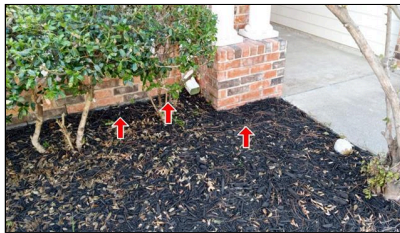
B. (Picture 1)

(1) High soil line was noted around portions of the front exterior of home. This is conducive to moisture intrusion, pests, and wood destroying insects. Recommend maintaining a 4-6 inch clearance from the ground to the bottom of the brick veneer/siding and at least 1 foot between vegetation and home. The ground should also be graded to allow rain to drain away from the home.

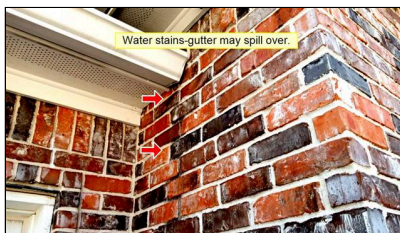
B. (Picture 2)

(3) The gutter at the front of the garage may need to be adjusted. It water stains were noted at the adjacent wall. This can likely be corrected by simply re-pitching the gutter.

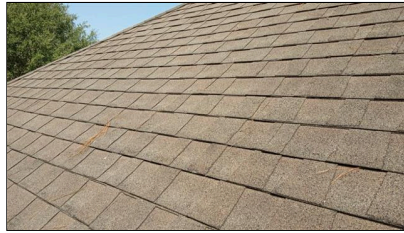
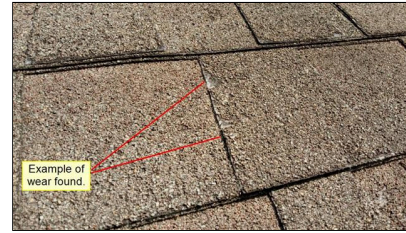
(1) Architectural shingles present. No shingles were forcefully lifted due to possible damage. Fasteners were evaluated from the attic/interior side of decking as best as possible. Visible wear/granule loss was noted in areas. See close up pictures of shingles for example of wear found.

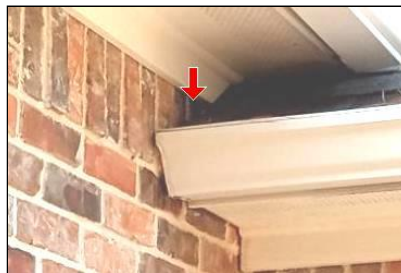
C. (Picture 4)

(2) Inspector did not observe a visible flashing at the roof-to-brick transitions.

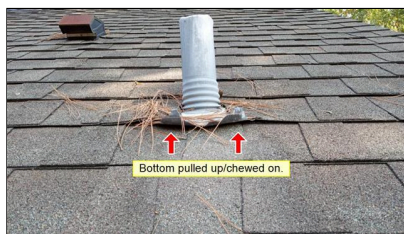
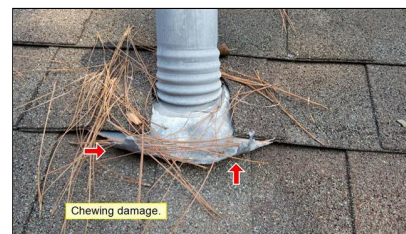
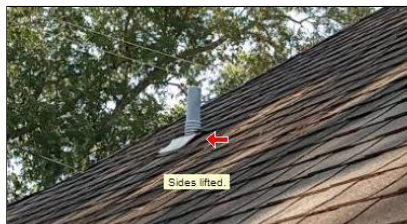
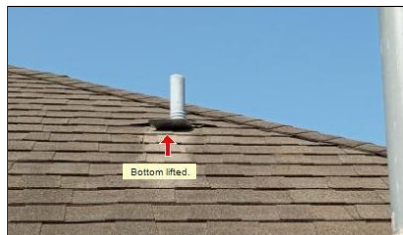
(3) Multiple damaged lead vent flashings were present. This appears to be due to rodent/squirrel activity. Recommend having repaired as necessary by a qualified roofing contractor.

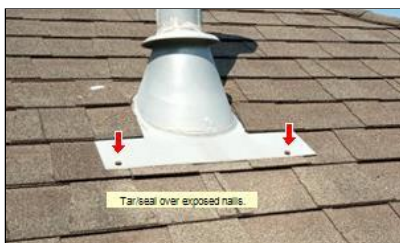
C. (Picture 9)

(4) Inspector recommends tarring/sealing over any exposed nails. This is a maintenance suggestion for your information.

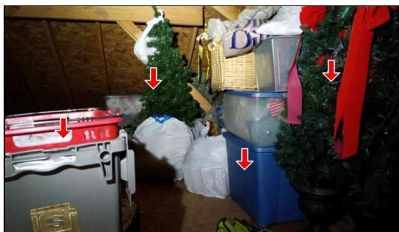
D. (Picture 1)

(2) Inspector had limited access to attic due to lack of clearance and obstructions. . The chimney penetration area was also not accessible. No determination/evaluation could be made of structural components, conditions, or building materials in inaccessible areas.

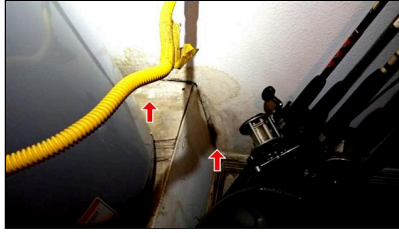
E. (Picture 4)

(2) The wall/trim adjacent to the water heater exhibited evidence of moisture intrusion.

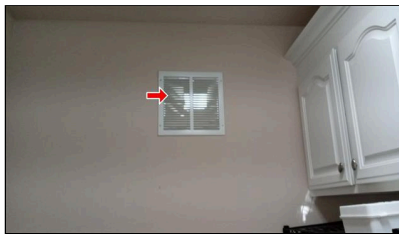
E. (Picture 5)

(3) Inspector recommends repairing the hole in the wall between the washroom and garage. This hole is currently allowing air/gases/etc from the garage to enter the home. It is also a break in the fire separation between the house and garage.

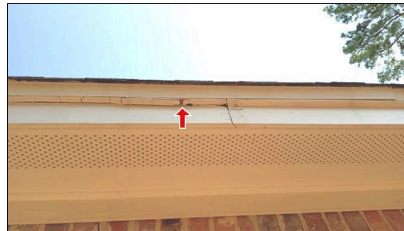
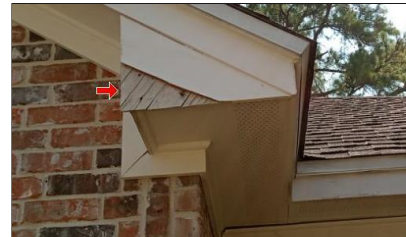
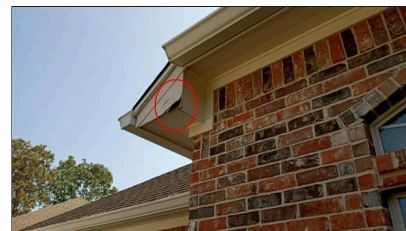
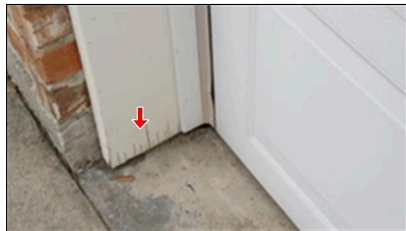
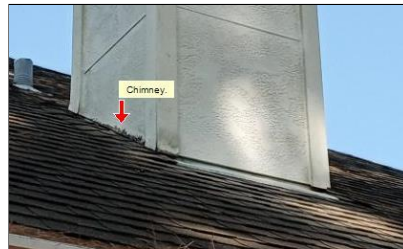
(4) The exterior of the home could benefit from maintenance/repair in areas.

Rot was noted at the fascia/behind the drip edge flashing in some locations.

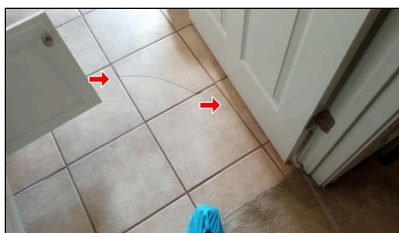
F. (Picture 1)

(1) Cracked tile were noted at the primary bath.

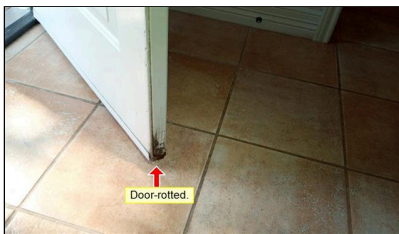
G. (Picture 1)

(6) The left side back door was rotted at the bottom.

This appears to be related to the grading of the concrete at the adjacent exterior.

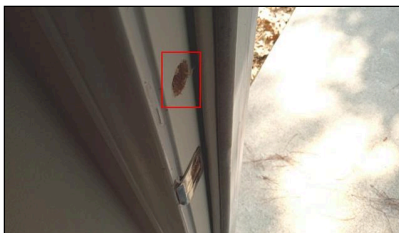
G. (Picture 2)

(7) The left side back door was missing a strike plate.

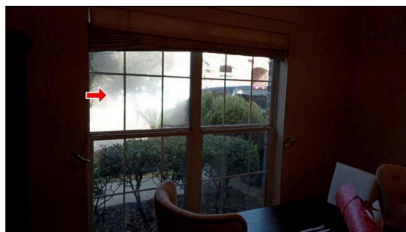
H. (Picture 1)

(1) Evidence found of the failure of the seal on insulated windows at various areas of home (including, but not limited to: one at dining area, one over front door, one over rear right window at the den). While not readily apparent at the time of inspection, other insulated-glass units may have also failed. Client may wish to have a window installation contractor take inventory if it is a concern. As these type windows age and are exposed to UV light, the sealing material eventually fails, allowing moisture to enter. This has little effect on the efficiency of the window, however, it is cosmetically undesirable.

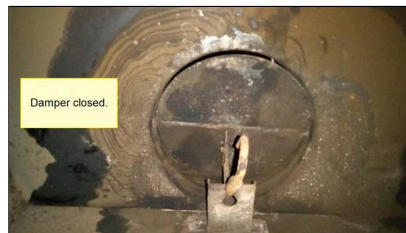
J. (Picture 2)

(2) It is recommended that homes with gas logs and/or log lighters have a metal clamp installed on the damper to prevent it from closing completely. The clamp creates a gap intended to ensure some ventilation if a fire is lit and the home owner forgets-to open the damper (even if electronic safeties are in place). The Texas Real Estate Commission has asked inspectors to inform clients of this recommendation. *This clamp is a safety device used with gas units that can be purchased at most home improvement stores and is easy to attach.*

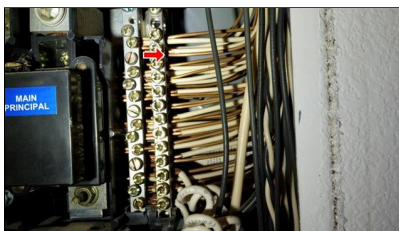
A. (Picture 3)

(2) Some of the neutral wires were double-tapped at the bus bar. There should be one neutral wire per lug. Each grounded conductor shall terminate within the panel board in an individual terminal that is not also used for another conductor ref. NEC 2002 408.21, NEC 2005 408.41. Recommend correction as necessary by an electrical contractor.

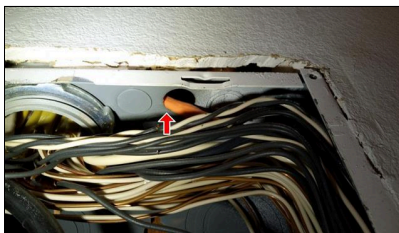
A. (Picture 4)

(3) One of the wires exiting the panel box is in contact with the edge of the knock-out hole, which can cut/damage the insulation. This wire should be protected by a bushing. Recommend correction.

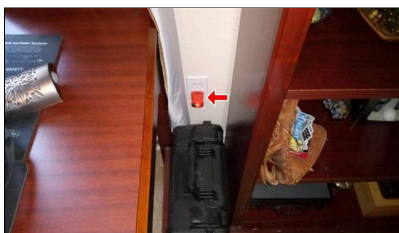
B. (Picture 2)

(3) Two receptacles in the front right bedroom tested as "open ground". Recommend having corrected as necessary.

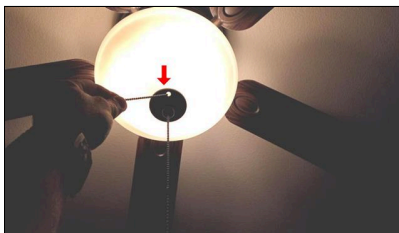
B. (Picture 3)

(4) The fan speed pull chain was stuck at the ceiling fan in the front right bedroom.

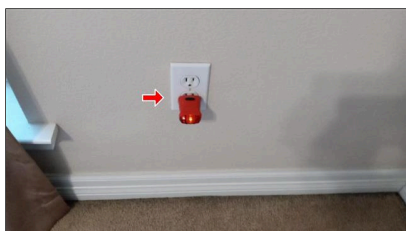
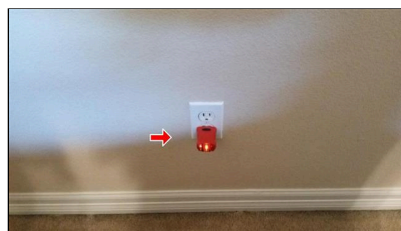
(5) Two receptacles in the front middle bedroom tested as reverse polarity. Recommend having corrected as necessary.

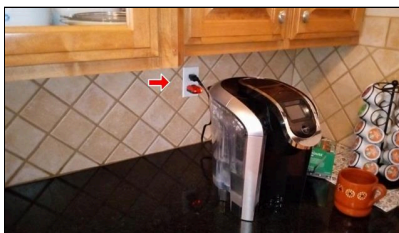
B. (Picture 6)

(6) One receptacle at the kitchen countertop tested as "hot-ground reversed". Recommend having corrected as necessary.

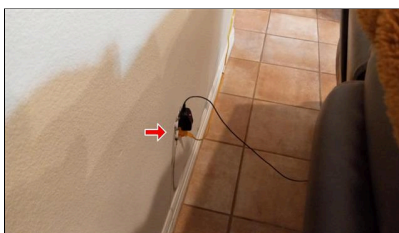
B. (Picture 7)

(9) A receptacle at the front of the den was missing its cover.

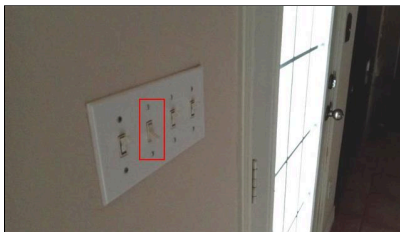
B. (Picture 8)

(10) One switch to the left of the back door at the den was not wired properly. Client may wish to have checked.

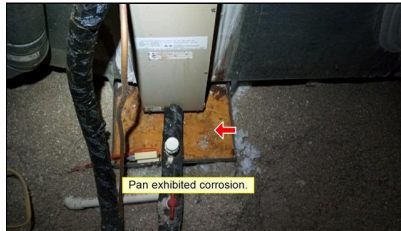
B. (Picture 2)

(2) The catch pan under the AC unit exhibited corrosion.

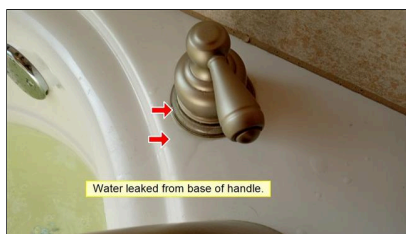
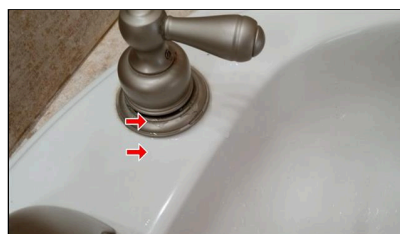
(3) Water leaked from the base of the cold water supply handle at the rear sink fixture in the primary bath.

Water leaked from the base of the hot water supply handle at the jetted tub fixture.

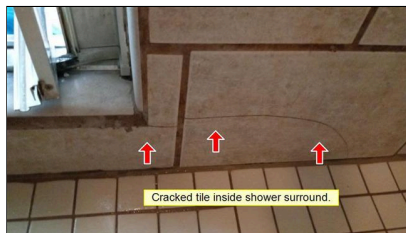
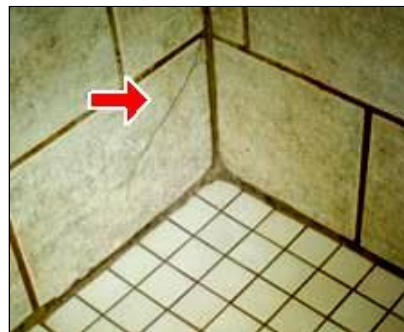
(4) Cracked tile were noted near the bottom of the shower surround at the primary bath. This is a potential concern. Recommend having checked/repared as necessary by a qualified contractor.

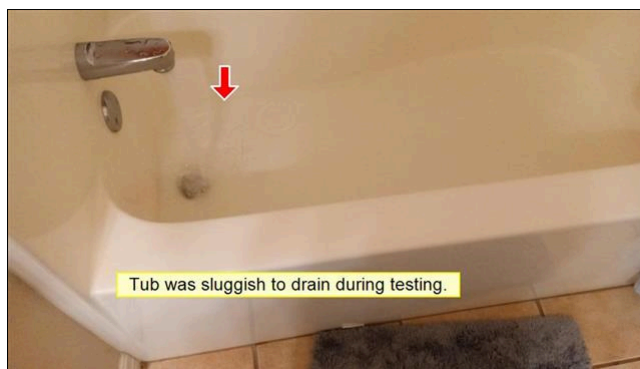
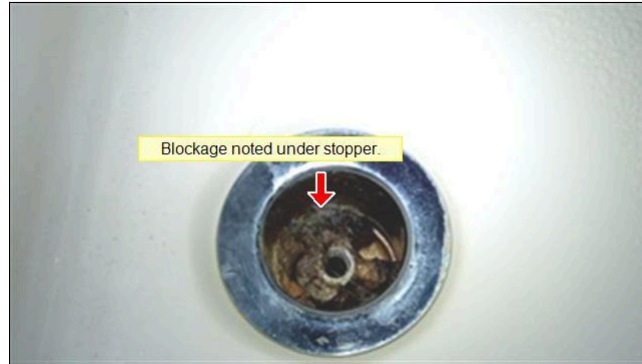
(1) The tub at the hall bath was slow to drain. This appears to be due to a blockage under the stopper (hair ball observed).

A sluggish or blocked drain may indicate a localized concern or may be related to the condition or flow of branch or main waste lines. Shower/tub drains are prone to recurring blockage from hair and soap buildup. Have checked by a qualified plumber to determine whether cleaning or other corrective measures are required.

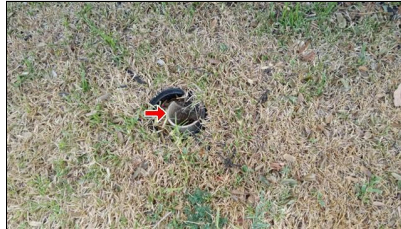
B. (Picture 3)

(2) A damaged/uncapped pipe was noted at the right side of the front yard. This pipe appears to be for a valve. Inspector was not able to verify due to the pipe being full of debris. Client may wish to have checked as a precaution.

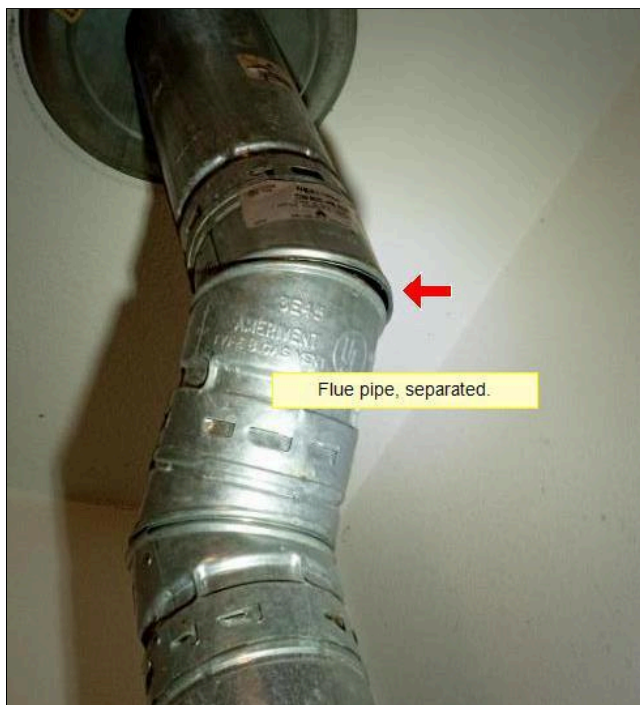
C. (Picture 3)

- (2) The water heater was installed without a catch pan/drain. Client may wish to add.
- (3) Part of the flue pipe for the water heater was separated. Recommend having corrected by a qualified contractor.

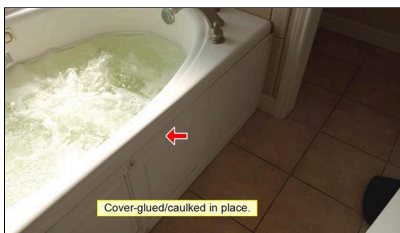
D. (Picture 3)

(2) No access door found for servicing and/or inspecting motor/mechanisms of jetted tub. If the tub requires work the front decorative cover will have-to be removed (panel is currently glued/caulked-on).

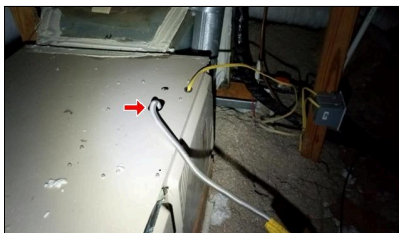
E. (Picture 1)

(3) The furnace is installed with a flexible gas line connector. Although unlikely, this flexible line can be damaged over time if it contacts the metal enclosure of the furnace (due to the vibration of the equipment). The typical fix for this would be simply extending outside the furnace enclosure with a rigid gas pipe, then connecting to the flexible line. The Texas Real Estate commission has asked inspectors to rate this as a deficiency (when these flex lines enter the furnace enclosure). Recommend having corrected by a qualified professional (relatively easy fix).

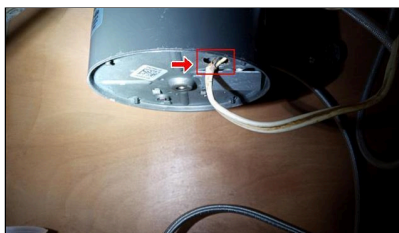
B. (Picture 1)

(1) The food disposer wiring is missing a romex connector (anti-strain device). Recommend repair as needed.

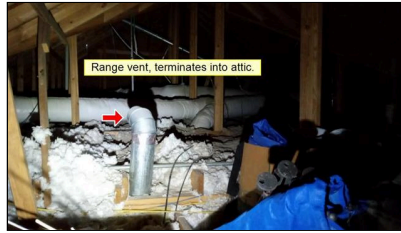
C. (Picture 1)

Range vent was found to terminate into attic. Kitchen exhaust fan vents should not discharge into the attic area. Recommend correction by a qualified contractor.

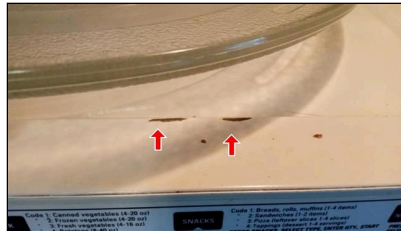
E. (Picture 1)

(1) Some finish damage/corrosion was noted inside the microwave.

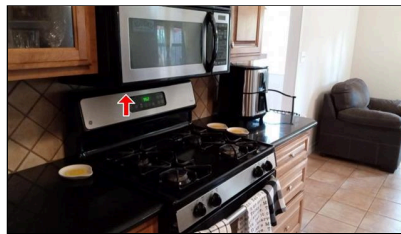
E. (Picture 2)

(2) The microwave was mounted lower over the range than typically encountered.
