RE: Job # 22-50073
2605 Clark Lane
Orange, Texas 77632

Subject: Structural Inspection

Description of the Building: Main House

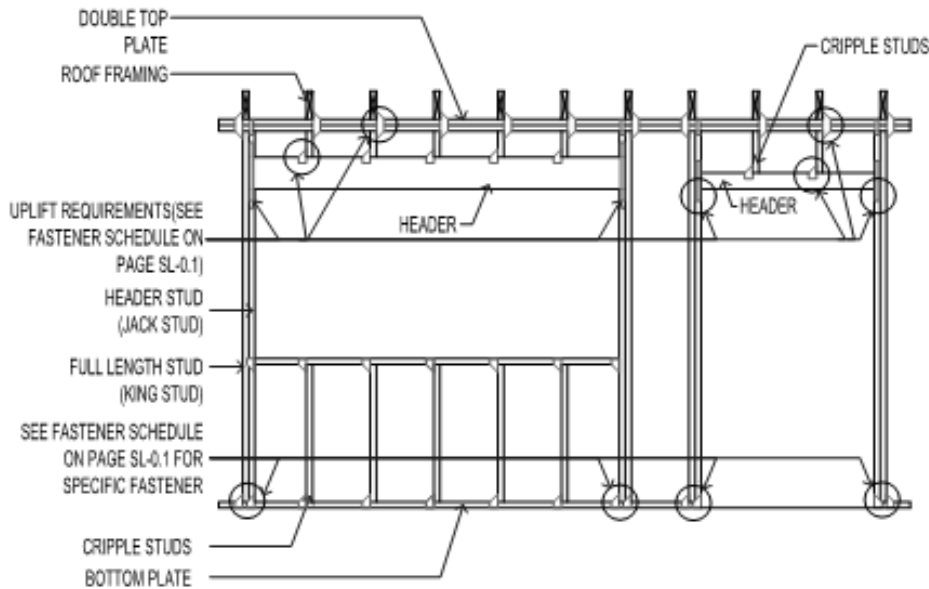
DT-68 FRAMING AND CONNECTIONS FOR OPENINGS

Stud wall/ header framing: The wall framing consisted of 2x6 syp for the sole plate, studs @ 16” o.c., and double top plate. The rafters are 2x6 syp @ 16” o.c. We found that the studs were missing clips and/or strapping, from the top plate to stud and stud to sole plate. We found that the header on the exterior load bearing walls were 2x6 syp boxed in. The 2x6 headers are undersized for supporting the loads from above. The headers are not strapped or clipped to the studs. The ceiling joists are 2x6 syp. The 2x6 rafters are resting on the top plate. The rafters are not strapped properly. Every other rafter had a H2.5A installed from rafter to top plate. This is not typical for a windstorm design. These straps are crucial for creating a continuous load path to the foundation.

Stud wall/ header framing: The wall framing consisted of 2x6 syp for the sole plate, studs @ 16" o.c., and double top plate. The rafters are 2x6 syp @ 16" o.c. We found that the studs were missing clips and/or strapping, from the top plate to stud and stud to sole plate. We found that the header on the exterior load bearing walls were 2x6 syp boxed in. The 2x6 headers are undersized for supporting the loads from above. The headers are not strapped or clipped to the studs. The ceiling joists are 2x6 syp. The 2x6 rafters are resting on the top plate. The rafters are not strapped properly. Every other rafter had a H2.5A installed from rafter to top plate. This is not typical for a windstorm design. These straps are crucial for creating a continuous load path to the foundation.

It is recommended to add Simpson H2.5A clips from top plate to stud and from stud to sole plate @ every stud location. Replace headers according to the span legend below. Add Simpson LSTA18 straps on each side of the headers. See DT-68 framing and connections for openings detail for guidance. Add Simpson H2.5A clips from every rafter to double top plate.
