Invasive Stucco Inspection

Brooke Sankey
904 W 18th St Unit D
Houston, TX 77008

October 12, 2021

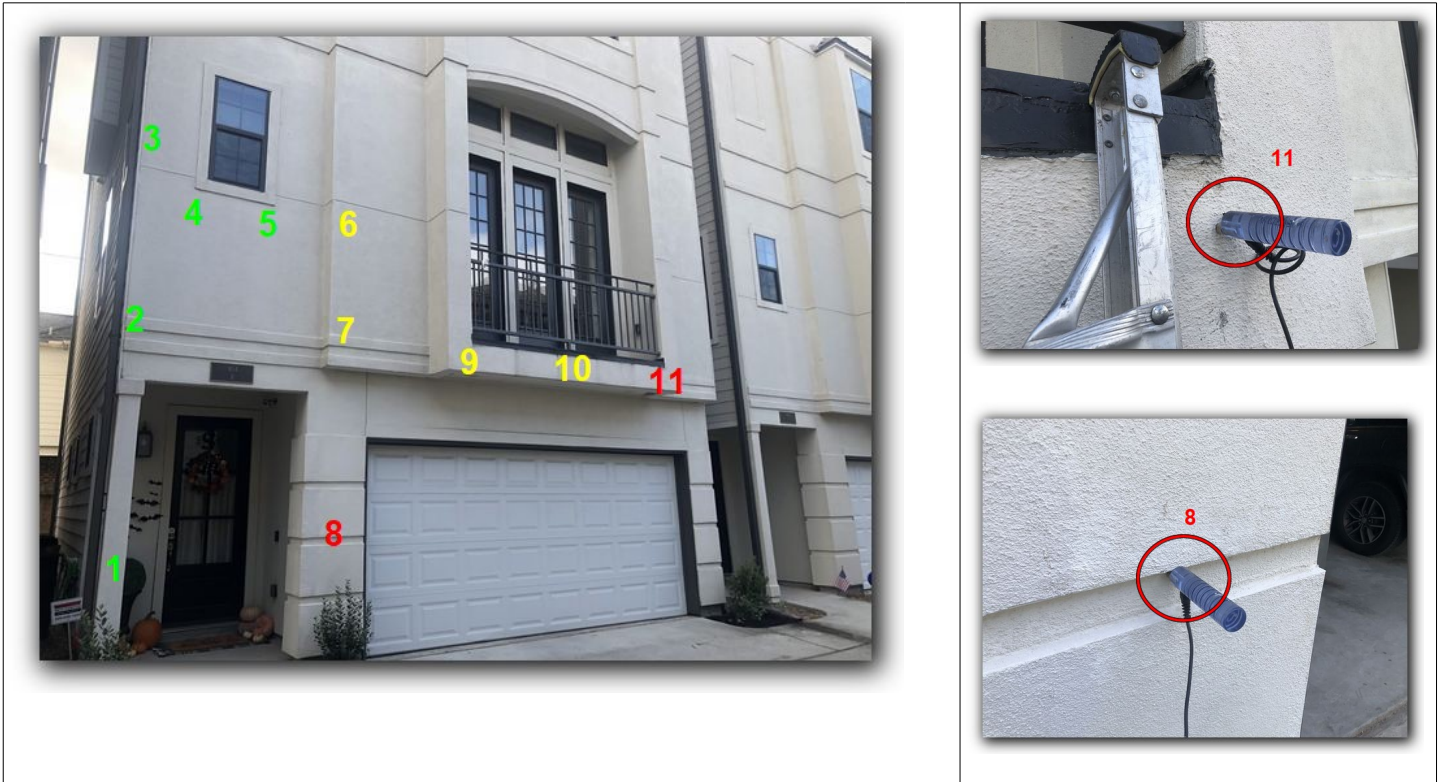
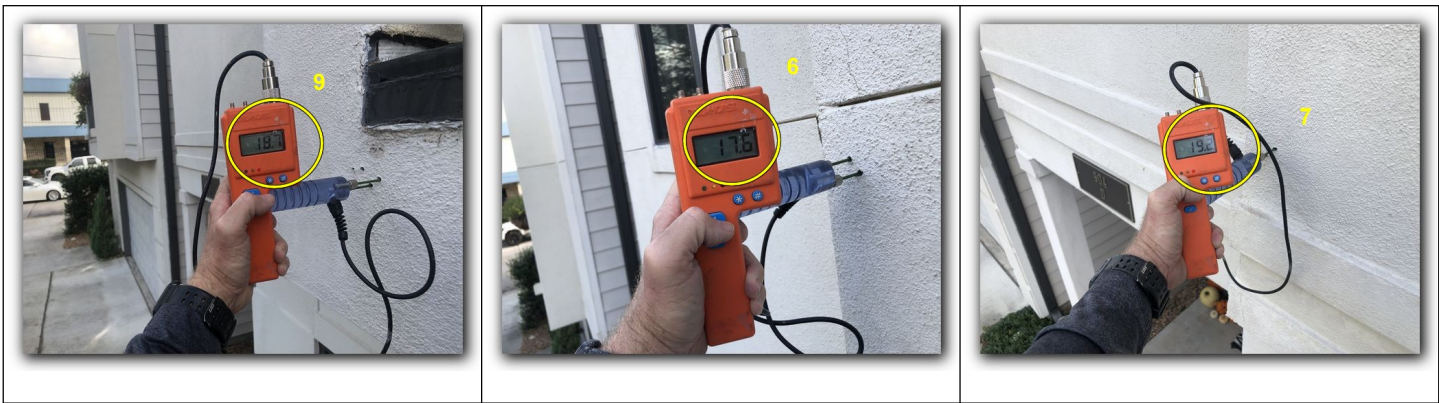
Front Elevation 1

Location	Moisture Reading	Substrate Condition	Observations / Comments
1	Low	Firm	Cracks and deteriorated sealant
2	Low	Firm	
3	Low	Firm	
4-5	Low	Firm	Deteriorated/missing sealant
6-7	Mid Range	Semi Soft - Damage	Cracks and deteriorated sealant
8	High	Soft - Damage	"
9-10	Mid Range	Semi Soft - Damage	Missing weep screed/Missing diverter/end dam flashing/Deteriorated/missing sealant
11	High	Soft - Damage	"

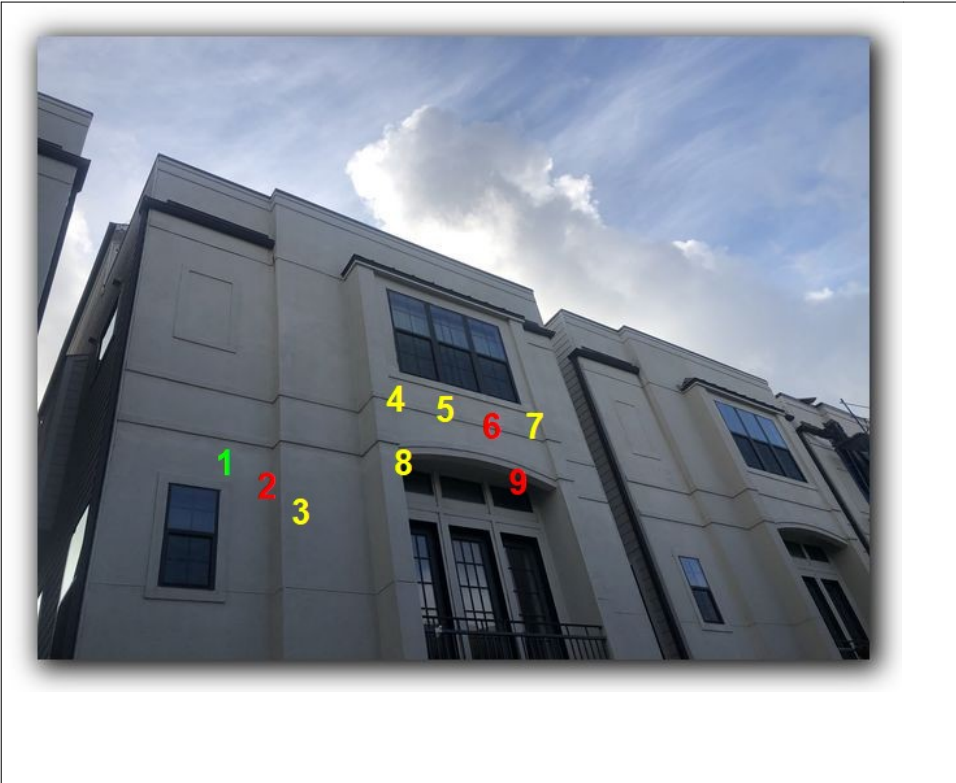
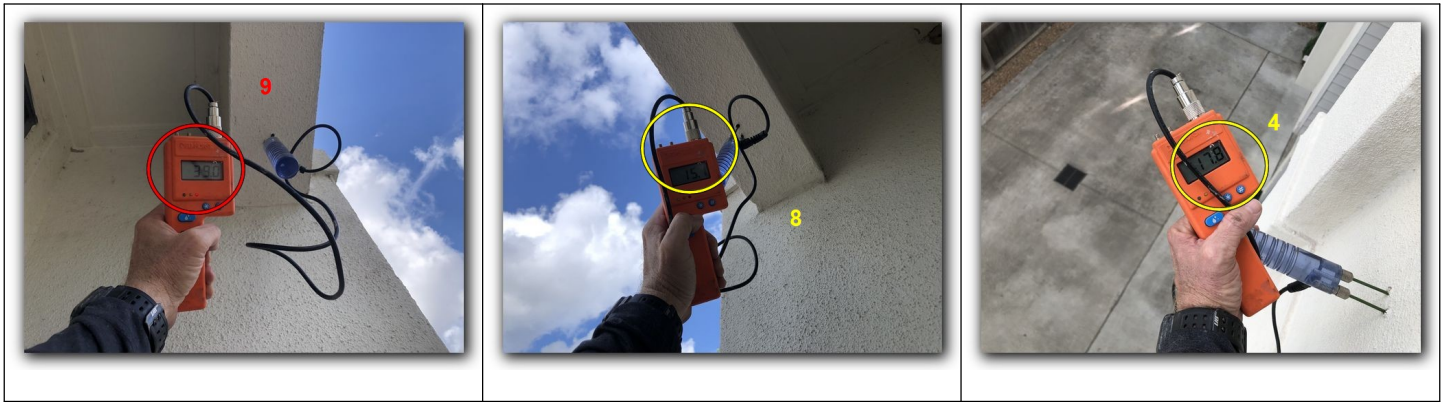
Front Elevation 2

Location	Moisture Reading	Substrate Condition	Observations / Comments
1	Low	Firm	
2	High	Soft - Damage	Cracks and deteriorated sealant
3	Mid Range	Semi Soft - Damage	Cracks and sealant missing
4-5	Mid Range	Semi Soft - Damage	Missing weep screed/Cracks and deteriorated sealant
6	High	Soft - Damage	"
7	Mid Range	Semi Soft - Damage	"
8	Mid Range	Semi Soft - Damage	"
9	High	Soft - Damage	"

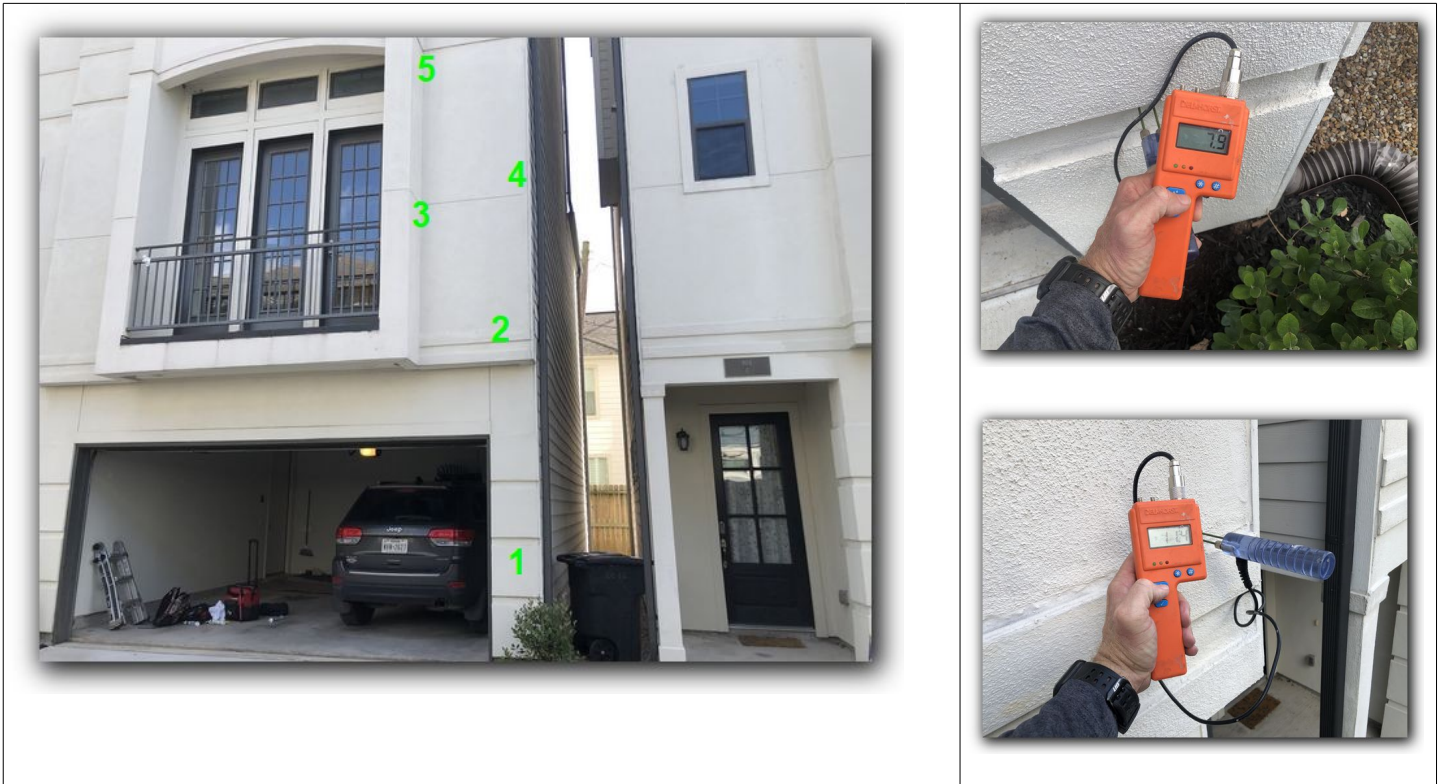
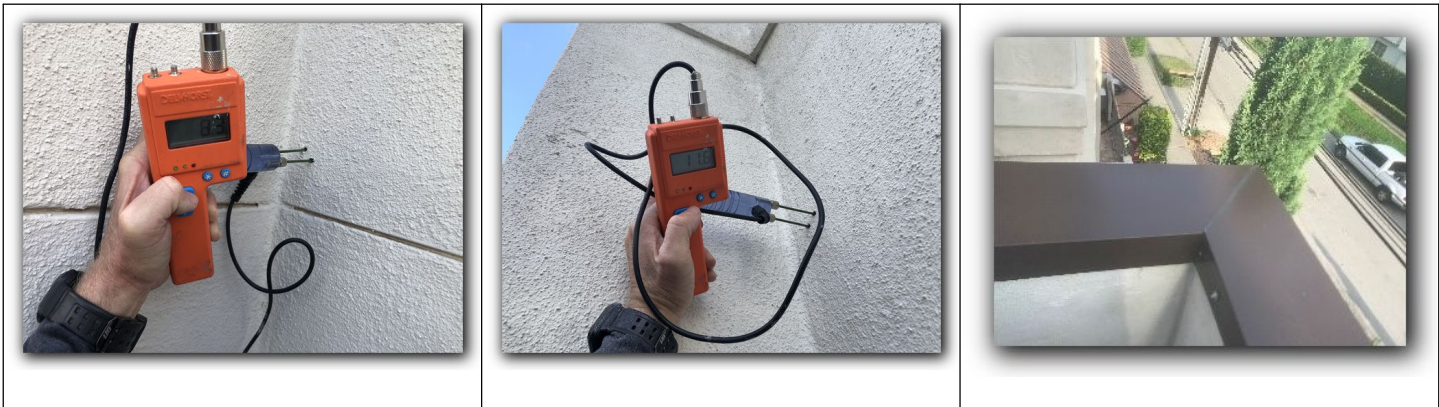
Front Elevation 3

Location	Moisture Reading	Substrate Condition	Observations / Comments
1	Low	Firm	
2	Low	Firm	
3	Low	Firm	Cracks and sealant missing
4	Low	Firm	Deteriorated/missing sealant
5	Low	Firm	Cracks and sealant missing

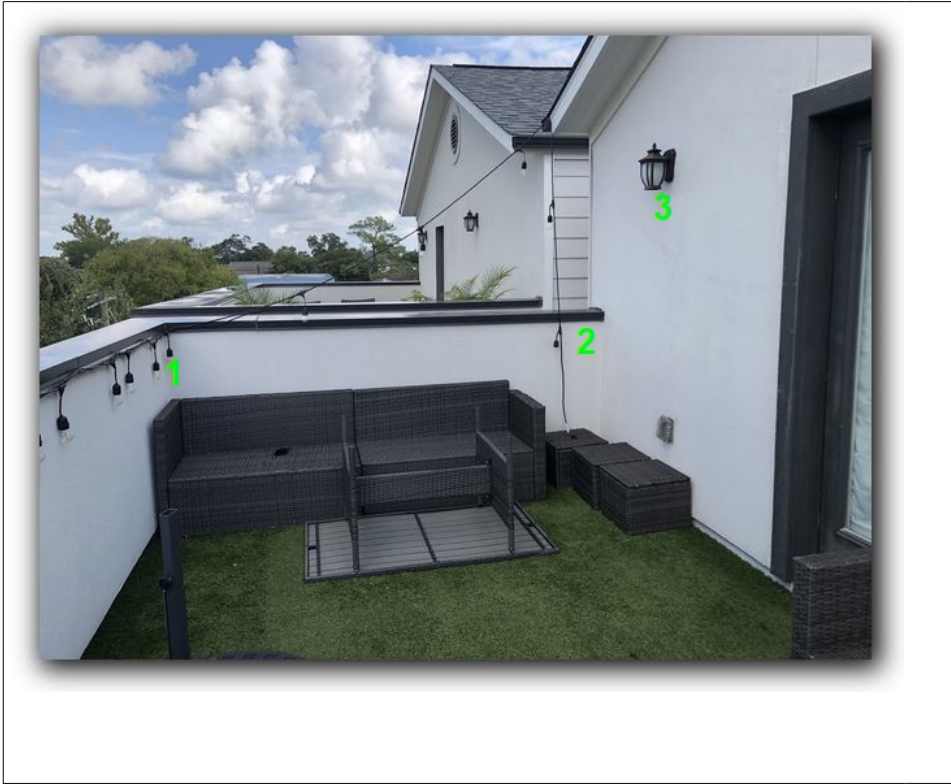
Roof Top 1

Location	Moisture Reading	Substrate Condition	Observations / Comments
1	Low	Firm	Deteriorated/missing sealant
2	Low	Firm	Deteriorated/missing sealant
3	Low	Firm

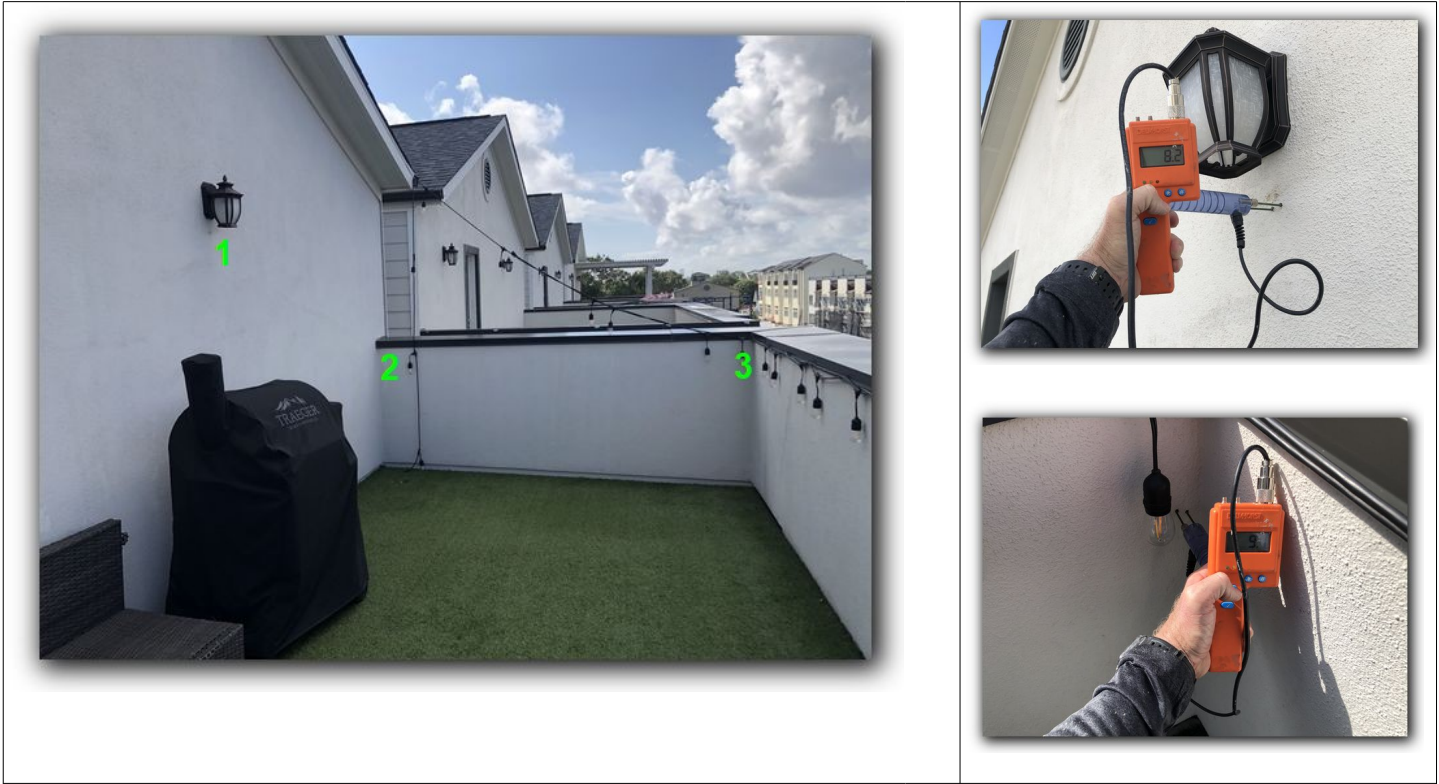
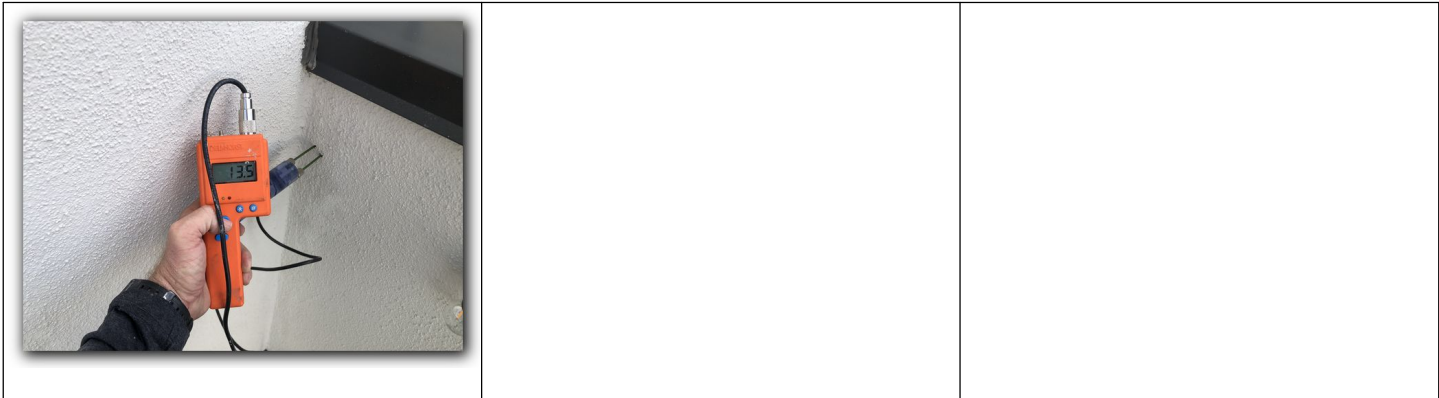
Roof Top 2

Location	Moisture Reading	Substrate Condition	Observations / Comments
1	Low	Firm	
2	Low	Firm	Deteriorated/missing sealant
3	Low	Firm	Deteriorated/missing sealant

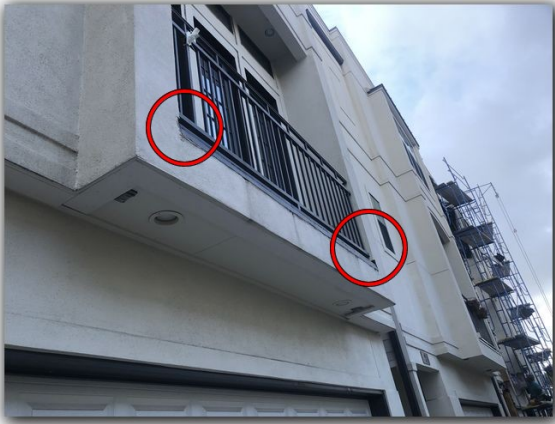
1.1

1. End dam flashing is not present / visible at the balcony wall terminations.

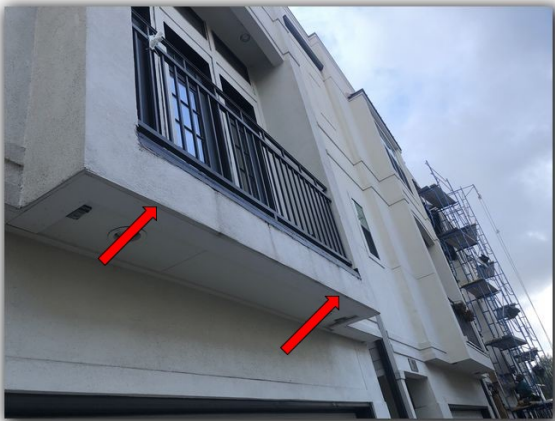
2.1

2. Missing weeps / vents / drainage openings were found during the inspection. This has led to elevated moisture within the wall cavity at the substrate and damaged. Repairs should include repairs to the substrate and installation of weeps / drainage openings.

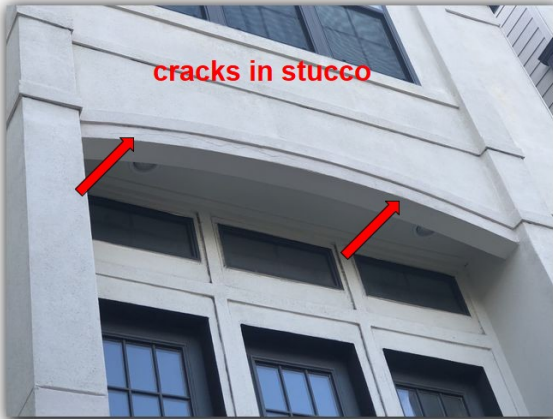
3.1

3. Cracking was found at sections of the stucco walls. The below photos are a sampling of the cracks found, but do not represent all cracking. Recommend repairs by a qualified contractor.

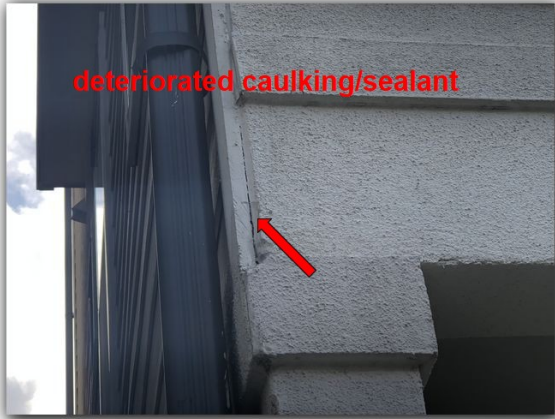
4.1

4. The sealant / caulking which has been used to seal areas at joints, transitions, and voids on the exterior veneers are starting to deteriorate as evident by cracking and/or shrinkage around these areas. This material acts as a moisture barrier to prevent water from moving to the underlying wall cavity and should be continuously monitored and maintained. It is recommended that a qualified tradesman be contacted to evaluate and determine if the re-sealing of the exterior veneers should be considered.

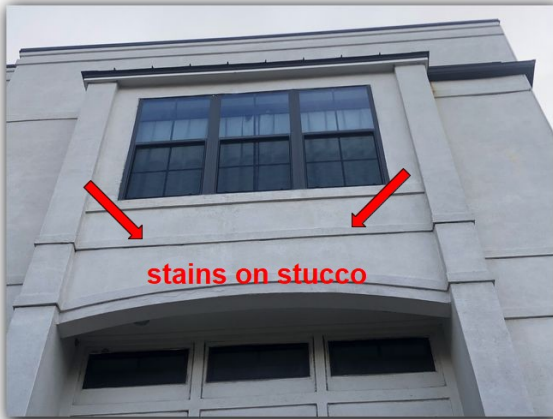
5.1

5. Discoloration was noted at portions of the stucco veneer surfaces which could indicate moisture behind the stucco base coat.

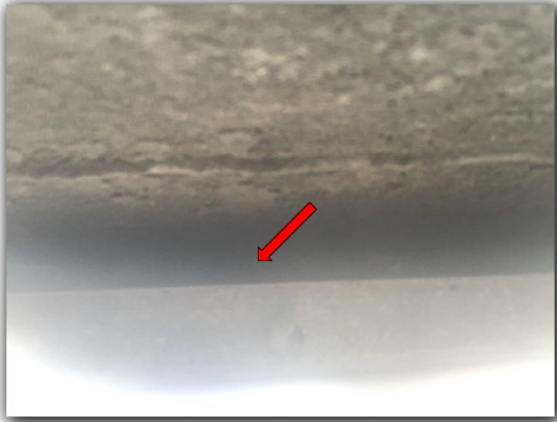
6.1

6. Plastic has been wrapped around the bottom of the wood substrate at the drainage plane on right side of the garage (behind surface veneer). Recommend correcting this deficiency along with any underlying wood rot.

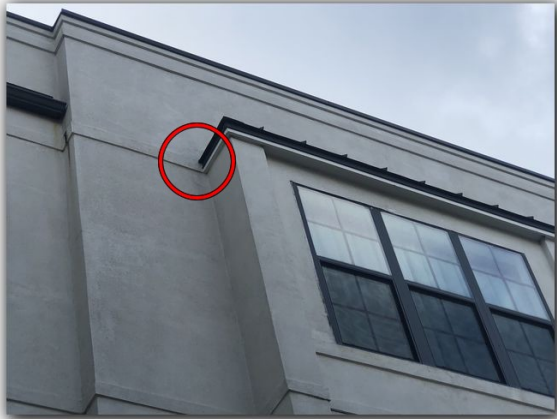
7.1

7. Kickout / diverter flashing has not been installed at the wall and roof intersections. This has led to elevated moisture readings at the substrate. It is recommended that a qualified contractor be consulted to correct this problem to prevent ongoing water penetrations and substrate damage.

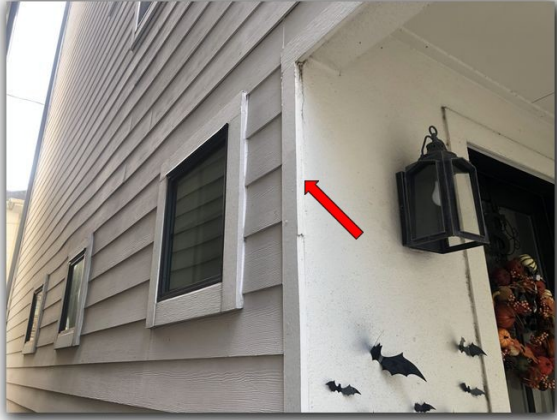
1.1

1. The transition between the stucco and dissimilar materials is missing a sealant joint. The stucco should terminate into a casing bead to create a joint between the two materials. The sealant joints should be a minimum of ¼ inch and no more than ¾-inch with a backer rod and approved sealant.

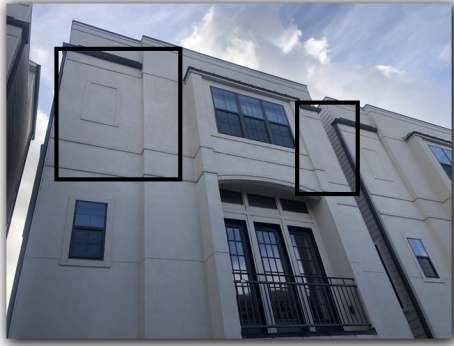
The areas in the photos below with the black outline were inaccessible (could not reach with 27' ladder, inoperable windows at the interior and because ladder placement was obstructed when safely extended)

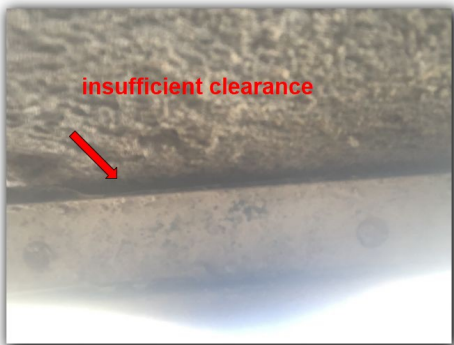
Front left areas of the underlying substrate / sheathing and the plastic vapor barrier were not visible or accessible for inspection around the perimeter of the home due to the clearance between the wall and termination and foundation.
