**Seller's Disclosure Packet**  
**115 Colonel Drive**

CONCERNING THE PROPERTY AT 115 Colonel Drive, Richmond, TX 77469  
(Street Address and City)

Report Identification: 115 Colonel Dr, Richmond, TX 77469 - May 26, 2022

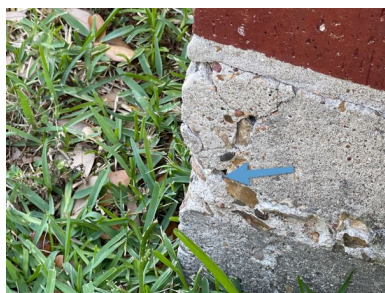
Foundation corner fracture(s) existed, which are generally the result of differential movement between the masonry walls (expanding) and the concrete foundation (shrinking). Although this condition did not appear to adversely affect the structure, sealing these cracks may be desired as they could provide hidden access for wood destroying insects. Please note that the corners should be examined periodically. If the fracturing worsens and the corner(s) break off then the brick veneer may lack proper support and repair would be needed.

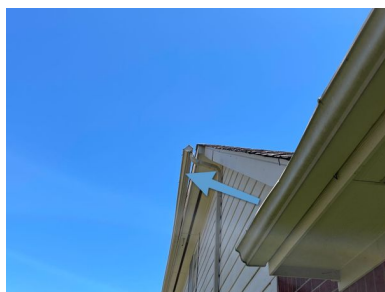
The roof gutters are dented and/or damaged at one or more locations. This can result in gutter overflow and/or improper drainage in those areas. Repair or replace as necessary.

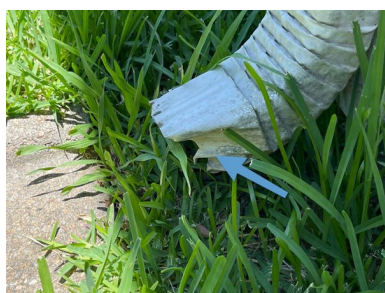
## 3: Damaged downspout elbow

One or more gutter downspout elbows are damaged. Replace as desired for better performance.

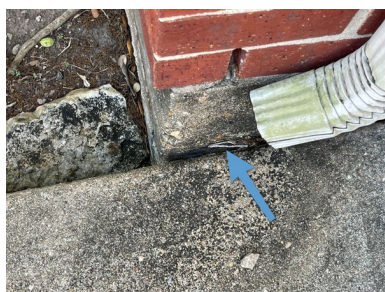
The gutter downspout empties into the driveway slab joint at one or more locations. This can allow moisture to accumulate under the driveway and/or foundation and can result in heaving over time. The downspout should be repositioned to direct drainage away from the foundation.

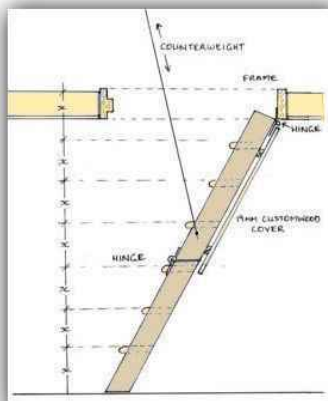
The attic ladder is improperly installed. It appears the ladder is not cut to the proper length causing it buckle at the lower hinge. This can reduce the load bearing capacity of the ladder.

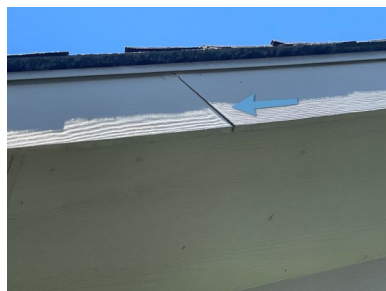
**2: Separated caulk joints in the soffit and fascia**

There are separated joints in the soffit and fascia board at one or more locations. The joints should be sealed to prevent moisture penetration and/or pest intrusion in those areas.

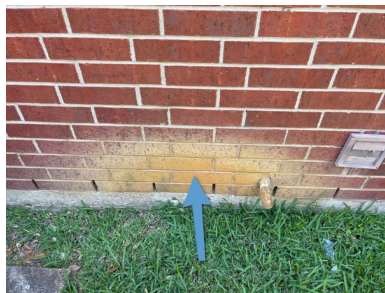
Rust stains were observed on the veneer. This appears to be the result of drainage from the cooling equipment emergency condensate drain. A siding professional should be retained to determine the best method of cleaning the veneer.

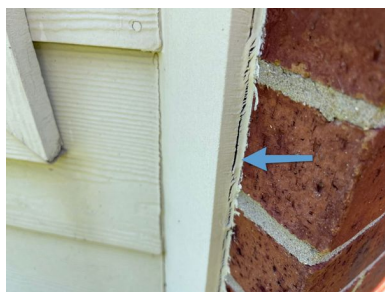
There are separated caulk joints at the exterior wall trim at one or more locations. The joints should be sealed to help prevent moisture penetration in those areas.

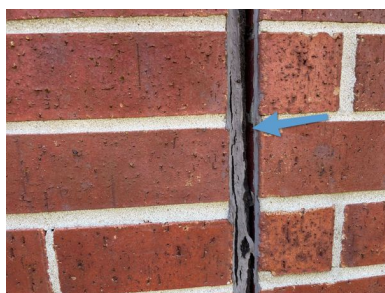
### 4: Seal control joint

The brick control joint on one or more sides of the house is not sealed. The joint should be sealed to help prevent moisture and/or pest intrusion in that area.

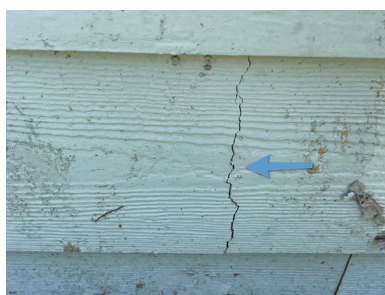
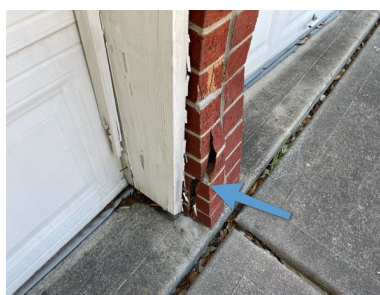
There is mechanical damage to the siding at one or more locations. Repair as needed.

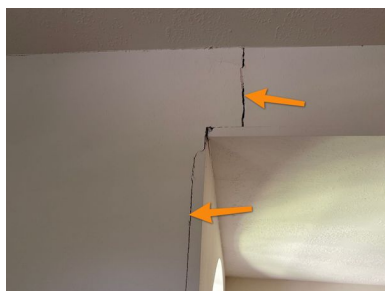
### 7: Fractures in interior walls

The interior wall coverings are fractured at one or more locations. This appears to be the result of movement in these locations. This alone does not indicate failure of a foundation. Monitoring these locations is advised.

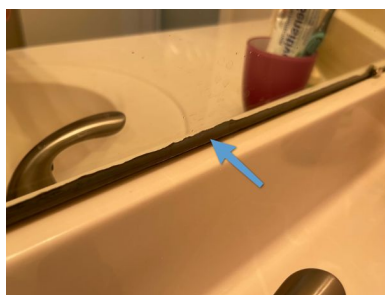
One or more mirrors are degrading. This can happen over time as the mirror ages or with exposure to UV rays. Replace the mirror as needed.

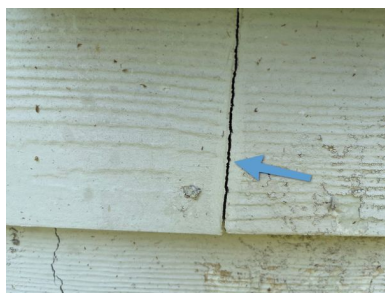
**10: Siding maintenance**

The hard board siding needs to be sealed at the joints to prevent moisture penetration in those areas.

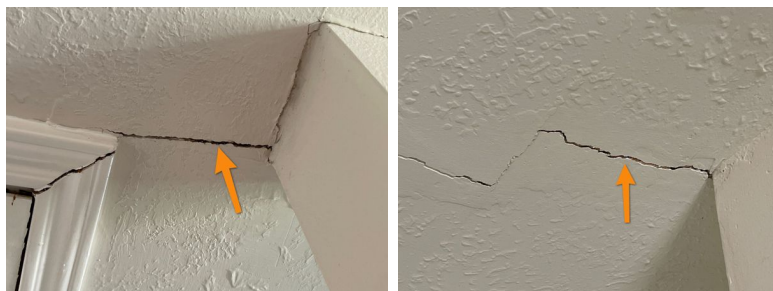
Fractures were observed on the ceiling in one or more areas throughout the house. This may correlate with or indicate structural movement. The fracture(s) should be monitored over time for further separation and evaluated as necessary.

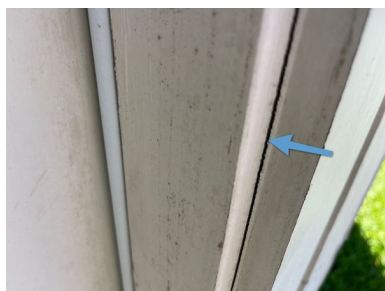
One or more exterior door frames are not sealed to the exterior wall covering. The door frames should be sealed to the exterior wall coverings to help prevent moisture and/or pest intrusion in those areas.

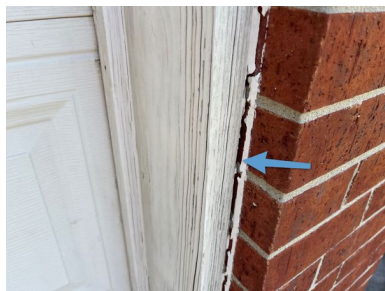
**4: Garage door- Seal caulk joint**

There are separated caulk joints at the overhead garage door casing. The joints should be sealed to help prevent moisture penetration in those areas.

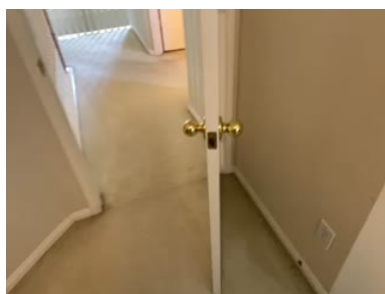
One or more door(s) swing(s) on their own when set at a partially open position. This is commonly referred to as "ghosting". This repair can be accomplished by removing a hinge pin and bending the pin slightly and then replacing the pin. This will add friction on the hinge and prevent ghosting.

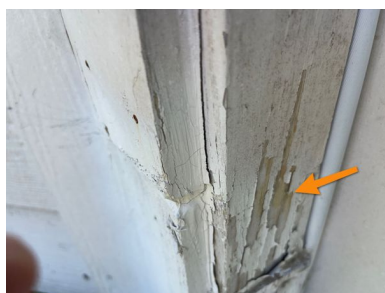
There is inadequate/missing paint or sealant at one or more exterior door casings. Sealant or paint should be applied to minimize moisture damage.

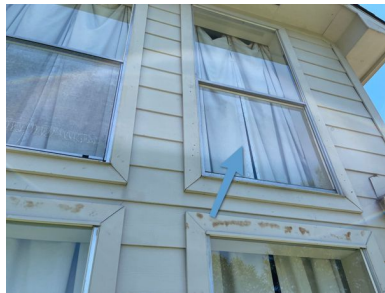
One or more windows are missing a screen. Recommend replacement.

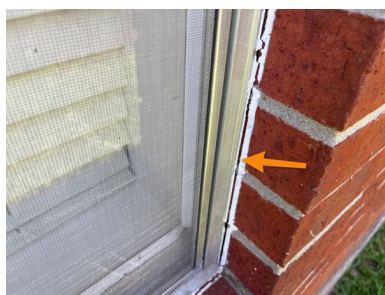
One or more windows showed signs of separated caulk joints. This is often correlated with structural movement. Seal the joints to prevent moisture penetration and monitor for further evidence of movement.

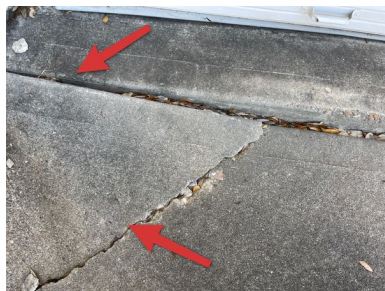
The sidewalk/drive way is heaved up at one or more locations. This presents a trip hazard. There are new processes, such as Mudd Jacking, that are low cost and effective methods of leveling driveways and side walks.

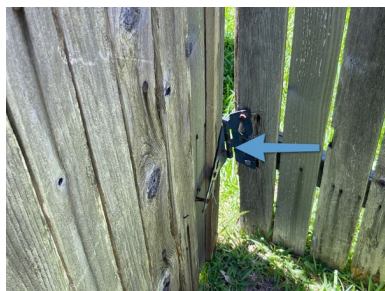
Damage was observed to the fence/gate at one or more locations. Repair or replace as required.

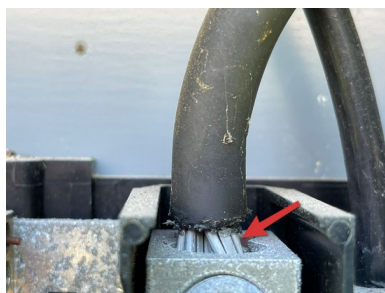
There is missing antioxidant grease on the aluminum conductor connections to the electric service panel. The connections should be greased to ensure proper conductivity and to help prevent oxidation.

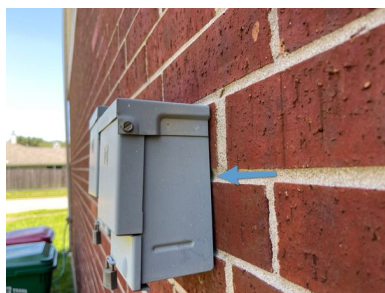
One or more exterior electrical panels are not sealed to the wall. The panels should be sealed to prevent moisture intrusion in the opening behind the panel.

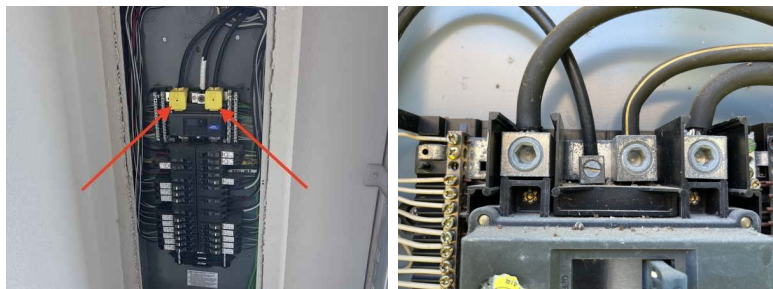
There are no terminal covers installed over the service entrance conductors. Terminal covers should be in place to protect against accidental contact with high voltage wiring. Repair is advised.

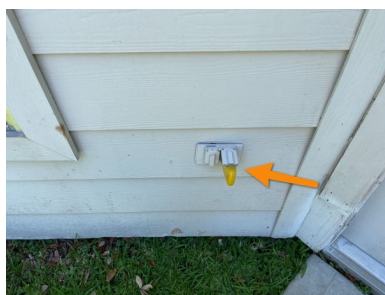
One or more outlets tested as “open hot” (no power). Further evaluation and/or repair by a licensed electrician is advised.

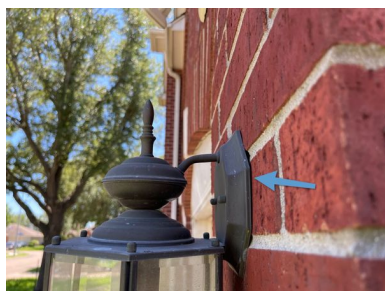
**2: The exterior fixtures are not sealed to the wall**

One or more exterior fixtures are not sealed to the wall. Fixtures should be sealed to prevent moisture penetration in those areas.

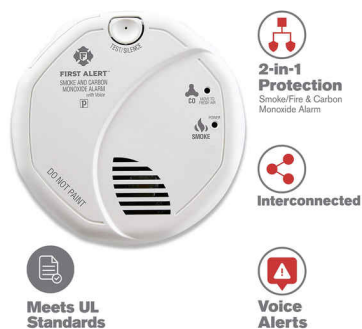
There are missing carbon monoxide alarms in the home. Carbon monoxide alarms should be installed in accordance with current standards, as follows: 2009 International Residential Code R315.2.1 New construction. Carbon monoxide alarms shall be provided in dwelling units when either or both of the following conditions exist. 1. The dwelling unit contains a fuel- fired appliance. 2. The dwelling unit has an attached garage with an opening that communicates with the dwelling unit. R315.3 Location. Carbon monoxide alarms in dwelling units shall be installed outside of each separate sleeping area in the immediate vicinity of the bedrooms. When a fuel-burning appliance is located within a bedroom or its attached bathroom, a carbon monoxide alarm shall be installed within the bedroom. Carbon monoxide is an odorless, colorless, and tasteless gas that is near impossible to identify without a proper detector. It is caused by fuels not burning completely, including wood, gasoline, coal, propane, natural gas, gasoline, and heating oil. This unburned fuel can come from anything from clothes dryers, water heaters, and ovens to ranges, a fire-burning fireplace, or a car left running in a closed garage.

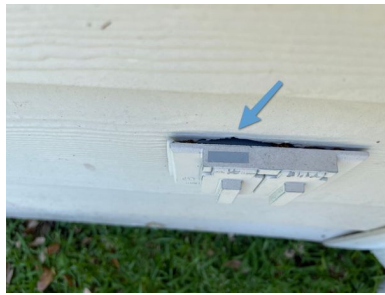
The exterior outlet should to be sealed to the wall to prevent moisture from causing damage. Seal and/or replace as necessary

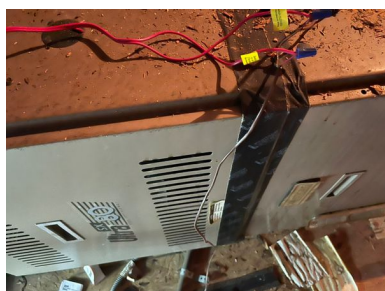
The air handling cabinet in the attic was sealed shut at the time of the inspection. Cutting any permanent sealant is beyond the scope of this inspection. Therefore the air handler could not be uncovered. The cover should be removed and the internal parts of the air handler should be evaluated before closing.

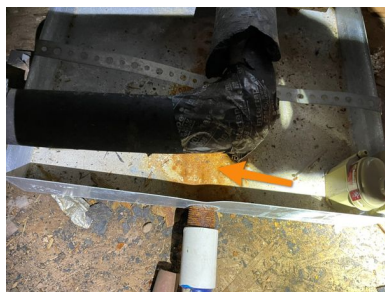
There is rust in the evaporator coil emergency condensate drain pan. This may indicate that the primary drain is clogged or that the system is under performing. Further evaluation and/or repair by a licensed HVAC technician is advised.

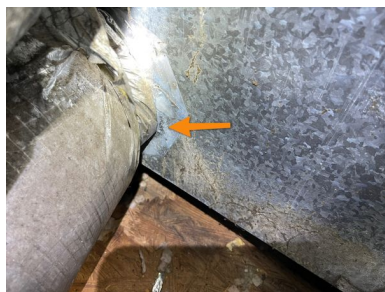
**2: Fungal growth on the plenum**

Fungal growth is forming on the duct plenum. This may indicate this area is not properly insulated. Further evaluation and/or repair by a licensed HVAC technician is advised.

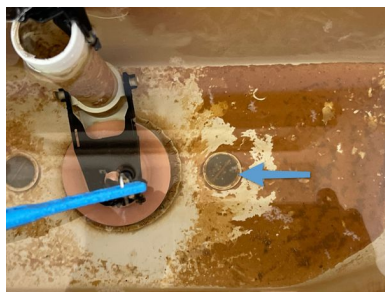
One or more toilet tank bolts are rusted. The bolts should be monitored for leaks and replaced as required.

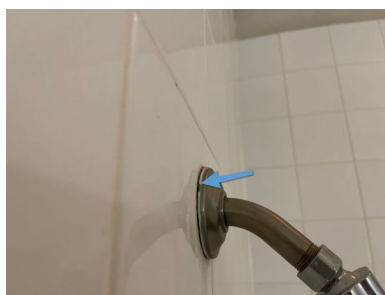
The bathtub and/or shower fixtures are not properly sealed to the wall at one or more locations. The escutcheons and fixtures should be sealed to the wall to prevent moisture penetration in those areas.

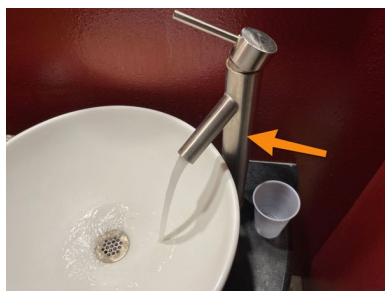
**4: Loose plumbing fixtures**

One or more interior plumbing fixtures are loose. This could be due to a loose fastener or loose plumbing and could cause a leak if stressed. Further evaluation by a qualified plumber is recommended.

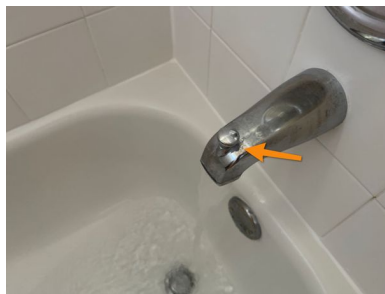
The shower diverter did not engage at one or more bathtubs. Further evaluation and repair by a licensed plumber is advised.

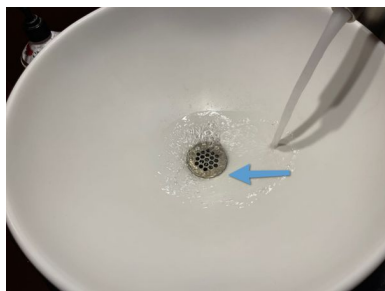
The drain stopper is missing or non-functional at one or more sinks or tubs. Repair and/or replace as necessary.

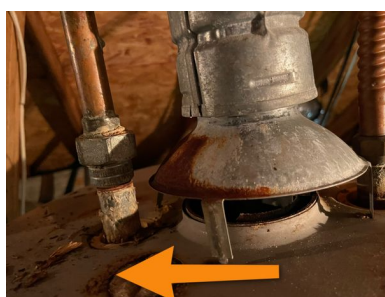
One or more observable rust spots were present at the water heater housing. This is typical of units that are nearing the end of their life expectancy. Further evaluation and/or repair by a licensed plumber is advised.

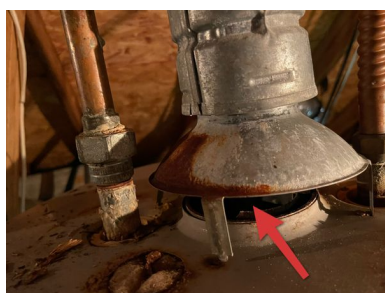
**4: Draft hood displaced**

The water heater draft hood is not centered on the exhaust flue. This can allow carbon monoxide to escape. Further evaluation by a qualified plumber is recommended.

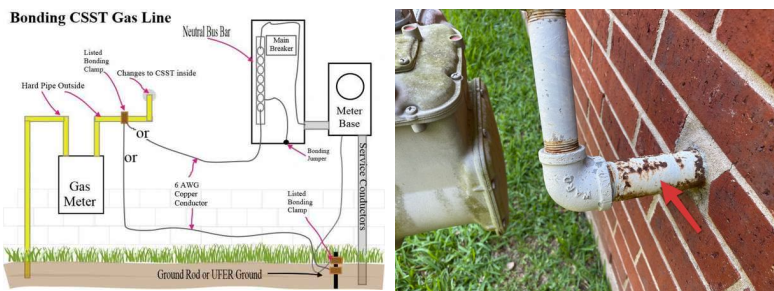
The gas piping system is not bonded to the grounding electrode system. This house may predate these standards. Where metal piping servicing the house is capable of being energized, it should be bonded to the grounding electrode system. This is reflected in the 2012 International Residential Building Code as follows: E3609.7 Bonding other metal piping. Where installed in or attached to a building or structure, metal piping systems, including gas piping, capable of becoming energized shall be bonded to the service equipment enclosure, the grounded conductor at the service, the grounding electrode conductor where of sufficient size, or to the one or more grounding electrodes used. The bonding conductor(s) or jumper(s) shall be sized in accordance with Table E3908.12 using the rating of the circuit capable of energizing the piping. The equipment grounding conductor for the circuit that is capable of energizing the piping shall be permitted to serve as the bonding means. The points of attachment of the bonding jumper(s) shall be accessible.

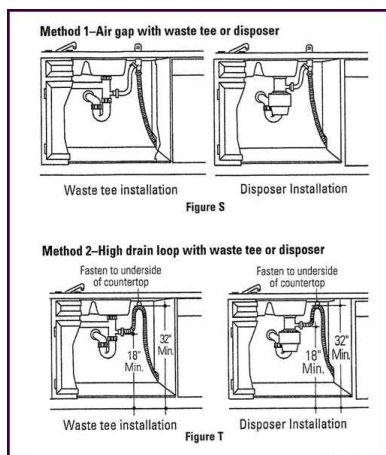
There is no air gap or sanitary loop in the dishwasher drain line to prevent waste water from contaminating the potable water supply. It is recommended that a sanitary loop or air gap be installed in the drain line.
