FIG Services LLC d/b/a FOX INSPECTION GROUP

Property Inspection Report #10/21/20231815 Auburn Trail
8616 Daffodil St. Houston, TX 77063

PROPERTY INSPECTION REPORT FORM

1815 Auburn Trail, Sugar Land, TX 77479

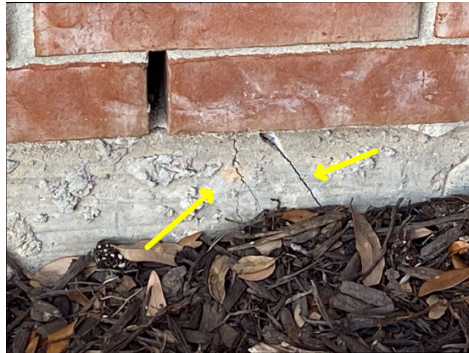
Observed one or more cracks in the foundation; south of garage door

Foundation crack observed south of garage door

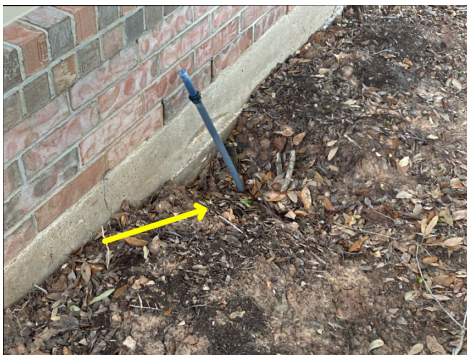
Depressions in soil near foundation are detrimental to good foundation maintenance, recommend filling in depressions.

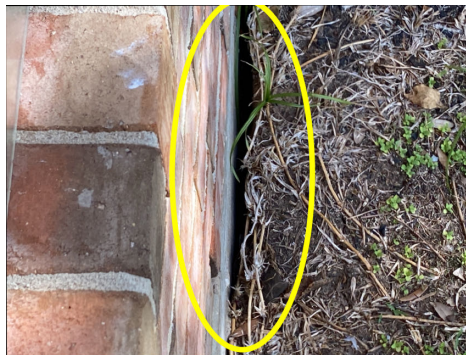
The soil has pulled away/separated from the foundation; indicates inadequate moisture level of soil supporting the foundation system, this situation should be addressed to prevent damage to the foundation.

Soil pulled away from foundation at Southside of home

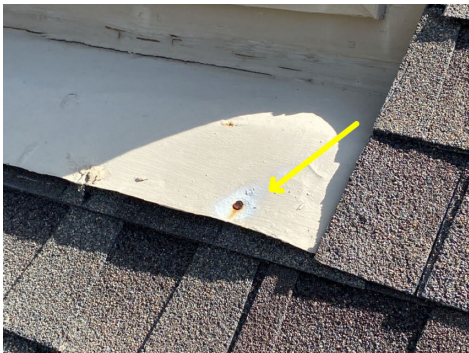
Exposed staples/nail-heads/fasteners observed on the roof are not properly sealed. Water entry possible.

Exposed staples/nail-heads/fasteners observed on the roof are not properly sealed.

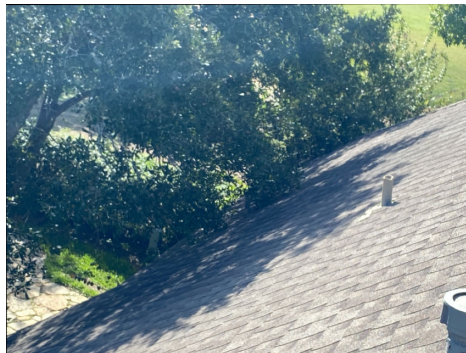
Tree limbs in contact with the roof can/ will damage the roof.

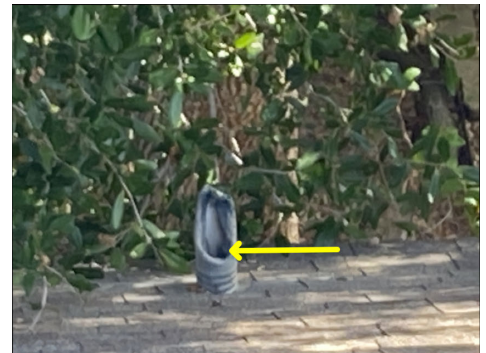
Not all lead flashing of drain waste vents are properly rolled down interior of plumbing vent pipes and/or are damaged by squirrels, which may allow some rainwater entry.

Not all lead flashing of drain waste vents are properly rolled down interior of plumbing vent pipes and/or are damaged by squirrels.

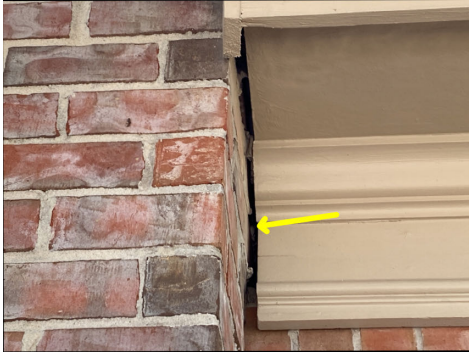
Missing/deteriorated sealant at frieze board and brick intersection on North exterior wall

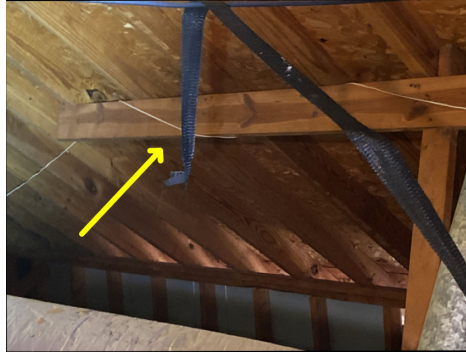
Observed insufficient purlin (roof bracing) struts (supports) in the attic. Needs additional purlin struts at 4-foot centers down to load-bearing walls for proper roof support.

Observed insufficient purlin (roof bracing) struts (supports) in the attic.

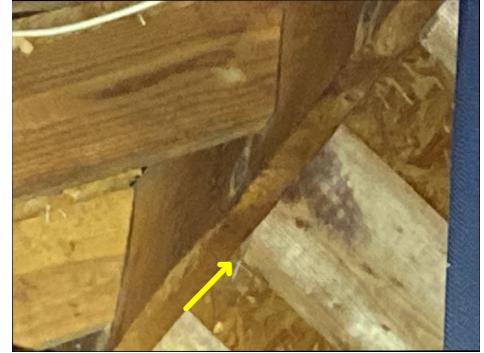
Ridge and/or valley board(s) not deep enough to support ends of rafters. Recommend repair as needed.

Ridge and/or valley board(s) not deep enough to support ends of rafters.

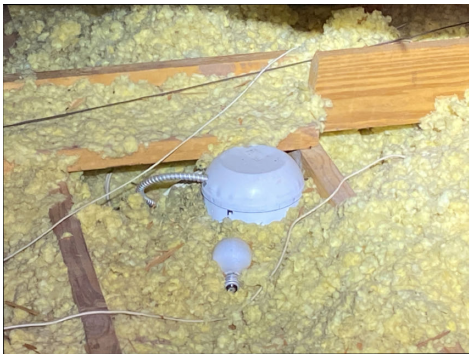
Inspector is unable to verify if recessed lights are rated to be in contact with insulation. It is a fire hazard for insulation to be within 3" and wood to be within 1" of recessed lights.

It is a fire hazard for insulation to be within 3" and wood to be within 1" of recessed lights.

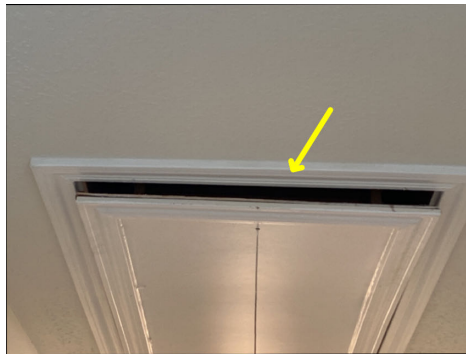
Attic ladder door does not fully close to seal gaps and prevent conditioned air loss.

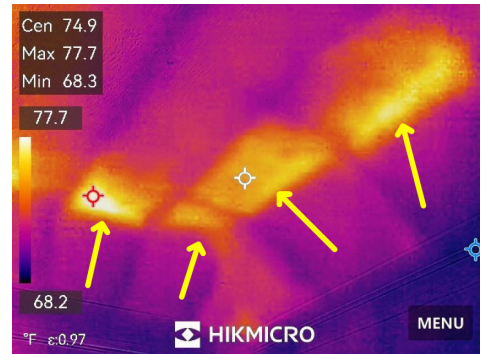
Insulation not properly positioned/missing in areas, etc.

Insulation not properly positioned/missing in areas.

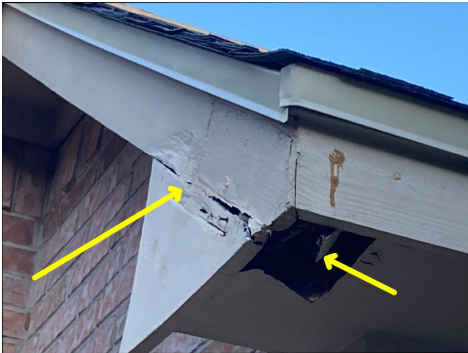
Wood rot observed on East exterior side of home

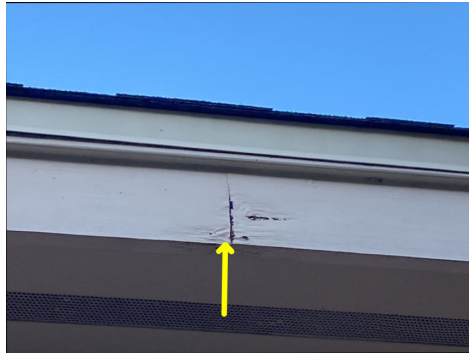
Wood rot observed on East side of home

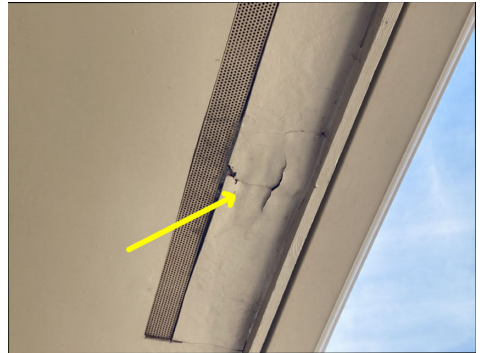
Wood rot observed at the southwest corner of home

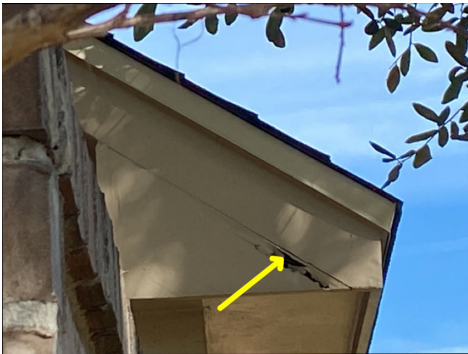
Wood rot observed on east exterior wall south of home

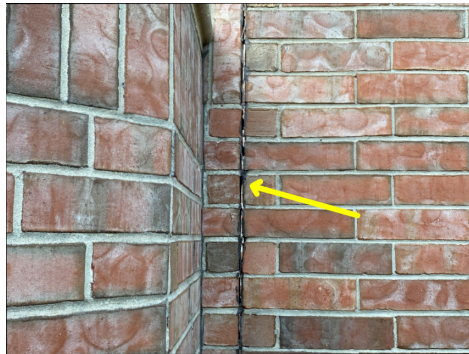
Expansion joint needs caulking.

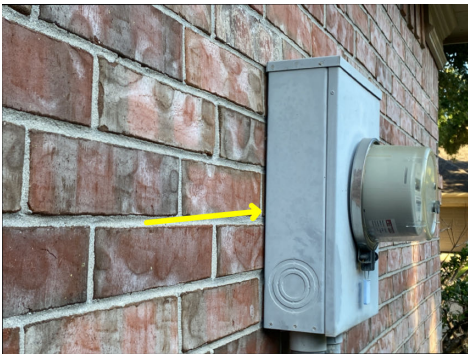
Missing/deteriorated sealant at meter box.

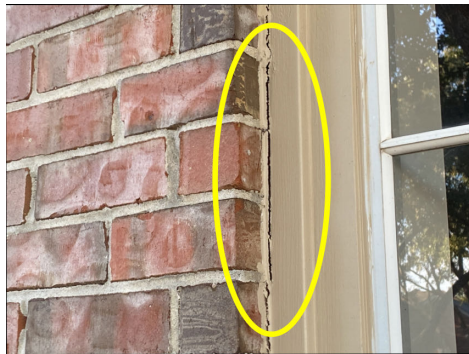
Missing/deteriorated sealant around windows observed in multiple locations

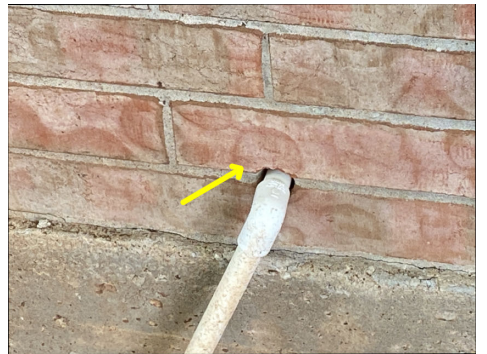
Missing/deteriorated sealant at North exterior wall

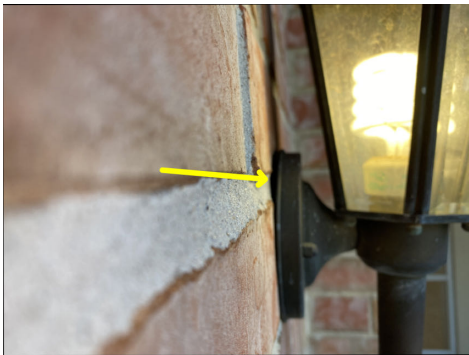
Missing/deteriorated sealants at exterior lights observed in multiple locations

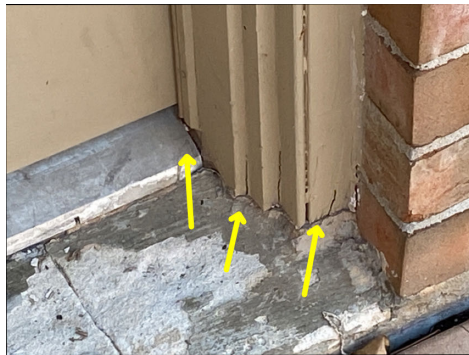
Missing/deteriorated sealant at door threshold observed at multiple locations

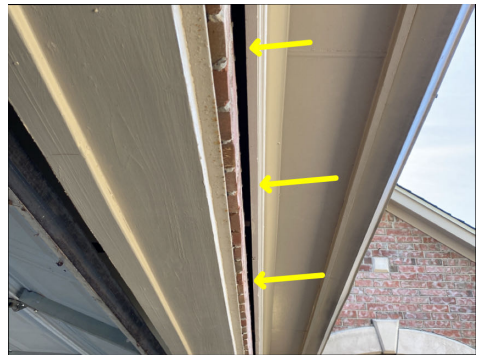
Frieze board separation at one or more corners of the house / garage. Indication of foundation movement.

Frieze board separation at West exterior walls garage

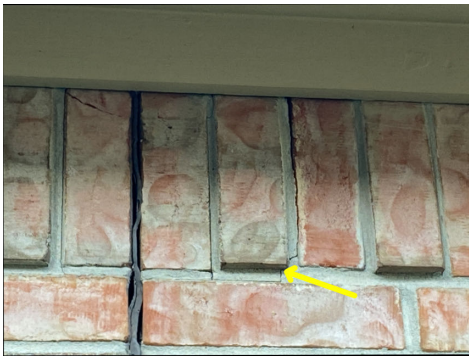
Typical cracks observed on East exterior wall

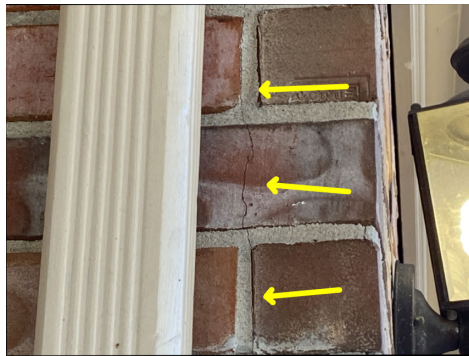
Cracks in brick/stone veneer and/or repairs, at northwest exterior wall of garage

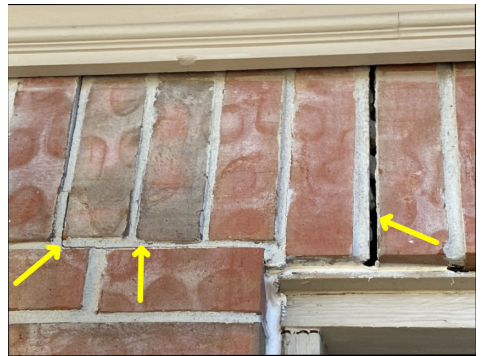
Brick crack observed at North corner of garage door

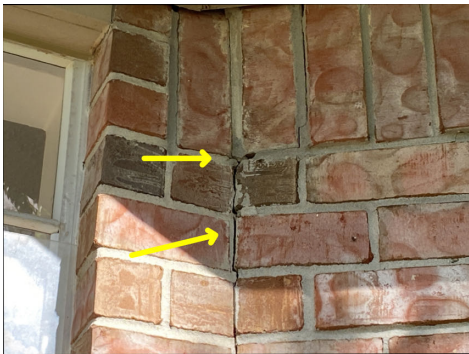
Brick cracks observed at South exterior wall

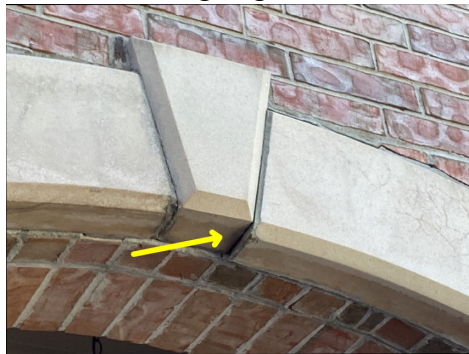
Cracks in the brick arch were observed. Loose bricks are hazardous.

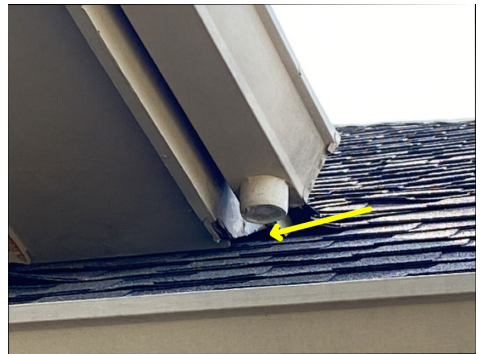
Gaps at joints in building components are potential pest / rodent entry points.

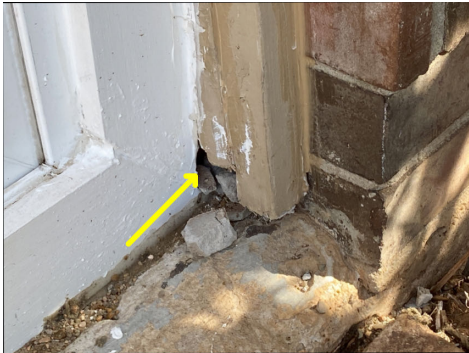
Gaps at joints in building components are potential pest / rodent entry points.

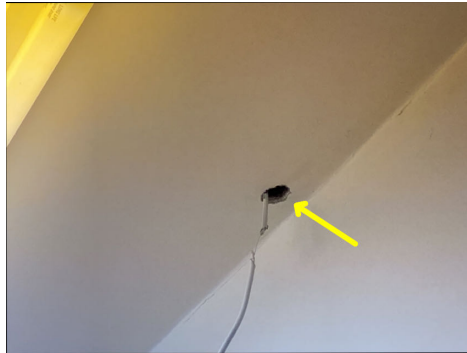
Recommend repairing holes/openings in garage walls/ceiling.

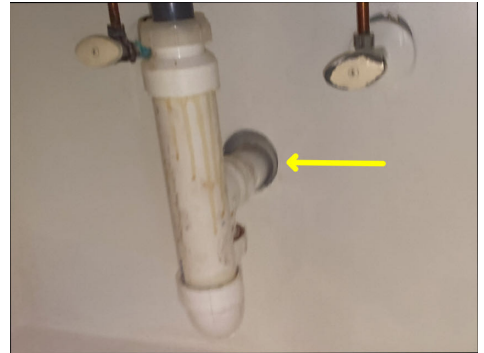
Recommend sealing all holes in cabinets to reduce air and water infiltration.

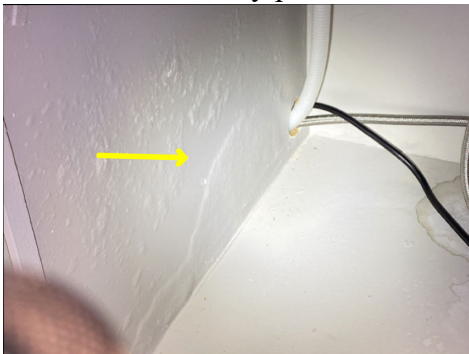
Water damage to the base of the cabinet below the kitchen sink.

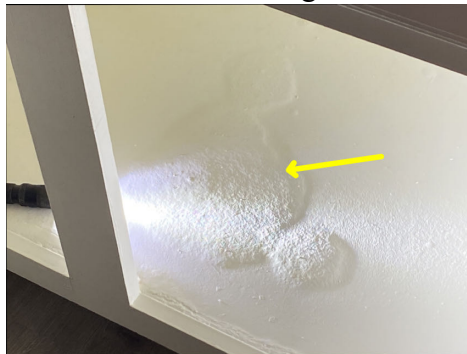
Water damage observed master bathroom West sink

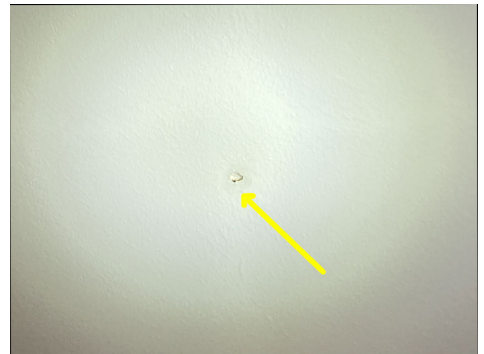
Impact damage observed at garage entry door

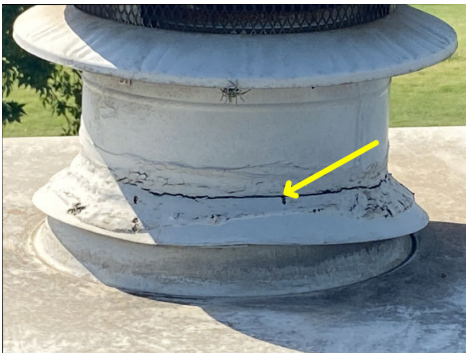
Storm collar needs caulking on the chimney.

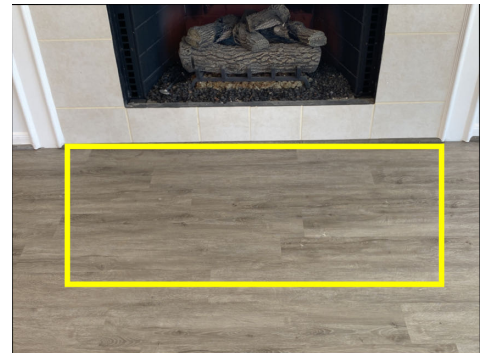
Inadequate sized non-combustible hearth extension at sides of the fireplace.
Where the fireplace opening is more than 6 square feet the hearth extension shall extend 20 inches in front and at least 12 inches beyond each side of the opening.
Per IRC 1003.10.

Inadequate sized non-combustible hearth extension at sides of the fireplace.

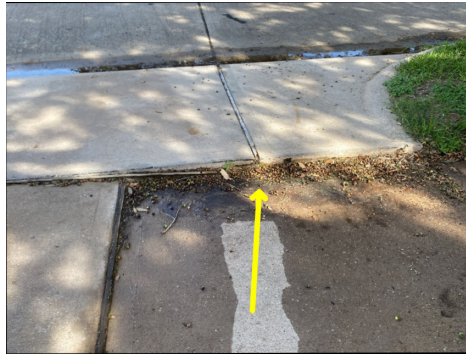
Tripping hazard observed at multiple locations in driveway

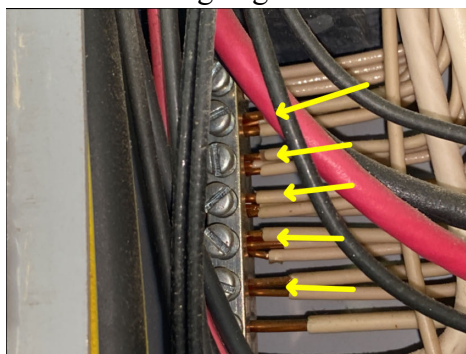
Observed two or more neutral conductors under one screw lug on neutral bus. Current industry standards and NEC permit one neutral conductor per screw lug.

Observed two or more neutral conductors under one screw lug on neutral bus.

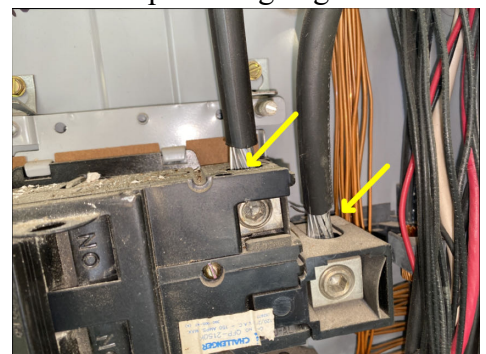
Did not observe anti-oxidant compound (grease) on all exposed aluminum feeder wiring.

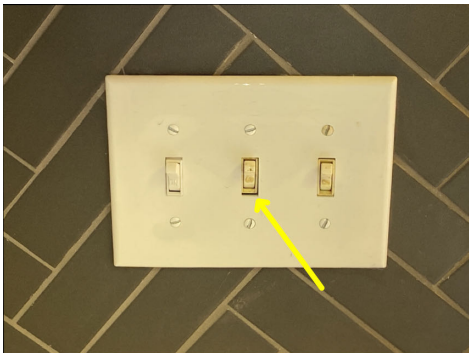
Disposal switch installed upside down.

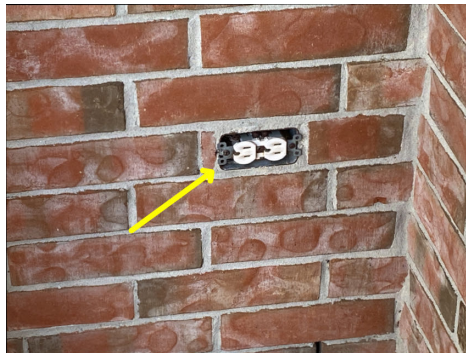
Front entry missing weatherproof covering

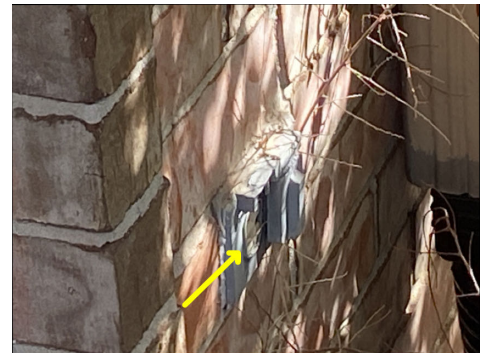
Damaged covering at South exterior outlet

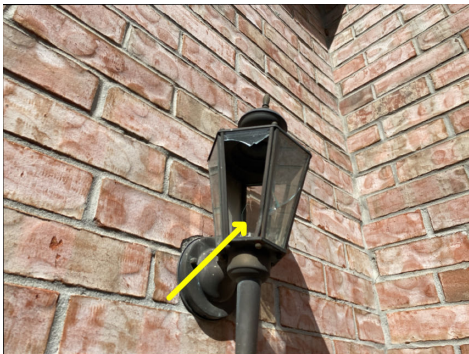
Is porch exterior light light fixture damaged.

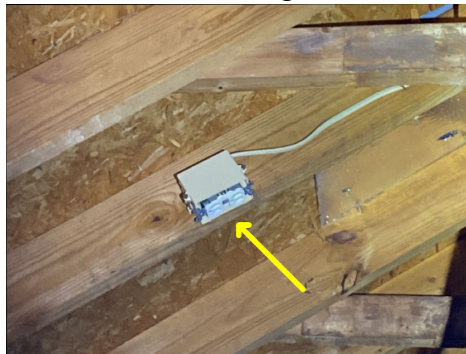
Attic cover plates were either missing or damaged.

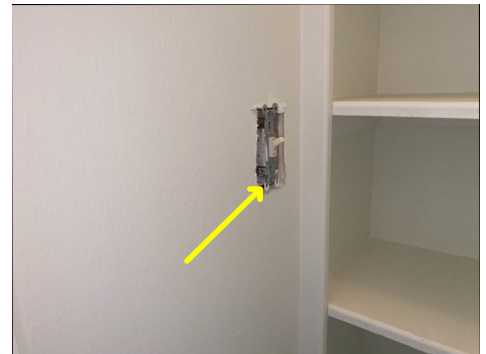
Pantry cover plates were either missing or damaged.

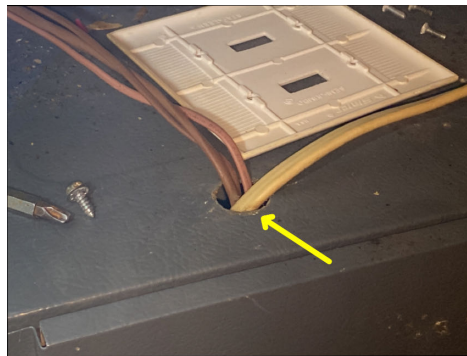
Electrical wiring not secured.

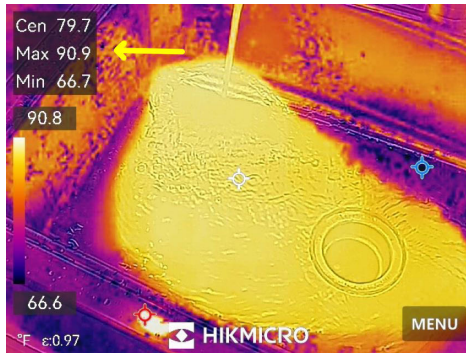
The water heater was not operational, not performing its intended function.

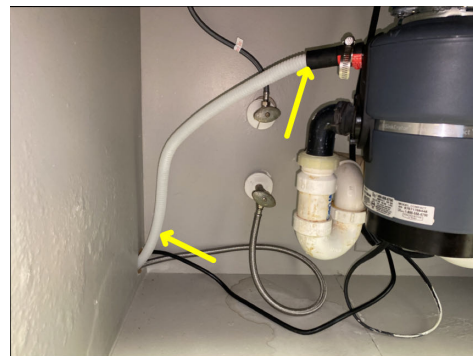
Drain line needs to be better elevated and secured above side inlet of disposal.

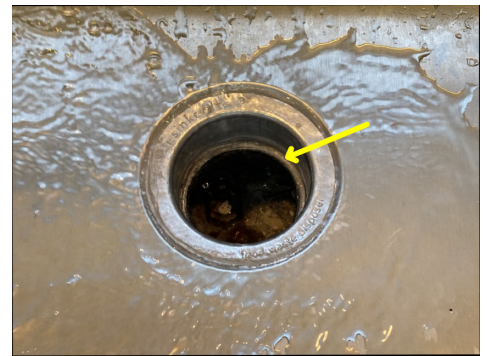
Rubber splash guard is missing and / or deteriorated.

Rubber splash guard is missing.

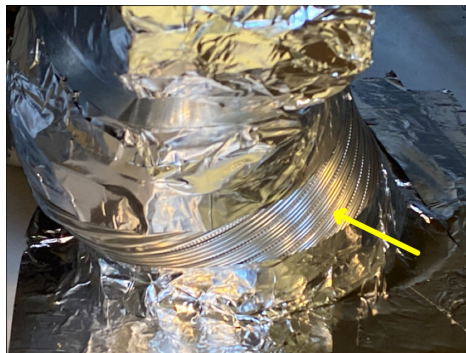
Improper vent duct material used. Current industry standards requires smooth interior single-wall duct constructed of galvanized steel, stainless steel or copper. The duct serving the hood shall have a smooth interior surface. Per IRC 1503.1.

Improper vent duct material used.

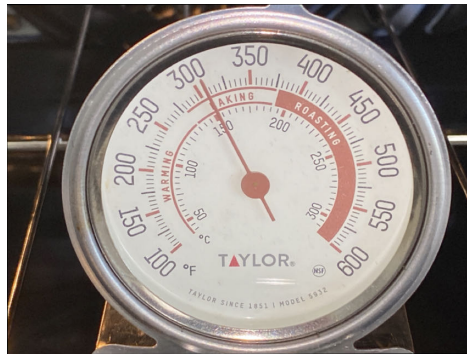
Thermostat/knob needs adjustment/replacement, when it is set at 350 degrees oven heats to approximately 305 degrees.

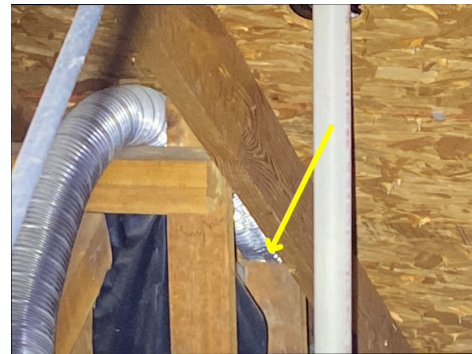
Exhaust fan improperly vents into the attic, should vent to the exterior.

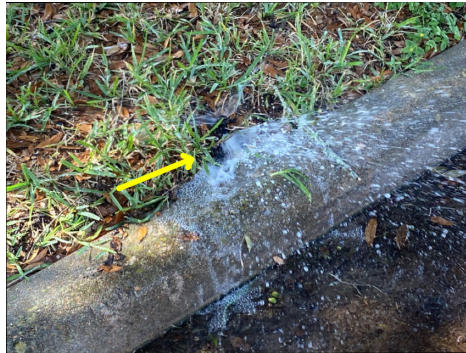
Damaged water line, water gusher in the yard; Station 1

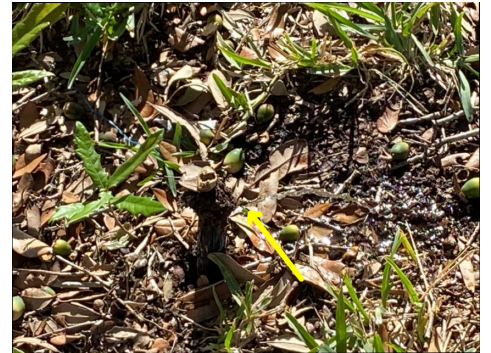
Zone 1 spray heads are clogged and / or grass has grown over head, blocking / preventing proper operation.

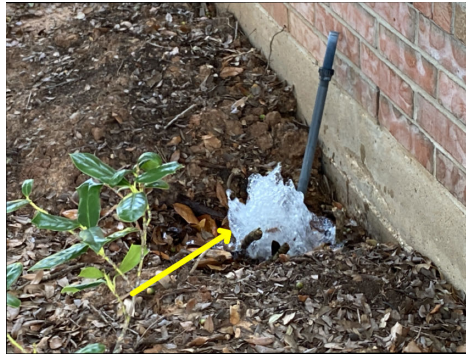
Damaged water line, water gusher in the yard; Station 2

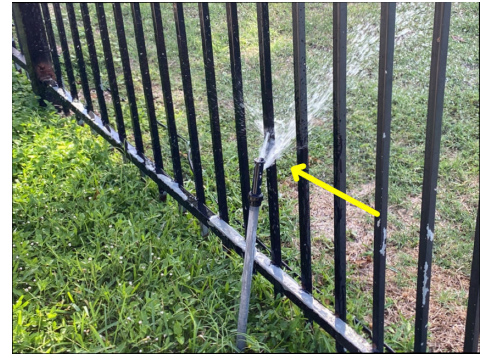
Damaged water line, water gusher in the yard; Station 3

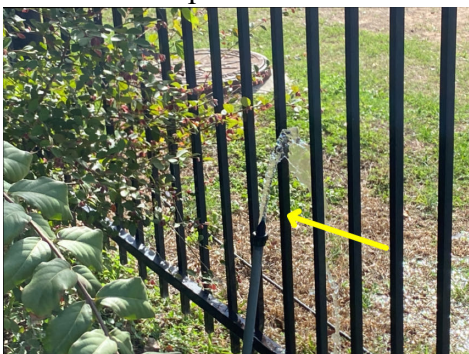
Damaged water line, water gusher in the yard; Station 3

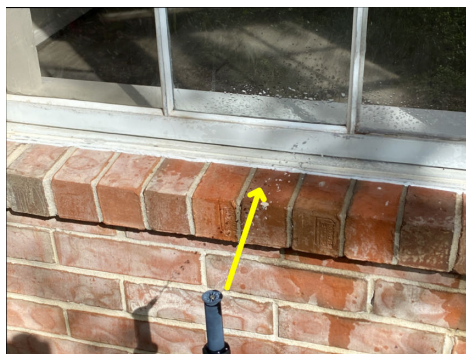
Zone 3 spray heads need adjustment for proper yard cover and reduced over-spray on the house, fence, and paved areas.

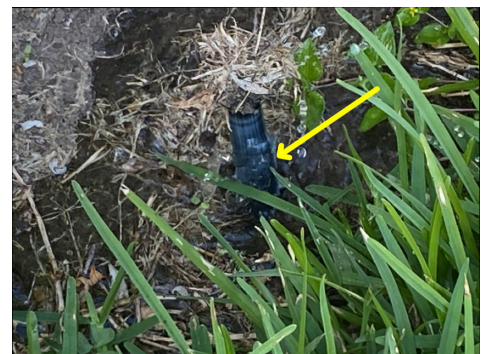
Damaged water line, water gusher in the yard; Station 4
