PRELIMINARY FOUNDATION INSPECTION REPORT: JOB NO. 23-F212

LOCATION: 17022 Blackhawk Blvd
Friendswood, TX

DATE OF INSPECTION: July 2, 2023

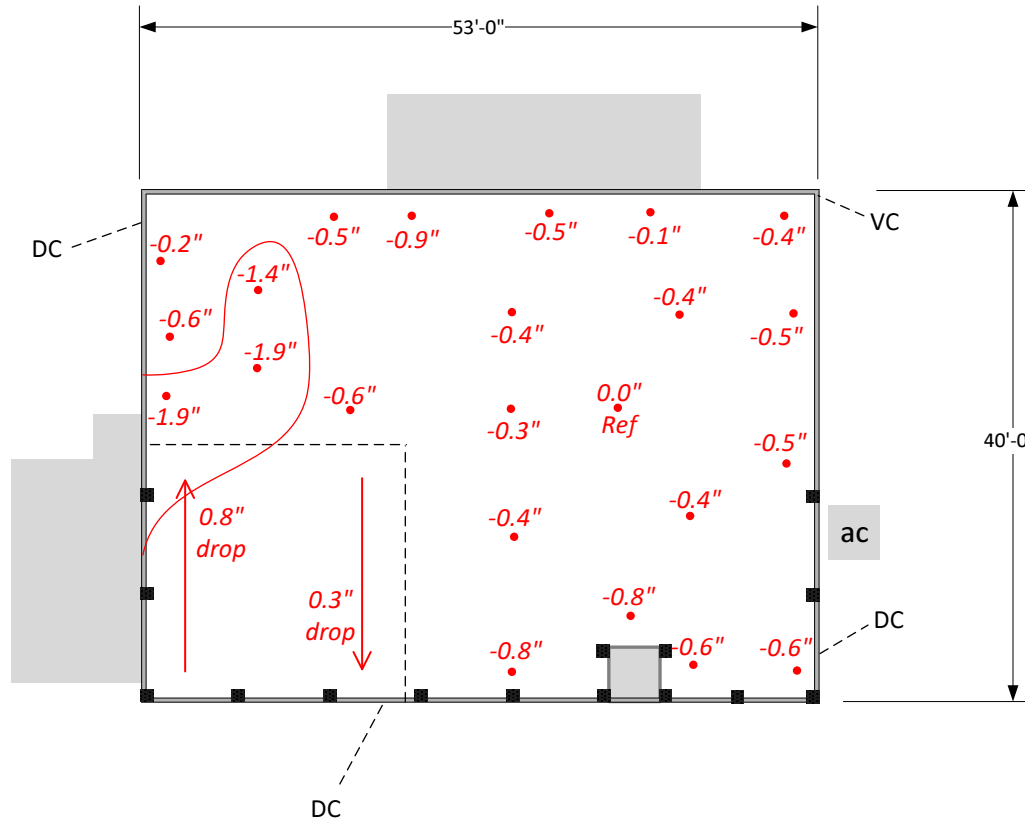
A laser floor scan was taken throughout the interior as detailed on the attached report. The stabilized perimeter portion of the foundation does show up to 0.8" of elevation drop when compared with the center of the structure. This is common after foundation repair and not of concern. The stabilized perimeter work completed appears to be supporting the foundation as intended. The master bathroom area does show some interior settlement. While spot elevation readings do show interior settlement of up to 1.9", all door frames show to be square and no significant sheetrock cracks were present in the area of concern. Based on physical observation, laser slope readings and door level checks, it is likely that the current settlement was present prior to the time of remodel which was at least 3 years ago. If the area of concern was to be stabilized, it would require interior entry for stabilization. While the settlement is not preferred, the degree of settlement and the amount of deficiencies are not enough to warrant foundation stabilization work at this time. All doors are functioning without door racking or excessive misalignment and interior sheetrock deficiencies are minimal to non-existent. If a significant remodel were to take place, I would recommend stabilizing the master bathroom area at that time. It also should be noted that a distinct diagonal brick veneer crack is present outside the master bathroom back left perimeter area and the front bedroom right front perimeter area. In the front bedroom section, the area has already been stabilized and further lifting would be counterproductive. In the master bathroom back corner, slope readings are not significant enough to warrant lifting the structure. In both areas, interior cosmetic issues were minimal to non-existent.

Slope readings shown in red in inches of elevation drop vs center of structure

Exterior Deficiencies

DC – Diagonal Brick Crack
 VC – Vertical Brick Crack

■ Existing Pressed Piles

I do not recommend foundation repair work at this time. I do recommend that the homeowner establish a regular watering plan around the perimeter of the house during periods of dry weather so that the moisture in the soil supporting the foundation will continue to remain more consistent.
