**BPG Inspection, LLC**

**4601 Woodway Avenue  
Rosenberg TX 77471**

Client(s): Serrano  
Inspection Date: 9/27/2023  
Inspector: Silviu Stanescu , TREC #24311 (TX)

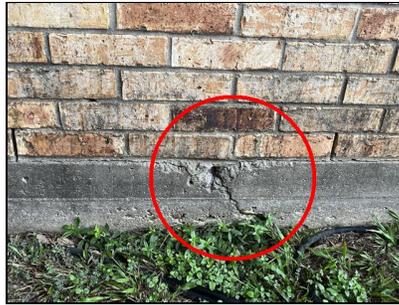
At the time of inspection the foundation appeared to have some movement considered beyond normal, exceeding acceptable tolerances. Observations made to support this opinion are listed, but not limited to the following: cracks observed on the exterior foundation; cracks in exterior veneer wall covering; window frame separation; interior sheetrock cracks and/or stress indicators; Doors will not close properly, stick or bind in jamb. A structural professional should be consulted to evaluate the current integrity of the foundation and propose necessary repairs (if any).

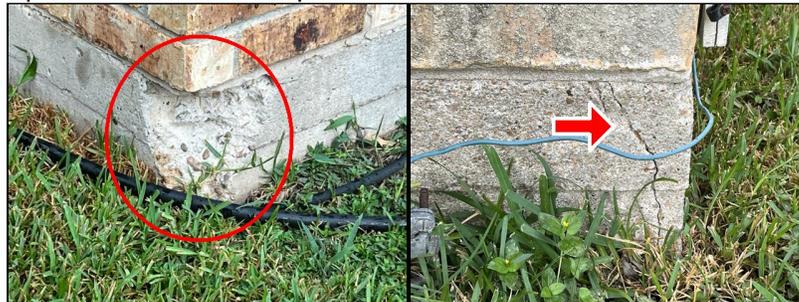
The corner "pops" and cracks visible at the outside corners of the foundation result from differential movement between the slow expansion of the brick wall, and the shrinking of the concrete foundation. Although they are not a structural problem, repair is recommended to prevent them from progressing further. Sidewalk repair caulking is the typical product used for this repair

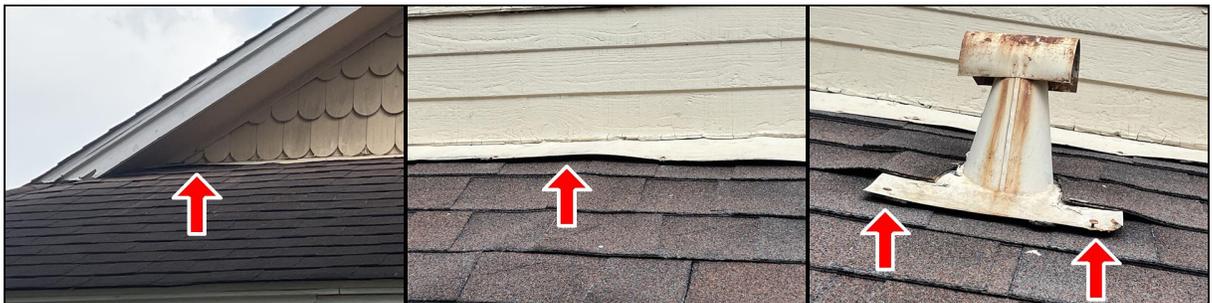
There were vent, counter or step flashings observed to be raised, improperly sealed and/or damaged. A qualified roofer should reseal and seal these roofing components as needed to prevent any future water penetration.

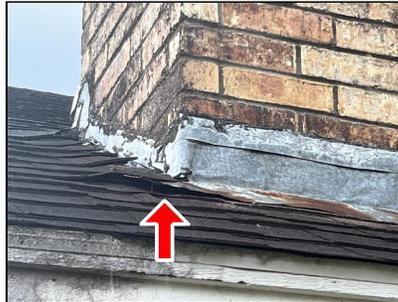
The chimney flashing is loose, and could present an area for water penetration. A qualified roofer should evaluate and perform repairs as needed.

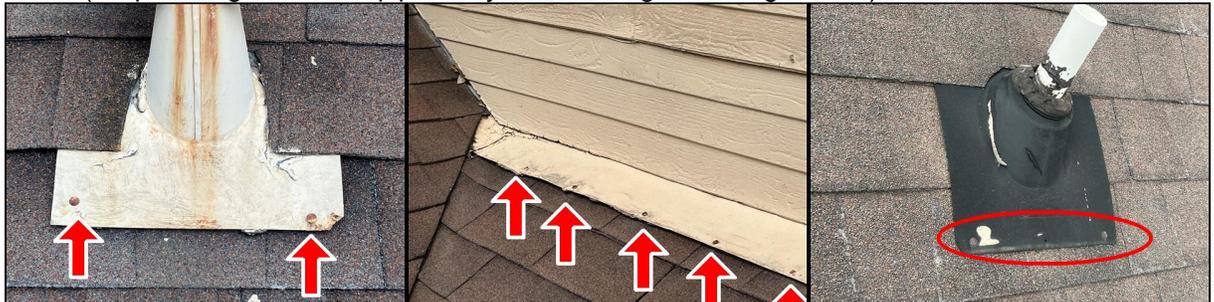
There were several roofing fasteners observed to be improperly sealed or exposed. Left unsealed the fastener penetrations could present a point of water penetration into the roof structure. Seal (caulk) all exposed roofing fasteners (i.e. plumbing vents, flue pipe roof jacks, flashings, and ridges lines).

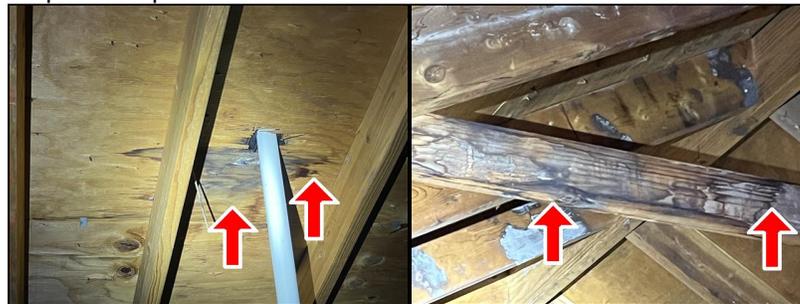
There was evidence of leaks in areas of the attic (flue pipe penetrations). It could not be determined if any areas of the deck require repair. Replacement of flashing, jackboots or parts of covering at these areas may be necessary to ensure it is leak free. Roofer should evaluate roof covering, deck and exterior flashings and jackboots for need of repair or replacement.

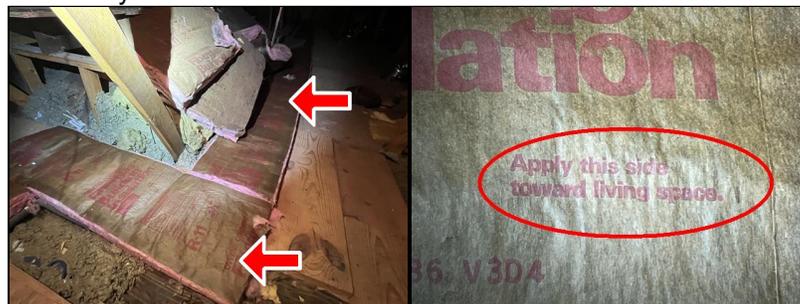
BAT insulation observed to be improperly installed in attic. As per manufacturer's instructions, the moisture barrier (kraft paper) should be installed towards the living space of the house. Recommend having a qualified contractor make the necessary corrections

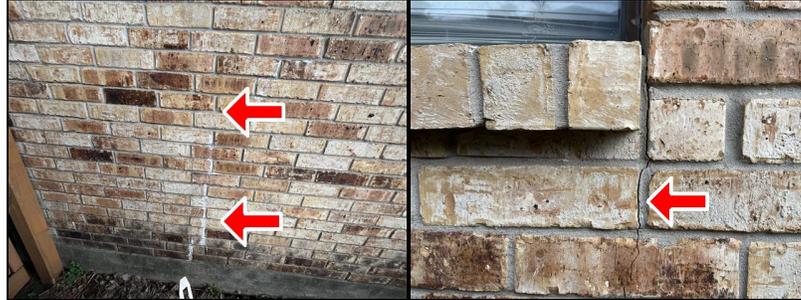
There are joint cracks on the walls in various locations. These cracks appear to be typical settlement/shifting joint cracks with no other visible displacement. Recommend sealing (mortar) crack to prevent moisture incursion and monitor for further settlement/separation

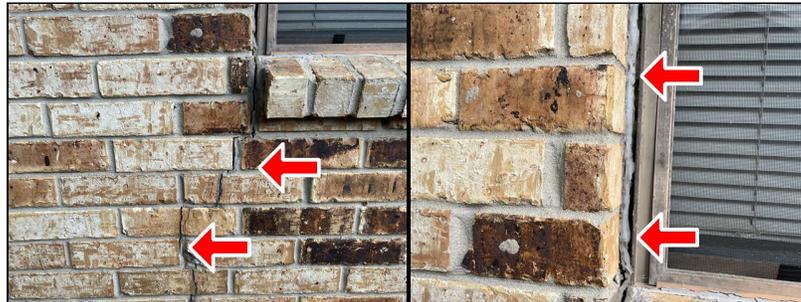
Set cracks in brick, stone and mortar observed in various locations. These cracks should be repaired to prevent moisture intrusion and further expansion. Have a qualified mason further evaluate and make any necessary repairs.

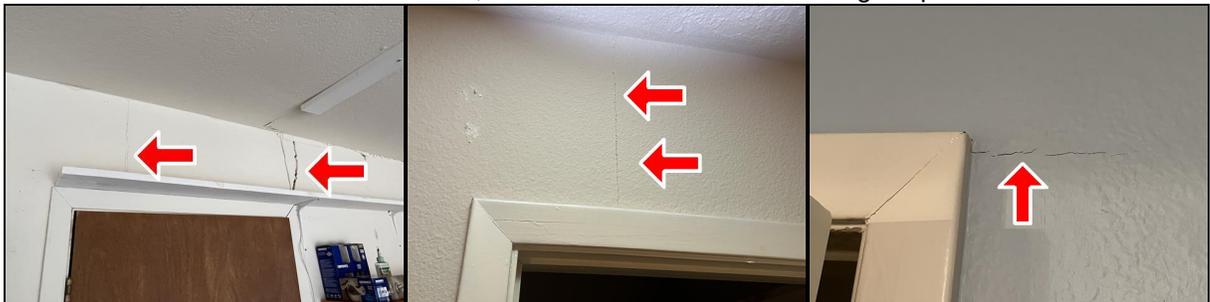
Cracks on interior walls in various areas, consistent with structural settling. Repair as needed.

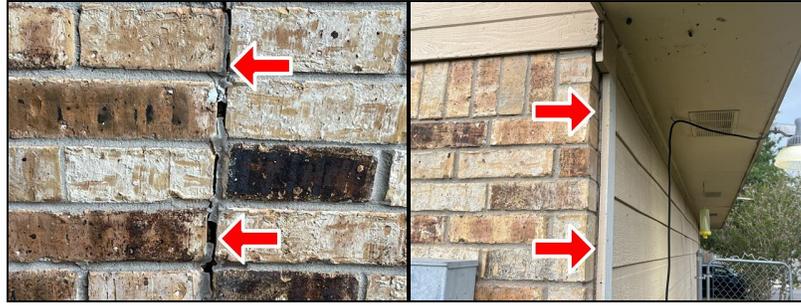
Exterior siding trim & transitional joints should be re-sealed (caulk) to prevent moisture incursion.

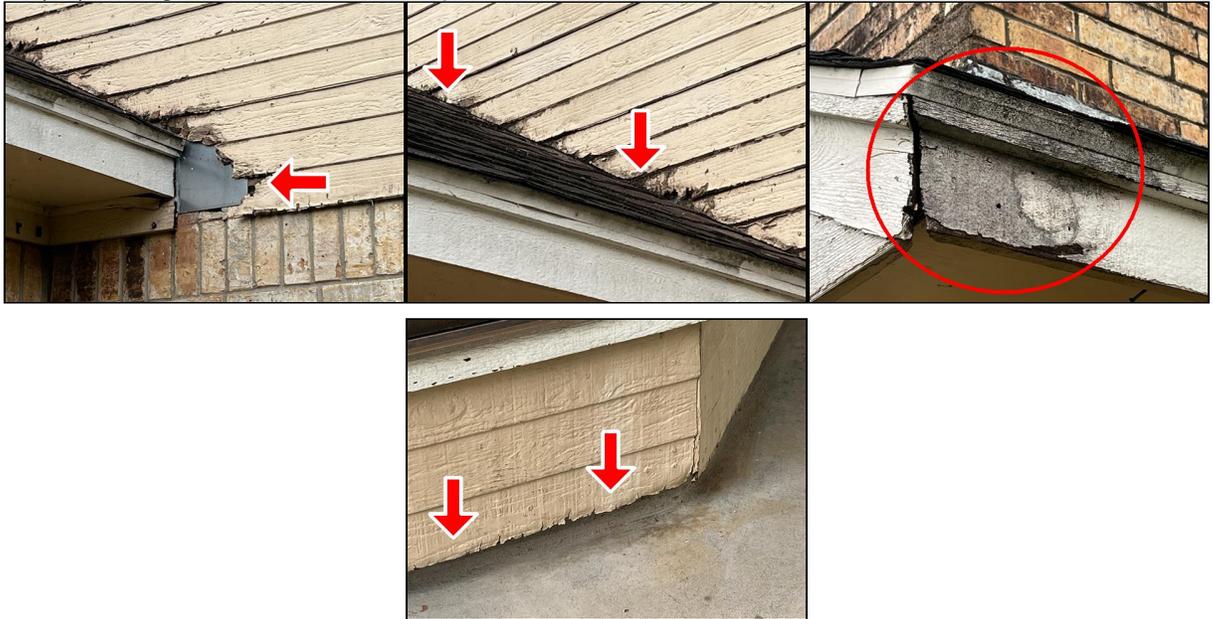
There are areas of the home exterior wood siding, trim, fascia, etc. that have sustained varying levels of water (rot) damage and are in need of repair

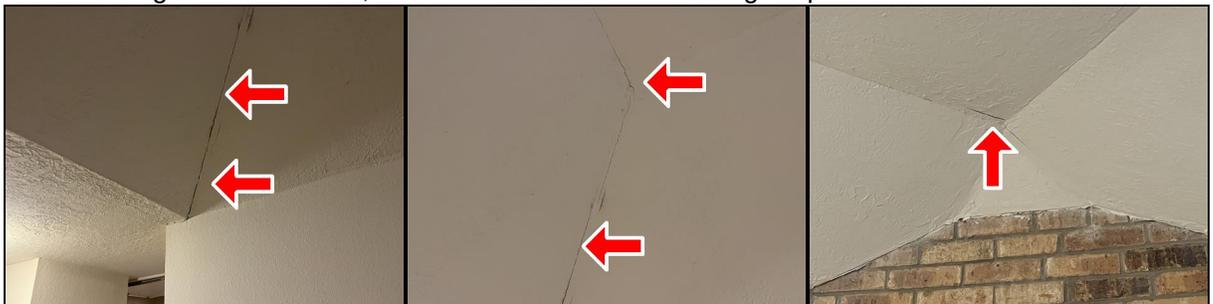
Cracks on ceiling in various areas, consistent with structural settling. Repair as needed.

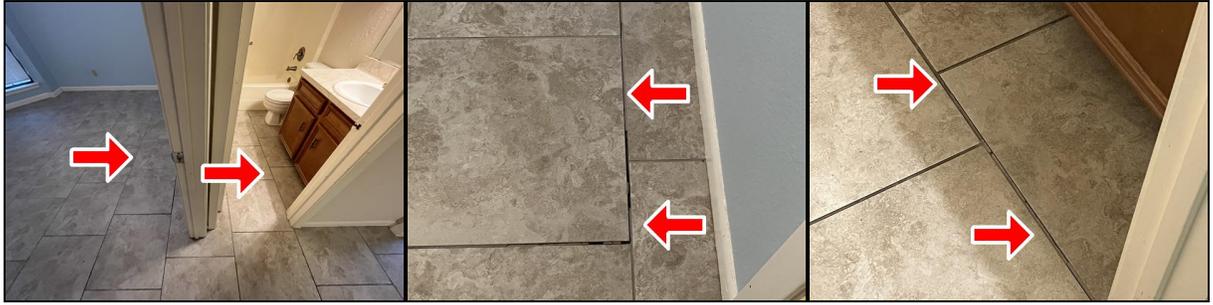
Cracked mortar at tiles observed in guest bedroom and hall bath. The cracks appear to be following a pattern consistently typical of foundation settlement. Recommend mortar/grout repair as needed.

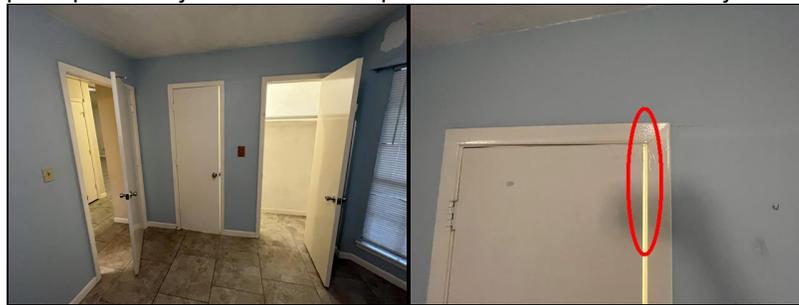
Closet door out of square/plumb in jamb. Have a carpenter evaluate and make adjustments, repairs.

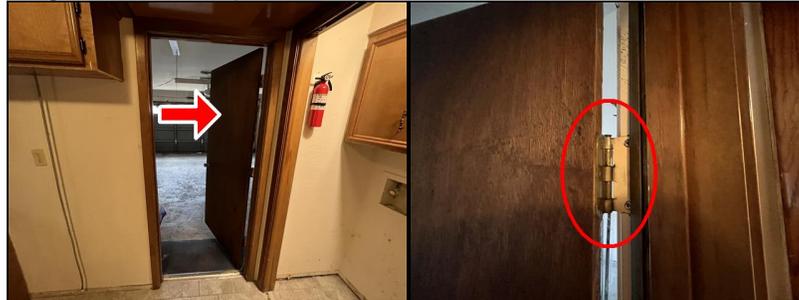
The door from inside garage to inside the home is not a solid core or metal clad, fire rated door. Additionally, I recommend installing self closing hinges as a safety feature to prevent exhaust gases (car, appliance) from entering the house. Replacement is recommended to meet modern standards.

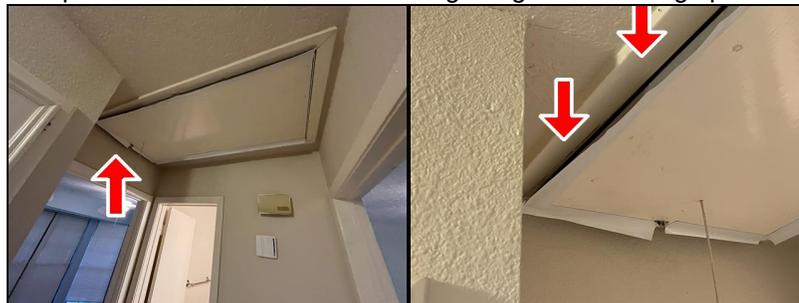
Attic door is out of square, does not close completely. Recommend having a qualified contractor make the necessary corrections to prevent heat/cold in attic from migrating into the living space.

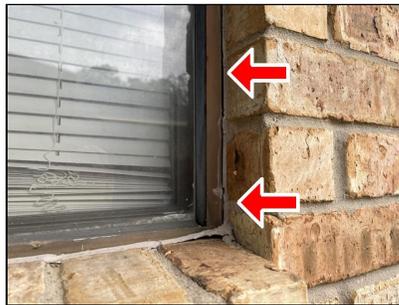
Fresh sealant/caulk applications recommended on exterior window frames at walls. This is an ongoing maintenance item that should be performed on a regular basis to prevent the entry and subsequent damage from water/moisture.

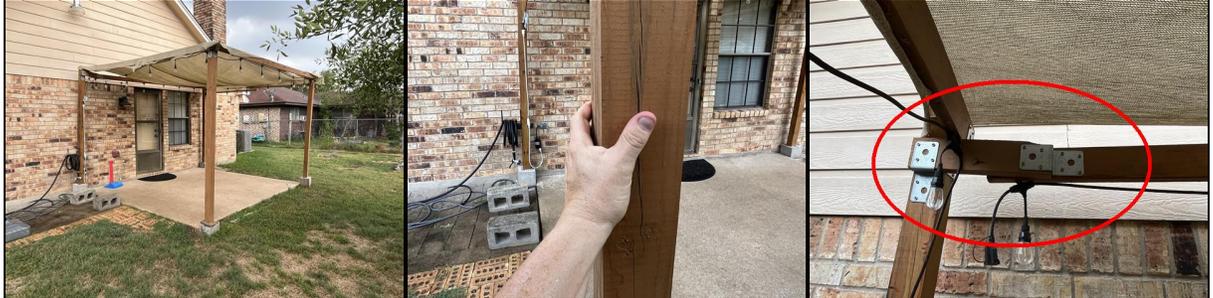
The pergola at rear of home appears to be structurally unstable (wobbly). Recommend having a qualified contractor further evaluate and make any necessary repairs.

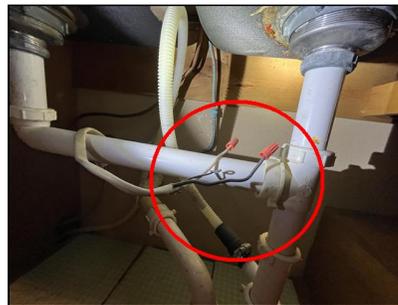
There were exposed connections, open boxes observed under the kitchen sink. Secure, enclose in rated enclosures to prevent hazards.

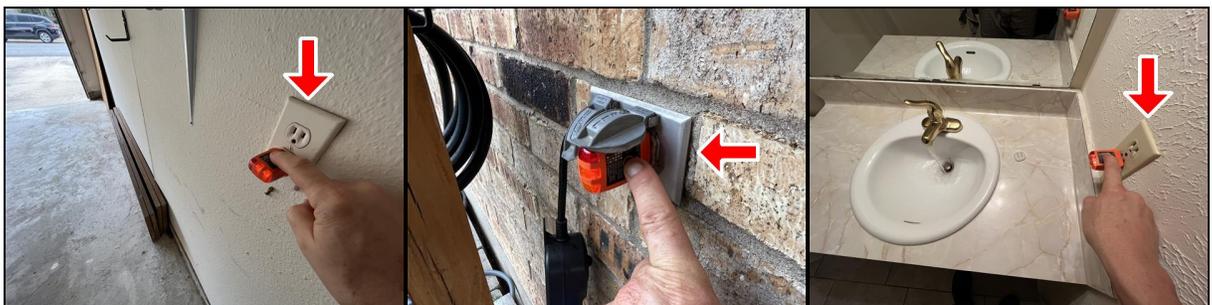
There are no GFCI (Ground Fault Circuit Interrupt) protected outlets in locations called for by today's standards: all kitchen, baths, non dedicated garage below 6', and exterior outlets. I recommend updating to current standards.

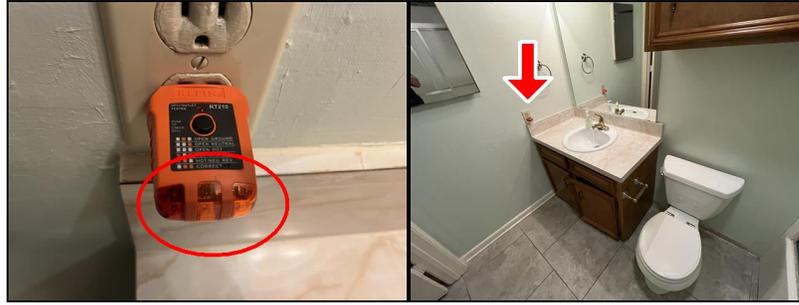
There was an outlet found to be non-functional in the master bath. I recommend further evaluation/ diagnosis and repair by a licensed electrician.

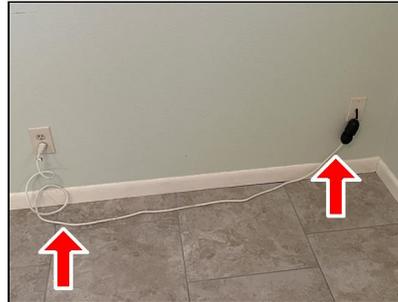
The circuit/outlet in guest bedroom is using an extension cord as permanent wiring. This circuit should be properly hardwired in rigid conduit or removed.

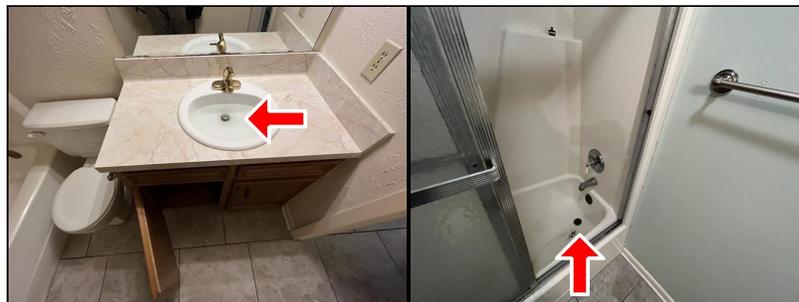
The drain was slow, and may be clogged in the guest bath sink and master bath tub. I recommend repair by a plumber.

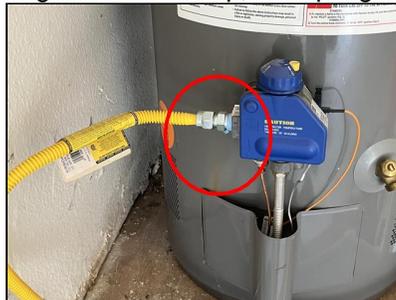
Gas supply to the water heater is missing a sediment trap, or drip leg as called for by current standards.

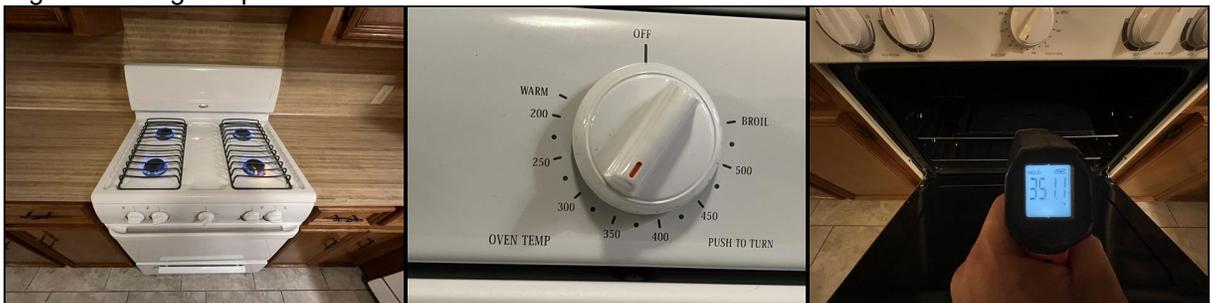
There is no child protection anti-tip device installed. Anti-tip brackets prevent the stove from accidentally tipping over if weight is placed on the oven door

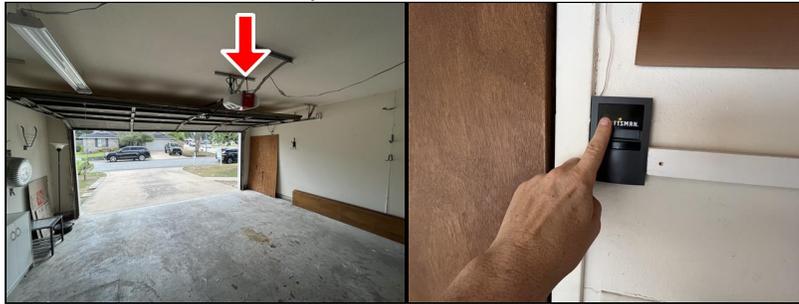
Garage door opener would not close normally without assistance by holding down the switch/button, and safety features could not be inspected. Sensitivity may be set too high, or unit may require repair. A qualified garage door contractor should evaluate and repair as needed.

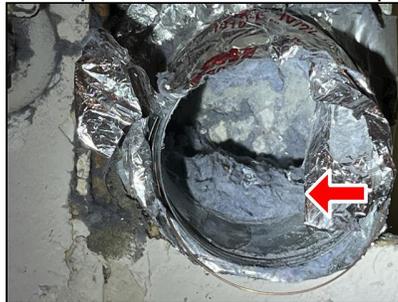
The dryer vent has excessive lint build-up and should be cleaned prior to use.
