## PROPERTY INSPECTION REPORT

Prepared For: Art Walsh  
(Name of Client)

Concerning: 11 Greenview St, Montgomery, TX 77356  
(Address or Other Identification of Inspected Property)

By: Alan Cunningham, License # 22302 8/18/2020  
(Name and License Number of Inspector) (Date)

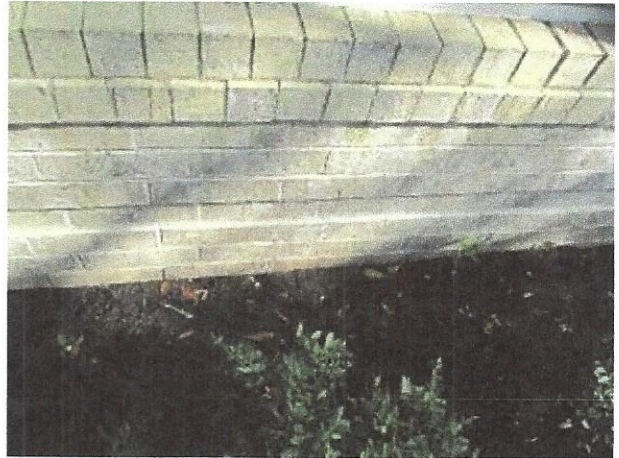
High soil level #2

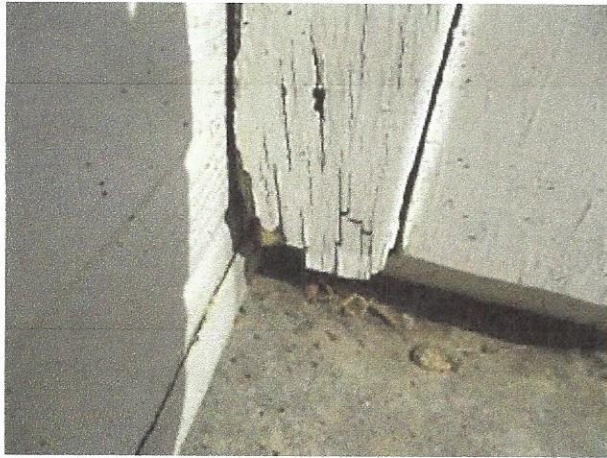
Wood rot #3

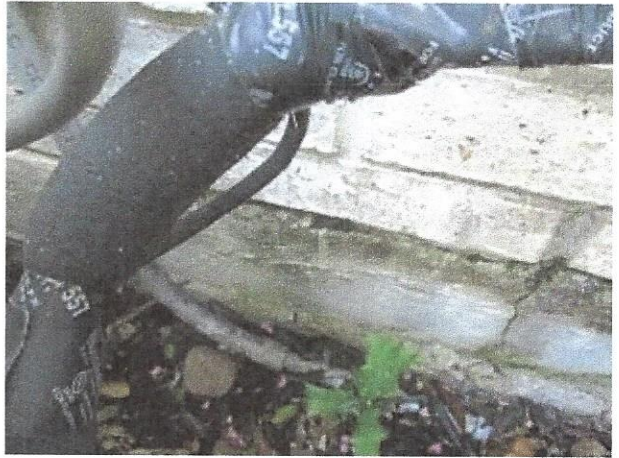
Excessive moisture #4

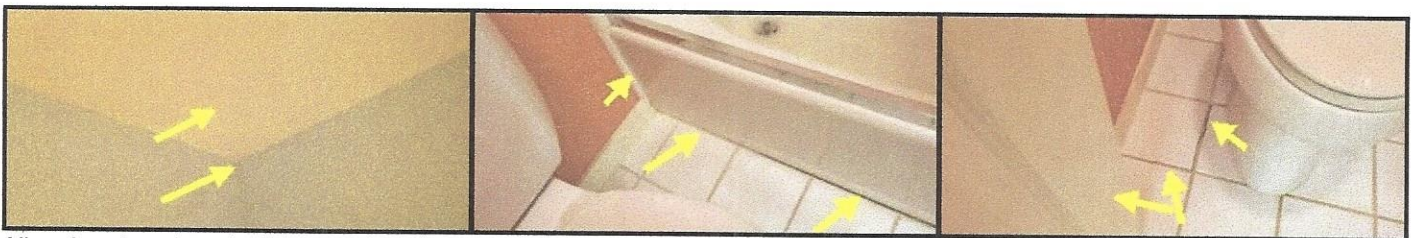
F.3. Minor drywall cracks and nail pops are common in ceilings that are attached to vaulted ceilings. Expansion and contraction can cause not flexible drywall to crack at seams. Recommend repair as needed for aesthetics. (main bath)

F.4. Recommend repairing tub to floor joints to prevent possible water penetration. (guest bath)

**F.5. Cracked floor tiles were observed in the guest bathroom and should be repaired to prevent further damage from moisture penetration.**

Minor drywall cracks and nail pops are common in ceilings that are attached to vaulted ceilings

Recommend repairing tub to floor joints to prevent possible water penetration

Cracked floor tiles

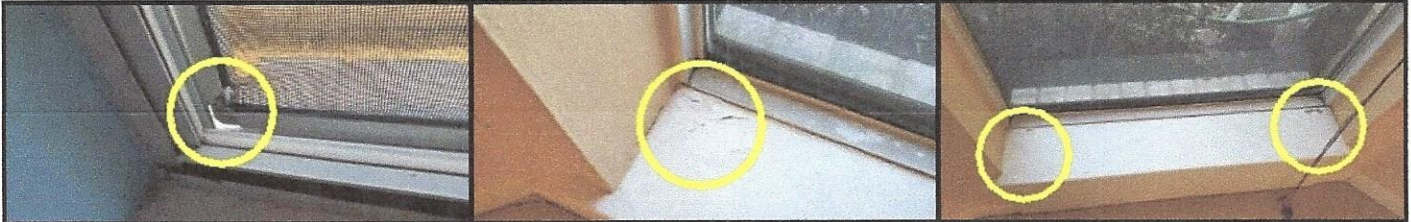
Missing or damaged windows screens

Possible moisture damage was observed at window sills

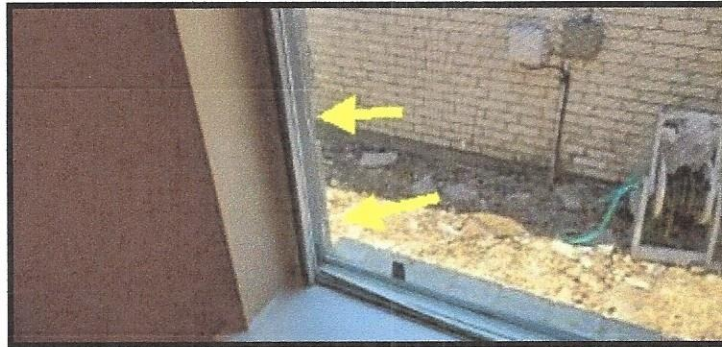
Missing or damaged windows screens

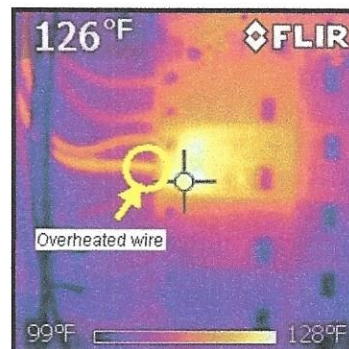
One breaker slightly warm

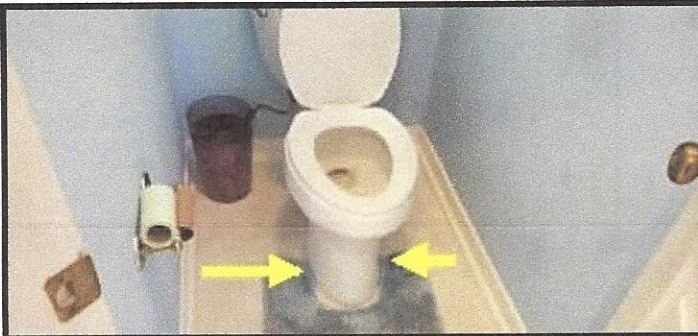
The commode is loose

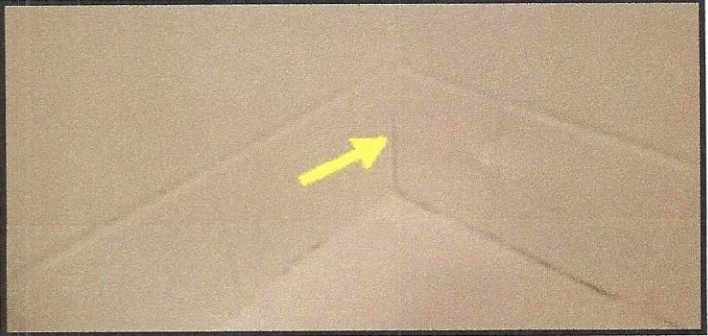
Cracked, deteriorated and/or missing tub/shower grout

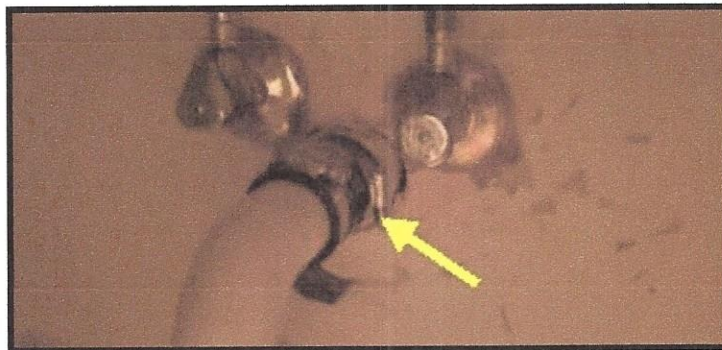
B.3. Flexible drainage connections were observed. This type of drainage connection is meant for a temporary repair. Recommend utilizing a rigid type piping to assure future performance and prevent leaks. (half bath)

Flexible drainage connections were observed

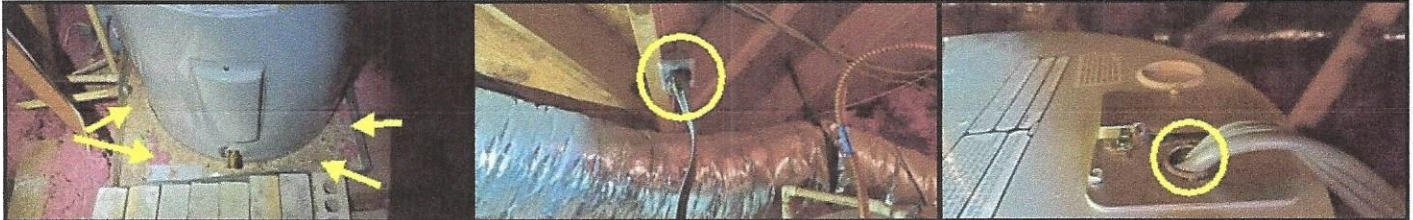
Debris/insulation was observed in drip pan

Water heaters were observed to be improperly wired

Wiring and/or conduit is not properly secured to unit (unit 2)

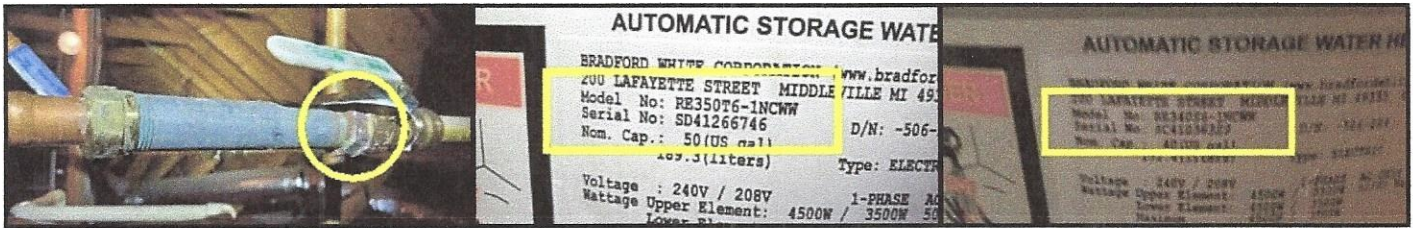
Corroded fittings on top of water heater
