**Advantage** *Home Inspections*

PROPERTY INSPECTION REPORT FORM

DANZIG HAMPTON <i>Name of Client</i>	01/20/2024 <i>Date of Inspection</i>
100 SOUTH BROCKMAN, CLUTE, TX 77531 <i>Address of Inspected Property</i>	
Eddie Rape <i>Name of Inspector</i>	TREC # 5013 <i>TREC License #</i>
<i>Name of Sponsor (if applicable)</i>	<i>TREC License #</i>

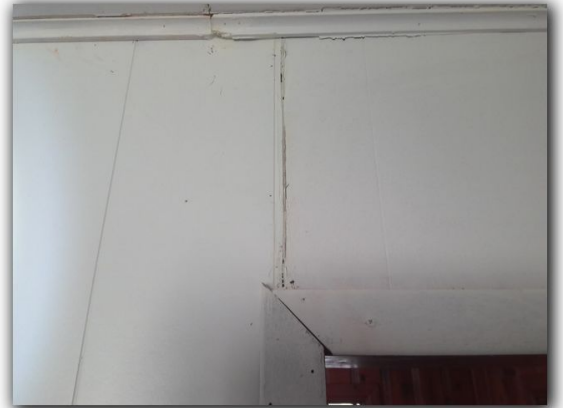
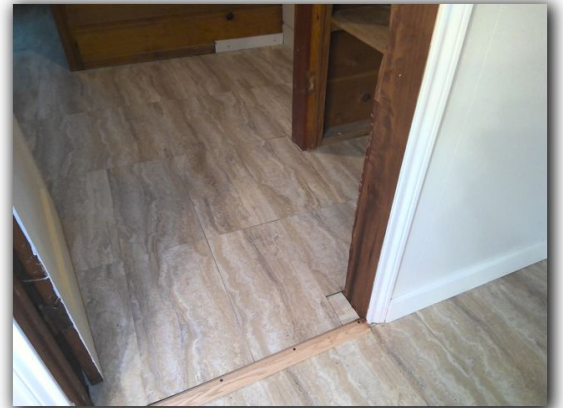
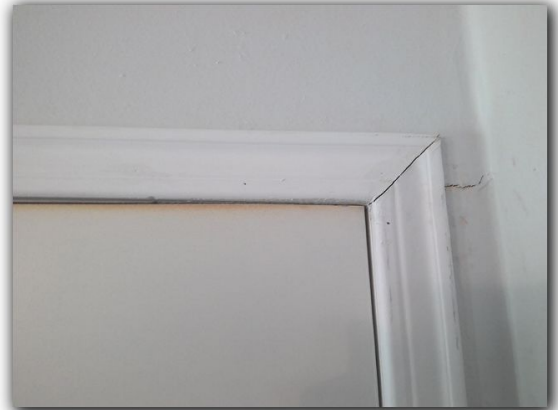
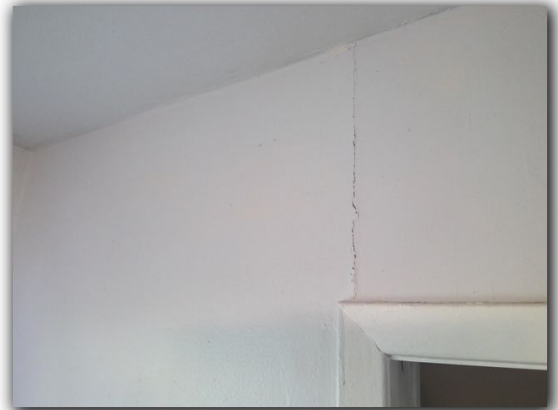
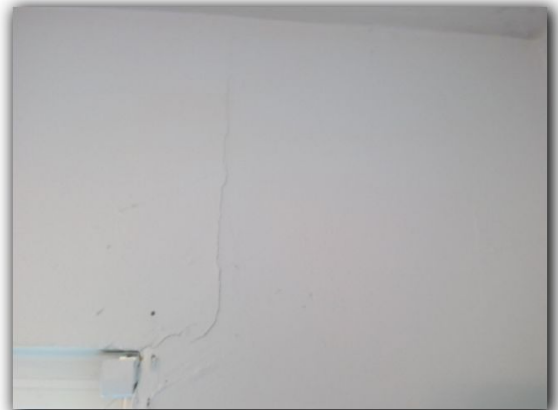
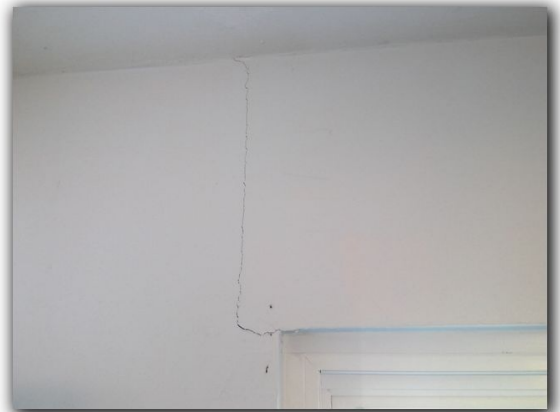
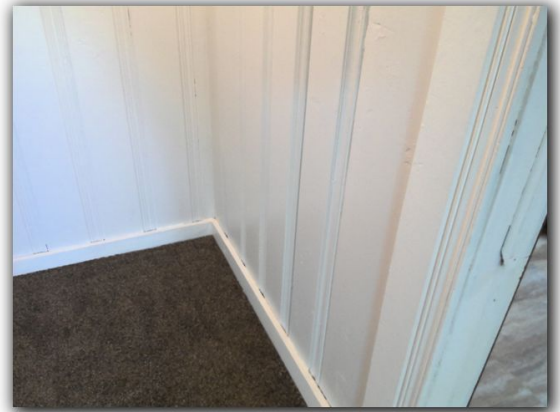
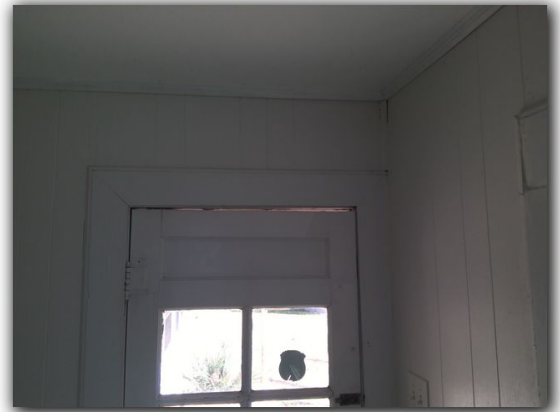
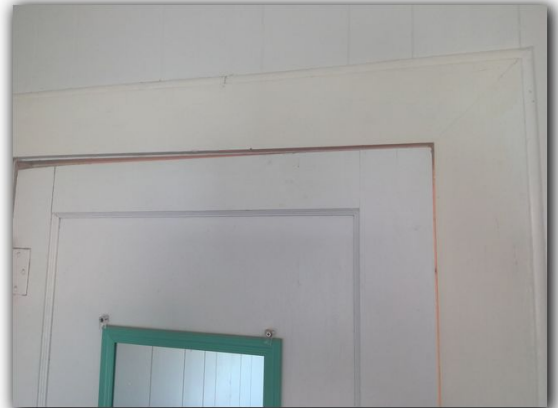
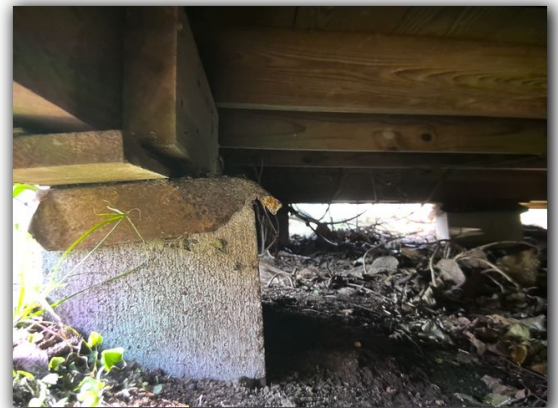
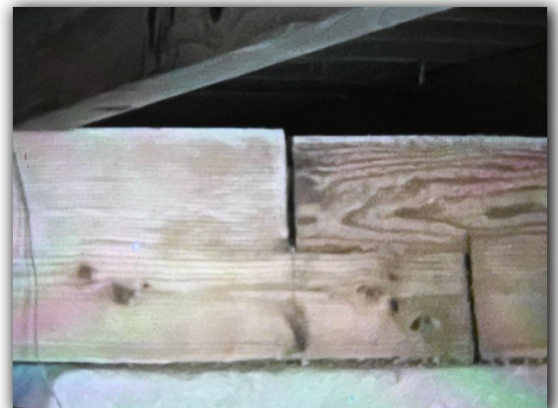
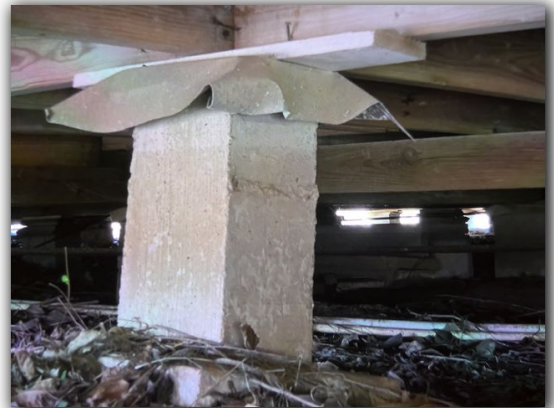
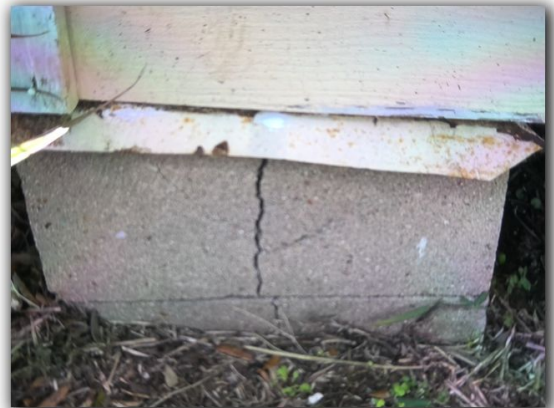
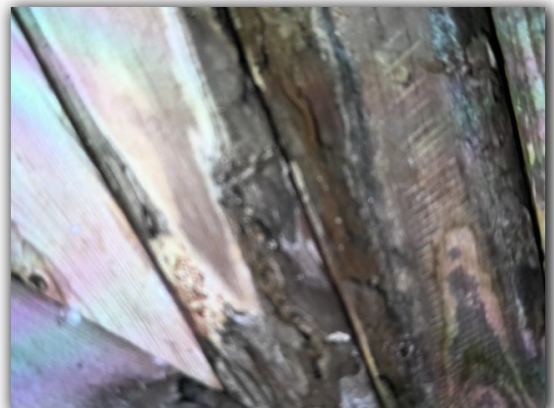
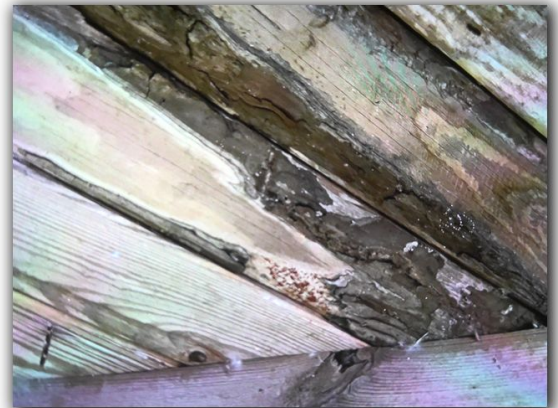
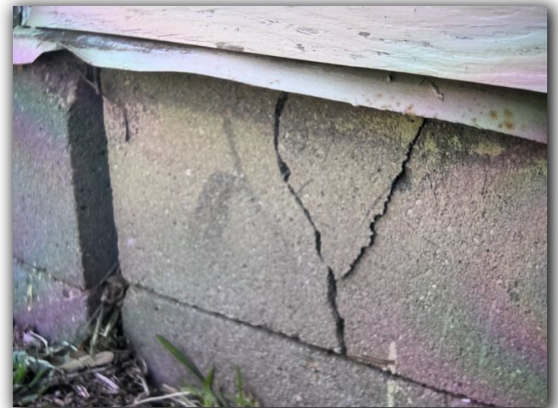
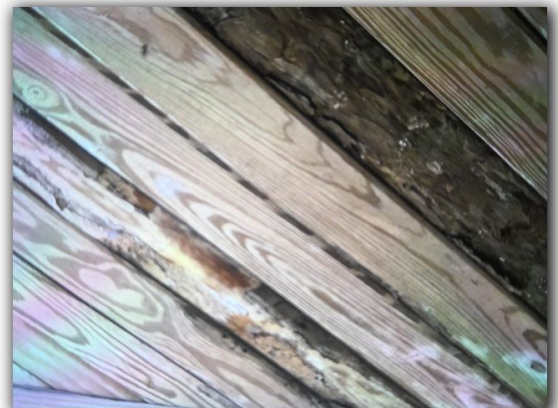
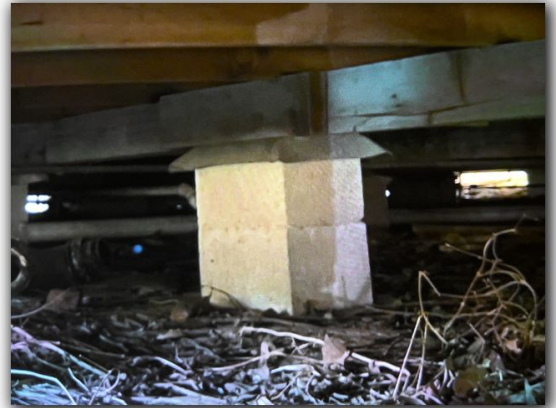
1.MODERATE TO EXCESSIVE SIGNS OF MOVEMENT WERE OBSERVED AT MOST ROOMS THROUGHOUT RESIDENCE. SEVERAL DOORS THROUGHOUT RESIDENCE DO NOT PROPERLY FIT INTO THE DOOR FRAMES. FLOORS SLOPE EXCESSIVELY AT SEVERAL ROOMS THROUGHOUT RESIDENCE.

2.SOME FOUNDATION BLOCKS ARE CRACKED AND UNDERSIZED. CINDER BLOCKS ARE REQUIRED TO BE AT LEAST 8" X 8"X 16" PLACED IN A HORIZONTAL POSITION ON TOP

OF THE PAD. PIER PADS ARE MISSING AND/OR UNDERSIZED. ALL PIERS (BLOCKS) SHOULD BE RESTING ON 16"X16"X 4" CONCRETE PADS. SEVERAL FOUNDATION BEAMS ARE EXCESSIVELY CRACKED, BOWED AND ARE PULLING AWAY AT BEAM JOINTS. SEVERAL FOUNDATION BLOCKS ARE LEANING EXCESSIVELY AND/OR NOT TOUCHING BEAMS. MOST TERMITE SHIELDS ARE EXCESSIVELY CORRODED. FOUNDATION COMPONENTS HAVE INSUFFICIENT ELEVATION ABOVE FINISHED GRADE OF THE CRAWL SPACE. CURRENT CODES REQUIRE A MINIMUM OF 12 INCHES OF CLEARANCE BETWEEN THE BEAMS AND GRADE, AND A MINIMUM OF 16 INCHES OF CLEARANCE BETWEEN THE FLOOR JOISTS AND GRADE. FLOOR DECKING IS WEATHER DAMAGED AND/OR ROTTEN AT VARIOUS AREAS BELOW RESIDENCE. VIEW OF MOST FLOOR DECKING WAS NOT ACCESSIBLE.

DUE TO DEFICIENCIES OBSERVED, I BELIEVE THE PIER & BEAM FOUNDATION IS IN NEED OF REPAIR. I RECOMMEND CONSULTING WITH A FOUNDATION SPECIALIST.

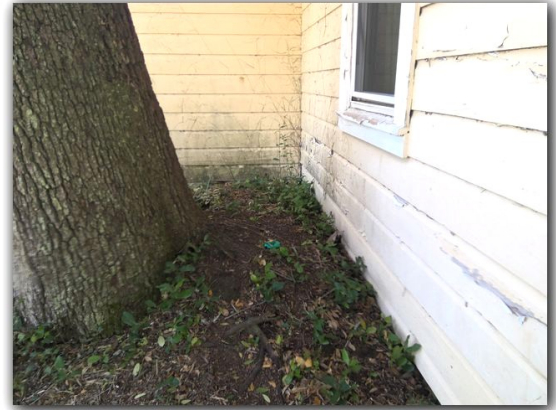
1.CRAWLSPACE GRADING IS LOWER THAN THE SURROUNDING YARD IN SOME AREAS. THIS CAN CAUSE WATER TO DRAIN AND POND BELOW THE RESIDENCE. IDEALLY, CRAWLSPACE GRADING SHOULD BE SLOPED TO ALLOW WATER TO DRAIN FROM BENEATH THE RESIDENCE.

2.TREES ARE TOO CLOSE TO FOUNDATION AT N/E AND S/W SIDES OF RESIDENCE.

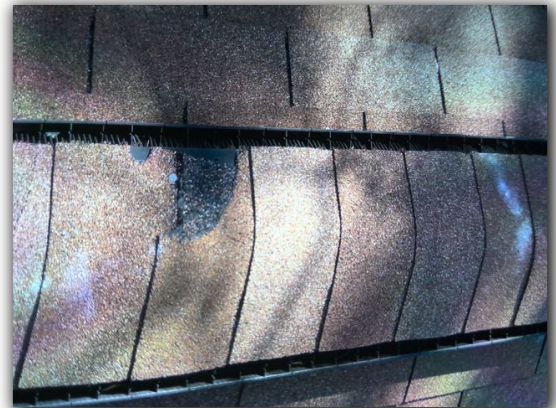
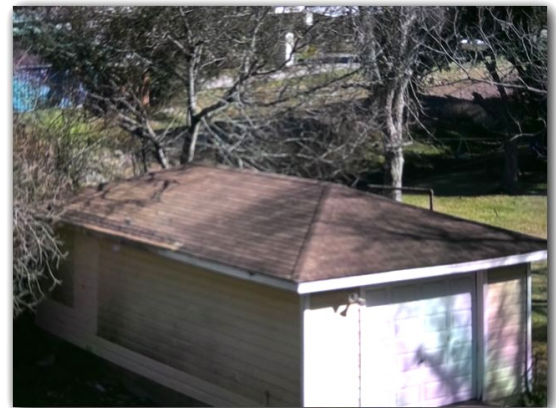
- 1.DAMAGED/MISSING SHINGLES WERE OBSERVED AT MAIN RIDGE VENT.
- 2.DETACHED GARAGE; SHINGLES ARE RAISED, CRACKED, CHIPPED, DAMAGED, MISSING AND/OR LOOSING AGGREGATE AT VARIOUS AREAS AT ALL SIDES OF DETACHED GARAGE. MOST SHINGLES APPEAR TO BE VERY BRITTLE, WEATHER DAMAGED AND ARE NEARING THE END OF THEIR LIFE SPAN.

I RECOMMEND CONSULTING A REPUTABLE ROOFING CONTRACTOR FOR FURTHER EVALUATION.

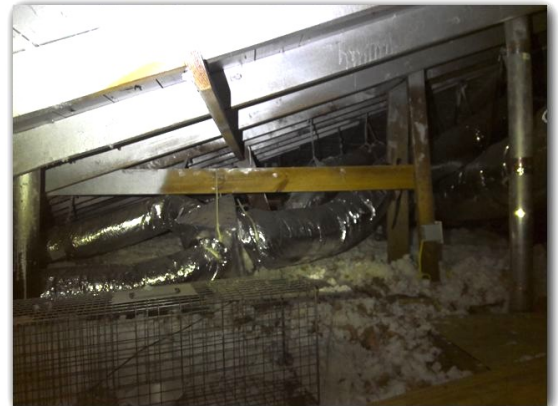
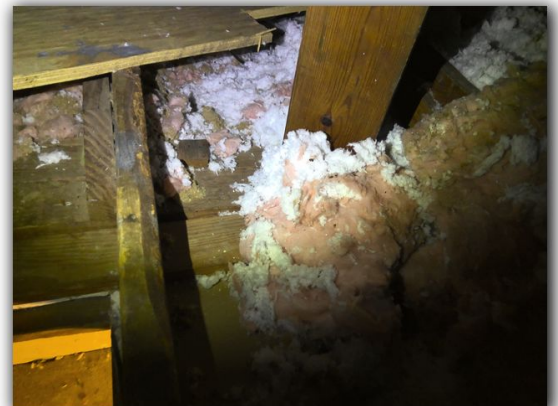
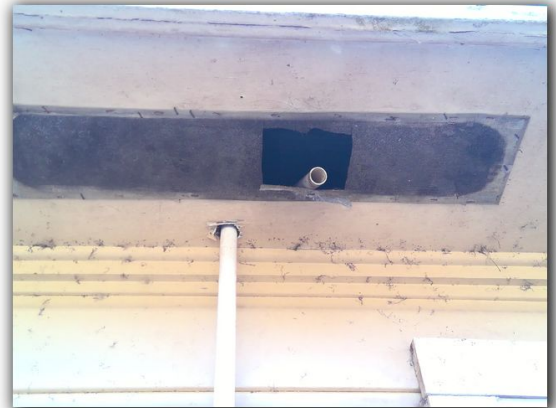
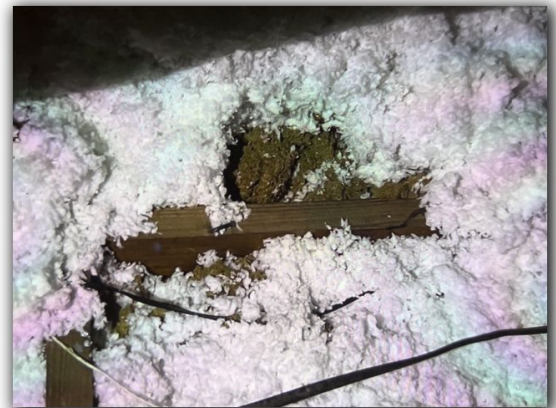
NOTE: EXCESSIVE AMOUNTS OF RODENT WASTE WAS OBSERVED AT VARIOUS AREAS THROUGHOUT THE ATTIC. I RECOMMEND CONSULTING A LICENSED PEST CONTROL TECHNICIAN FOR FURTHER EVALUATION.

USED IN MODERN RESIDENTIAL CONSTRUCTION. DURING THE RE-ROOFING PROCESS IT IS COMMON FOR ROOFER'S TO OBSERVE THE WOOD TO BE SPLIT, CHUNKED AND DAMAGED AT THE TOP SIDE OF THE BOARDS. THIS CONDITION IS NOT AS EASILY OBSERVED FROM THE ATTIC SIDE. MOST OF THE TIME THE DAMAGE IS NOT OBSERVED UNTIL THE ROOF COVERING IS STRIPPED. IN MANY CASES THE ROOF DECKING NEEDS TO BE REPLACED DUE TO THE DAMAGED DECKING. THIS POTENTIAL ISSUE MAY NEED TO BE FACTORED IN, FOR A MORE ACCURATE RE-ROOF ESTIMATE. I RECOMMEND CONSULTING WITH A REPUTABLE ROOFING CONTRACTOR FOR FURTHER EVALUATION.

2.INADEQUATE ROOF SUPPORT. MISSING AND/OR UNDERSIZED RAFTERS, PURLIN BOARDS, COLLAR TIES AND RIDGE BEAM SUPPORT BOARDS WERE OBSERVED THROUGHOUT ATTIC. I RECOMMEND CONSULTING A REPUTABLE CONTRACTOR FOR FURTHER EVALUATION.

3.SCREEN IS LOOSE, TORN AND/OR MISSING AT SOME SOFFIT VENTS. THE SCREEN NEEDS TO BE REPAIRED TO PREVENT PESTS, BIRDS OR ANIMALS FROM ENTERING THE ATTIC.

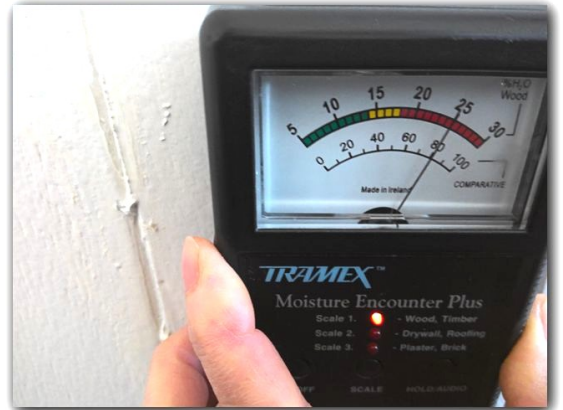
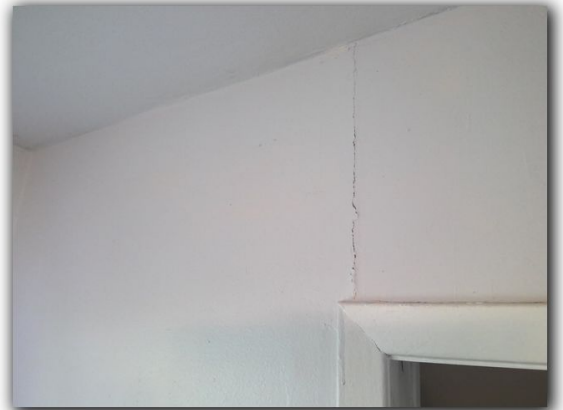
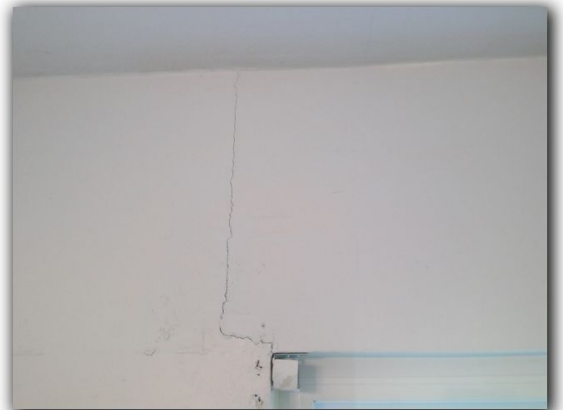
1.WATER STAINED AND/OR DAMAGED WALLS WERE OBSERVED AT LOWER, EAST WALL OF EAST SIDE BEDROOM. I PLACED A MOISTURE METER ON THE WALLS AND THE MOISTURE METER DETECTED VERY HIGH LEVELS OF MOISTURE AT/AND NEAR THE STAINS.

2.MODERATE TO EXCESSIVE SETTLEMENT CRACKS TO SHEETROCK WALLS AND/OR LOOSE/BOWED PANELING WAS OBSERVED AT MOST ROOMS THROUGHOUT RESIDENCE.

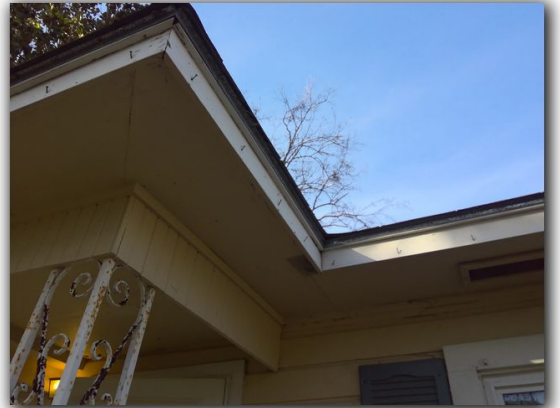
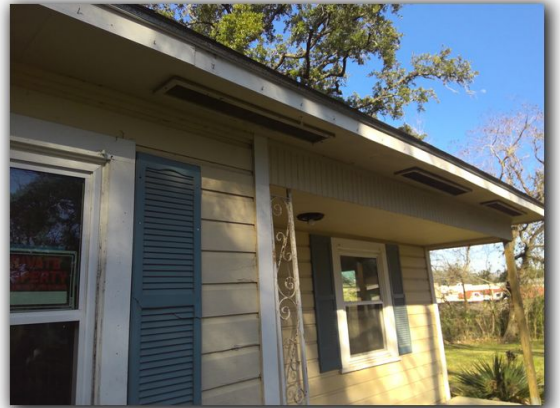
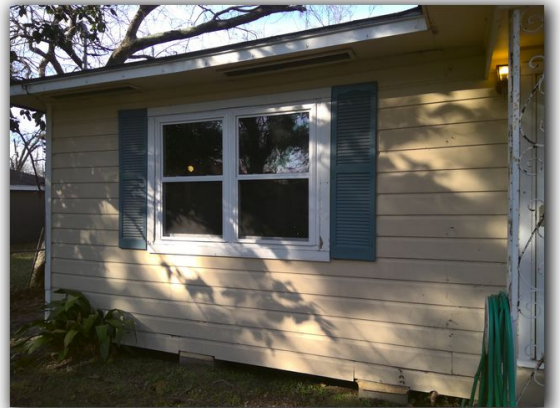
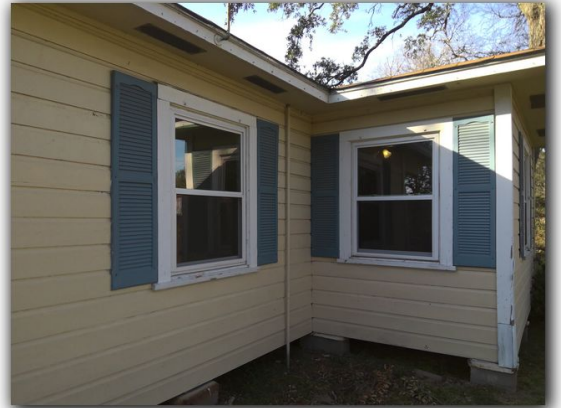
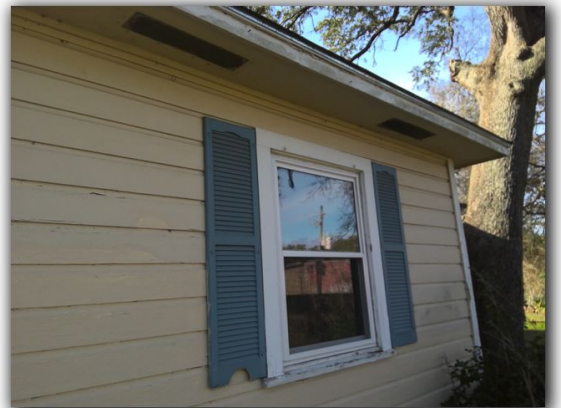
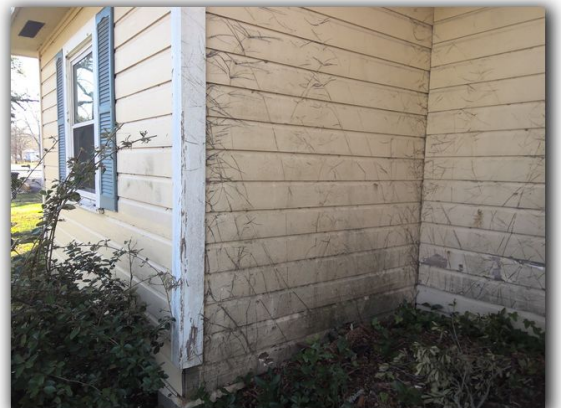
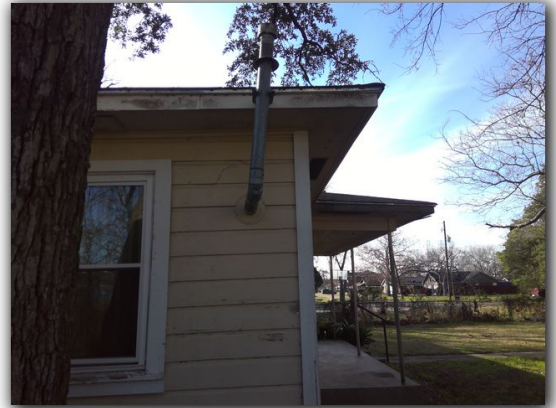
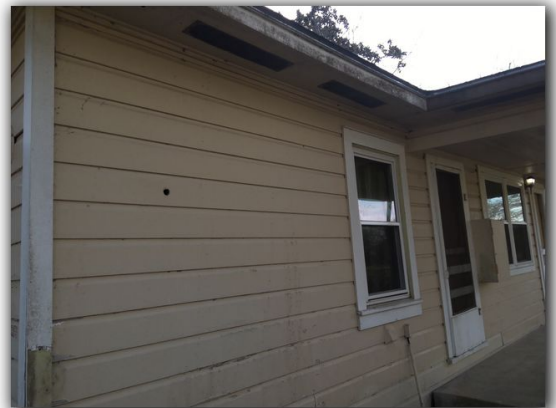
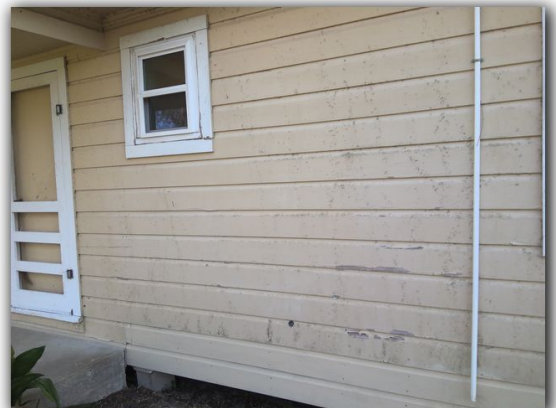
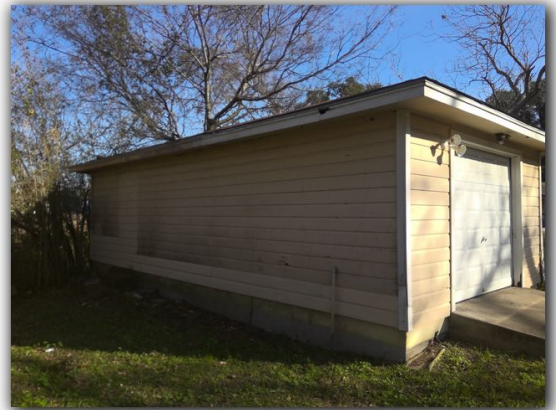
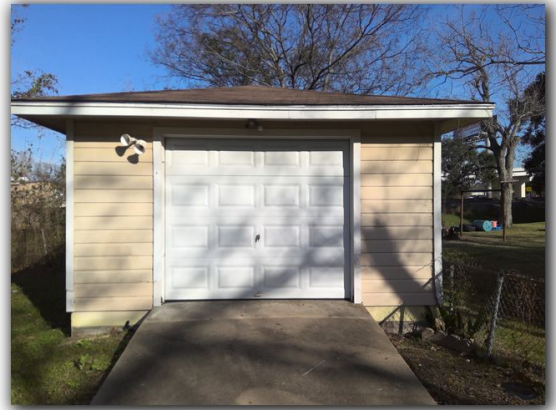
1.SIDING, FACIA BOARDS, SOFFIT BOARDS AND/OR TRIM ARE LOOSE, CHIPPED, NEEDS MORE CAULKING, NEEDS MORE PAINT AND/OR WEATHER DAMAGED AND/OR ROTTEN AT VARIOUS AREAS AT ALL SIDES OF RESIDENCE AND DETACHED GARAGE.

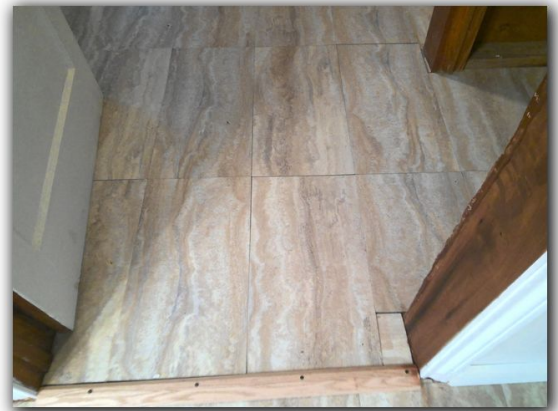
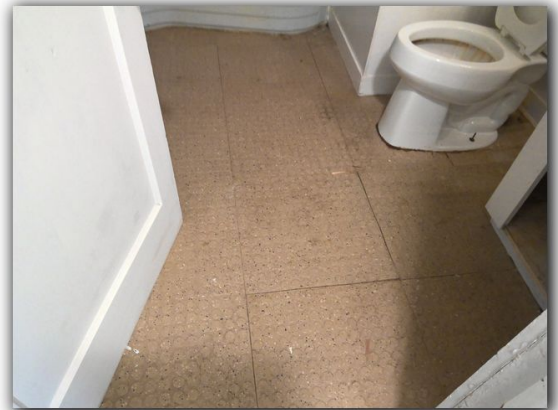
1.EXCESSIVE SETTLEMENT CRACKS WERE OBSERVED AT DEN.

1.LOOSE, CHIPPED AND/OR DAMAGED FLOORING WAS OBSERVED AT VARIOUS AREAS THROUGHOUT RESIDENCE. THIS COULD BE A TRIP HAZARD.

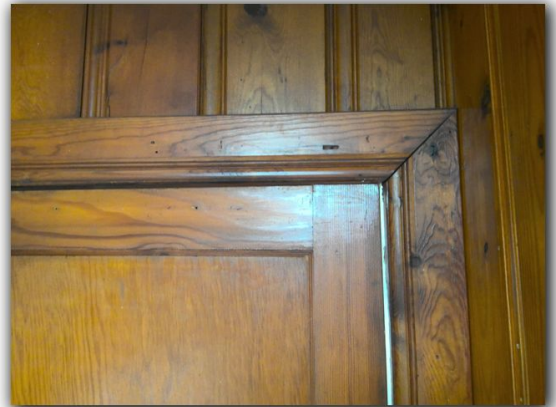
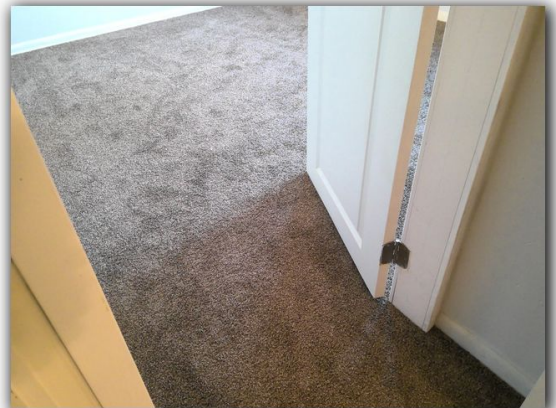
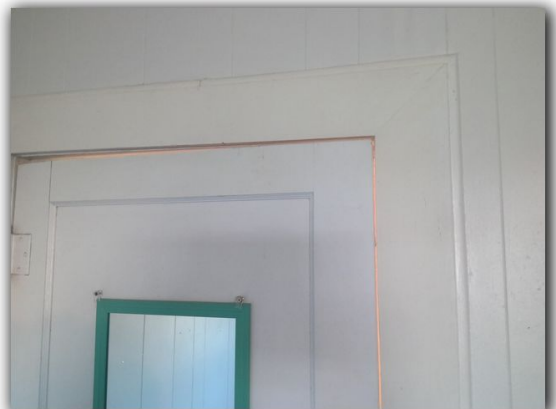
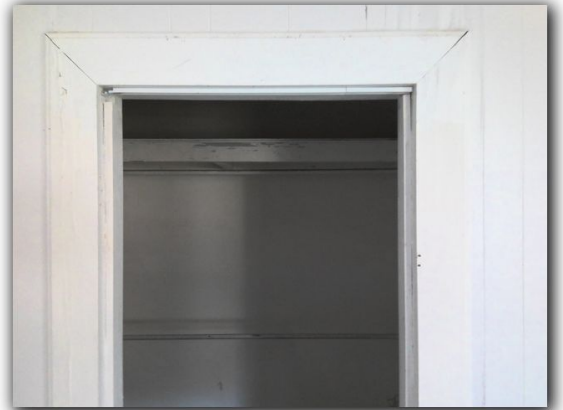
1.DOORS STICK AND/OR DO NOT PROPERLY FIT INTO THE DOOR FRAMES AT SEVERAL DOORS THROUGHOUT RESIDENCE. THIS IS A COMMON CHARACTERISTIC OF EXCESSIVE FOUNDATION MOVEMENT.

3.CLOSET DOOR IS MISSING AT EAST SIDE BEDROOM.

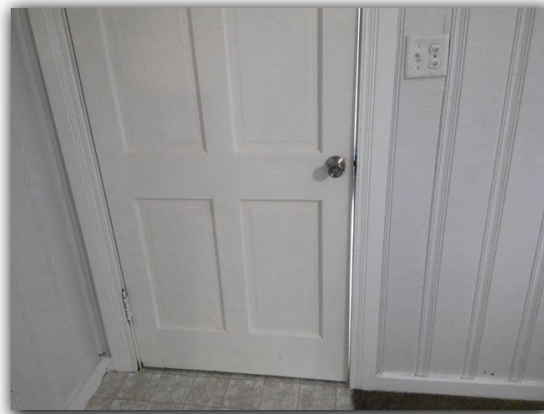
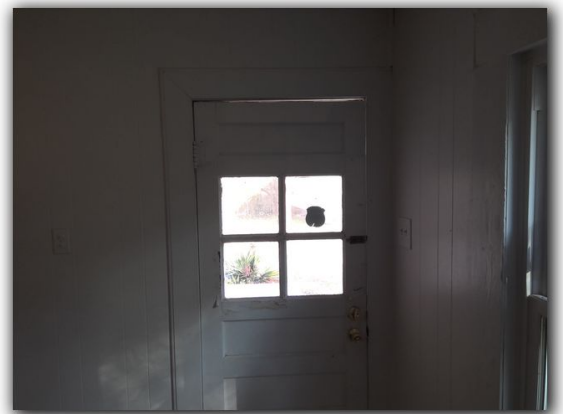
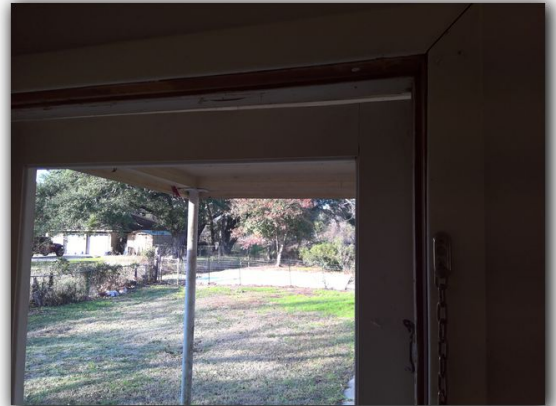
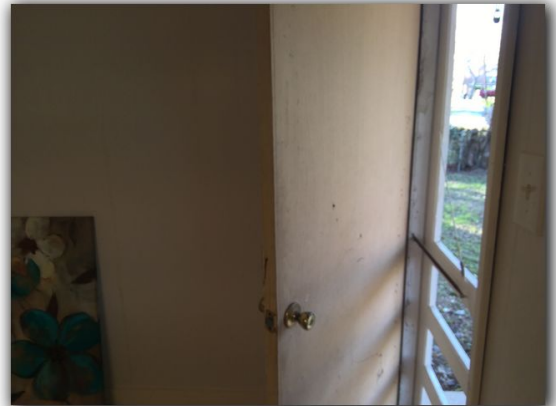
- 1.DOORS ARE WEATHER DAMAGED AND ARE IN POOR CONDITION AT BACK DOOR AND UTILITY ROOM DOOR.
- 2.DAMAGED PAINT WAS OBSERVED AT EAST SIDE, FRONT DOOR. THE DOOR NEEDS TO BE PROPERLY PREPPED, SANDED AND PAINTED TO PREVENT FURTHER DAMAGE.
- 3.LOOSE, TORN AND/OR MISSING WEATHER STRIPPING WAS OBSERVED AT ALL EXTERIOR DOORS.
- 4.WOOD AT LOWER PORTION OF DOOR FRAME IS WEATHER DAMAGED AND/OR ROTTEN AT OVERHEAD GARAGE DOOR.
- 5.SAFETY GLASS LABELS WERE NOT OBSERVED AT EAST SIDE FRONT DOOR. CURRENT RULES REQUIRE ALL PATIO DOOR GLASS TO BE SAFETY GLASS.
- 6.SCREEN DOOR IS DAMAGED AT BACK DOOR.

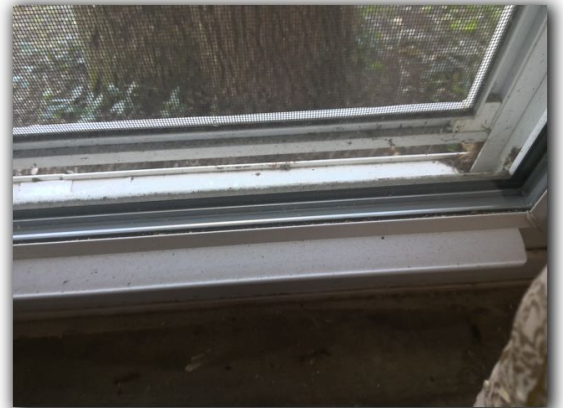
1.IMPROPERLY SIZED WINDOW SCREENS AT UTILITY ROOM.

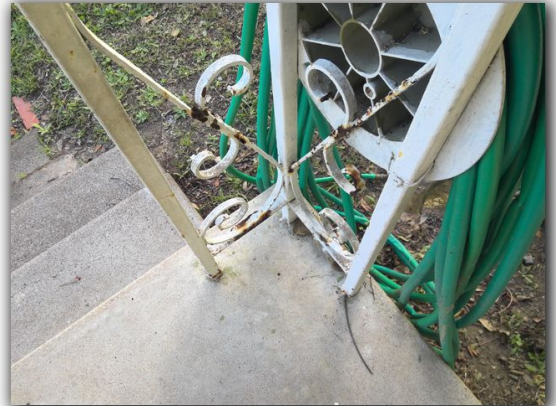
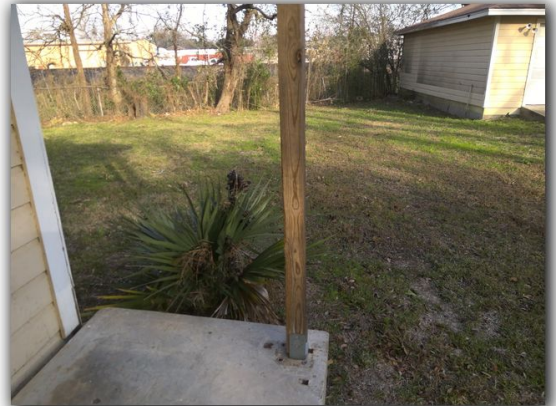
Comments:
1.LOWER PORTION OF PORCH PILLARS ARE WEATHER DAMAGED/CORRODED AT FRONT PORCHES.
2.4 X 4 DIMENSIONAL COLUMN APPEARS TO BE UNDERSIZED AT EAST SIDE, FRONT PORCH. I RECOMMEND CONSULTING WITH A REPUTABLE CONTRACTOR FOR FURTHER EVALUATION.

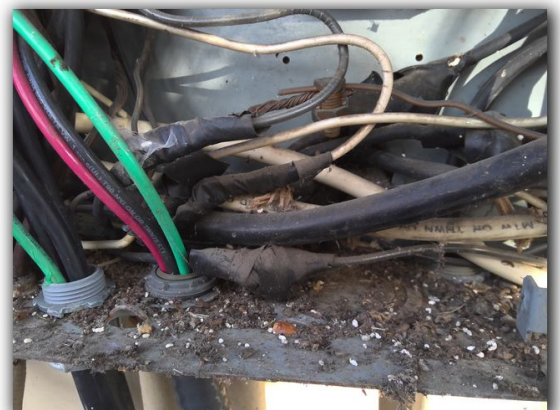
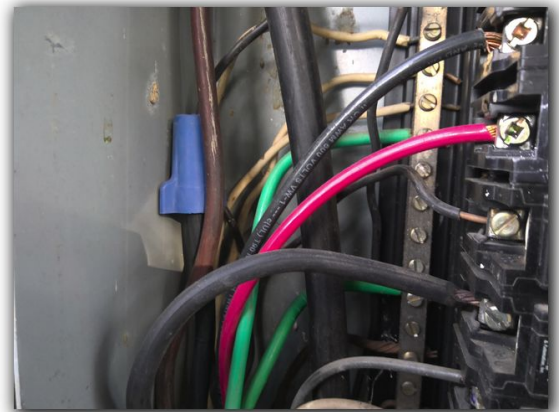
I-T-E BRAND, 200 AMP BREAKER PANEL: LOCATED AT WEST SIDE, EXTERIOR WALL OF RESIDENCE.

- 1.GROUND WIRES ARE SHARING THE SAME GROUND LUG/SCREW. CURRENT CODES DO NOT ALLOW MORE THAN ONE ELECTRICAL WIRE PER LUG/SCREW.
- 2.EXPOSED WIRE ENDS WERE OBSERVED INSIDE THE BREAKER PANEL THAT WERE TAPED, BUT IT NOT APPEAR TO HAVE WIRE NUTS. THE EXPOSED WIRE ENDS SHOULD BE PROPERLY CAPPED WITH WIRE NUTS.
- 3.WIRE NUTS SHOULD BE WRAPPED/SECURED WITH ELECTRICAL TAPE.
- 4.ALL CIRCUIT BREAKERS NEED TO BE PROPERLY IDENTIFIED AND LABELED.
- 5.ALTHOUGH NOT REQUIRED WHEN HOME WAS BUILT, NO ARC FAULT CIRCUIT INTERRUPTER BREAKERS WERE OBSERVED TO REQUIRED POWER OUTLETS. THESE ARE SAFETY DEVICES DESIGNED TO TRIP OFF WHEN ARCING IS DETECTED IN POWER OUTLETS AND/OR WIRING. NEW RULES REQUIRE ALL 15 AND 20 AMP BREAKERS TO BE ARC FAULT CIRCUIT PROTECTED.
- 6.CURRENT RULES REQUIRE A WHOLE HOUSE SURGE PROTECTOR TO BE INSTALLED.

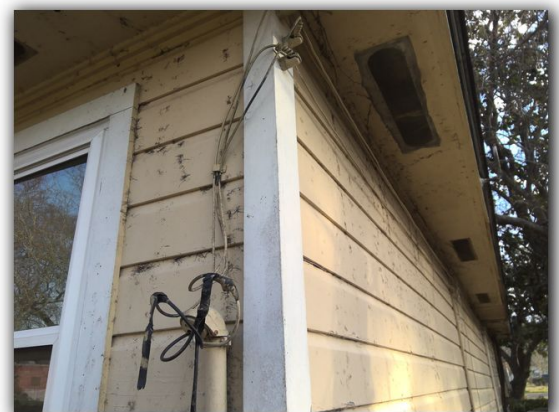
WEATHER HEAD AT N/W SIDE OF RESIDENCE:

1.WEATHER HEAD AND/OR ELECTRICAL WIRES ARE TOO LOW AND TOO CLOSE TO THE RESIDENCE, TO MEET CURRENT RULES. WIRES WERE ENERGIZED AT TIME OF INSPECTION. I RECOMMEND CONSULTING WITH A LICENSED ELECTRICIAN FOR FURTHER EVALUATION.

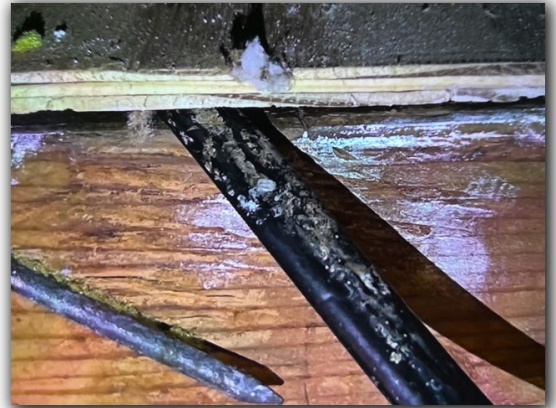
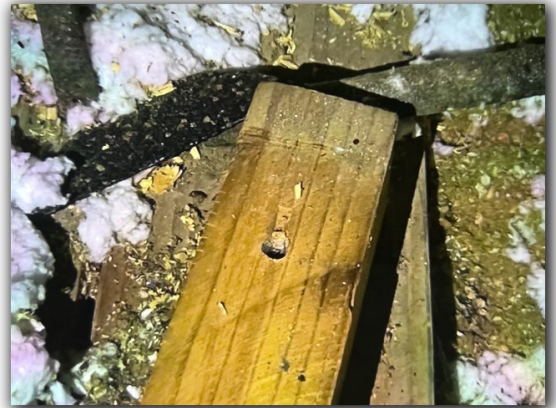
- 3.NO POWER TO POWER OUTLETS AT UTILITY ROOM AND EAST SIDE LIVING ROOM. I TAGGED/LABELED THE POWER OUTLETS FOR EASY IDENTIFICATION.
- 4.POWER OUTLETS ARE LOOSE IN THE WALL AND/OR HAVE LOOSE/WORN POWER OUTLET CONNECTIONS AT EAST SIDE LIVING ROOM AND UTILITY ROOM. ORANGE STICKERS WERE PLACED ON OUTLETS FOR EASY IDENTIFICATION.

- 8.TAMPER RESISTANT POWER OUTLETS ARE NOT INSTALLED AT ALL REQUIRED LOCATIONS AT RESIDENCE. THE TEXAS REAL ESTATE COMMISSION STANDARD OF PRACTICE RULES REQUIRE INSPECTORS TO LIST NON-TAMPER RESISTANT POWER OUTLETS, LESS THAN 5 1/2 ABOVE THE FLOOR AS DEFICIENT.

- 9.EXPOSED WIRE ENDS AT SOUTH SIDE ATTIC SHOULD BE ENCLOSED IN A JUNCTION BOX.
- 10.DAMAGED SHEATHING WAS OBSERVED ON A ELECTRICAL WIRE AT SOUTH SIDE ATTIC.

- 11.ELECTRICAL WIRES ARE IMPROPERLY INSTALLED BELOW ATTIC DECKING. THIS CAN CAUSE DAMAGE TO THE WIRES AND IS A FIRE HAZARD.
- 12.LOOSE, UNSECURED, IMPROPERLY INSTALLED ELECTRICAL WIRES WERE OBSERVED LAYING TOO CLOSE TO THE ATTIC ENTRANCE.

- 15.DAMAGED CONDUIT WAS OBSERVED AT BACK SIDE OF RESIDENCE.

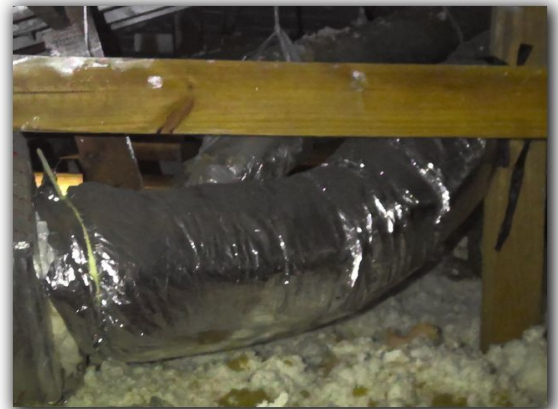
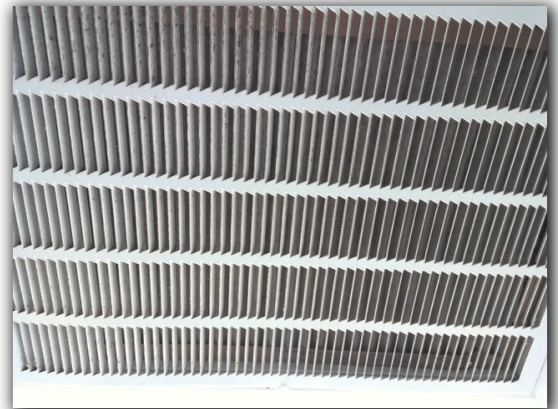
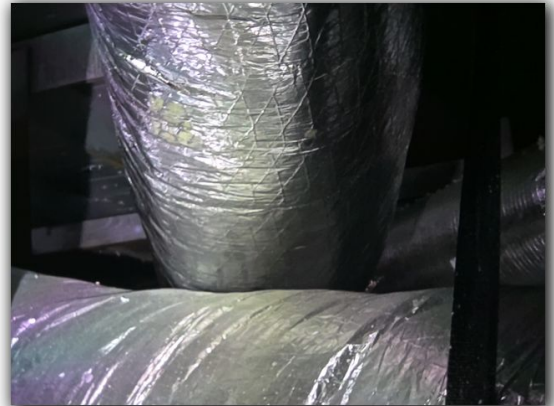
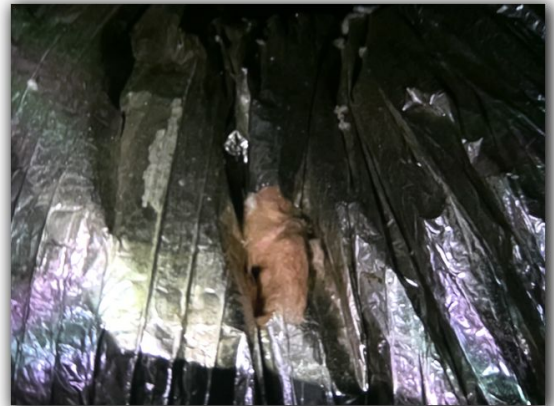
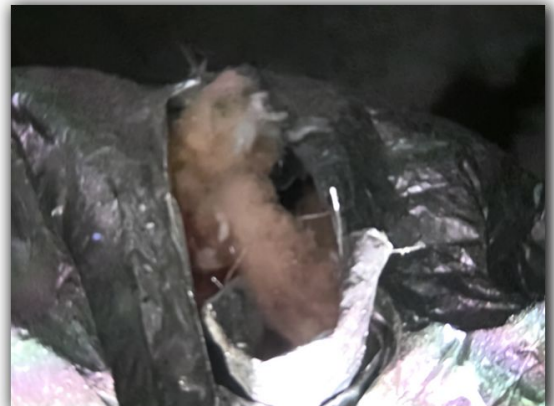
1. RUBBER INSULATION IS DAMAGED AND/OR MISSING ON THE SUCTION/DISCHARGE LINE, AT/OR NEAR THE EVAPORATOR HOUSING.

- 1.THE INSULATION IS LOOSE AND/OR TORN ON SEVERAL DUCTS THROUGHOUT ATTIC.
- 2.THE RETURN AIR FILTER IS DIRTY. THIS CAN CAUSE DAMAGE TO THE EVAPORATOR COILS WHICH ARE NOT ACCESSIBLE. I RECOMMEND HIRING A LICENSED H.V.A.C. TECHNICIAN FOR FURTHER EVALUATION.
- 3.DUCTS SHOULD BE KEPT FROM TOUCHING OTHER DUCTS, TO PREVENT CONDENSATION. BLANKET INSULATION IS A GOOD WAY TO SEPARATE THE DUCTS.
- 4.DUCTS SHOULD BE RAISED OFF OF THE ATTIC FLOOR TO PREVENT CONDENSATION.

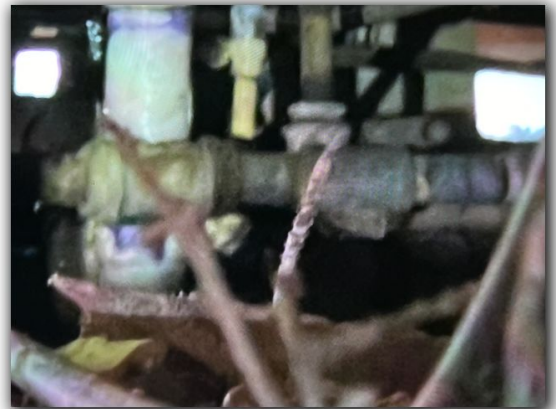
1.DROP IN WATER PRESSURE WAS OBSERVED WHEN OPERATING MORE THAN ONE WATER FIXTURE. GALVANIZED WATER PIPES ARE SUBJECT TO CORROSION. AS CORROSION BUILDS UP INSIDE THE PIPES, THE PIPES BECOME CONSTRICTED, RESULTING IN LOSS OF WATER PRESSURE AND/OR LEAKS. RUST WARTS AND/OR CORROSION WAS OBSERVED ON SEVERAL WATER LINES BELOW RESIDENCE. I RECOMMEND CONSULTING WITH A LICENSED PLUMBER FOR FURTHER EVALUATION.

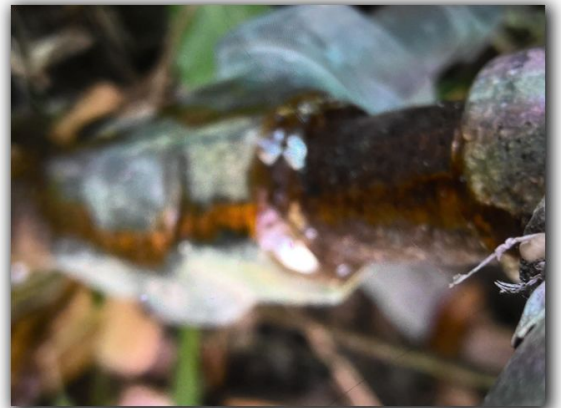
- 1.CURRENT CODES REQUIRE BACKFLOW PREVENTERS (ATMOSPHERIC VACUUM BREAKERS) AT ALL EXTERIOR HOSE BIBS. THESE ARE INEXPENSIVE SCREW ON ADAPTERS THAT PREVENT CONTAMINATED WATER FROM BEING SIPHONED BACK INTO POTABLE WATER LINES.
- 2.WATER IS LEAKING AT PIPE JOINT AT BACK SIDE OF RESIDENCE.

- 1.CURRENT REGULATIONS DO NOT PERMIT THE USE OF P.V.C. WATER LINES, EXCEPT AT EXTERIOR AREAS OF RESIDENCE. P.V.C. WATER LINES WERE OBSERVED AT SOME INTERIOR AREAS OF RESIDENCE.

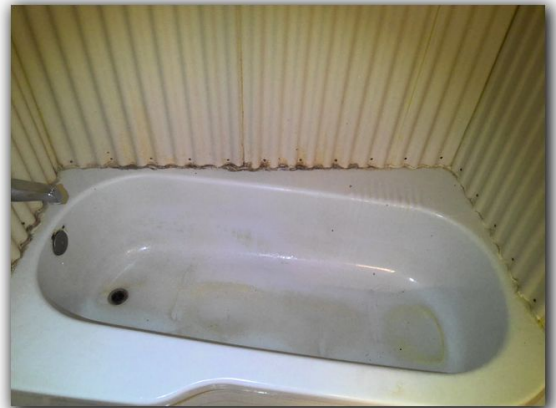
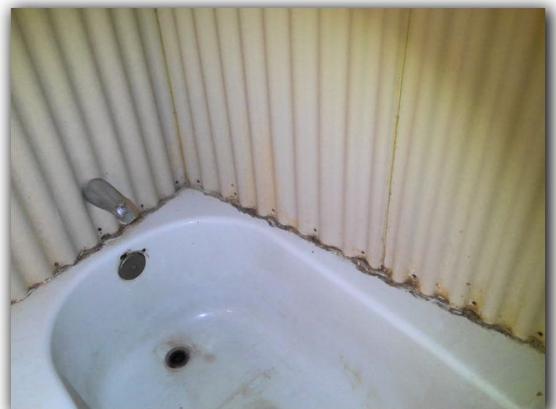
SOUTH SIDE HALL BATHROOM:

1. IMPROPER/EXCESSIVE AMOUNTS OF CAULK WAS OBSERVED AT SHOWER SURROUND PANELS. WATER CAN TRAVEL BELOW THE BUILT UP/EXCESSIVE CAULK.
2. SHOWER PANELS NEED MORE CAULKING. THE SHOWER PANELS ARE ALSO LOOSE AND TYPE OF MATERIAL IS NOT RECOMMENDED FOR USE AS A SHOWER SURROUND.
3. TOILET IS LOOSE AT THE FLOOR.

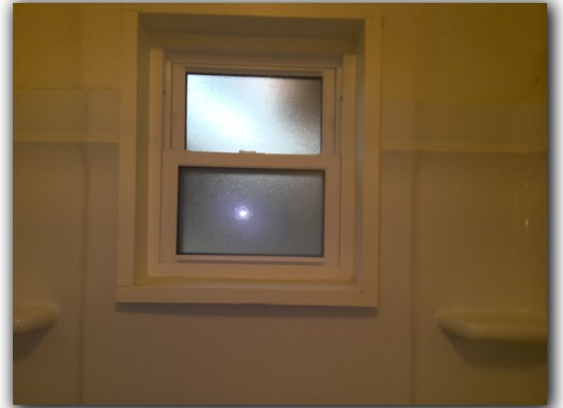
NORTH SIDE BATHROOM:

1. TOILET IS LOOSE AT THE FLOOR.
2. VERY LITTLE WATER PRESSURE AT SINK AND SHOWER FIXTURE.
3. SHOWER PAN DOES NOT PROPERLY SLOPE TOWARDS THE DRAIN. STANDING WATER WAS OBSERVED AT SHOWER PAN.
4. SHOWER SURROUND PANELS NEED TO BE ADDED AROUND THE BATHTUB/SHOWER TO PREVENT WATER DAMAGE AT WINDOW FRAME. SHOWER SURROUND PANELS AND/OR TRIM SHOULD BE AT LEAST SIX FEET ABOVE THE FLOOR.

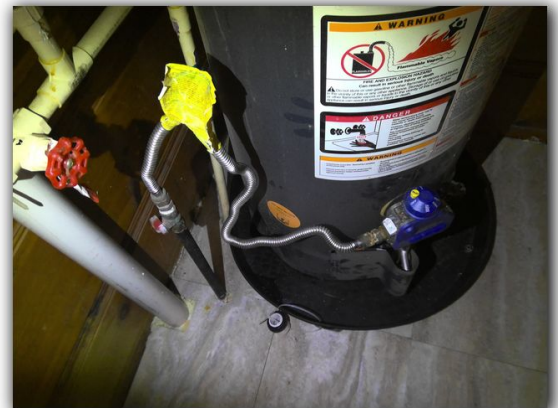
1. VENT PIPE IS IMPROPERLY INSTALLED. CURRENT CODES REQUIRE THE VENT PIPE TO EXTEND AT LEAST TWO FEET ABOVE THE ROOF LINE AND 8 FEET FROM A VERTICAL WALL.

2. WATER WAS LEAKING AT PIPE JOINT AT THE EMERGENCY DRAIN LINE.
3. AN EMERGENCY DRAIN LINE SHOULD BE INSTALLED AT THE EMERGENCY DRAIN PAN TO PREVENT WATER DAMAGE, IN THE EVENT THE WATER HEATER TANK LEAKS.
4. CURRENT RULES REQUIRE A SEDIMENT TRAP (DRIP LEG) TO BE INSTALLED ON THE GAS LINE NEAR THE WATER HEATER.
