1st Rate Inspections

Property Inspection Report

7 Eastwood Cir, Conroe, TX 77301
Inspection prepared for: Brenda Sarg
Real Estate Agent: Michael Serna - The Collective Realty Group

Date of Inspection: 10/30/2019 Time: 8:30 AM
Age of Home: 1985 Size: 1406
Weather: 59° F, Light Drizzle (fog)
Order ID: 13736

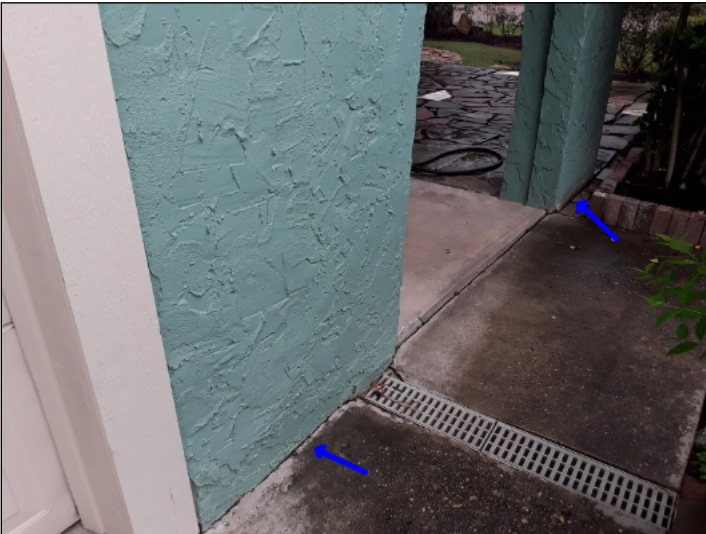
-The soil is too high or footing is too low which does not allow proper exposure of the slab. This can cause conducive conditions to Wood Destroying Insects or water penetration usually if there is improper slope. Mainly at - front

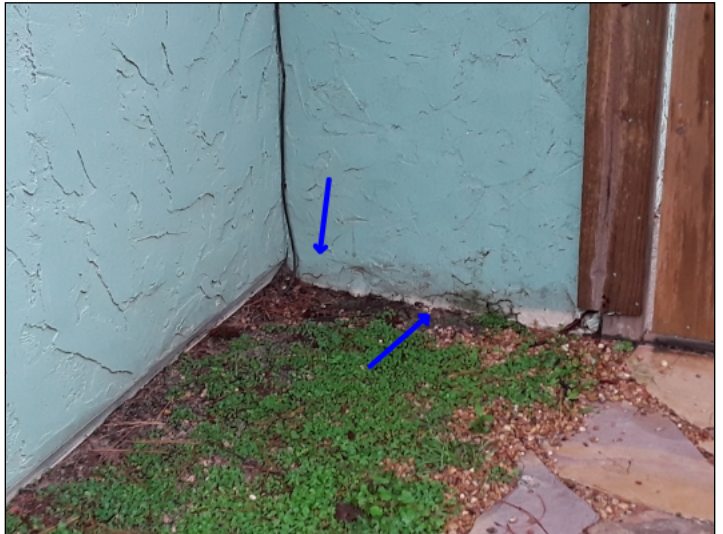
-The soil is too high or footing is too low which does not allow proper exposure of the slab. This can cause conducive conditions to Wood Destroying Insects or water penetration usually if there is improper slope. Mainly at - front

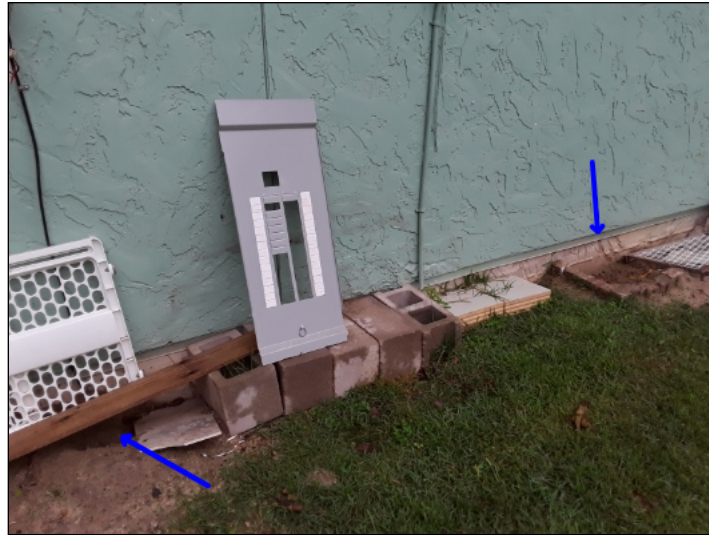
Holes noted at foundation. Mainly at - rear

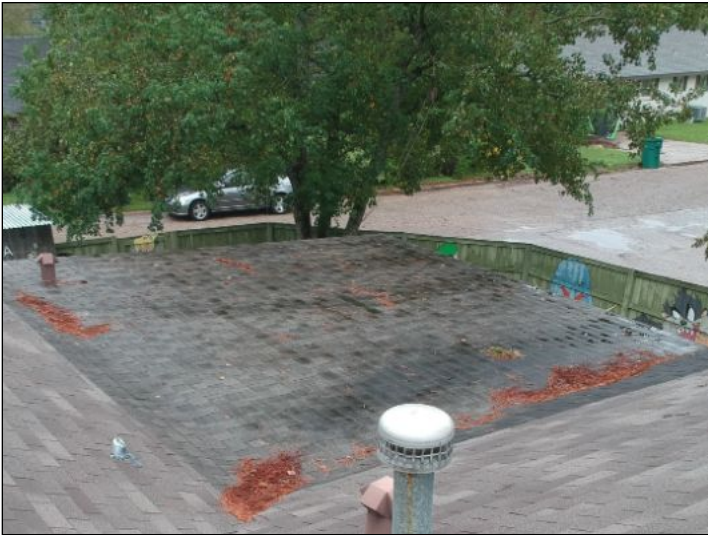
-Parts of the roof is ponding. This may cause leaks or damage to roof over time.

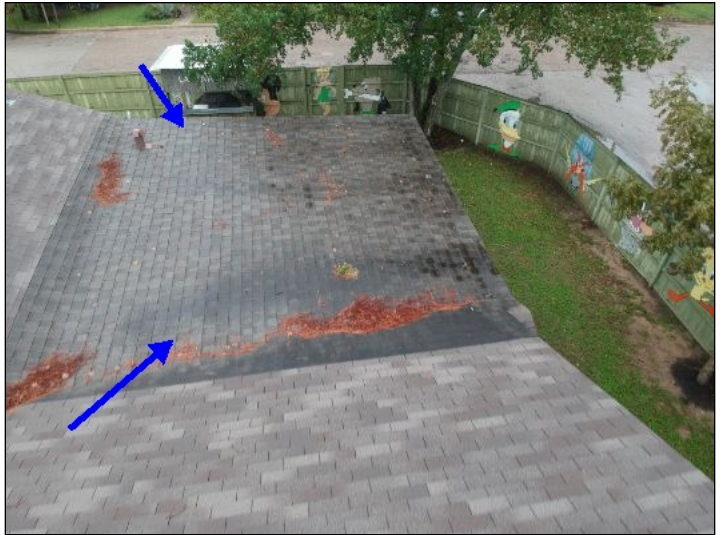
-The shingle roof covering had been applied over a surface with a pitch (slope) less than the industry standard, and is subject to leakage if proper underlayment was not used. Unable to determine if proper underlayment methods were used at time of inspection.

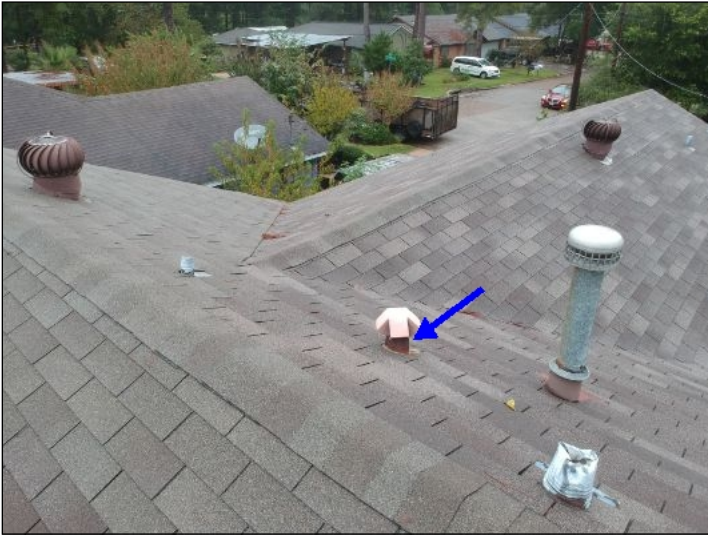
-There are signs of rusted flashing/vents on the rooftop. We recommend painting or replacing all rusted or deteriorated flashing/vents as needed.

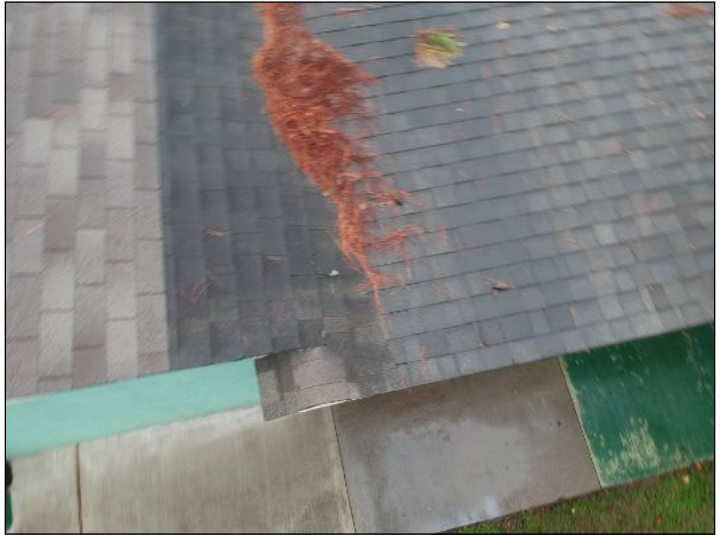
-Debris were noted on the roof which can cause water to back up on the roof and allow water to penetrate through the roofing materials, recommend removing debris from roof. Unable to fully inspect roof covering as debris limit the visibility of the roof surface.

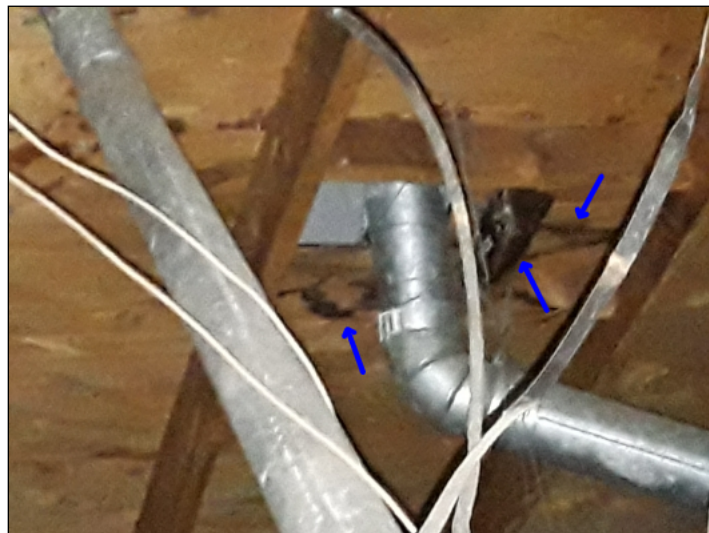
-The roof decking was deteriorated, recommend all deteriorated decking be replaced to help prevent further damage and water penetration into home. Mainly at - vent penetrations

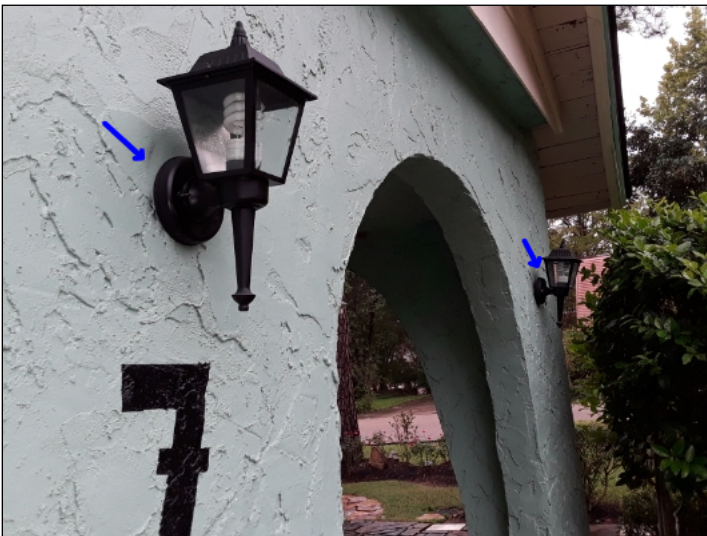
-Seal all electrical lighting fixtures at wall connection to help prevent water penetration. It is a good idea to leave a small opening at the bottom to allow any water penetrating to escape.

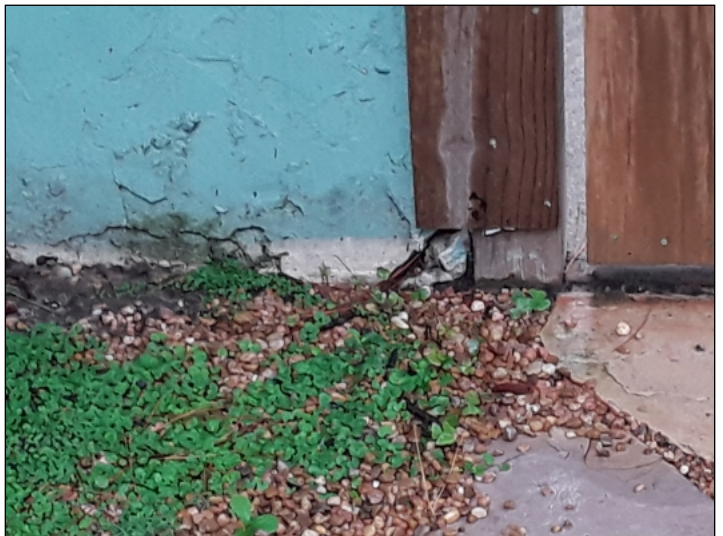
-Stucco is damaged, recommend repairs to help prevent water penetration. Mainly at - right

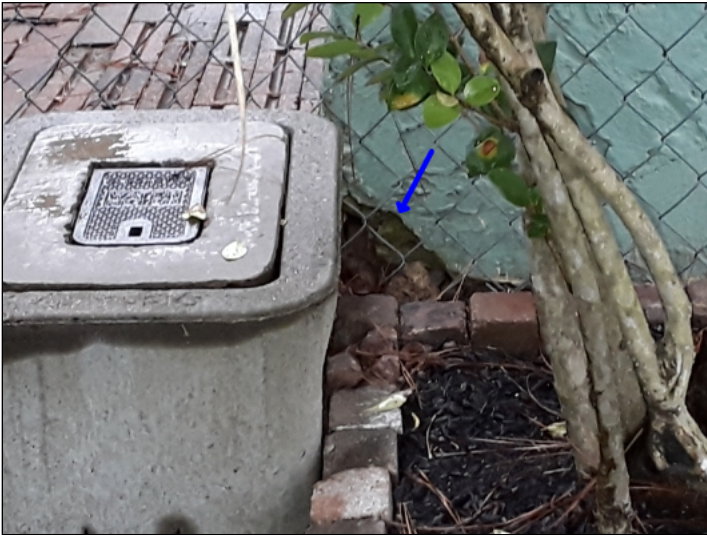
-Stucco is damaged, recommend repairs to help prevent water penetration. Mainly at - right

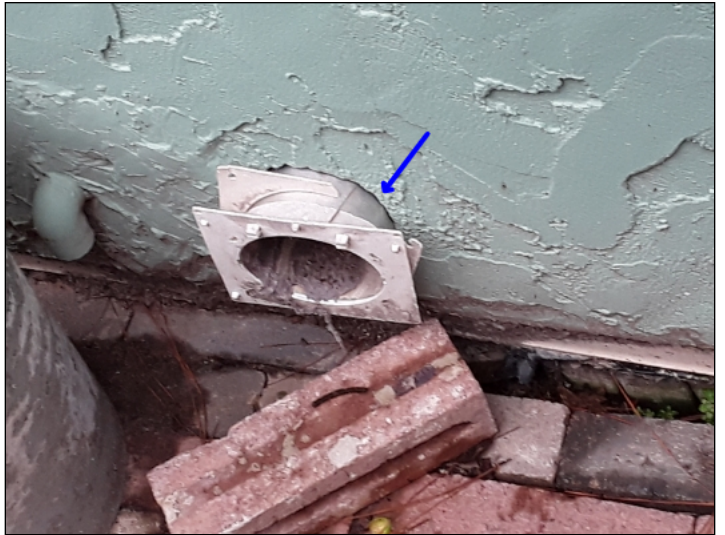
-A vent cover is damaged, recommend repairs to help prevent water penetration, rodent or bird intrusion. Mainly at - left

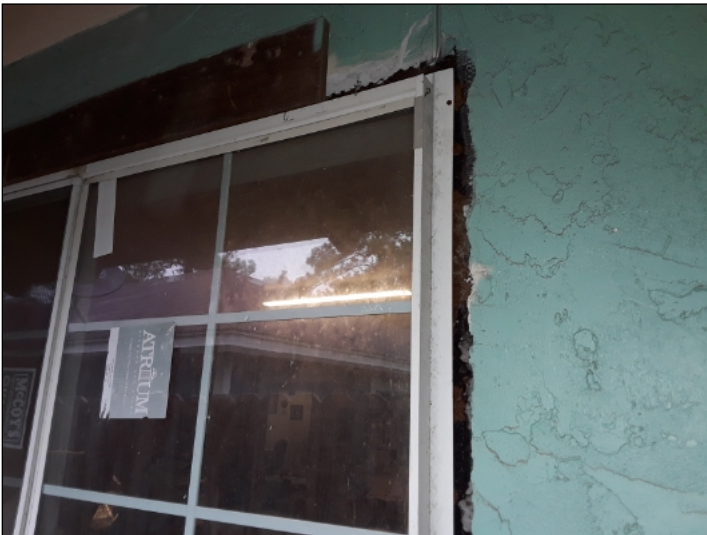
-Stucco is damaged, recommend repairs to help prevent water penetration. Mainly at - left (at garage window)

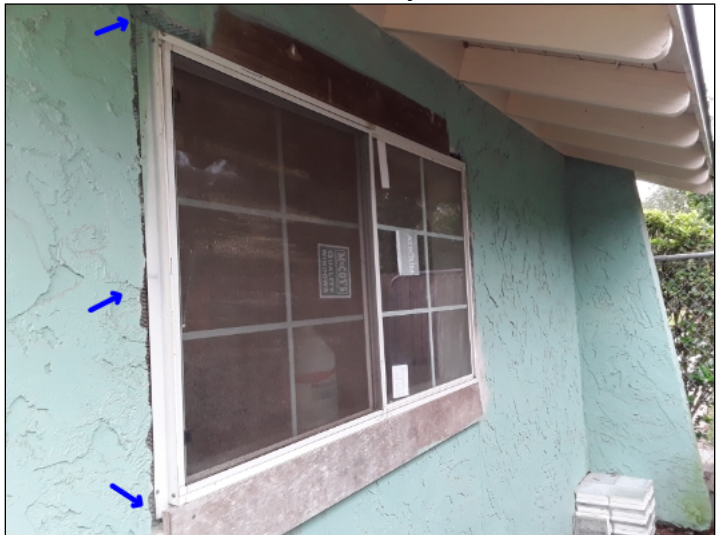
-Stucco is damaged, recommend repairs to help prevent water penetration. Mainly at - left (at garage window)

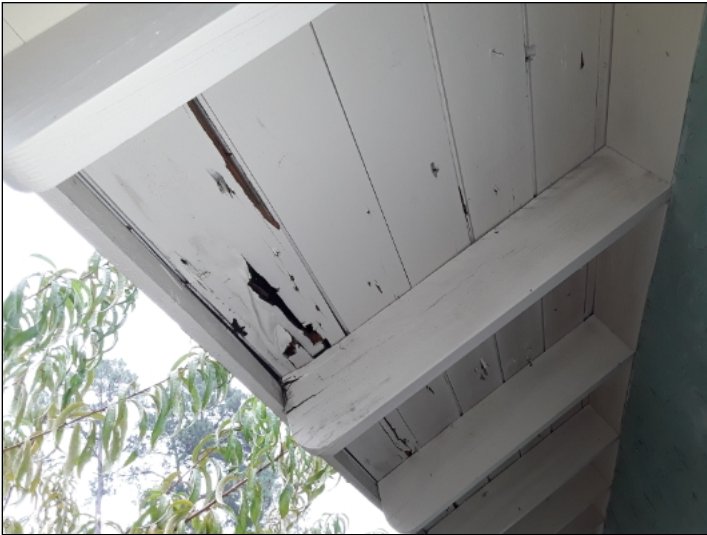
-Deterioration was noted at the soffit, recommend replacing all deteriorated soffit. Unable to determine the condition of the underlying materials. Mainly at - left rear

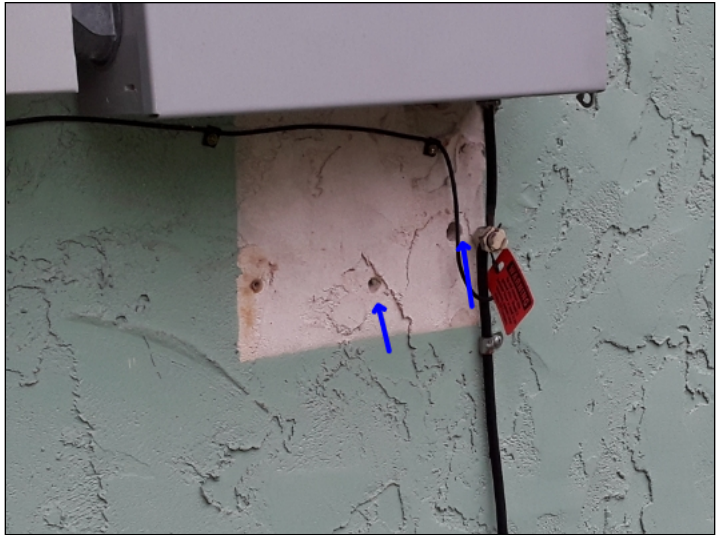
-Recommend sealing gaps & holes in stucco to help prevent water penetration. Mainly at - rear

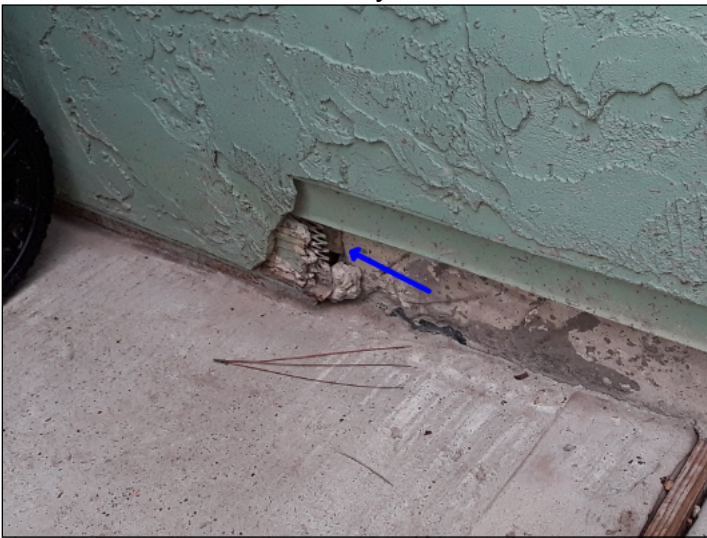
-Recommend sealing gaps & holes in stucco to help prevent water penetration. Mainly at - rear

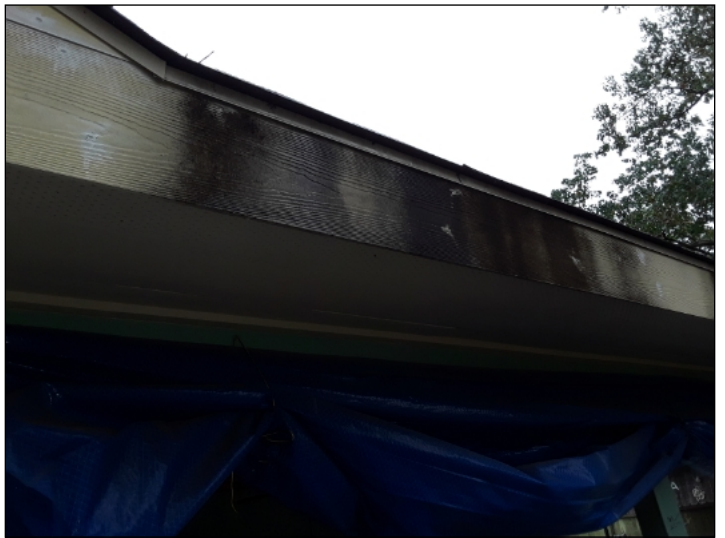
Stains noted at trim.

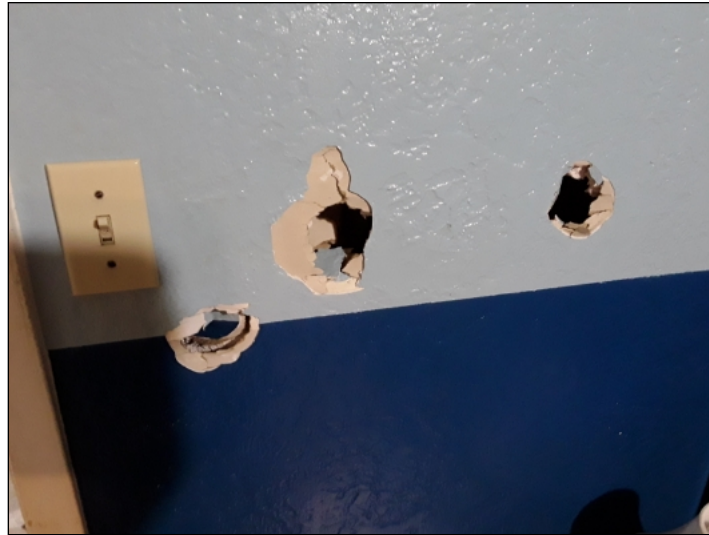
-There is damage to the drywall, recommend repairs as needed. Mainly at - front left bedroom

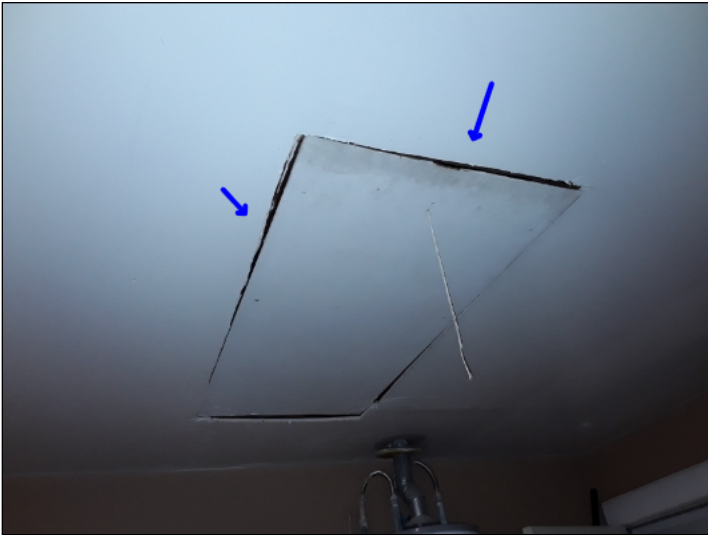
-There is no moulding around the attic stairway in the garage. Recommend adding trim to help maintain the proper fire break. The attic stairways are also not the proper fire rating by today's standards.

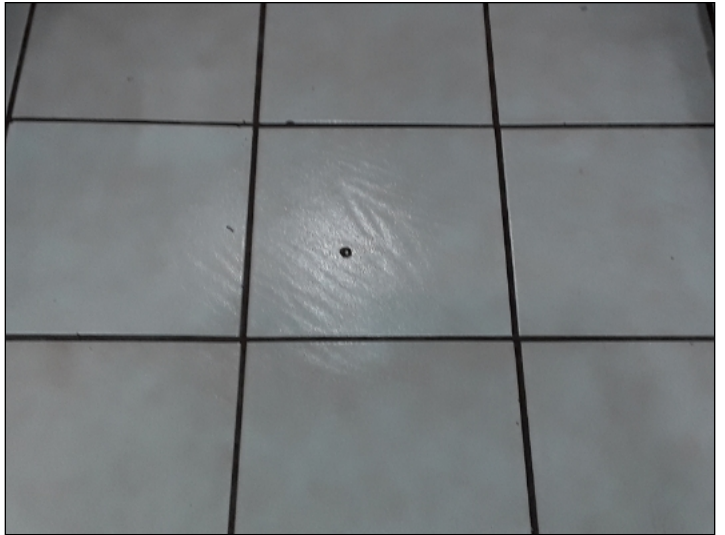
-Chips were noted in the tile. Mainly at - kitchen

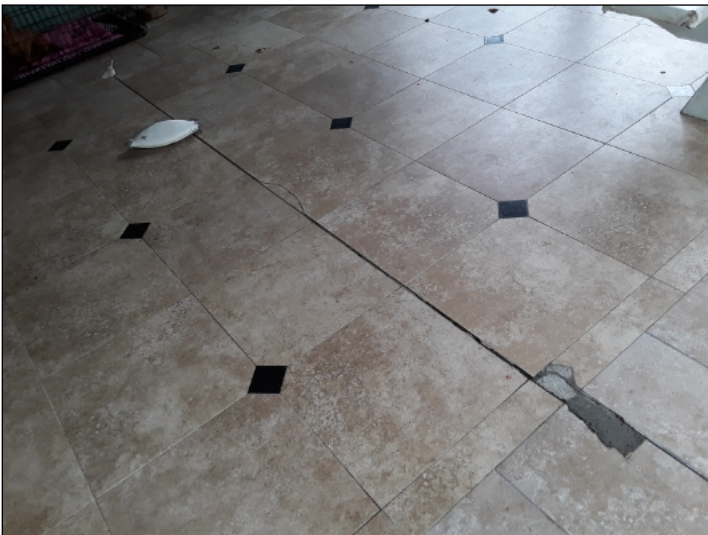
-Cracks were noted in the tile. Mainly at - patio

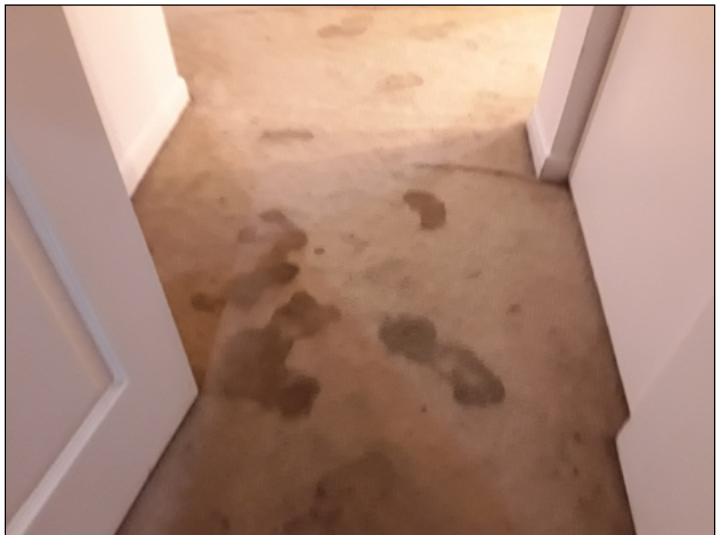
-The carpet is stained. Mainly at - master bedroom

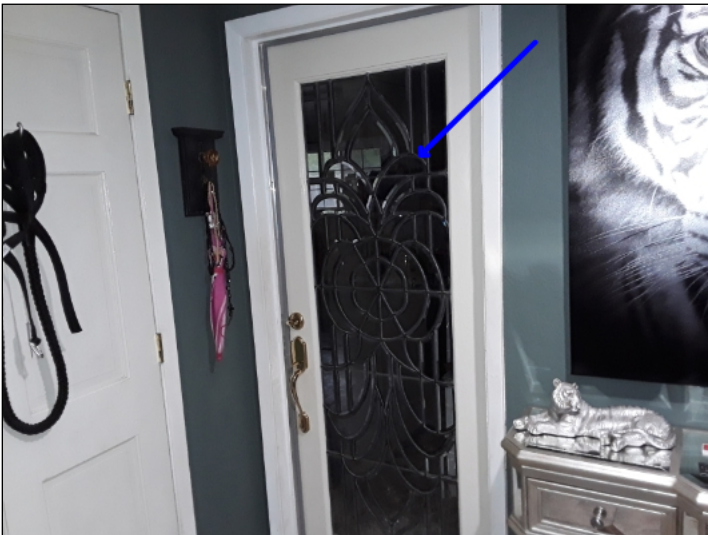
-The garage entry to home is not the proper fire rated door.

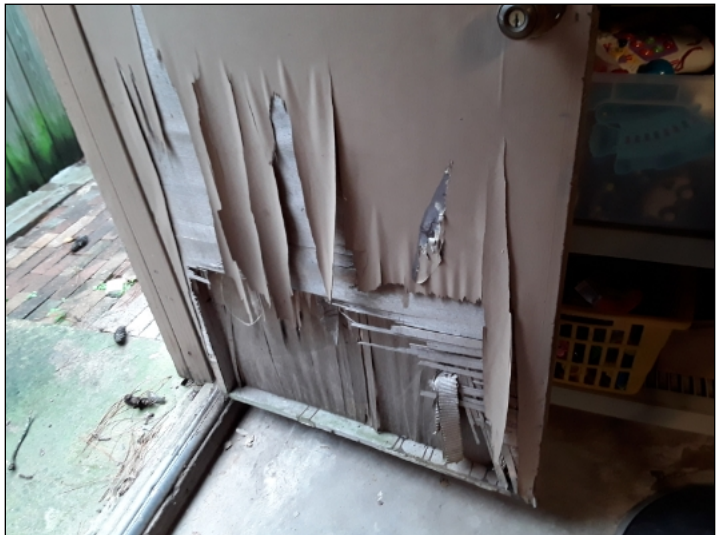
-The door is cracked or damaged. Mainly at - garage side entry.

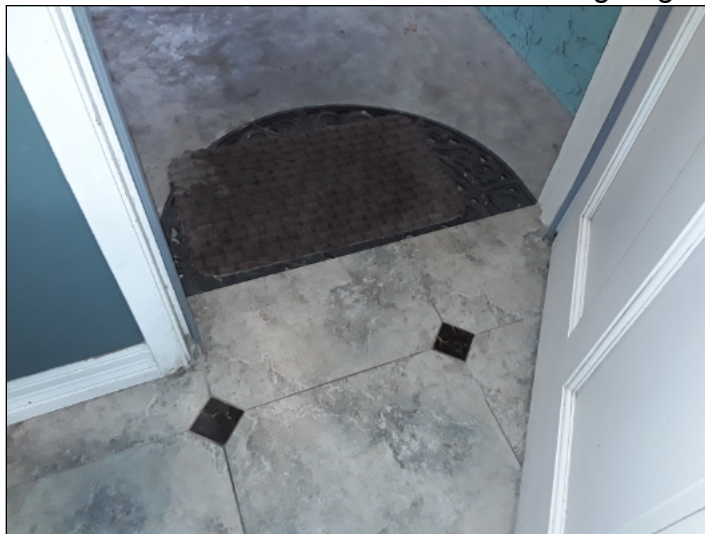
-The threshold is missing. Mainly at - front door

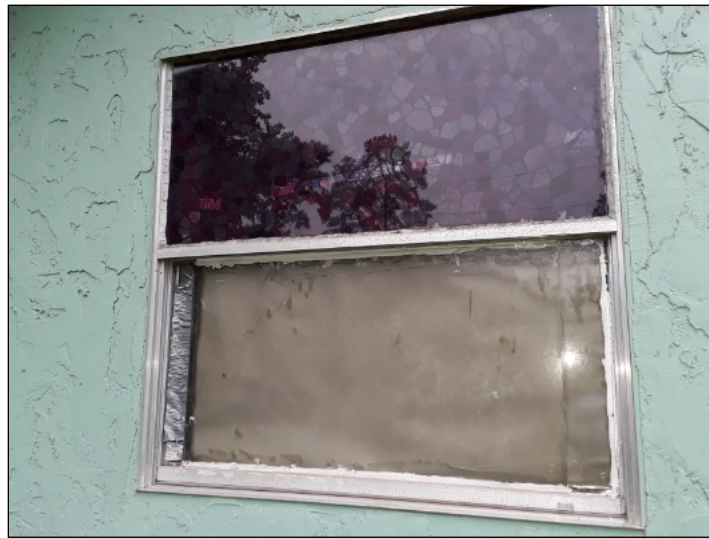
Damaged or incomplete window. Mainly at - rear

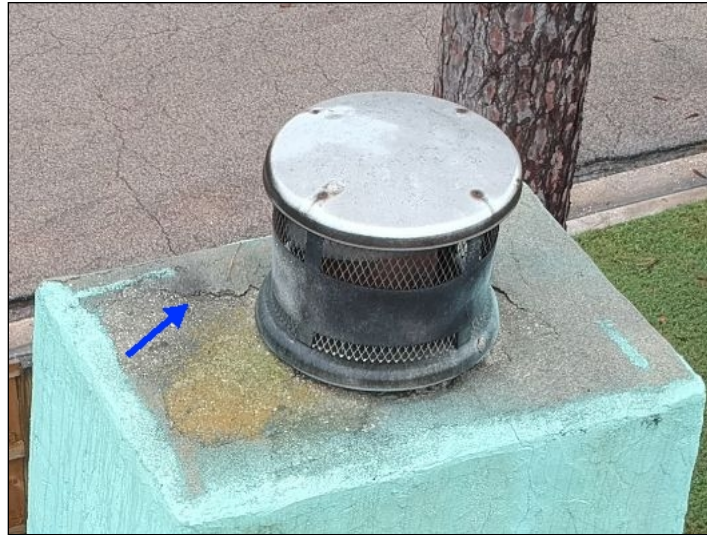
-Seal all cracks in mortar cap to help prevent further deterioration.

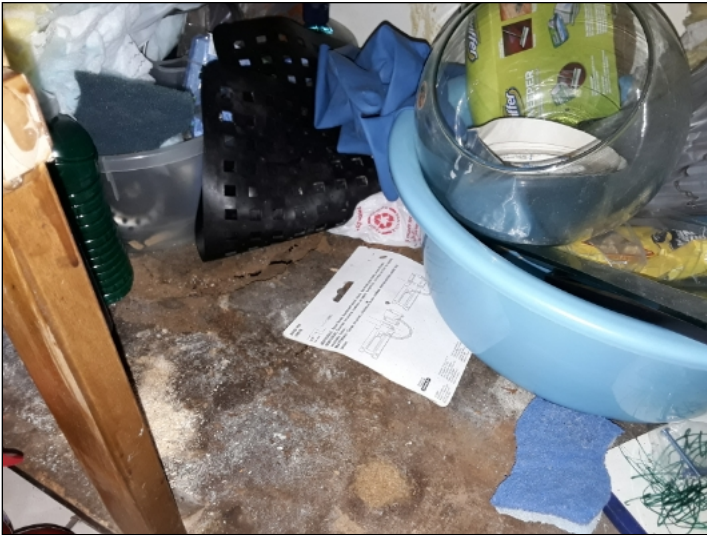
-The are signs of water damage in the cabinet under sink. Mainly at - kitchen

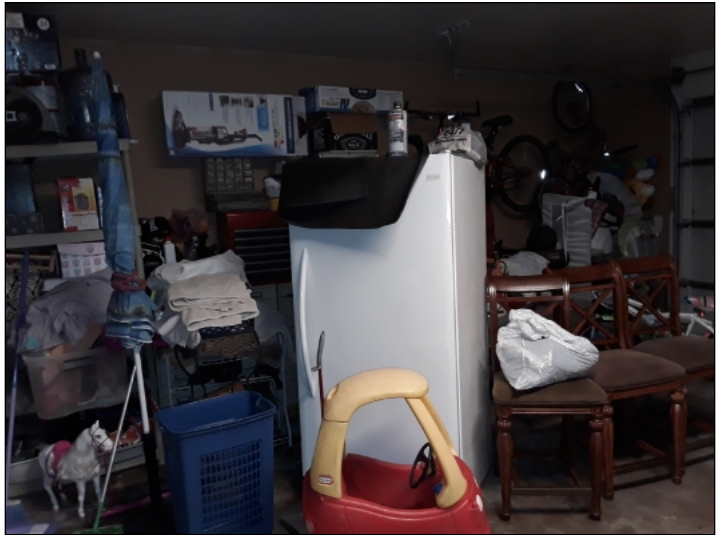
-Some areas has limited access due to personal items/furnishings. Mainly at - garage

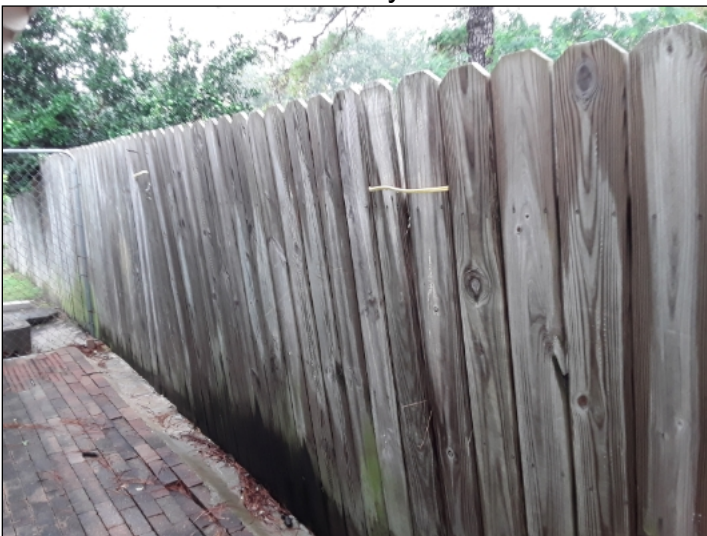
-Although fences are not inspected it was noted that the fence is showing some signs of damage or deterioration.

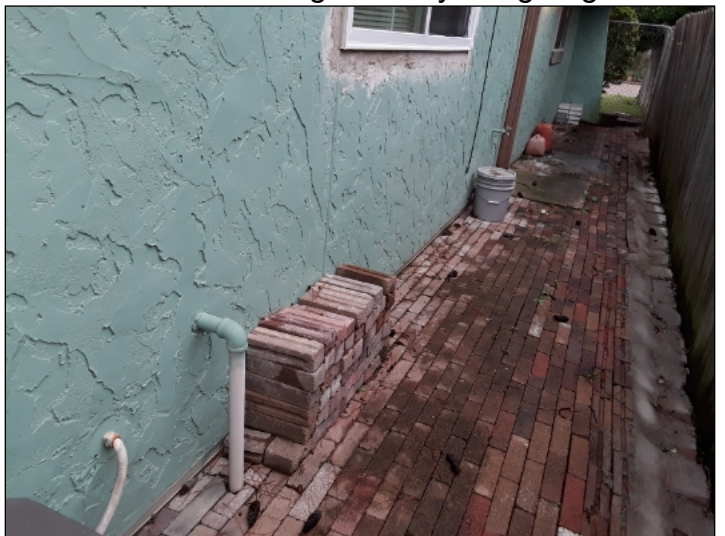
-Wood or other debris is stacked against the house. Recommend all wood or other materials be separated from the structure to help prevent conducive conditions for wood destroying insects.

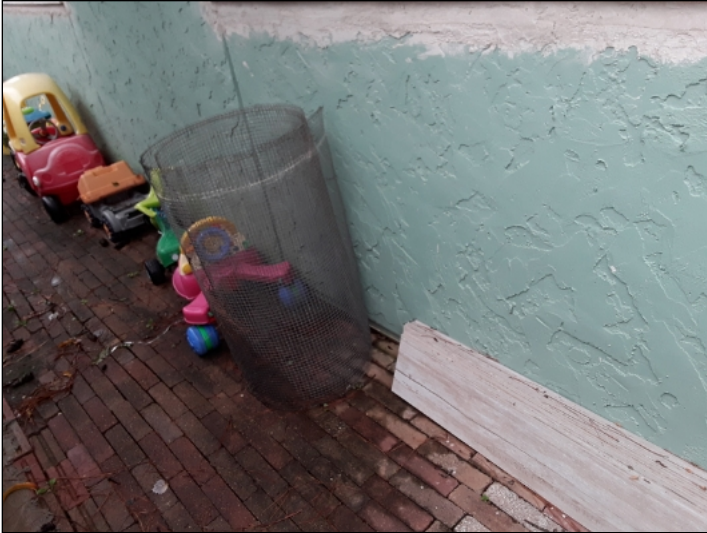
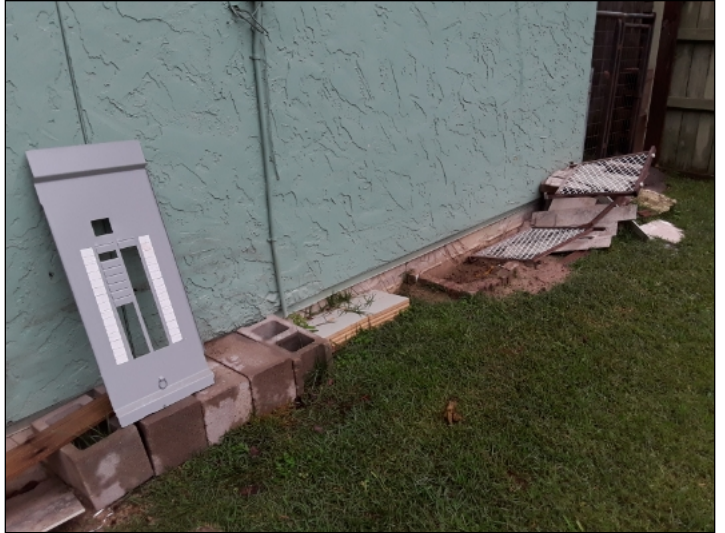
-Wood or other debris is stacked against the house. Recommend all wood or other materials be separated from the structure to help prevent conducive conditions for wood destroying insects.

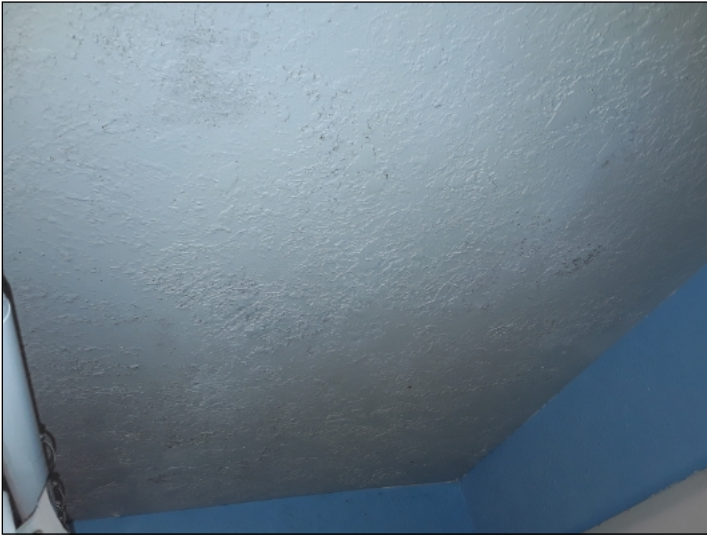
-Mold like stains are present, recommend remediation or cleanup as needed. Unable to determine condition of the underlying materials. Mainly at - above shower at hall bath

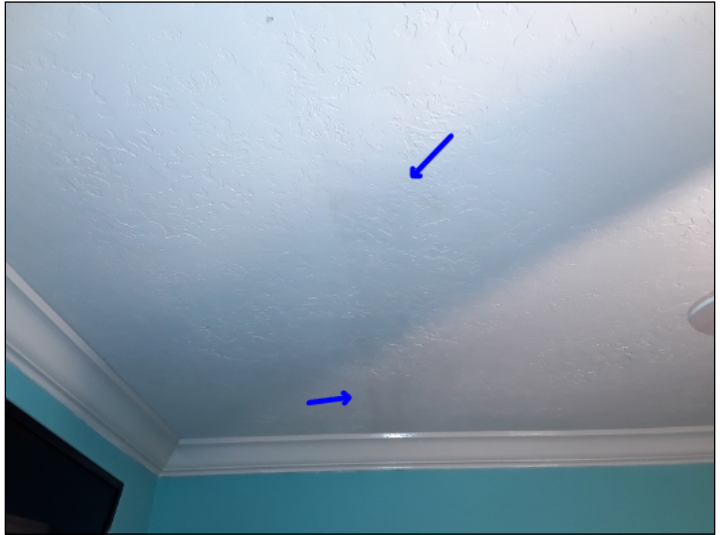
-Checked water stain with a moisture meter and found it to be at a normal level. Unable to determine condition of the underlying materials. Mainly at - middle bedroom

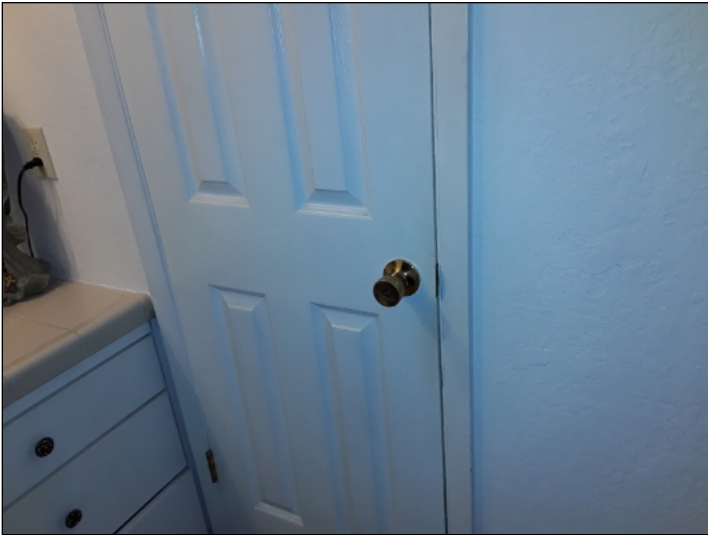
No access to closet at master bedroom. Locked.

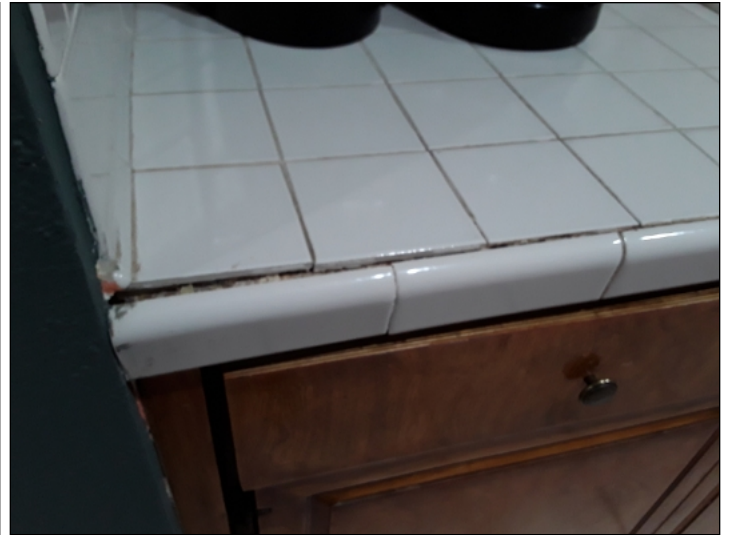
Countertop damaged. Mainly at - kitchen

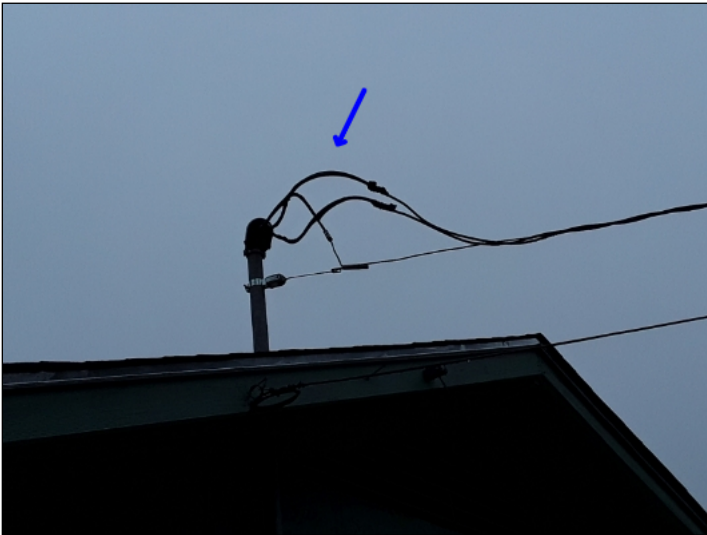
Improper drip loop. Recommend drip loops be formed on individual conductors to prevent the entrance of moisture into weather head.

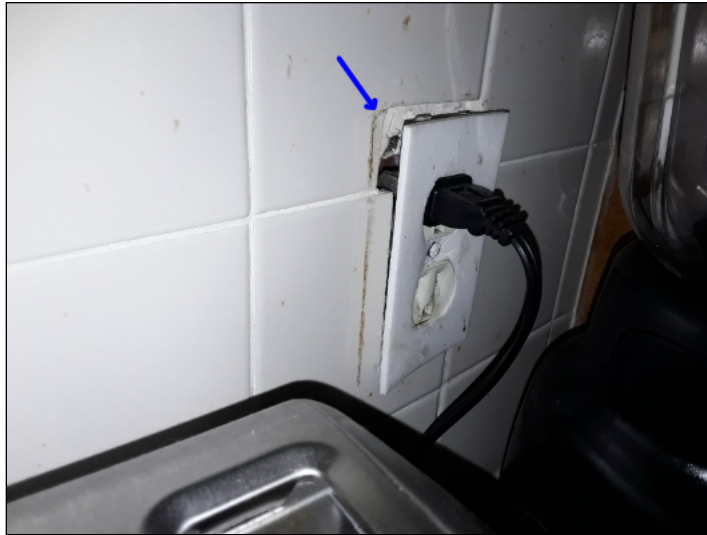
-Receptacle plate is broken or missing, recommend replacing covers to help prevent electrical shock.
Mainly at - kitchen

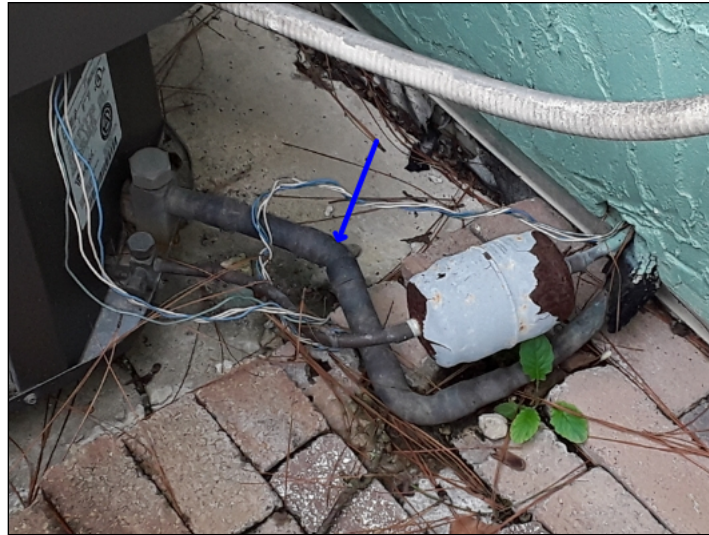
-The insulation is missing or damaged on the A/C suction line at the condensing unit. Recommend repair or replacement to prevent cooling loss from exterior temperatures.

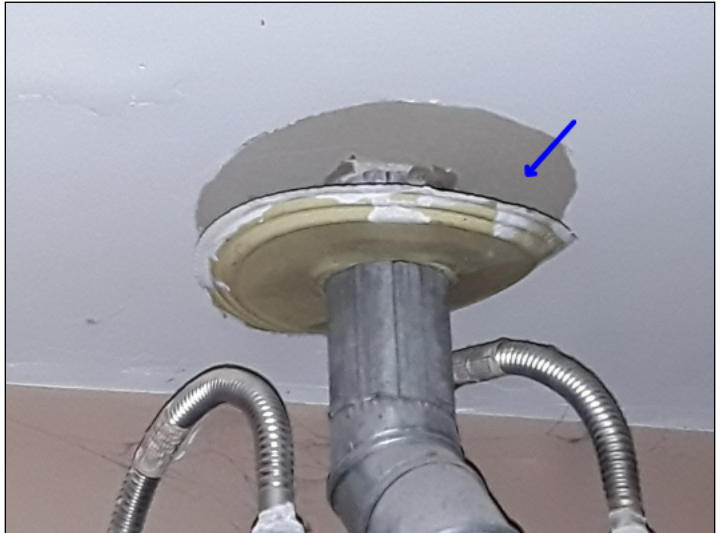
Flue collar not flush at ceiling.

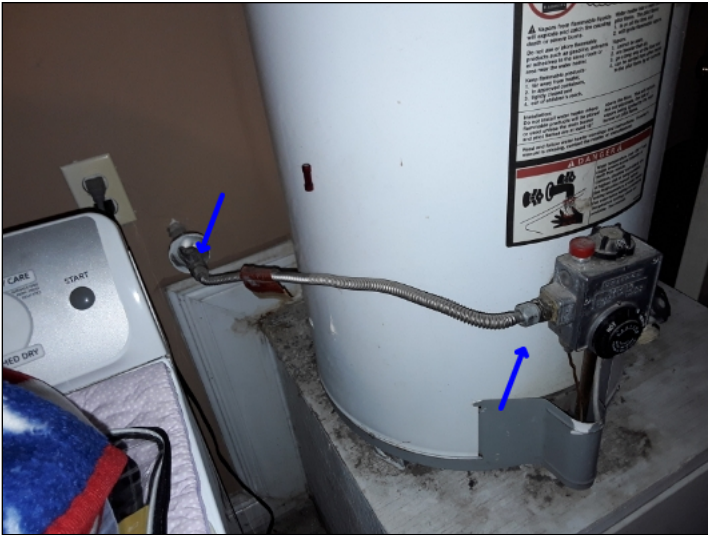
-No drip leg or sediment trap for gas line on water heater. This helps prevent trash from clogging jets.

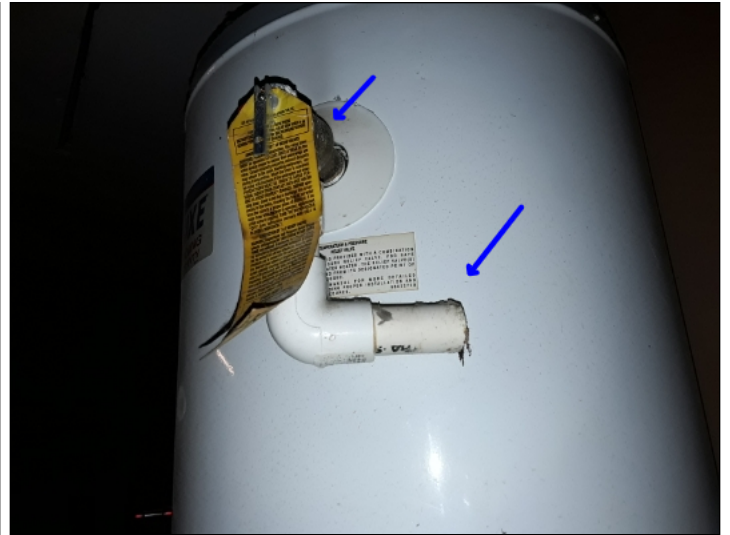
-There is no drain line for the water heater T&P (Pop-Off) valve.

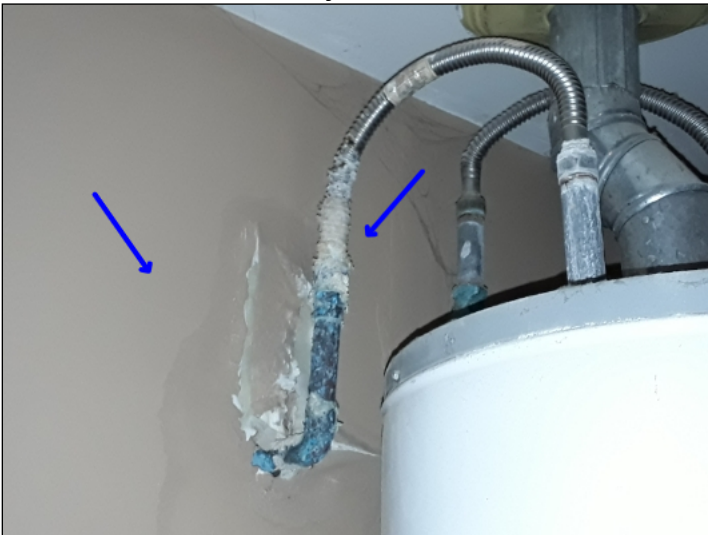
-There are indications of a possible water leak at the water heater connections due to rust/corrosion or deterioration at wall penetration. Recommend a licensed plumber be consulted for further evaluation and/or repairs.
