### I. STRUCTURAL SYSTEMS

#### A. Foundations

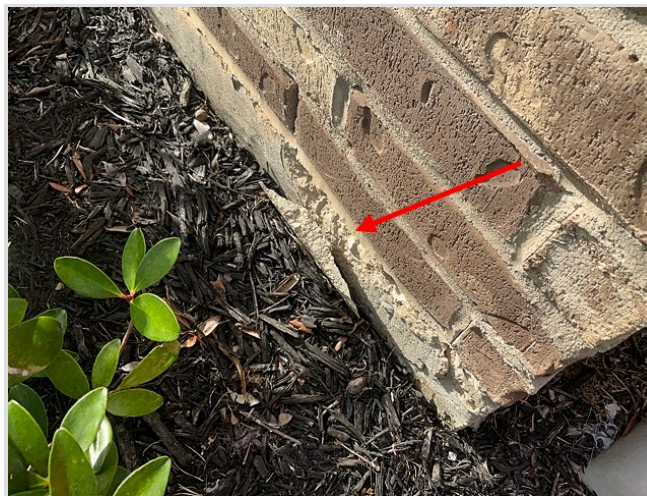
**Note:** Spalling (i.e., corner pops) at one or more corner(s) and/or "Honey Combing" was observed in areas on the side of the slab, Corner spalling and/or "Honey Combing" is common for slab foundations and generally does not affect the structural integrity of the foundation.

Spalling (front)

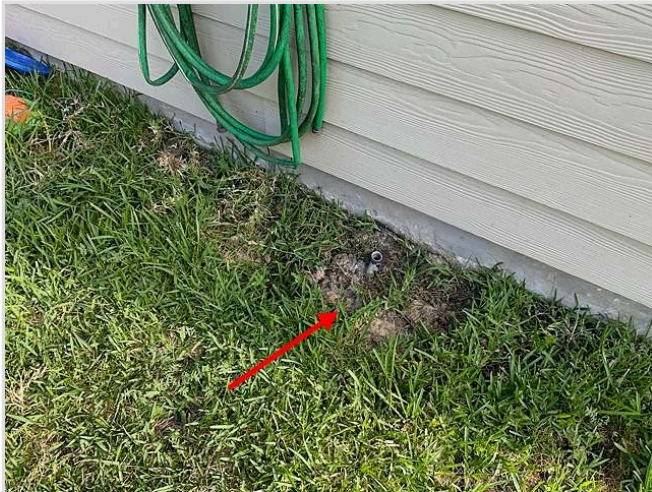
Soil erosion was observed in areas near/around the slab. Back-filling of soil in the eroded areas may be needed.

Soil erosion (rear)

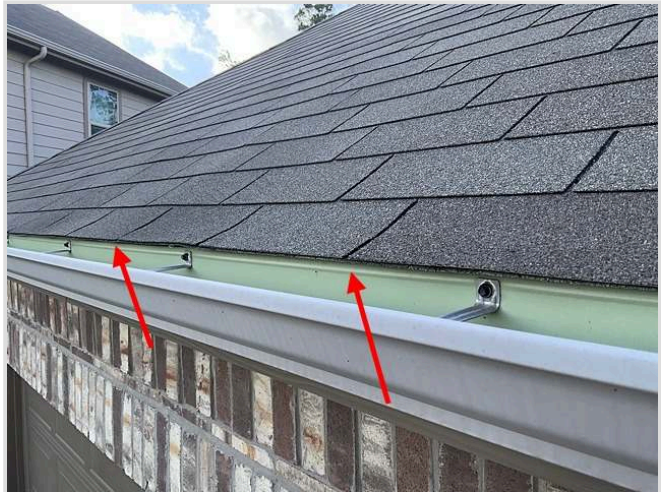
**Gutters were improperly installed in front of the drip edge flashing of the roof covering. Common industry standards call for the drip edge flashing to "drop" into the gutter trough.** At the time of this inspection, no adverse effects were detected or observed.

Gutters improperly installed in front of drip edge (front)

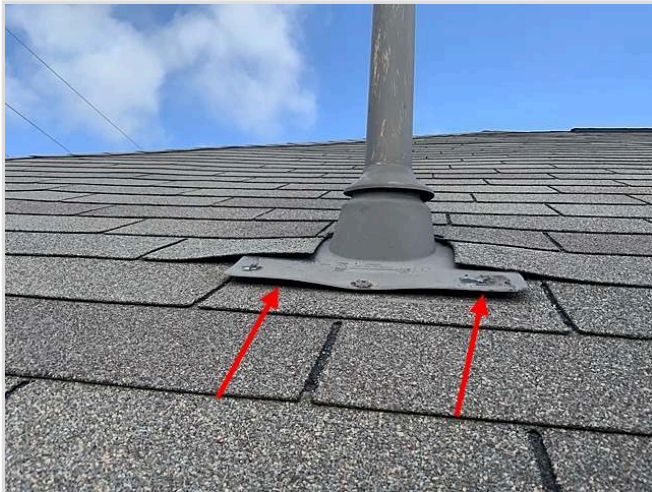
**Flashing was raised at one or more locations.** Proper installation of flashing is critical to certain areas of your roof — namely, the places where the roof surface meets a wall, valleys, protrusions such as vents and skylights, and the roof's edges.

Raised flashing (left)

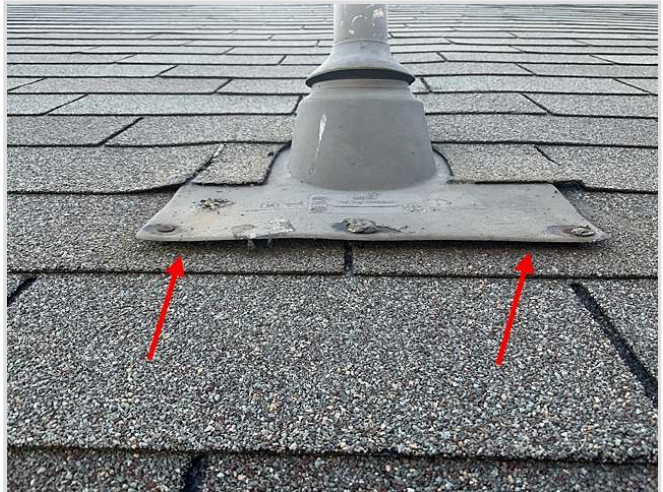
Raised flashing (right)

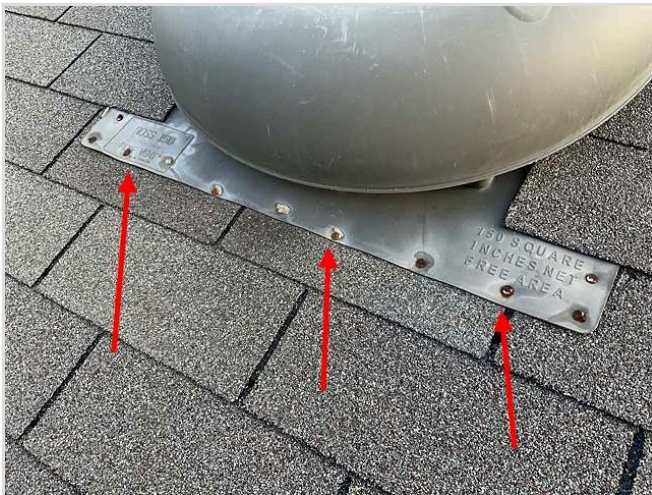
**Nails at flashing and shingle locations were not caulked and were in need of maintenance. Common industry standards call for nails that are exposed to the elements to be caulked/sealed to help prevent rust corrosion, which can lead to leaks.**

Nails in need of caulk maintenance (rear)

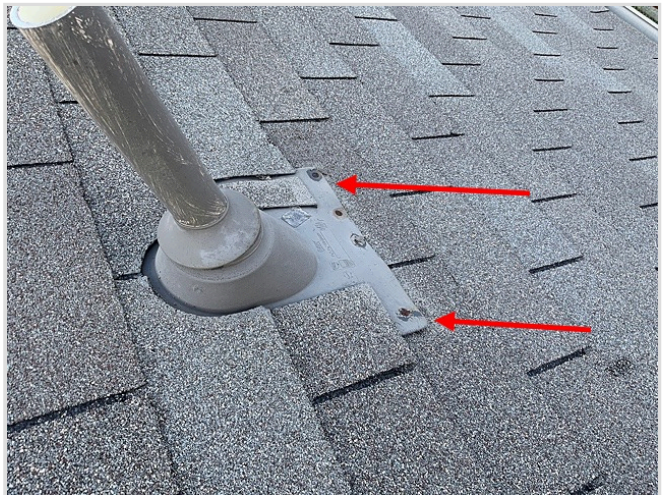
Nails in need of caulk maintenance (right)

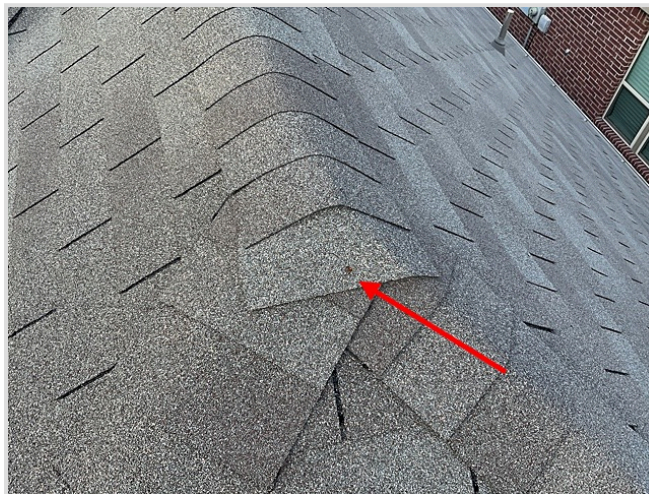
Nail in need of caulk maintenance (front)

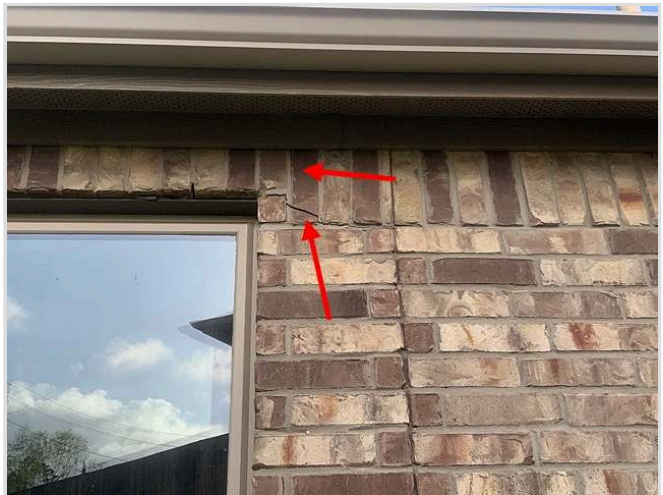
There were cracks in the brick/stone above and adjacent to window and door openings. Possibly due to a sagging or rusted headers/lintels that support the brick above the openings and did not appear to be structurally concerning/significant at the time of inspection.

Crack above and adjacent to window opening (left)

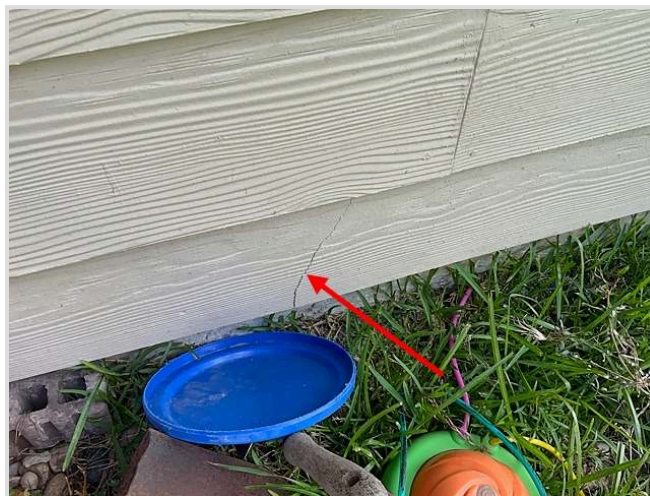
Exterior wall covering was observed to be damaged, warped, and/or not properly secured in some locations.

Damaged wall covering (rear)

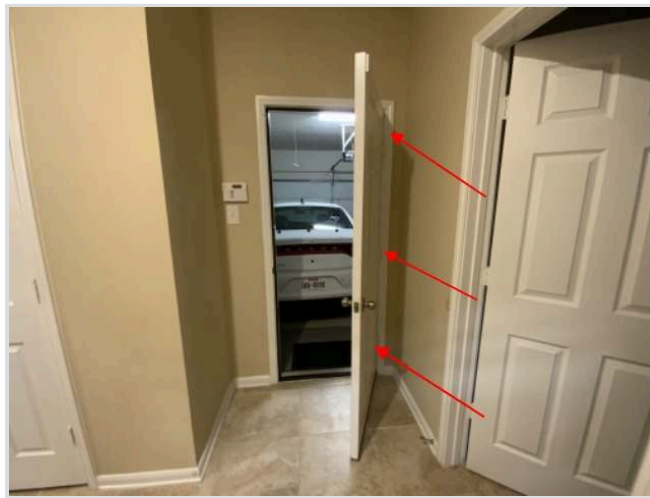
Self closing hinges or device was not installed on the garage entry door at the time of inspection.

Self closing hinges not installed (garage entry door)

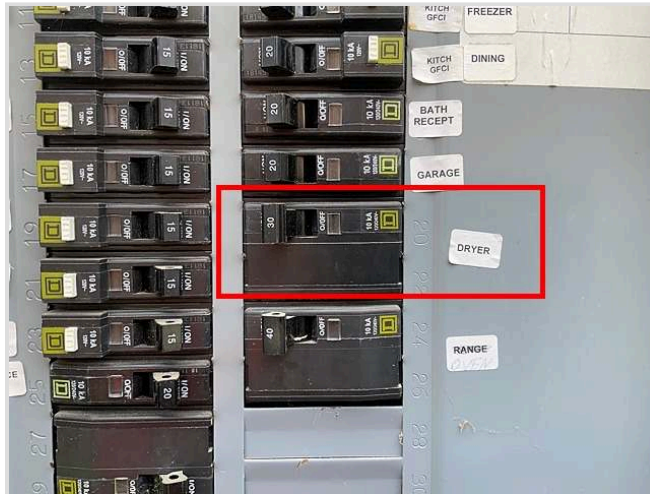
220-240V receptacle in the laundry room were not GFCI protected (TREC SOP/NEC 210.8). **Note:** This deficiency is reported due to recent change in the wording of the code and was not required when the house was constructed (grandfathered).

Dryer 220V not GFCI protected

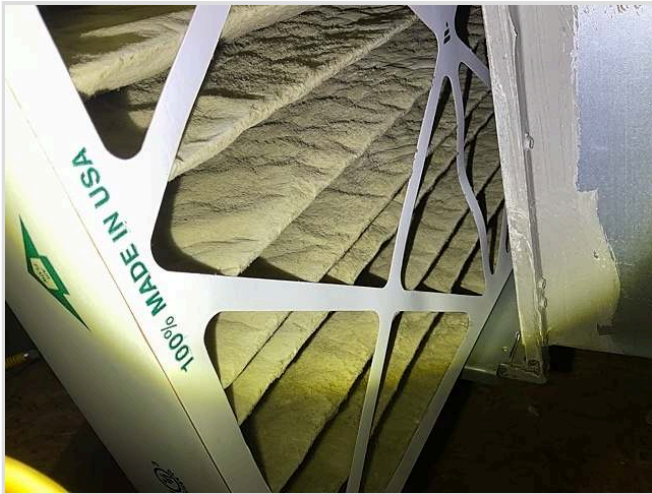
The filter was dirty and needed to be replaced. Dirty filter(s) indicate that the system had not been properly maintained and may require the need for cleaning/service.

Dirty filter

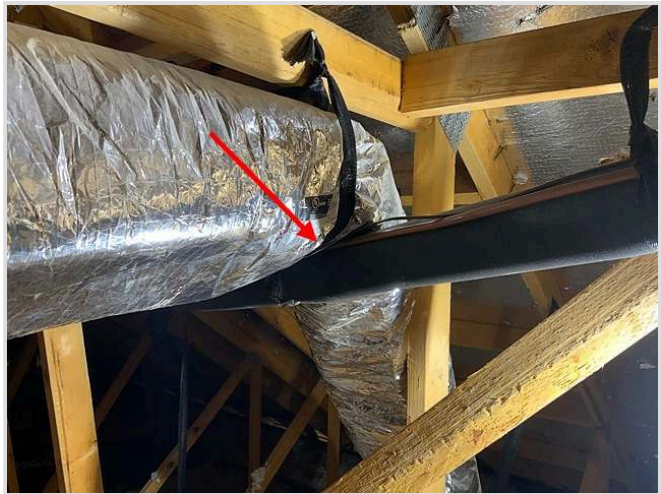
Ducts in the attic space were in contact with refrigerant lines and/or other duct. Points of contact between these items has been known to create condensation (sweating) in the attic space. Manufacturers recommend at least a 1" clearance around flex ducts.

Duct in contact with refrigerant line

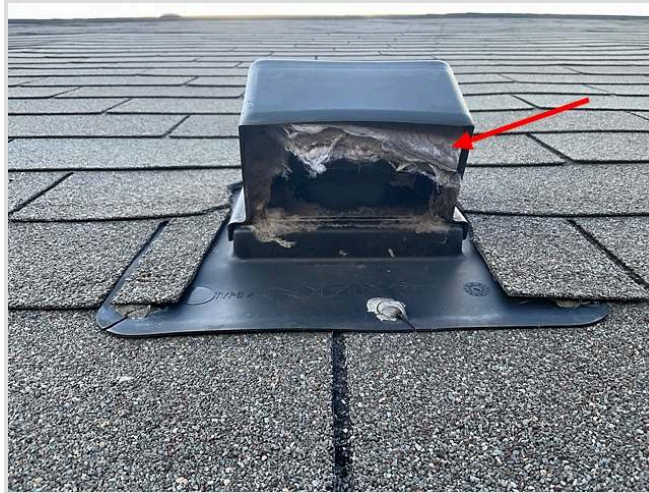
Dryer exhaust had excessive lint buildup and needed to be cleaned.

Excessive lint build up (right)
