RE: Foundation Inspection
Job #21615

The residence inspected was located at 4207 Butternut Ct in Houston, Texas.

4207 Butternut Ct

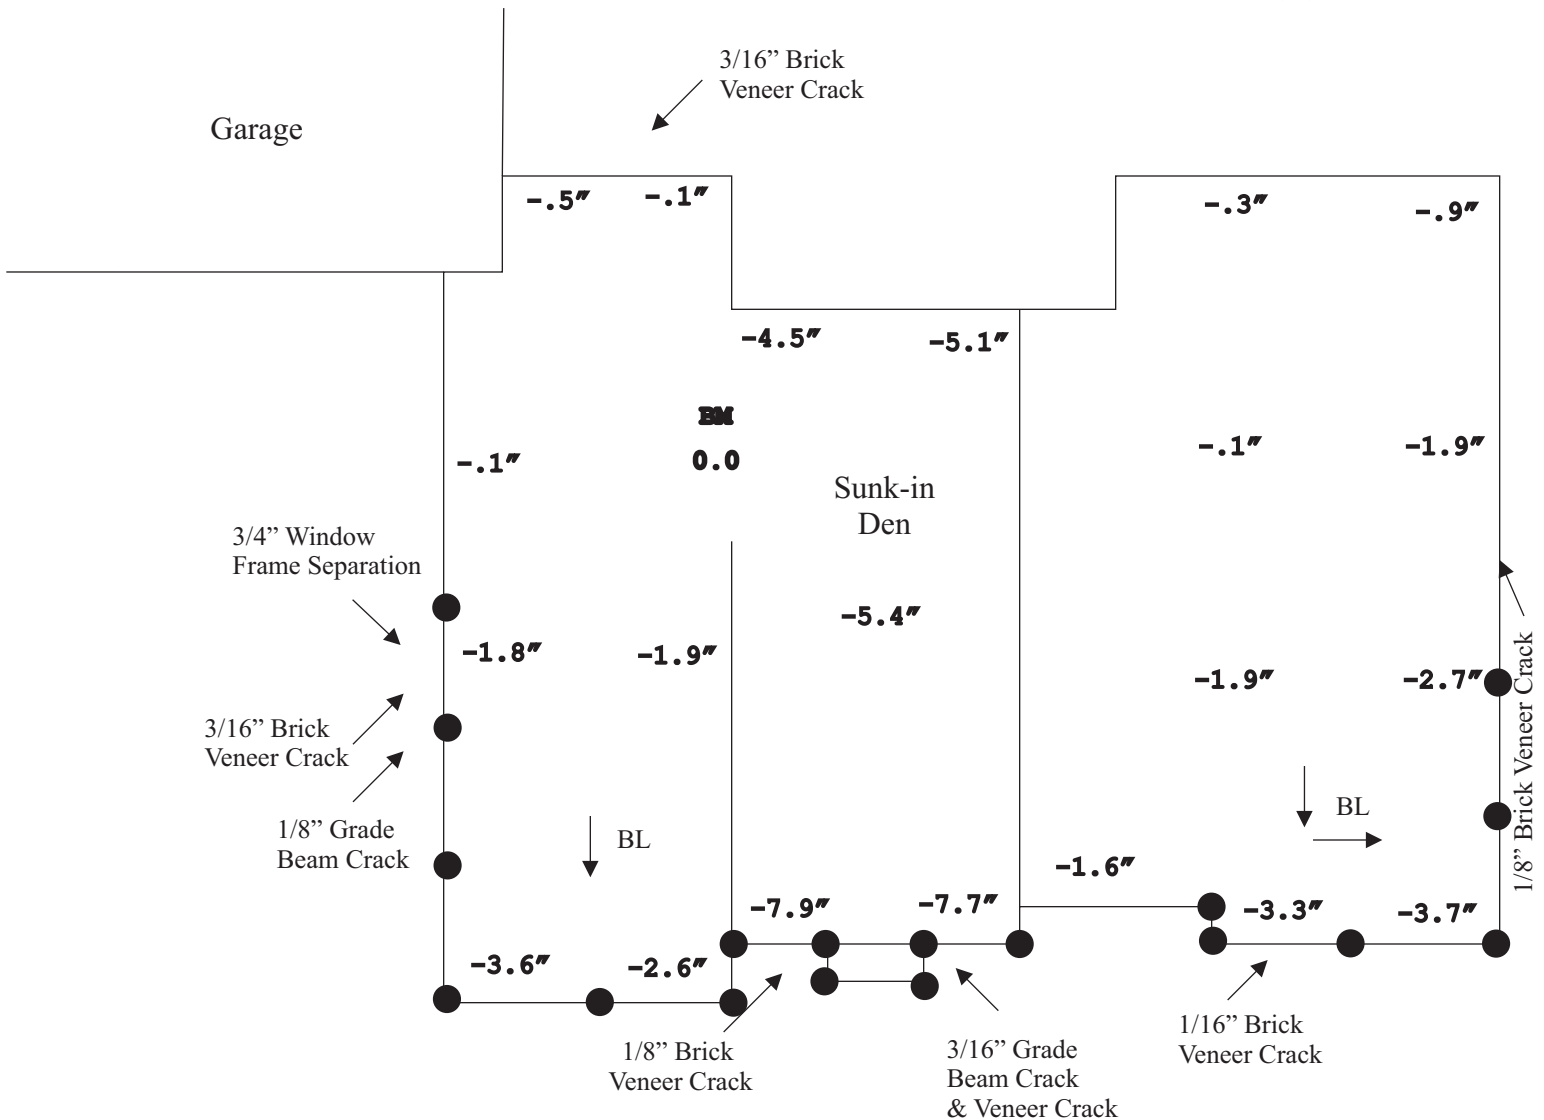
Foundation movement was observed along the front section of the house, as evidenced by floor elevations, window frame separation, uneven door clearances, doors not latching properly, sheetrock cracks, bubble levels, grade beam cracks, and brick veneer cracks. Spreadsheet calculations were performed utilizing the FPA (Foundation Performance Association's SC-13-1 Calculation Spreadsheet) resulting in a deflection ratio of L/350 which is excessive and will require foundation repair with piers. The tilt ratio 0.78% is still within the 1% allowable tolerance. This spreadsheet and report were reviewed and this engineer has taken into consideration the recommendations and guidelines of the ASCE (American Society of Civil Engineers), ACI (American Concrete Institute), and TRCC (Texas Residential Construction Commission).

Elevation Differential 3.7"
Instrument Repeatability Error 0.2"

Approximately 18 piers will need to be installed along the *Front section* of the house, as depicted on the attached diagram the reasonable placement is based on the opinions and engineering judgment of this engineer. The piers should be of either *driven piles* or a *bell bottom design* and described as follows:

- set on approximately 5-7-foot centers – Average Lift 2.5”
- drilled to load-bearing soils between 16 and 22 feet
- shaft diameters 8 to 10 inches, using 3 #3 steel rebar tied in a triangle
- bell diameter 20 to 24 inches, 8” shaft diameter minimum
- pier top reinforced with 6 #3 rebar, minimum dimensions are 20” x 24” and 12” deep
- minimum 5 sx mix or at least 3000 psi compressive strength
- shim with 3000 psi compressive strength precast blocks and steel.

Average Lift = Approximately 2.5"
