**1707 Gano Street
Houston TX 77009**

**Client(s): Furgeson
Inspection Date: 6/11/2018**

PROPERTY INSPECTION REPORT

Concerning: 1707 Gano Street, Houston, TX 77009

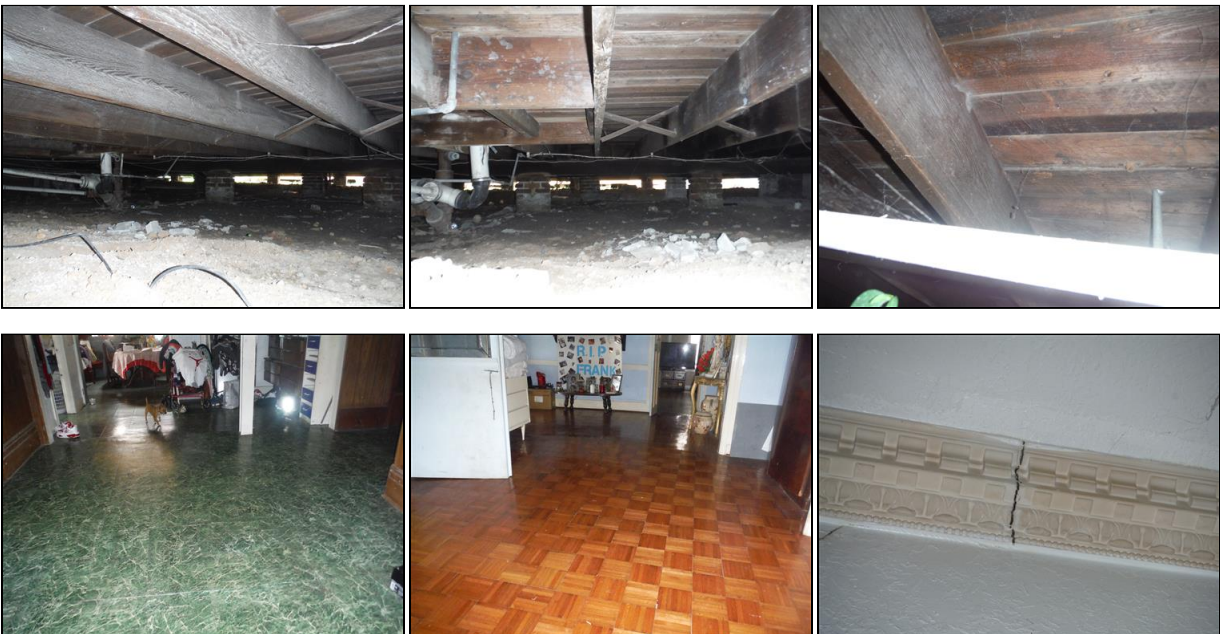
Some of the pier & beam foundation structure exhibits signs of differential settling (un-level floors, doors out of square, cracks in wall and ceiling sheetrock etc.). Pier and beam foundations do require maintenance, levelling or repair every few years (the intervals are dependent upon the materials and quality of construction). I recommend further evaluation of the foundation structure by a licensed foundation repair company familiar with this type of structure.

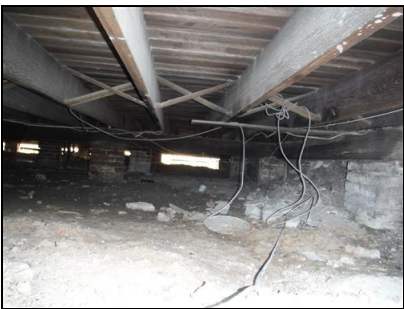
Noted no floor insulation as required by today's standards. Recommend adding insulation at crawlspace floor joist.

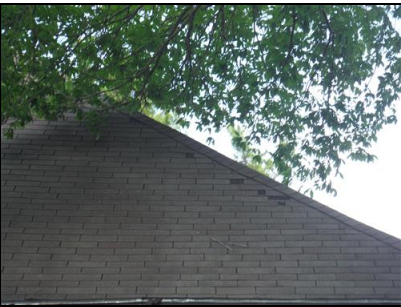
The shingles are worn with significant granular loss in various areas, some shingles are missing at rear. A roofer should perform a maintenance check on the covering for needed repairs, patching or replacement of worn shingles.

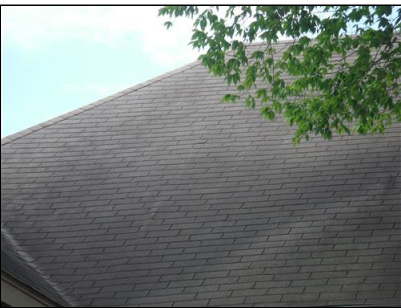
The shingles are lifting in various areas throughout the roof. These can become further damaged during storms or high winds. Recommend qualified roofer to reseal and apply roofing adhesive to lifted areas of shingles.

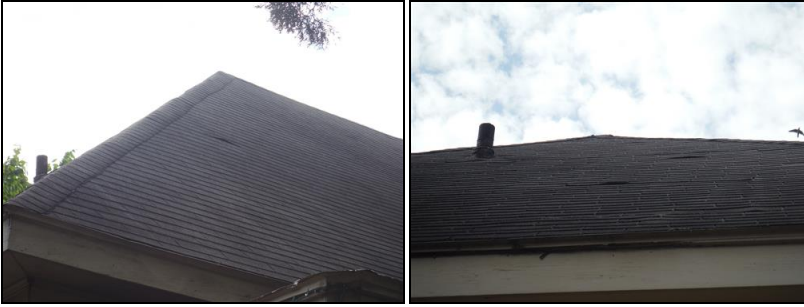
Several of the rubber roof jack vent collars are beginning to crack. A roofer may apply caulk around vent pipes to prolong life until jack replacement is required.

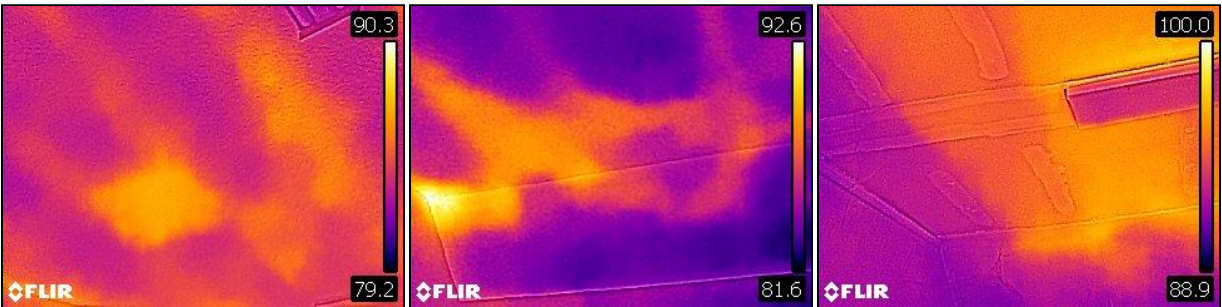
Insulation is deficient by current standards. Have contractor install additional insulation to R-40 for improved energy efficiency.

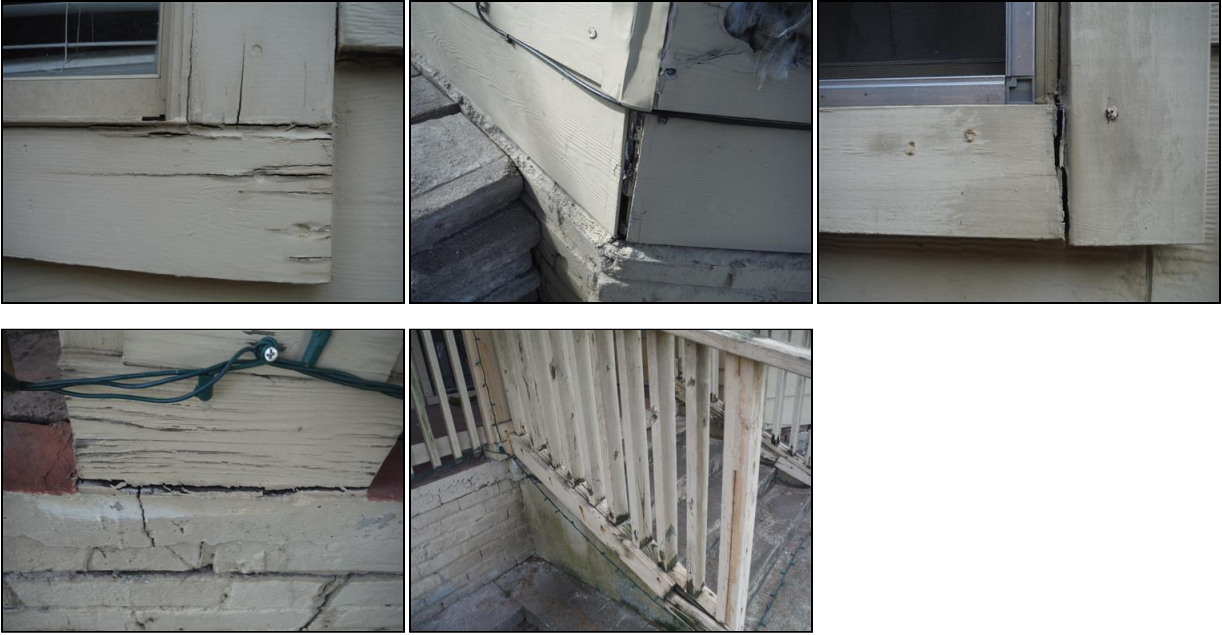
There are areas of the front, rear and sides of home exterior wood siding, trim, fascia, drip edge, door jambs, etc. that have sustained varying levels of water (rot) damage and is in need of repair

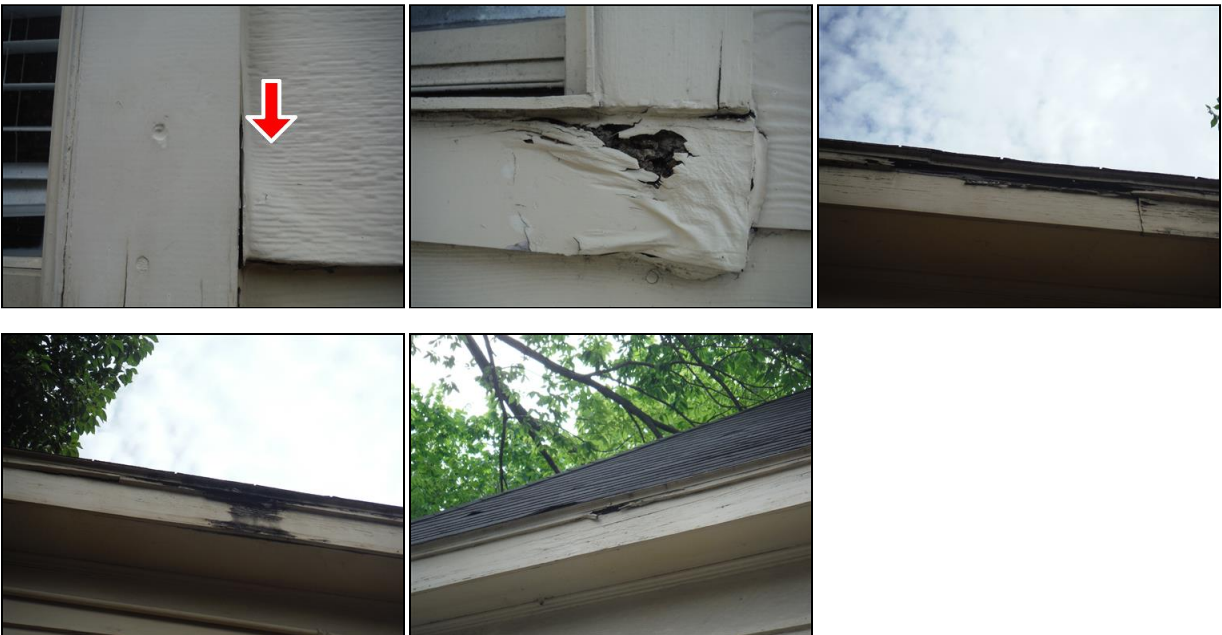
Noted multiple areas of siding boards aged or damaged. Recommend all affected areas are repaired or replaced as needed.

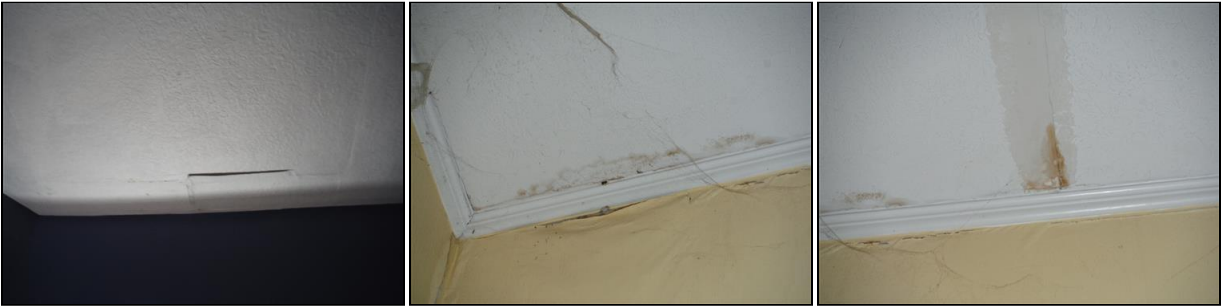
Noted multiple area of damaged ceiling, some with water staining that need further investigation. Repair or replace as needed in all areas affected.

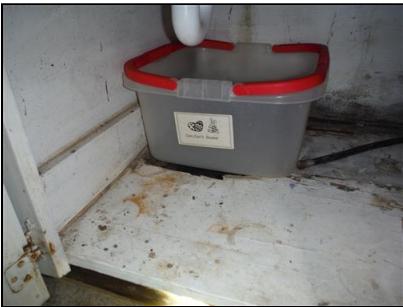
Kitchen sink area under cabinet flooring is significantly damaged/missing. Recommend having area repaired as needed. Area potentially has leaking activity.

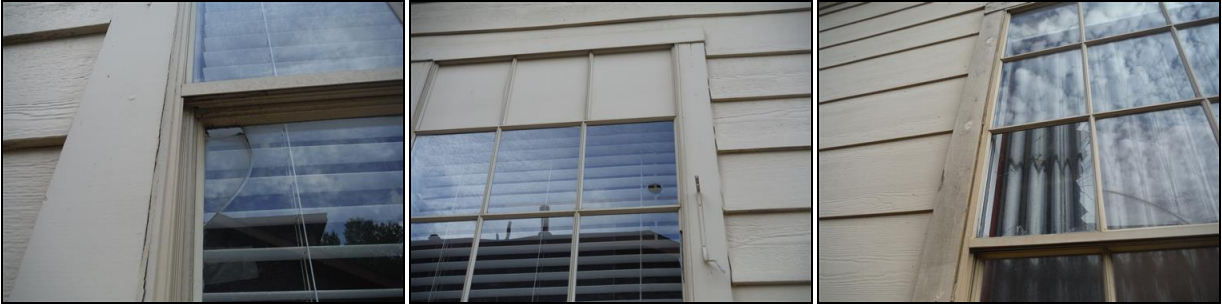
There are cracked glass panes at multiple locations.

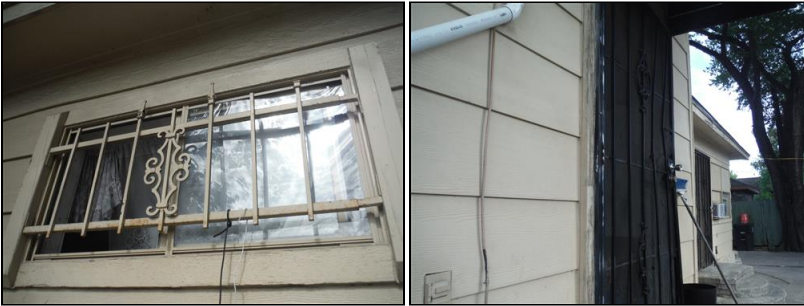
This house is equipped with burglar bars that are not operable. Burglar bars must be removable without the requirement of special tools, special keys or special knowledge for proper egress in the event of a fire. As a general safety rule, we recommend complete removal/replacement of these systems.

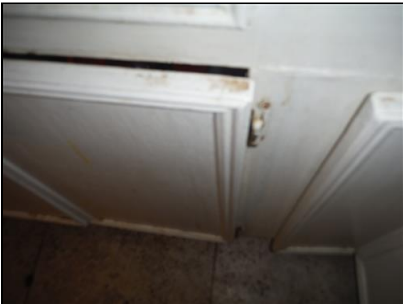
Noted kitchen cabinet doors that are damaged and not secured in place properly.

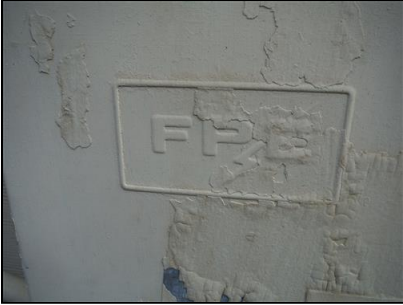
The main panel is manufactured by FPE (Federal Pacific Electric). These panels have documented trip hazards and are no longer manufactured. Further evaluation of the panel for repairs or replacement is required by a licensed electrician.

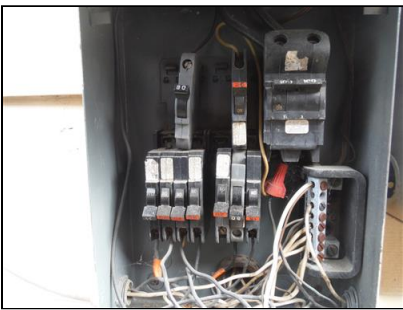
Dead front is missing at electrical panel.

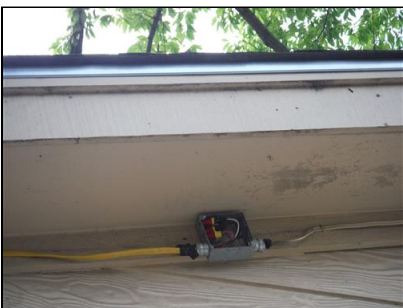
There were exposed connections, open boxes observed overhead exterior. Secure, enclose in rated enclosures to prevent hazards.

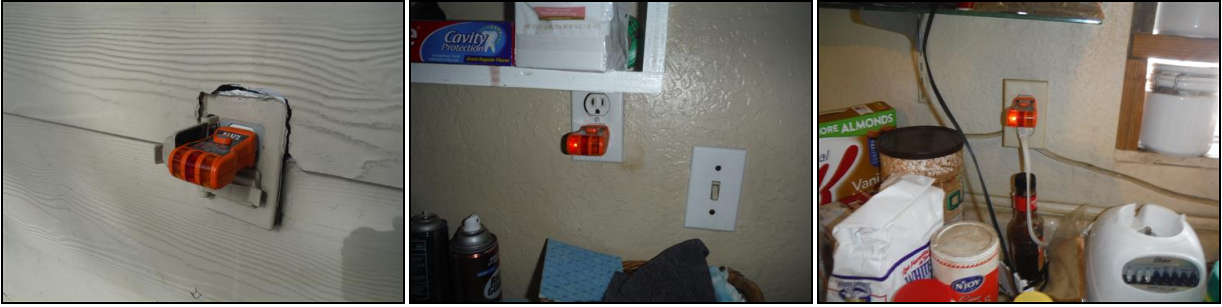
There are no GFCI (Ground Fault Circuit Interrupt) protected outlets in locations called for by today's

standards: all kitchen, baths, non dedicated garage below 6', exterior outlets,. I recommend updating to current standards.

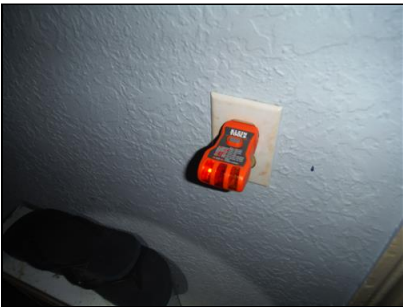
❌ There was an ungrounded circuit observed in most if not all rooms. The cause should be diagnosed and repaired by a licensed electrician.

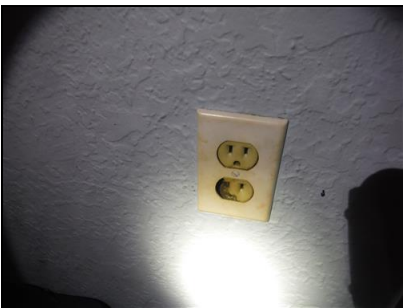
❌ Damaged receptacle at dining room area. Recommend having licensed electrician replace receptacle.

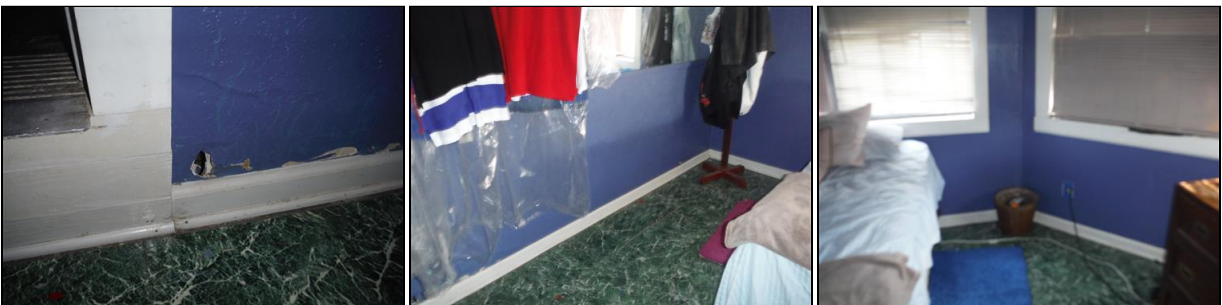
Found receptacle spacing is not set to standard. Receptacles need to be installed in a manner that no point measured horizontally along the floor line in any wall space is more than 6 ft. from a receptacle outlet. Receptacles need to be installed on any wall space that is 2 ft or more in width (including space measured around corners) and unbroken along the floor line by doorways, fireplaces, and similar openings. Extension cords are inherently more prone to failure that can cause fires or shock. Recommend having additional receptacles installed so that there is no space horizontally that is greater than 6 ft. to another receptacle.

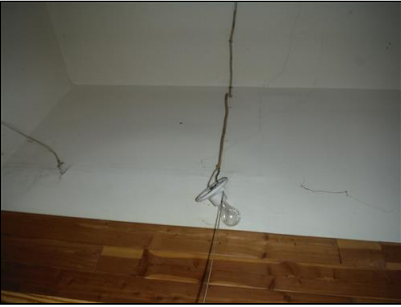
Closet light not properly installed and is hanging by wiring. Recommend having fixture properly installed.

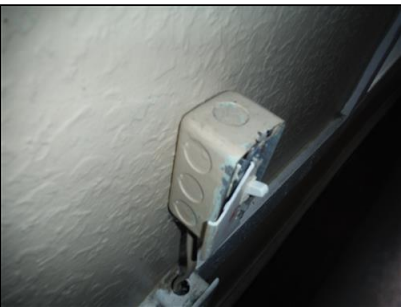
Replace missing cover plates on various outlets and switches. Prevent access to live components that can cause injury or electrocution.

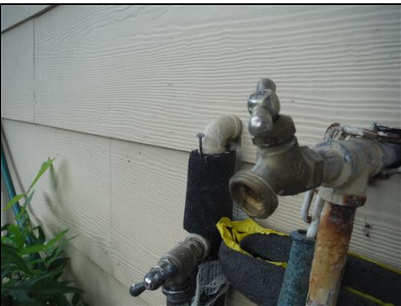
Some exterior hose bibs (faucets) are missing back-flow check valves as called for by today's standards

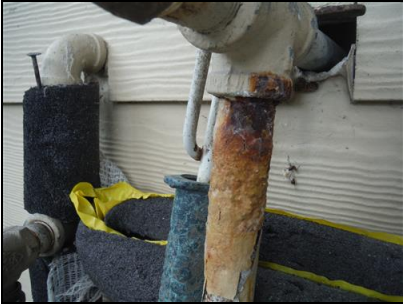
Noted areas of rust at connection points of galvanized piping at exterior and crawlspace. Noted no active leaks at time of inspection.

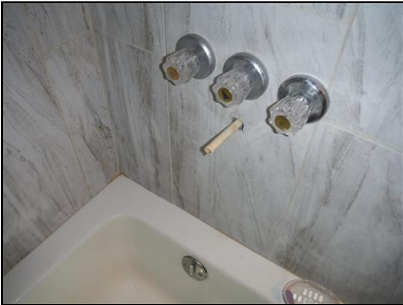
Right side bathroom shower is missing spout. Recommend installing spout in area.

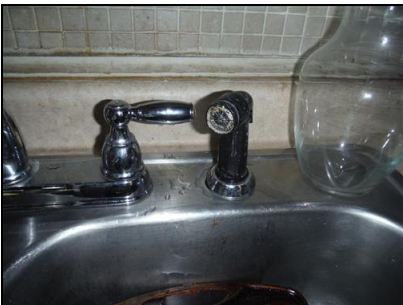
When activating the vegetable sprayer (kitchen) the water at faucet nozzle would not terminate. Faucet and vegetable sprayer are to dispense water independently of each other, it is either 100% out of faucet or when vegetable trigger is pressed 100% out of sprayer. Recommend properly repair/replace vegetable sprayer.

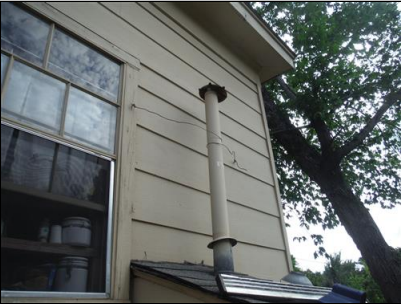
Noted the water heater flue is improperly installed and located too close to home structure and the overhang above. Recommend having licensed plumber further evaluate and repair as needed.

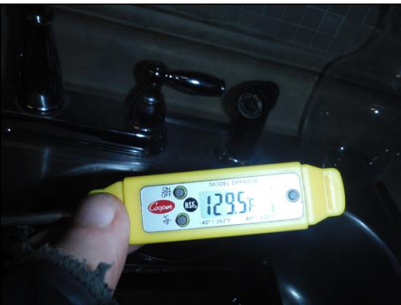
Temperature readings at sinks were measured at a higher than suggested setting. The U.S. Consumer Product Safety Commission (CPSC) urges all users to lower their water heaters to 120 degrees Fahrenheit. In addition to preventing accidents, this decrease in temperature will conserve energy and save money. Most adults will suffer third-degree burns if exposed to 150 degree water for two seconds. Burns will also occur with a six-second exposure to 140 degree water or with a thirty second exposure to 130 degree water. Even if the temperature is 120 degrees, a five minute exposure could result in third-degree burns. Consumers should consider lowering the thermostat to the lowest settings that will satisfy hot water needs for all clothing and dish washing machines.

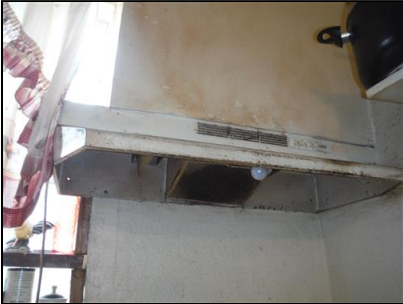
Range exhaust fan is inoperable

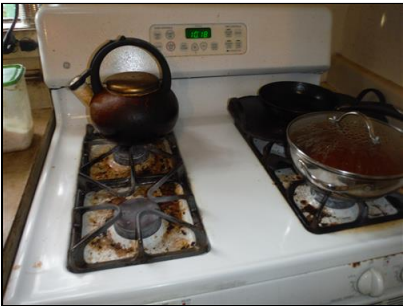
Noted that burners at some locations will not ignite when tested. Most of the time, when a gas burner refuses to light or runs poorly when lit, the cause is dirt or grease. Fine particles of dirt or grease spatters can clog the flame openings on the burner, or could be electronic igniter failing. Recommend having appliance technician evaluate concern and repair or replace as needed.

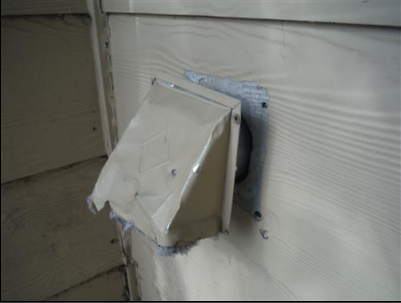
The exterior dryer vent cover is damaged, and is in need of repair. Also seal unit against wall.
