TREC REI 7-6
3403 Ramsgate Dr
Spring, TX 77388

Inspector
Donald Sellstrom
TREC License #24991
(281) 816 7007
info@htxhomeinspections.com

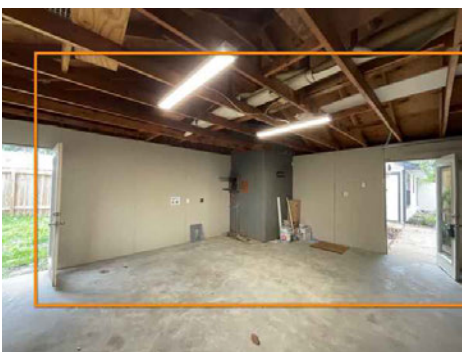
Attached garage add on

The structure showed signs of remodeling, renovations, and/or additions being added after original construction. This work may or may not have been performed by licensed contractor(s) with proper permits and code inspections, or in a workmanlike manner, etc. I suggest verifying with the seller and local code authority to determine if this work was done properly and that it conforms to the building standards applicable at that time. I also recommend viewing the municipal inspection records and permit information for this property. They may contain information on any upgrades, additions, renovations, change-outs, etc. which is not a part of my inspection process.

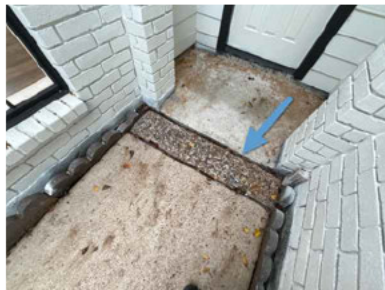
At front

Observed missing, deteriorated or lifted joint seal(s) at time of inspection. The key purpose of an expansion seal or joint is to provide a flexible connection point between two concrete, cement or similar structures and to help prevent moisture intrusion between two concrete slabs. Moisture intrusion between two slabs will cause the soil beneath the slabs to erode, which will increase the chance of excessive movement. Expansion seals and joints also allow two concrete slabs to expand during the drying period and help minimize moisture from entering under slab potentially undermining structure. Expansion joints that are not level with the walking surface become a trip hazard and will not function as they are intended.

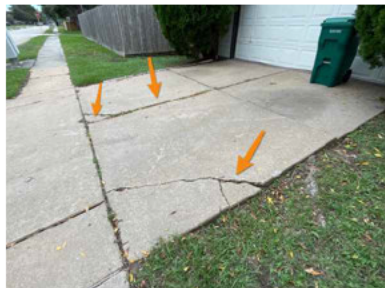
Observed damaged or cracked driveway, patio or other slab at time of inspection. Driveway and patio concrete slabs are not connected to homes foundation and is not as thick as the foundation slab Cracks that are in close proximity to the foundation can allow moisture intrusion in impacted area and cause the soil to erode. Tree roots, heavy equipment, wear and tear, settlement and grading erosion all or individually contribute to causing concrete to crack.

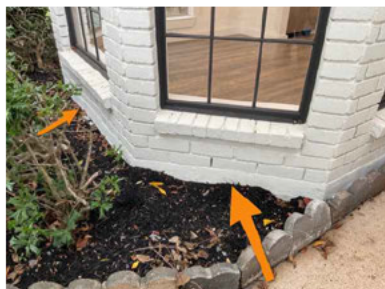
Foundation could not be completely inspected due to low siding, high soil or vegetation, inaccessibility, concrete patio, equipment, and/or a wrap around deck With siding installed on exterior walls it is recommended that 3-4” of the foundation wall be visible; with brick at least 1-2”.

Slab painted multiple locations

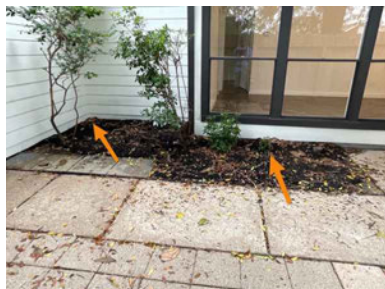
Left wall

Observed the grade level at or above the foundation in one or more area(s). Landscaping, grass, decks and soil height within 4" of the siding, stucco or brick veneer may allow moisture and pest intrusion within the wall cavity. Recommend allowing at least a 2" clearance between brick veneer, siding or stucco and the grade around the home.

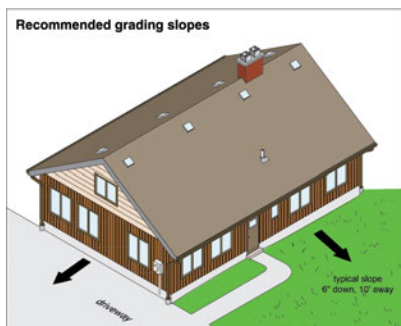
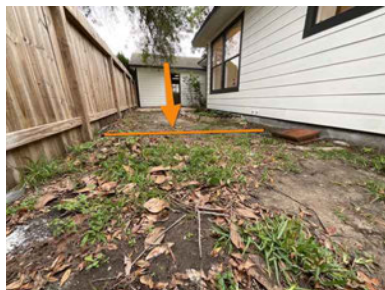
Left side

Observed improper grading in one or more areas of the yard. Grading should fall 6" within first 10' extending from the foundation wall outwards towards property line. If grading meets the required specifications runoff will properly drain, pooling won't occur and wet grading will dry out in a more timely manner.

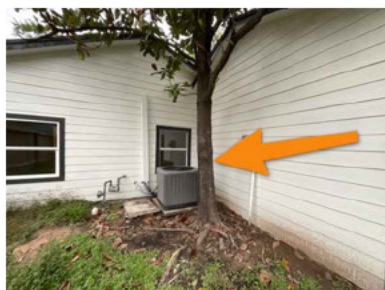
Observed a tree that appears to be too close to the home at time of inspection. Generally, a tree should be planted at least fifteen feet away from the foundation of a home. For larger, overstory species (taller than sixty feet), that distance should be increased to at least twenty feet from foundations and landscape features.

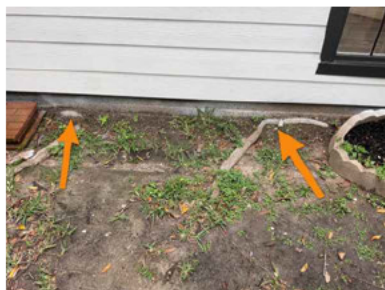
Left slab

Observed tree roots at or near foundation wall during inspection. Tree roots that are close to the foundation tend to pull moisture from the soil and cause the grading to lose its moisture balance. Typically, when roots encounter solid, impervious surfaces such as pipes, sidewalks, curbs and foundations, they are redirected laterally or up and over. However, if there is a breach or a crack in the foundation, they can and will exploit those voids in search of moisture.

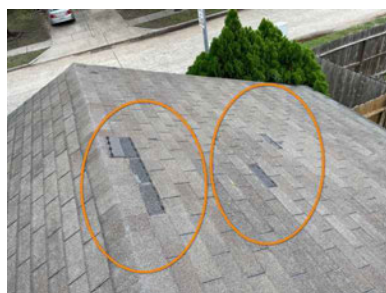
Garage

Observed damaged/missing roof covering in one or more locations of roof surface at time of inspection. Depending on severity of damage, defected roof covering may allow moisture penetration into roof structure and expedite degradation of roof decking materials. Tree branches in contact with roof surface, extreme weather conditions, wear and tear, manufacturer defects, and walking on stone roof are all conditions that can negatively impact the integrity and condition of roof coverings.

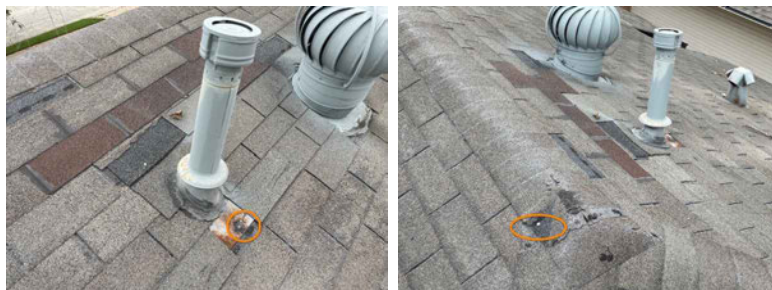
Observed missing/ deteriorating mastic atop fasteners securing roof jacks, flashing or roof shingles at time of inspection. Mastic on fasteners help prevent eventual rusting of the fasteners and moisture from entering the home at nail or screw penetrations.

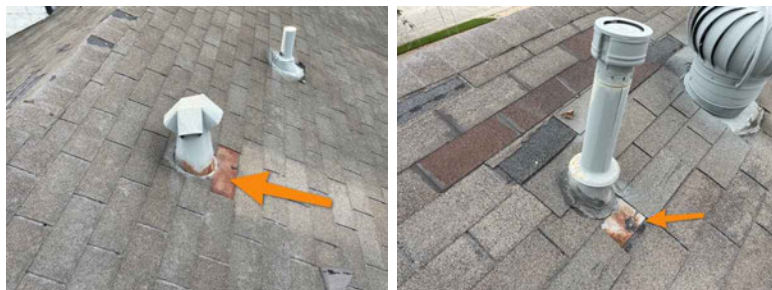
Rusted

Observed damage or rust on flashing in one or more locations. Flashings that are not painted at installation will expose the raw metal to moisture and over time, combined with debris, it will rust and deterioration may occur. Rust can render the flashing at the end of its useful life and may require it to be replaced. Damaged flashing can impact how well it can shed and prevent moisture intrusion.

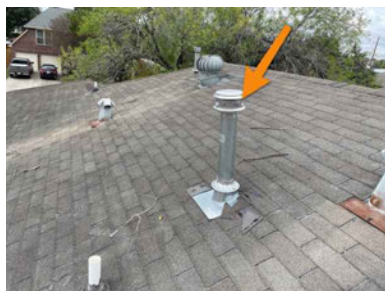
Observed unpainted/incompletely painted flashings in one or more locations. Recommend all flashing be painted to minimize rust and to match the trim work of the home.

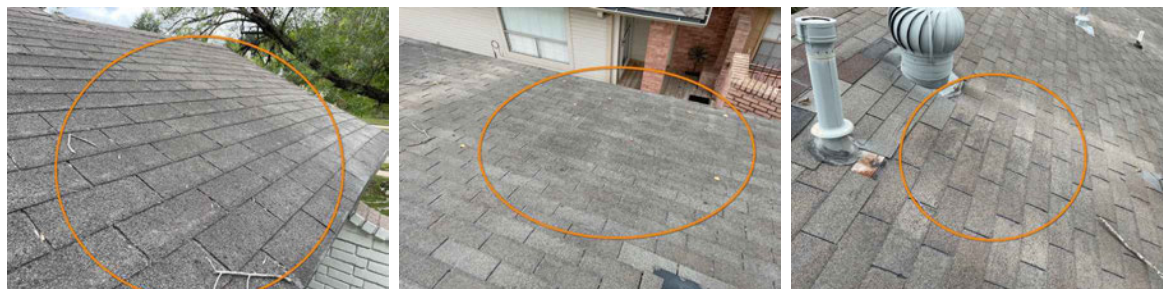
Observed granule loss on shingles. Granule loss that wears uniformly across the roof is normal. When shingles age and are exposed to different weather events it will cause the granule to become loose and wash away. Granules may also be removed or damaged due to installation during hotter temperatures combined with walking on shingles during installation.

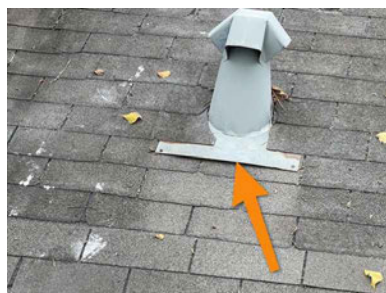
Observed lifted flashing in one or more areas at time of inspection. Flashing that is not flush to shingle surface can allow moisture penetration. Recommended a qualified roofing professional to further evaluate.

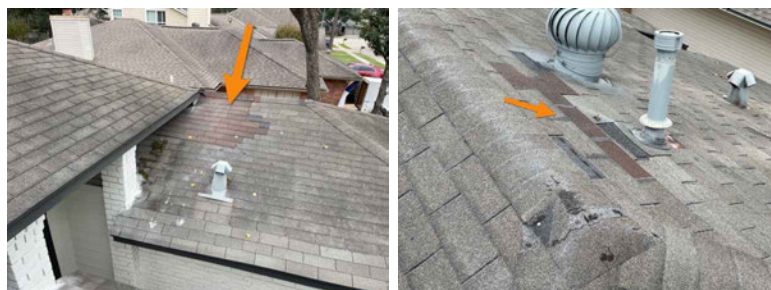
Observed what appears to be evidence of patchwork repair on roofing structure. This may be due to a previous water leak, replacement of damaged roof coverings, nailing over face of shingles or removal of attached fixtures. Recommend contacting seller/builder for further details or a qualified roofing professional to further evaluate. At the time of inspection there was no evidence of an active water leak.

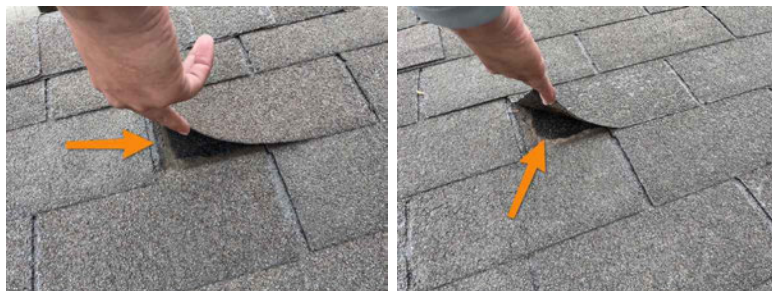
At time of inspection it appears that the adhesive holding the shingles from flapping in high winds is no longer effective. Each shingle is manufactured with an adhesive strip that allows it to adhere to its neighbor above when they are installed. The adhesive on the shingle is activated by heat—usually from sunlight beating down on the shingled roof. Adhesive strips that have deteriorated will expose shingles to potential damage and possible moisture penetration.

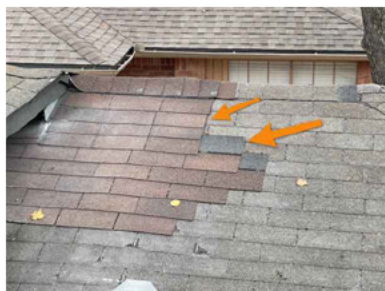
At patch near front roof

Observed what appears to be improperly installed roof covering at time of inspection. The inspector is not a professional roofing contractor. This is recommended due to the potential of moisture intrusion, overlay doesn't meet 5-7/8" for architectural shingles or 5-5/8" for 3-tab shingles or . Recommend a qualified roofing professional to further evaluate.

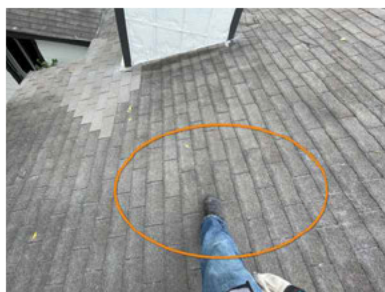
Near chimney

Observed what appears to be thin/soft roof decking upon inspection of roof. Thin/soft roof decking can be caused by moisture penetration that has began to deteriorate the wood panels or undersized thickness in panels that could be placed on over-spaced rafters. Standard roof sheathing thickness is 1/2" to 7/16". If using OSB for a roof deck, then 1/2" is recommended thickness but 7/16" is considered an industry standard. For plywood, which is slightly stronger than OSB, 1/2 thick is appropriate. Recommend further examination by a qualified roofing professional.

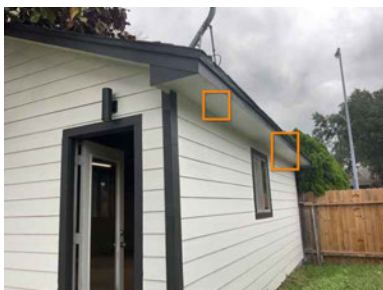
Attic ventilation appears to be insufficient due to lack of proper venting such as soffit or wall vents combined with ridge vents at time of inspection. Fully encapsulated spray foam insulation requires the attic space to be ventilated by supply vents that can heat and cool space or exhaust venting that will pull heat or cool air out of the attic. Poor attic ventilation can cause problems, such as ice dams, mold and mildew, and a shortened roof lifespan. Without proper ventilation, moisture can end up significantly damaging the roofing system. *The IRC (international residential code) requires 1sqft of net free ventilation area to every 150sqft of attic floor space.*

No soffit venting at garage add on

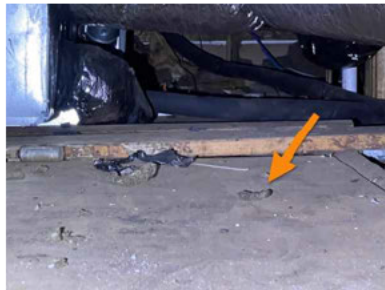
Observed signs of pest intrusion or pest control at time of inspection. Pest identifiers such as gnawing on fiberglass insulation or foam pipe coverings, rodent droppings, rodent traps, mud tubes on exterior foundation walls, actual sightings of pest during inspection and nest are an indication that there has been previous pest control attempts or current pest activity. Pest such as ants and wood destroying insects build nest utilizing the soil and can go undetected if soil level or grass is not kept at a proper height around foundation wall. Pest intrusion that has caused damage to structure could be an indication that wood destroying insects or termites have been present or are currently present.

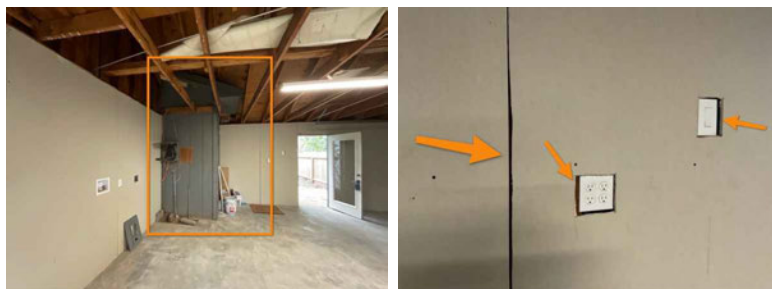
Garage Mutliple locations

Observed unmarked, unidentified or improperly installed fire rated wall in attic or garage space at time of inspection. Fire resistance rated construction is required to form a separation of adjacent spaces (such as townhomes and condominiums) to safeguard against the spread of fire and smoke within a building. To achieve proper fire rating drywall constructed walls must have identifying fire resistant labels and all joints and seams must be properly taped and floated. We recommend that the currently installed drywall be verified as fire rated, labeled and fully finished.

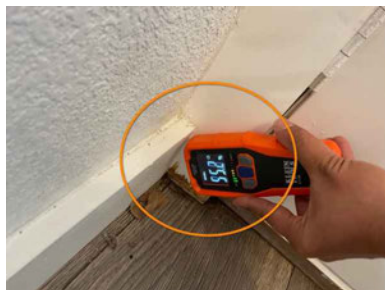
At rear door

Observed evidence of active moisture penetration/intrusion or leak at time of inspection. We are unable to verify extent of damage caused by moisture during inspection. Moisture content above 14% will compromise the integrity of drywall materials.

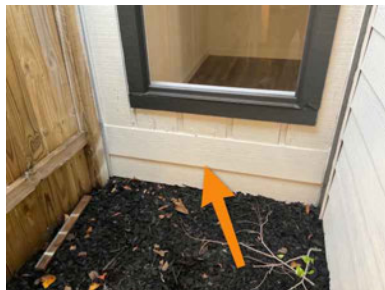
Left wall

Observed what appears to be patchwork repair on one or more interior/exterior wall(s). Patchwork repair may be an indication of previous water intrusion, foundation movement or unknown damage to surface.

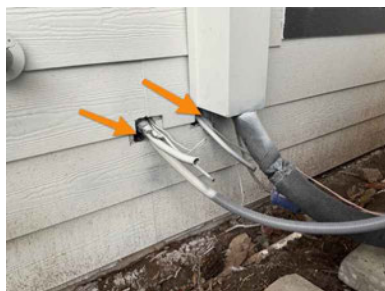
Rear wall

Observed unsealed penetration opening in one or more locations on exterior wall. The opening should be sealed to help prevent moisture and/or pest intrusion in that area.

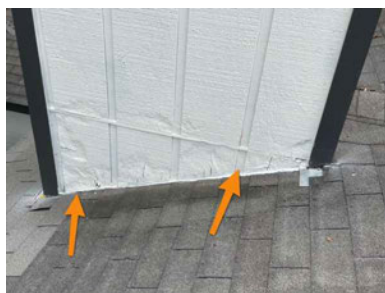
Observed deteriorating, damaged, loosely fastened or cut too short siding/trim on one/multiple exterior wall surfaces. Damaged and deteriorating siding can be from a multitude of causes (wood destroying insects, moisture penetration, impact from hard object, installation, etc) that are unknown to the inspector. Repairing or replacing siding/trim will help prevent potential moisture and/or pest intrusion.

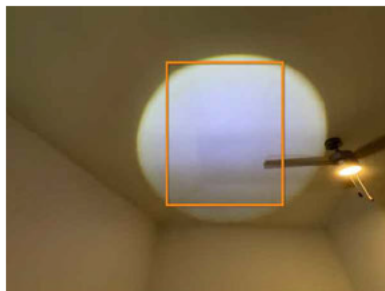
Primary Bedroom

Observed evidence of previous patchwork repair at time of inspection. Repairs to drywall may have been done due to prior leaks, damage to materials or remodeling prior to the sell of a home.

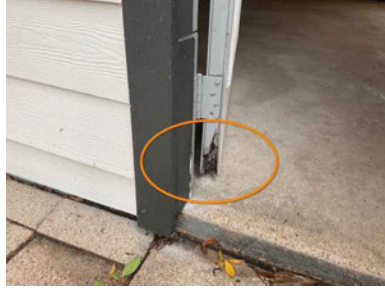
Garage

Observed damaged door at time of inspection. Damage does not impact proper operation of door when testing.

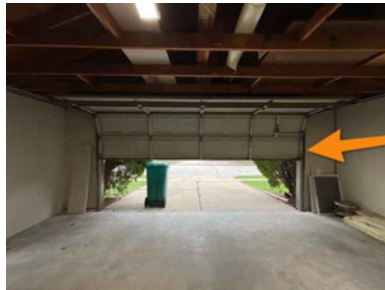
Observed door(s) not fully closing or opening, hard to close or binding when tested. Doors not opening or closing properly could be from the home settling, painting of door/frame, or misaligned.

Unable to completely open garage

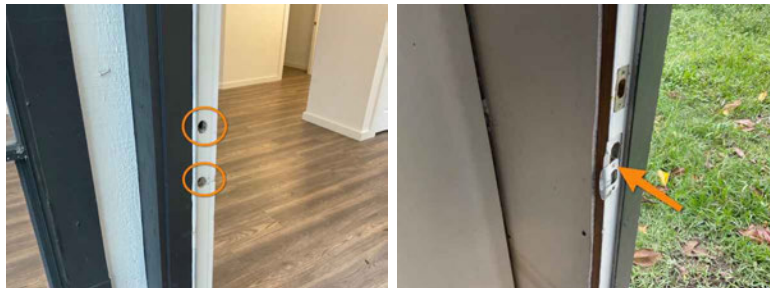
Garage

Observed door lock latch, deadbolt or ball latch strike plate missing or not properly secured at time of inspection.

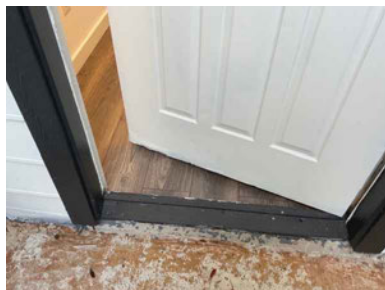
Front door

Observed insufficient, uninstalled or damaged door sweep at time of inspection. Recommend replacing or installing door sweep to prevent conditioned air loss, possible pest intrusion and moisture from entering home.

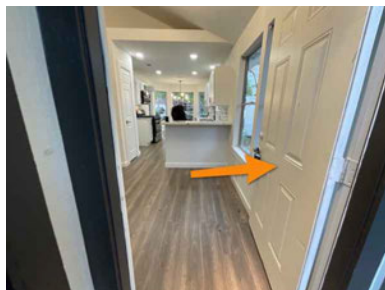
Rear door

Observed door that is moving on its own, opening or closing, when testing. This could be from the door being slightly out of level, the hinges have lost friction over time or the home has not settled properly.

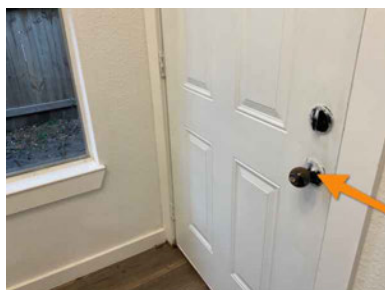
Rear door

Observed loose door handle(s) or lock during inspection. Loose door hardware subsequently can cause doors not to function properly.

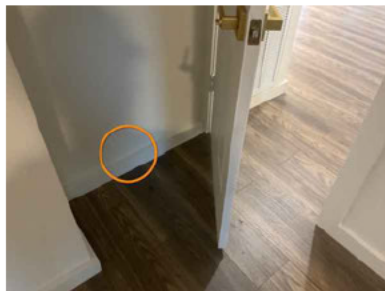
Bedroom 2

Observed missing or improperly functioning door stops in one or more locations at time of inspection. Door stops help prevent damage to walls, wood trimming or anything that may be in the way when the door has been fully opened.

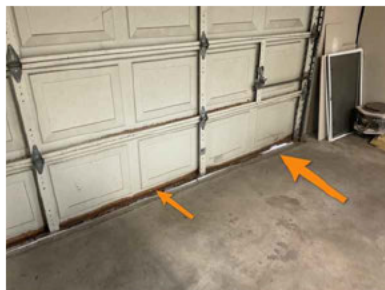
Garage door

Observed rust on metal door at time of inspection. This occurs from moisture eroding the paint and base primer exposing bare metal over time, depending on impact of moisture door may need to be replaced.

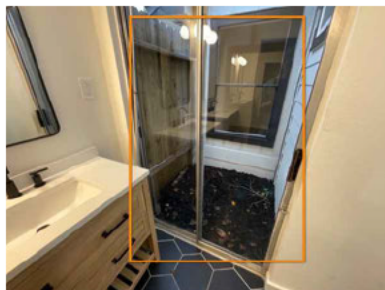
Primary Bathroom

Observed damaged or missing door screen on sliding door(s) at time of inspection.

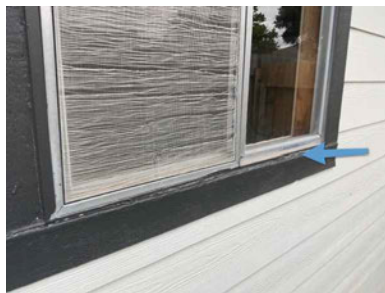
Garage

Observed missing or shrinkage of caulk around window(s) at time of inspection. Missing or caulk shrinkage on the exterior of a home will allow moisture penetration into wall cavity. Interior caulk shrinkage may allow for conditioned air to escape from inside the home to the exterior.

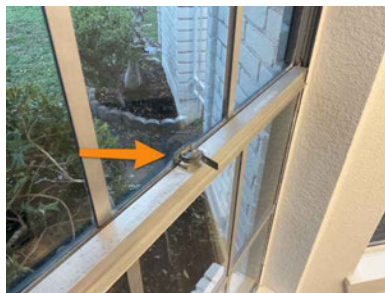
Dining Room

Observed window lock(s) that does not function properly at time of inspection. Lock appears to be damaged, loosely fastened, missing, hard to lock, or inoperable. Properly functioning window locks are part of the homes security and when they are not functioning properly can render easier than normal access to home.

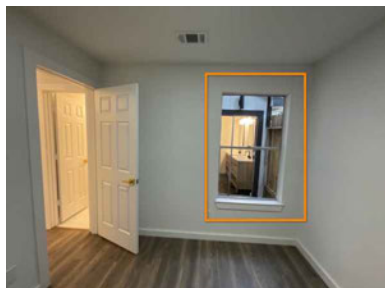
Observed one or more windows not opening or closing properly. Window(s) appear to be one or more of the following: painted shut, spring balance not functioning as intended, needs adjustment, hits top sash, requires a crank shaft, double window or is improperly installed. Recommend a qualified professional to further evaluate.

Bedroom 1 inoperable

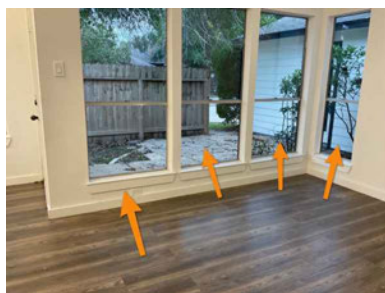
For example Living Room

Unable to verify if windows are safety or tempered glass at time of inspection. All glass or panels in fixed, operable, swinging, sliding and bifold doors must be constructed from safety glass, regardless of size. Fixed or operable windows must include safety glass if they measure larger than 9 feet square, the bottom edge is less than 18 inches above the floor, the top edge is more than 36 inches above the floor, and there is a walking surface within 36 inches of the glass. Tempered glass is not required unless all four of these conditions are met.

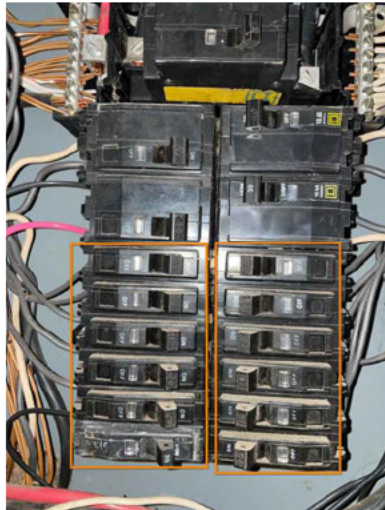
AFCI circuit breakers were not observed or missing during inspection of breaker panel. Depending on age of home AFCI protection may not have been required at the original time of build. New construction homes are required to have AFCI circuit breaker protection. AFCI protection is currently required for all 15 and 20 amp branch circuits providing power to outlets in residential family rooms, dining rooms, living rooms, parlors, libraries, dens, bedrooms, sunrooms, recreation rooms, closets, hallways, and similar rooms or areas.

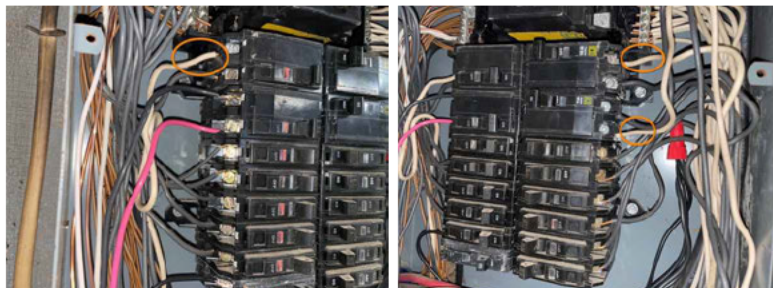
Observed white conductor wire without identifier marker labeling. White wires are typically used for neutrals but when used on breakers they must be identified with black electricians tape or some form of marking to identify them as hot wires.

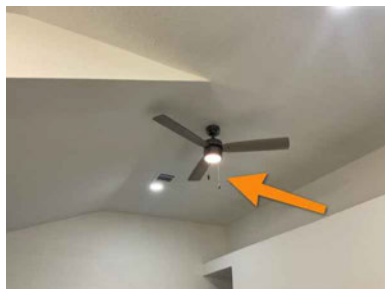
Living Room

Ceiling fan inoperable, needing remote device to test for proper functionality, appears to be improperly wired or not functioning correctly at time of inspection. Recommend a qualified professional to further evaluate or contacting seller.

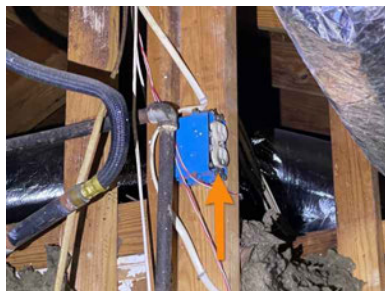
Attic

One or more receptacles are missing a cover plate or improperly sized. Recommend installing receptacle plate cover to prevent a potential shock hazard if receptacle is a electrical outlet.

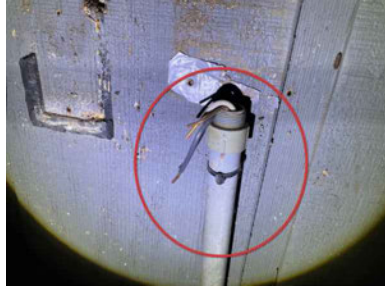
Garage

All wire connections & charged wires with exposed ends and splices should be covered in junction boxes for safety. Recommend a qualified electrician correct.

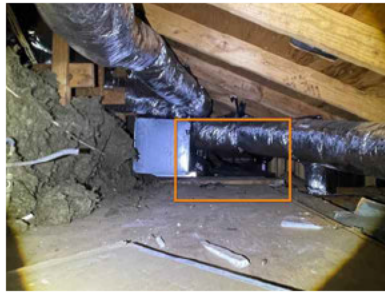
Furnace inaccessible:

No access, minimum head room requirement not met

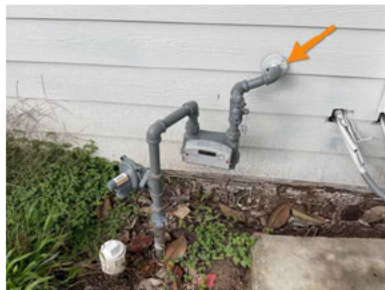
Unable to verify gas line bonding
