HOUSTON INSPECTIONS

PROPERTY INSPECTION REPORT FORM

03/08/2022

4615 Pin Oak Ln, Bellaire, TX 77401

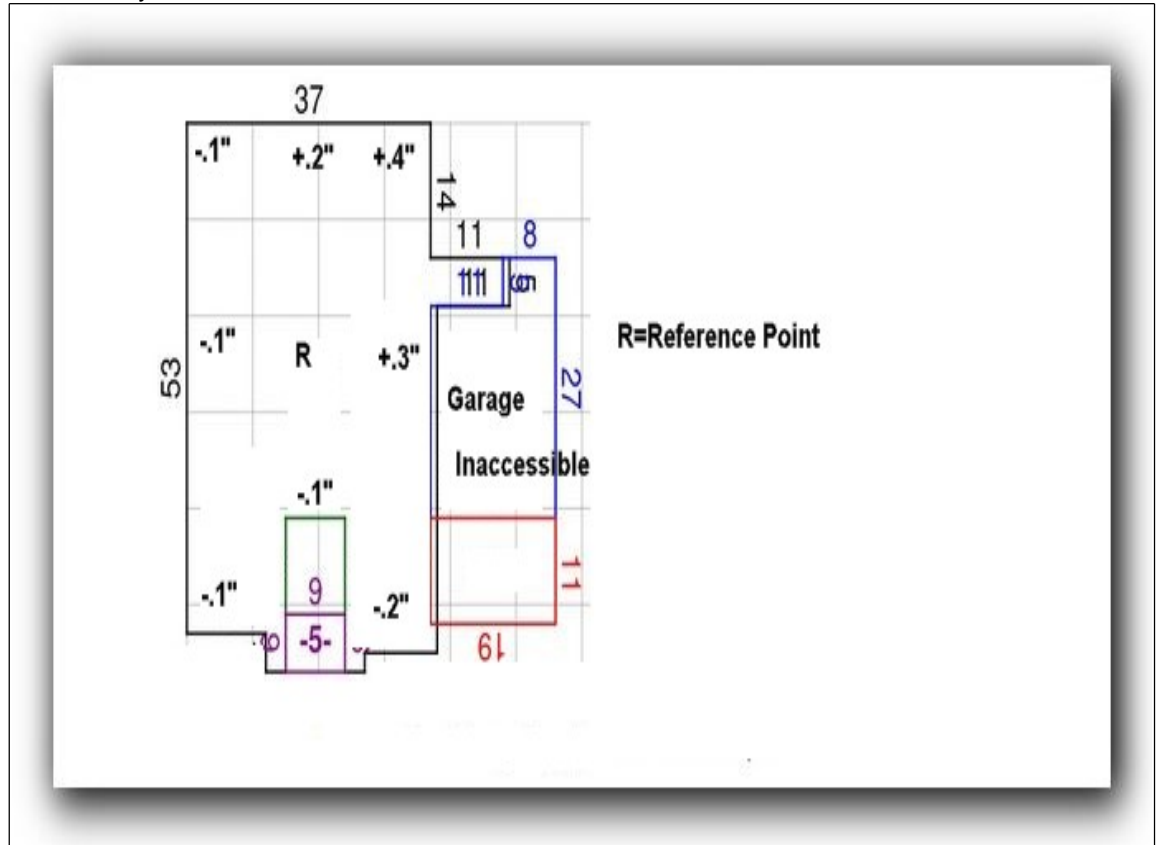
The below graph reflects measurements taken during the inspection to assist with determining the performance of the foundation. The outline / drawing is not to scale and does not accurately reflect every detail of the foundation walls.

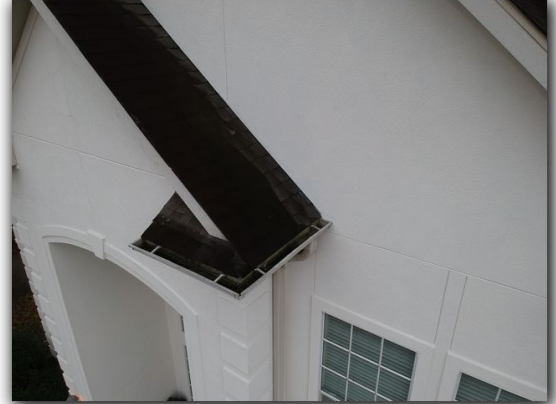
Kickout or diverter flashing is not installed at the required locations. This creates a possibility of water penetrations if not corrected.

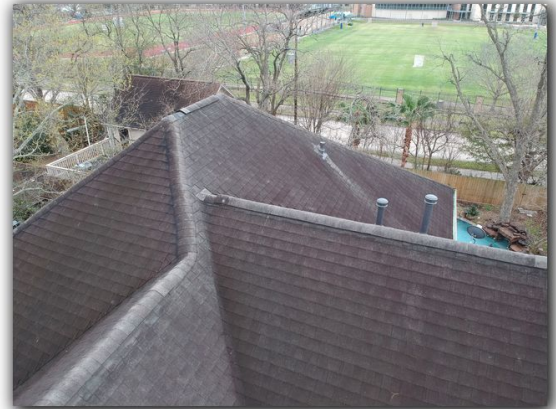
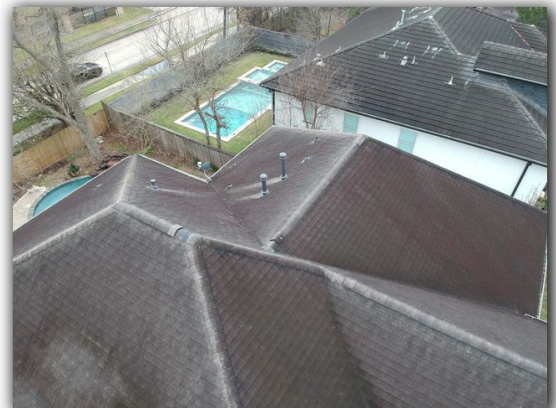
The hip and ridge shingles appear to have reached the end of their serviceable life's as evident by excessive loss of aggregate and damage at many locations. This commonly occurs when these shingles are a different quality than the main body. Recommend contacting a qualified tradesman to evaluate the roof and make the necessary repairs.

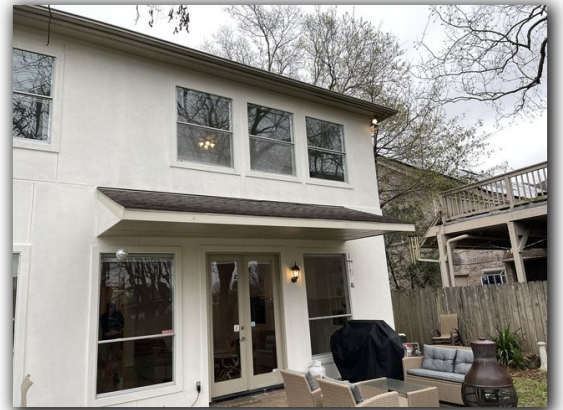
Sections of the roof flashing are raised which could lead to water penetrations. Recommend repairs.

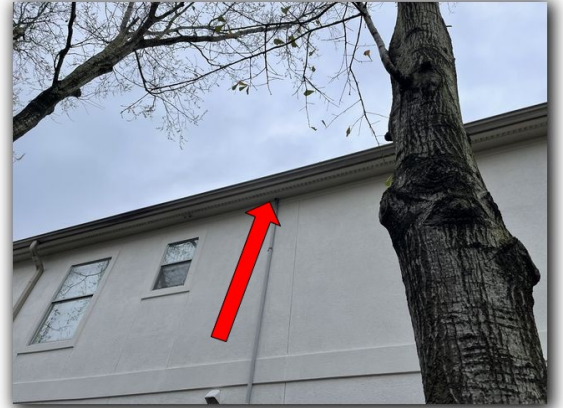
Voids were found at the left soffit. These voids should be sealed.

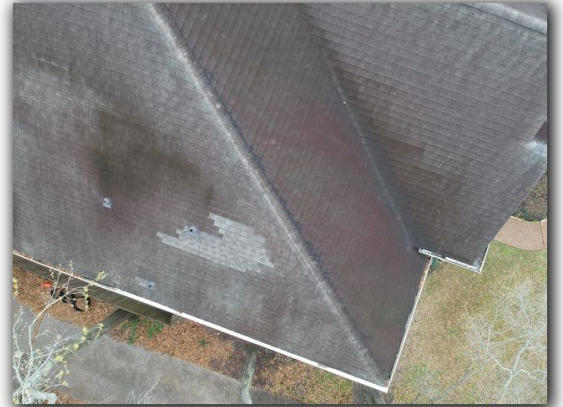
Evidence of roof patching was noted during the inspection as evident by different color and age shingles.

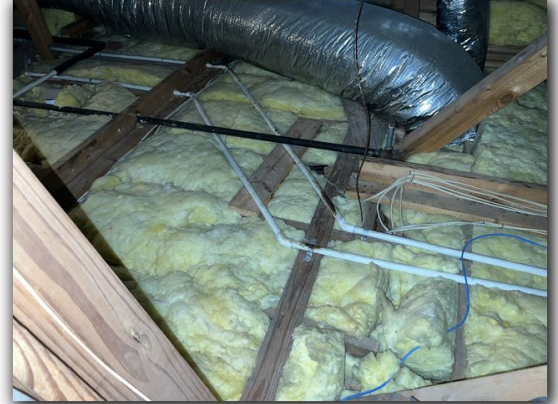
Evidence of rodent activity was noted in the attic as evident by nesting materials, holes, etc.

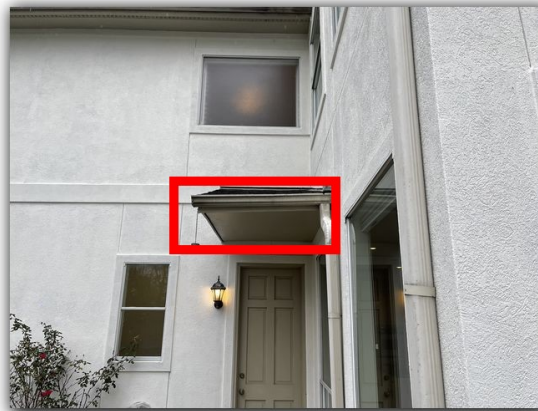
The right back patio cover is sagging. Recommend monitoring and repairing as needed.

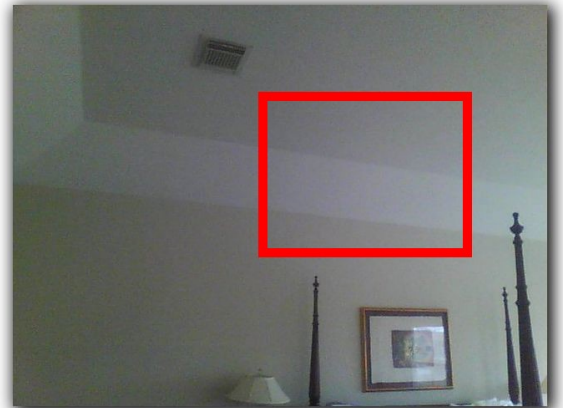
Missing insulation was found at sections of the ceiling / attic in the left side master bedroom while using a infrared camera.

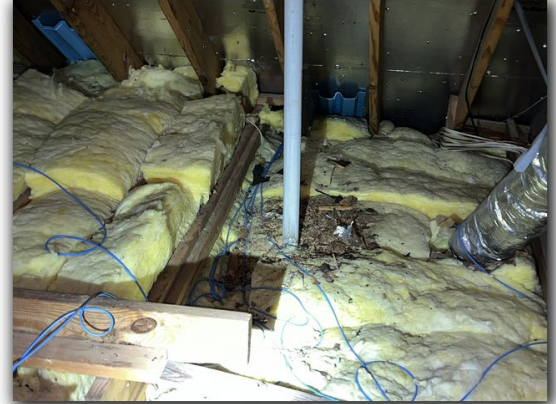
Evidence of previous structural repairs were found in the attic as evident by new lumber at several locations.

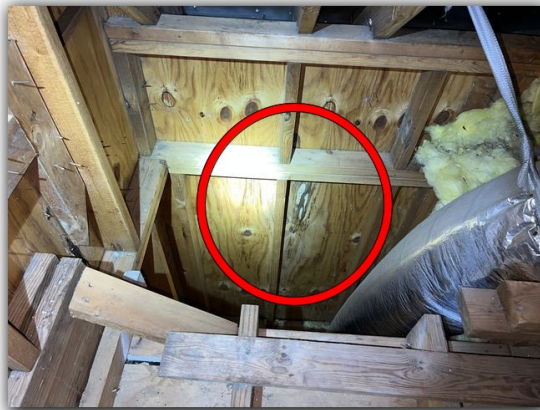
Possible staining / damage was noted at the plywood substrate at the front left portion of the home. An invasive stucco inspection is recommended.

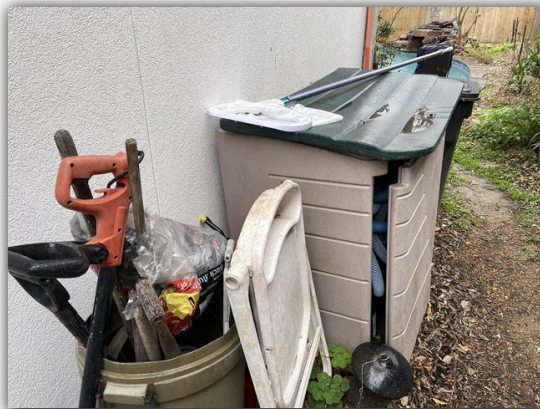
Debris has been stored against the Right Side of Property. This can conceal problems behind this items and restrict the inspection for wood destroying insects. Recommend removal of the items to provide access to the exterior veneers and foundation.

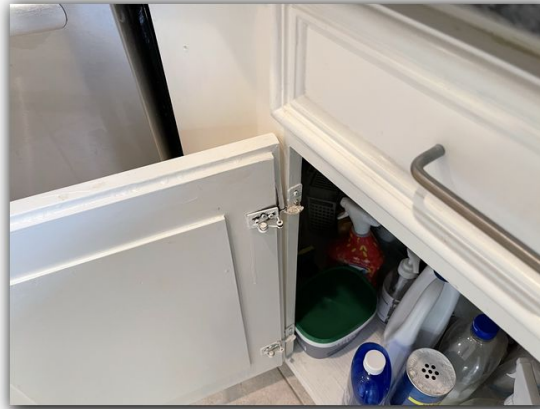
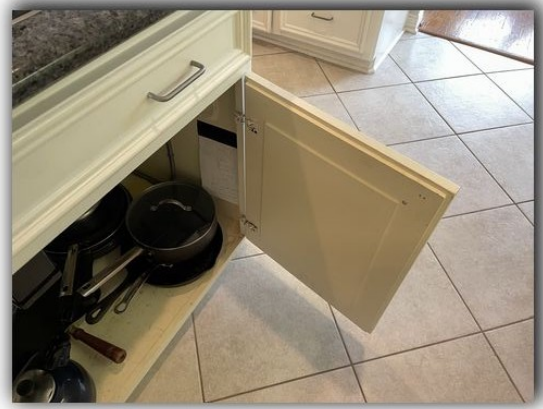
Loose hardware was found in the kitchen cabinets

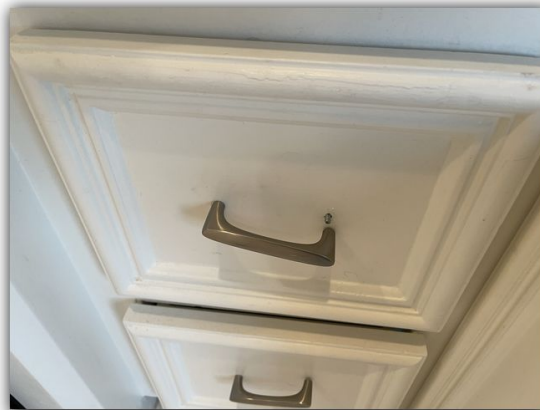
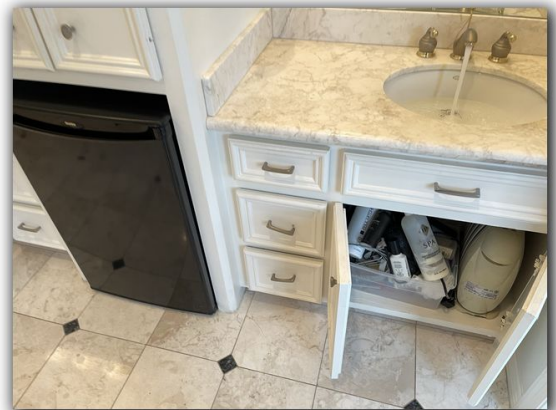
Loose hardware was found in the bathrooms.

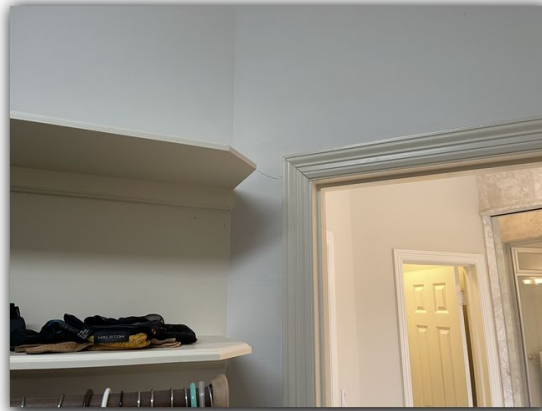
Hairline cracks were found on the interior of the property as evident of settlement.

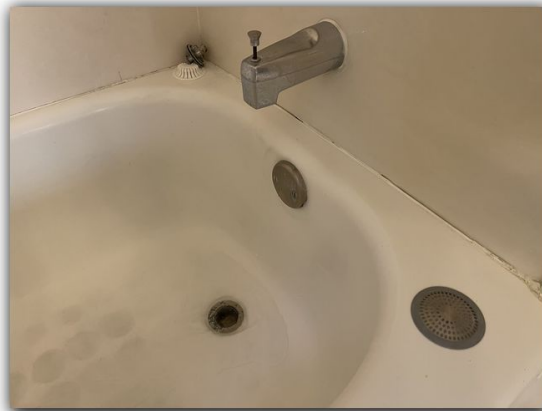
Damaged and missing grout/caulking was noted in the left guest bathroom shower/bathtub enclosure.

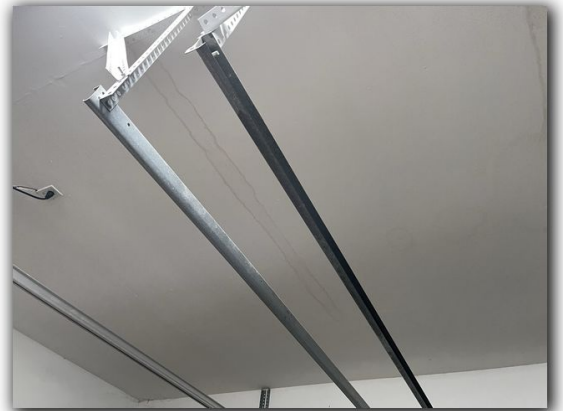
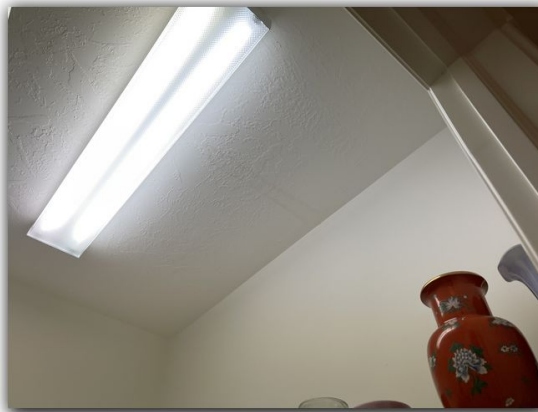
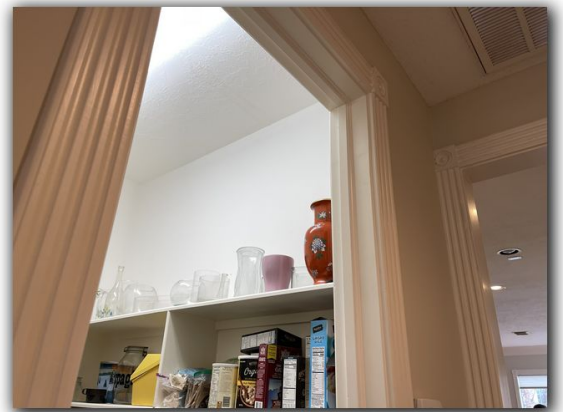
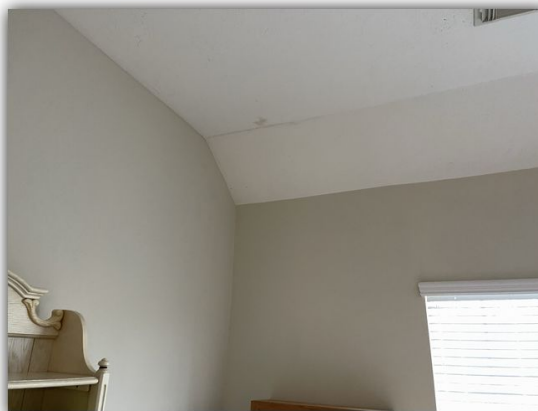
Damaged / discolored drywall was found in the garage, Kitchen Pantry and front left guest bedroom during the inspection. No abnormalities were found at this area with the infrared camera and no elevated moisture readings were observed when inspected with a pinless (non invasive) moisture meter. Recommend further evaluation to determine the needed repairs.

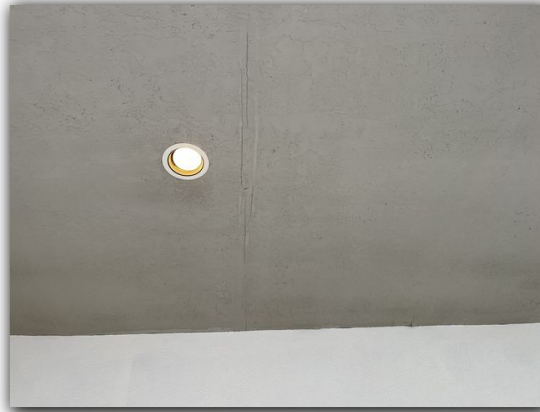
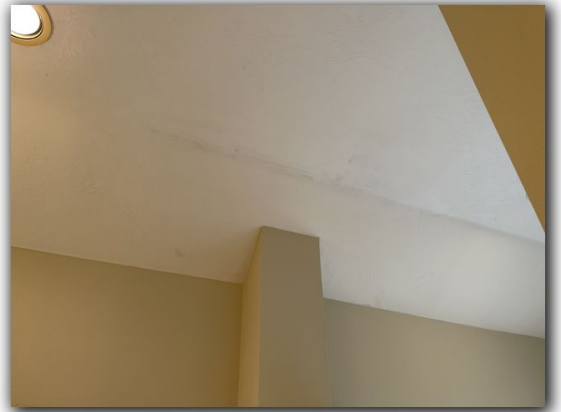
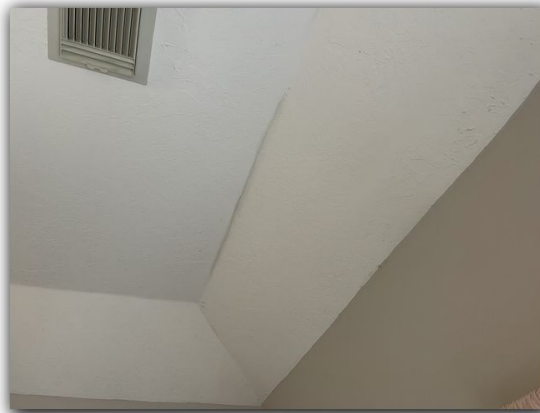
Cracking was noted on the interior ceiling of the property as evidence of settlement.

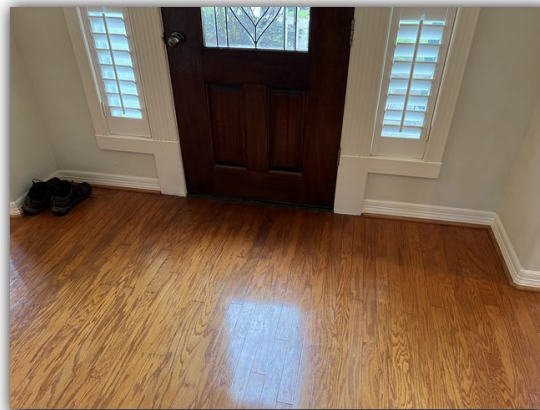
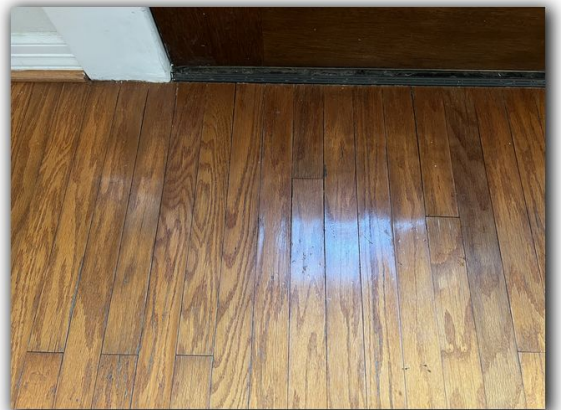
Warped / buckled wood floors were found in the den and front entryway. A qualified tradesman should be consulted to determine the source of moisture and needed repairs.

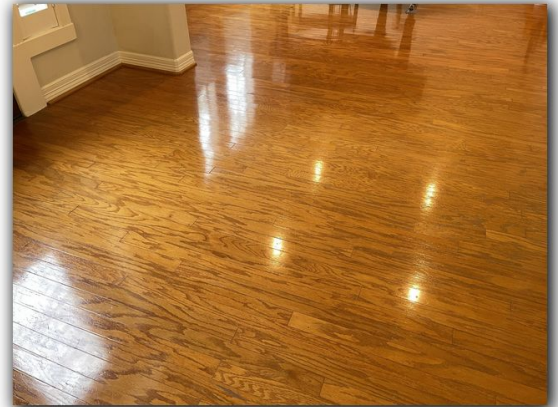
The wood floors are showing signs of wear and tear (ding's, scratches, etc.).

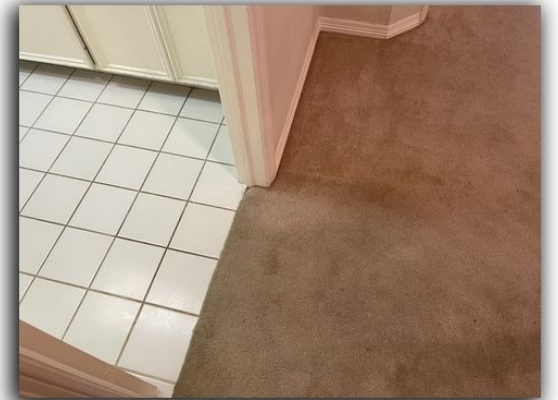
Stained and / or damaged carpet was found on the interior of the building.

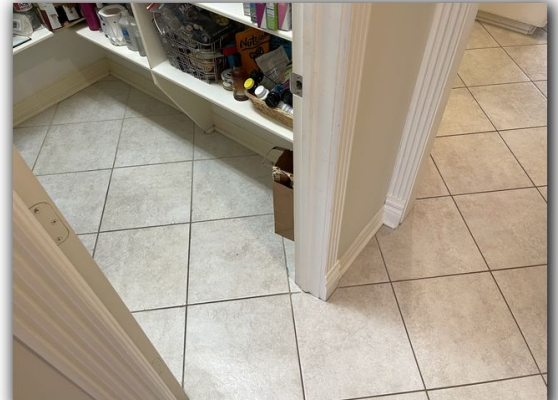
Chipped floor tiles were found in the Kitchen Pantry.

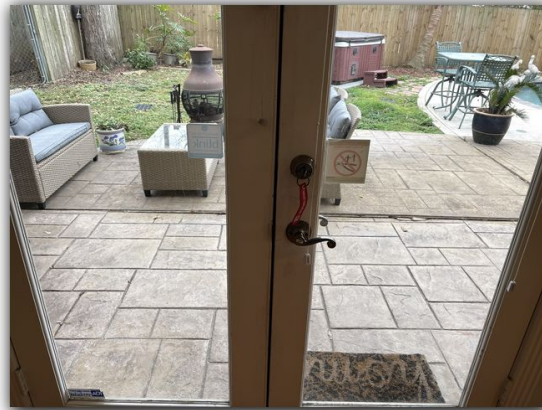
The dead bolt is difficult to operate at the rear exterior door. All dead bolts should be adjusted to operate properly and easily.

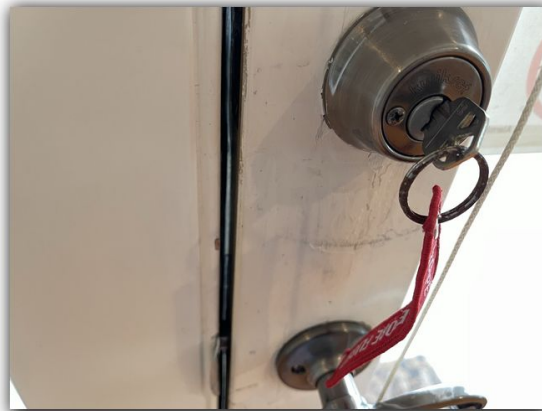
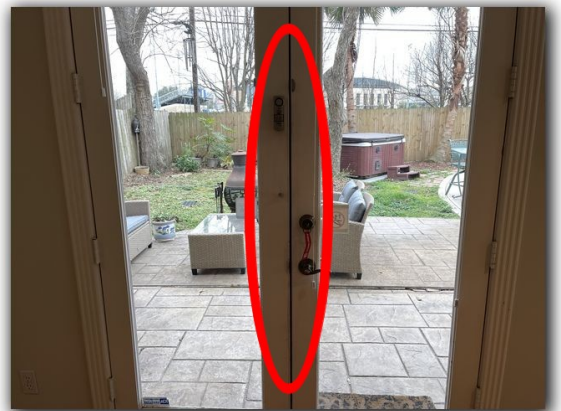
Voids were found at the weather stripping at the rear exterior door. Recommend improvements to improve the energy efficiency.

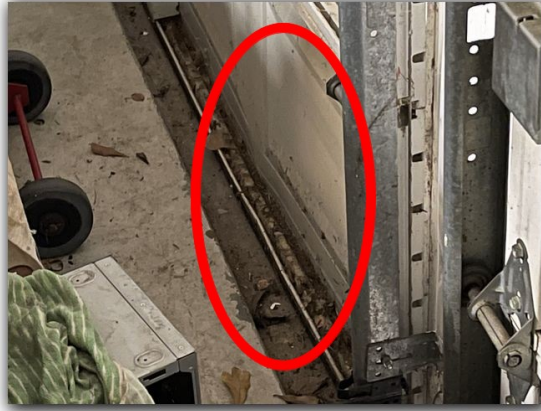
Damage was found at the garage door panels.

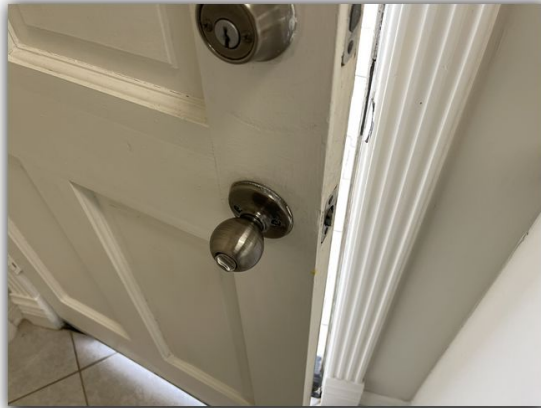
The right rear exterior door handle is not functioning, striker sticking in door.

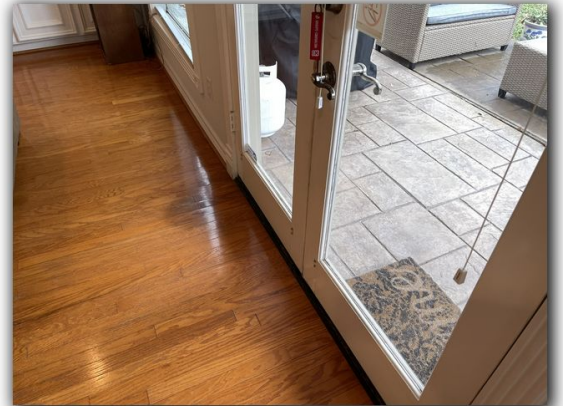
Damage was found at the rear exterior door.

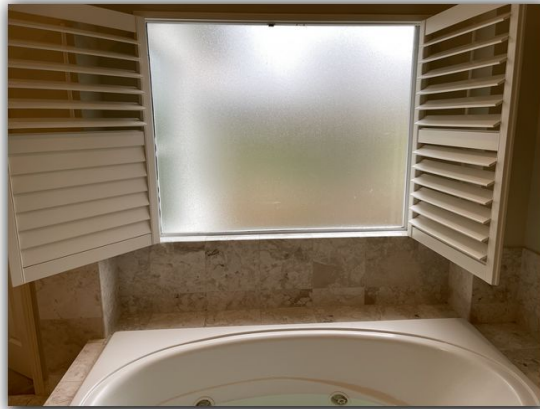
- Safety glass is not present in the following locations: 30" from Tubs
Safety / tempered glass is required to be installed in these locations as they are considered hazardous by current codes.

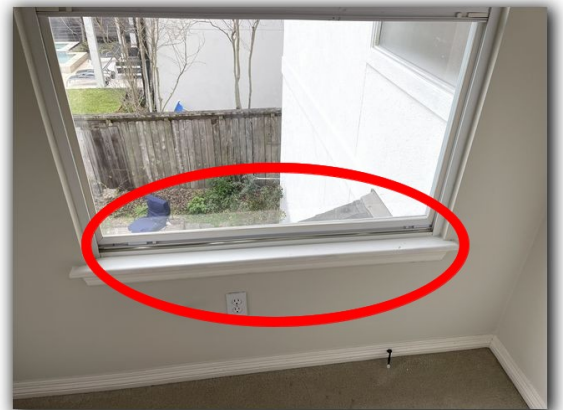
The window frame is damaged at the right front master bedroom storm window.

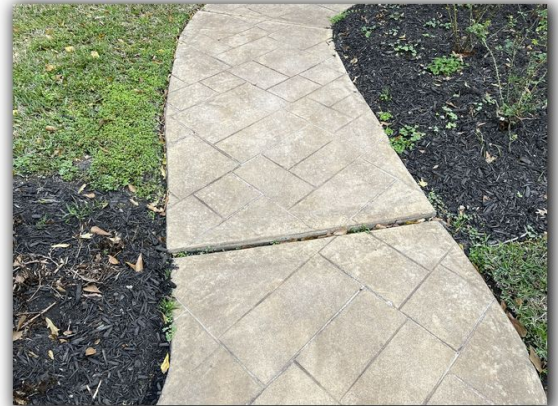
Uneven materials were observed at the flatwork. Flatwork should have a uniform surface (to prevent tripping) and slope away from the dwelling (i.e. patios, driveways, sidewalks, etc.).

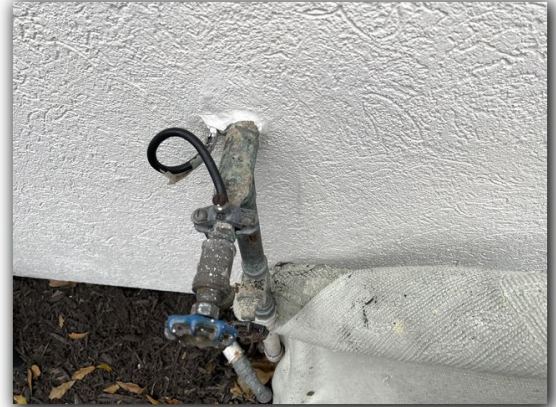
- Grounding clamp improper style for rod Installations
- Bonding not present / visible at gas lines
- Arc fault protection not installed at all required locations. Current codes require AFCI protection to be installed in kitchens, family rooms, dining rooms, parlors, libraries, dens, bedrooms, sunroom's, rec rooms, closets, hallways, and laundry rooms.
- Panel located in un-approved location (Clothes Closet, Damp Location, Etc.)
- Surge Protection not Installed Main Panel - Currently Required by Code

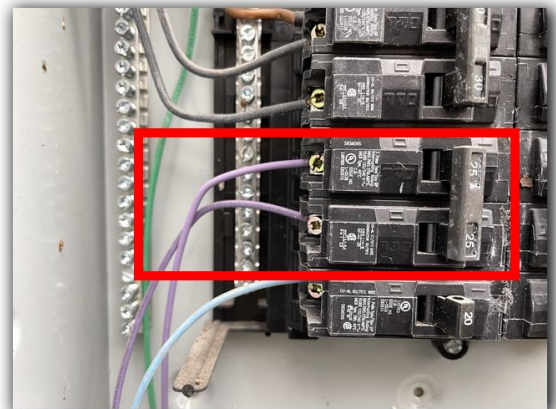
Oversized breakers were found within the exterior sub electrical panel. 25 amp breaker on 12 gauge wire. Each breaker is rated for a specific size conductor. Ideally, these breakers should be re-sized by a licensed electrician.

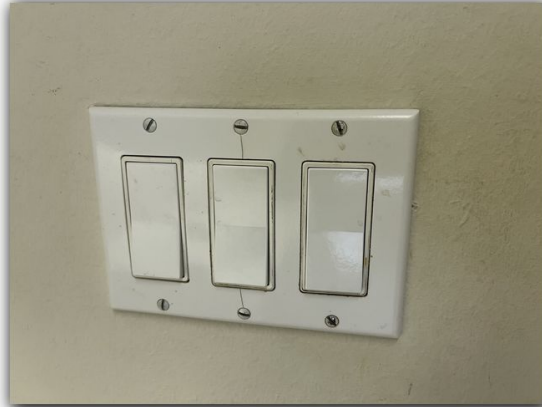
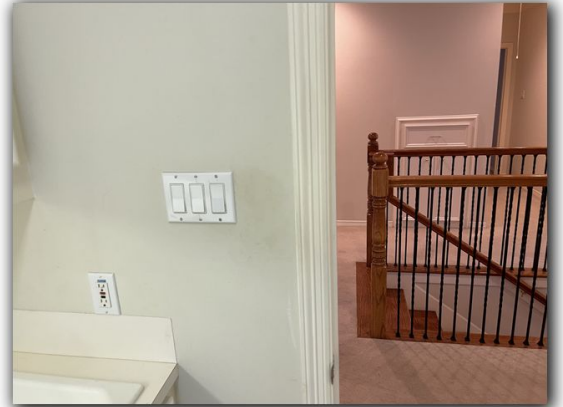
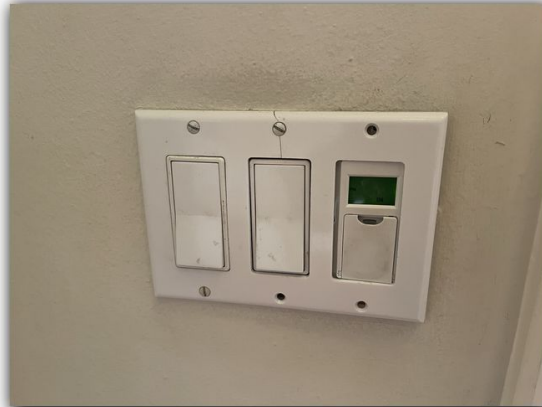
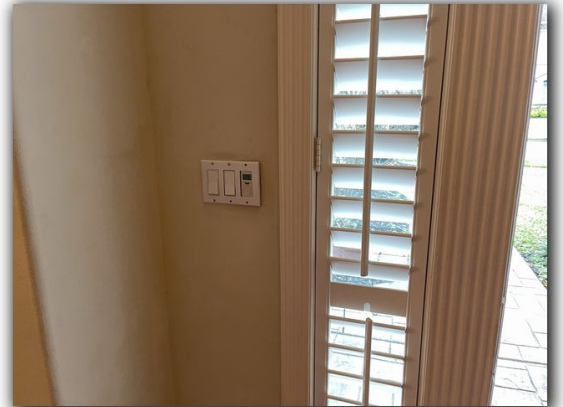
Damaged cover plates were found in the laundry room and front entryway. Recommend replacement of the plates.

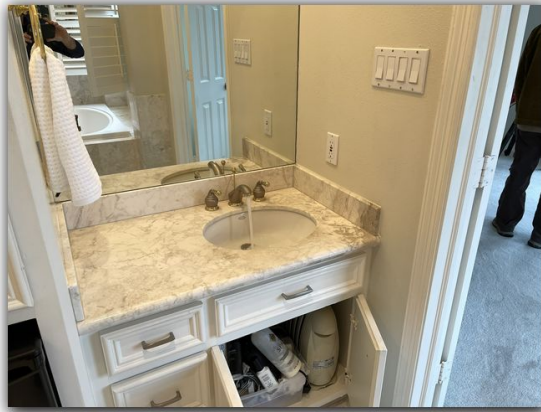
Loose receptacles were found at various locations. The receptacles should be better secured.

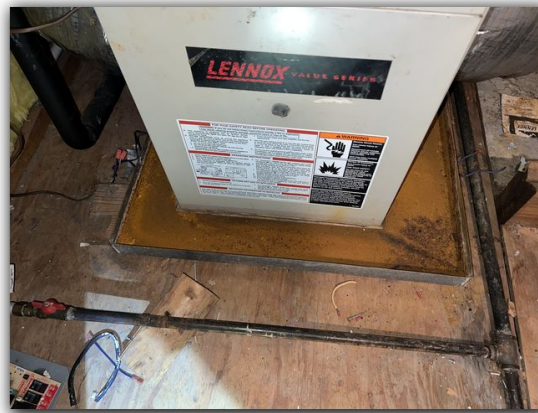
The overflow pan is rusted under the evaporator coil of unit # 2, apparently from water overflowing from the condenser drain line in the past.

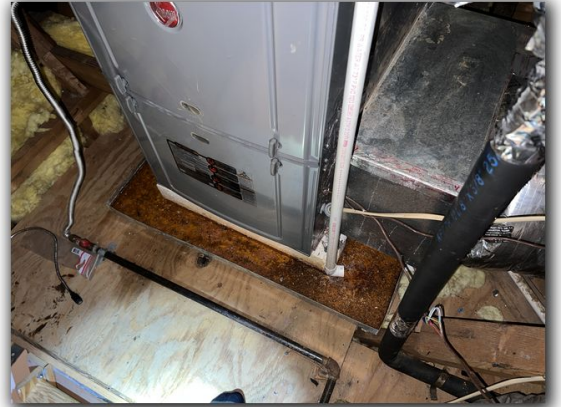
Standing water and a large amount of rust was found in the drain pan below the evaporator coil for unit #1 in the attic. This appears to be caused by condensation dripping from the housing.

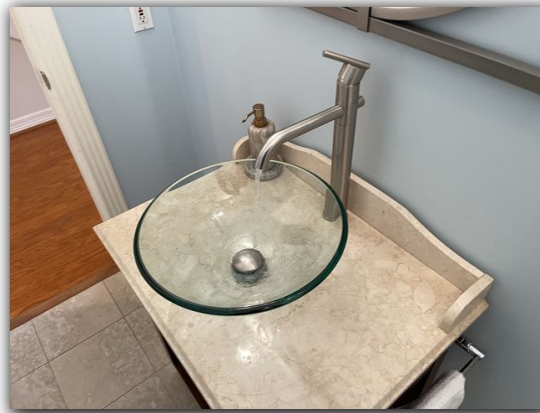
The sink downspout is loose at the surface the fixture is mounted on.

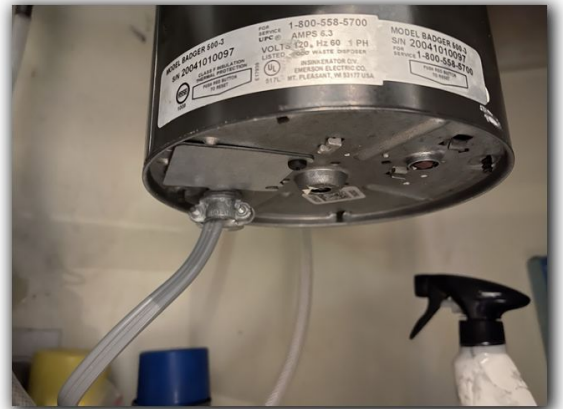
The clamp at the disposal housing and electrical conductor is loose. Recommend securing.

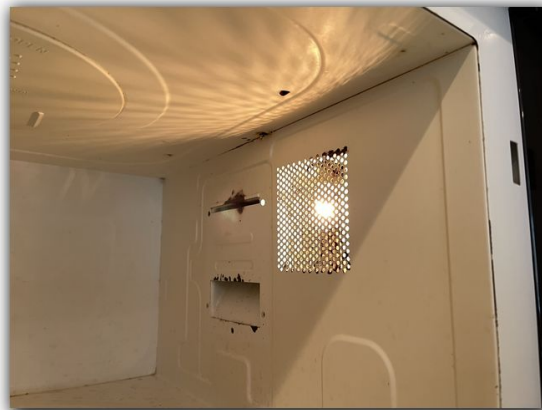
Damage was found on the interior of the microwave/liner.

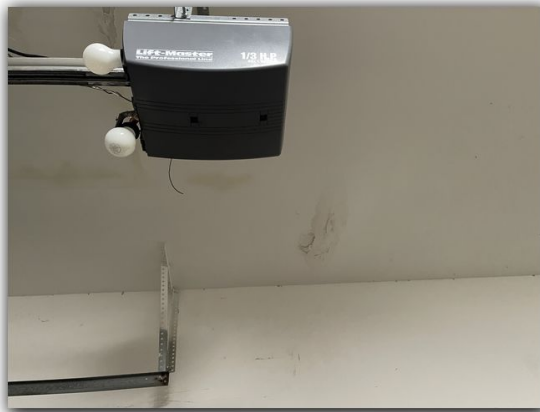
The light cover is damaged/missing at the operator.

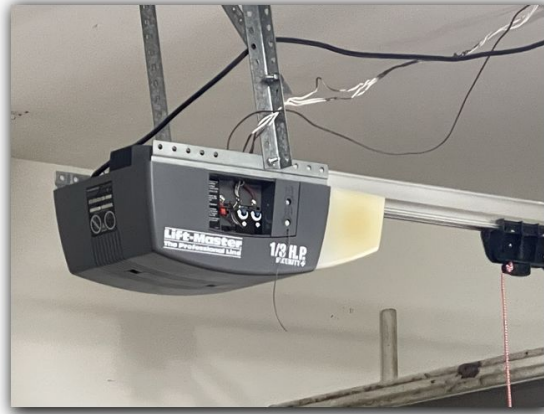
The light is not functioning at the garage door operator.

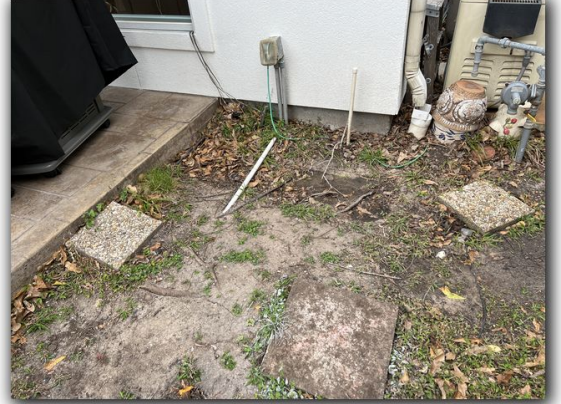
Evidence of underground leaks were found during the operation of zone #4 & #5 as evident by water surfacing from the ground. A qualified tradesman should be consulted to perform all necessary repairs.

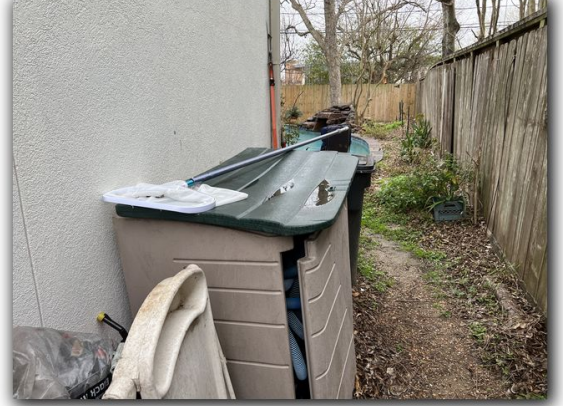
Overhead electrical service present, Do not use metal tools
Due to the electrical service for this property coming in above ground the use of metal tools around the pool is not recommended. This is a serious safety issue.

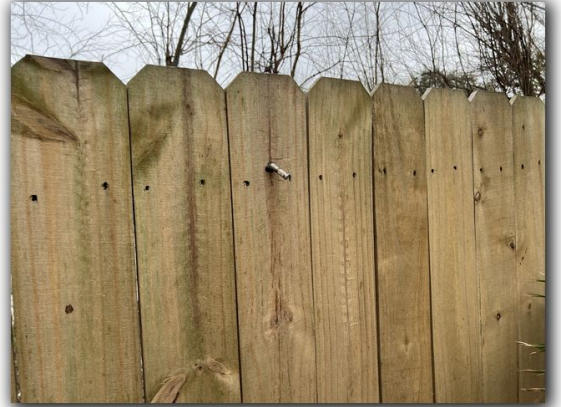
Nozzles not functioning were found at the sides and back fence during testing of the system.

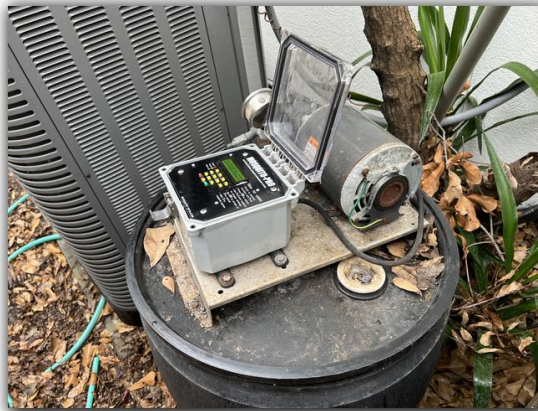
Rust and corrosion was noted at the pump housing.
