September 30, 2023

PROPERTY INSPECTION REPORT FORM

15007 Ridingwood Dr., Missouri City, TX 77489

Will Worthen

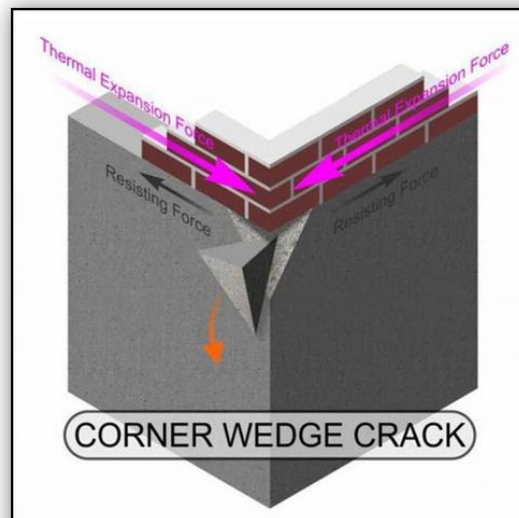
- Deflection cracks were observed in the exterior veneer.
- Separation of the exterior veneer and window frames was observed.
- Floor slopes and/or unlevelness were observed.
- The foundation rebar is visible at the edge of the foundation beam and needs to be properly covered on the north side, west side of the structure.

Note: One or more of the foundation perimeter beam corners were observed to be sheared off (corner pop). This is a common condition to observe and is due to thermal expansion and contraction of the different building materials. This condition does not adversely affect the foundation performance. However, in some cases, some cosmetic improvements may be necessary.

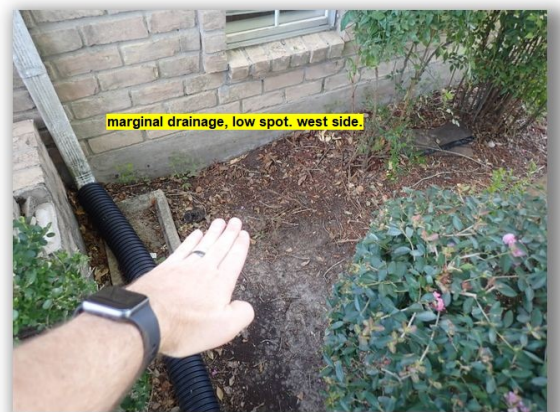
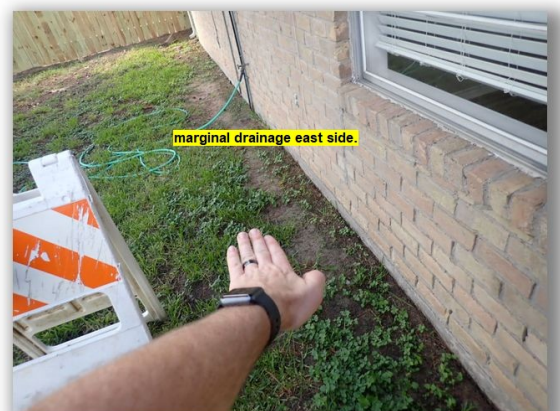
- Ground erosion was observed on the east side, west side of the structure. Fill dirt is needed against the foundation perimeter wall where the soil line is too low to help support the foundation footer properly.
- Fill dirt is needed on the east side, west side of the structure. The low spots in the finished grade (ground) adjacent to the foundation perimeter wall should be filled in to help prevent water from standing and/or ponding next to the foundation area.
- The soil line is too high on the south side, east side of the garage structure. Under current building standards there should be at least 4-inches of foundation visible below masonry veneer and 6-inches of foundation visible below wood type veneer.

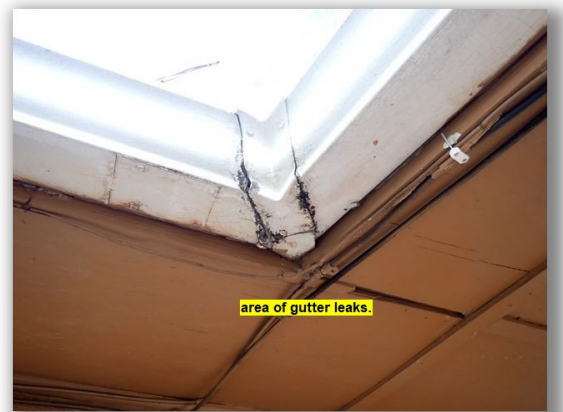
- It is recommended to clean the gutters.
- One or more of the gutter fasteners were observed to be pulling loose on the east side of the roof structure.
- It is recommended to repair minor leaks in the gutter joints and seams.

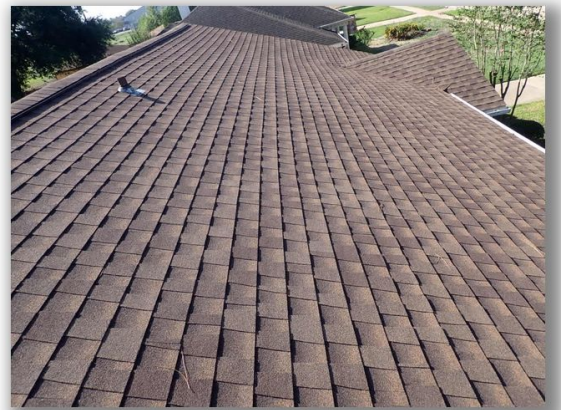
- Damaged shingles were observed on the east side, west side of the roof structure.

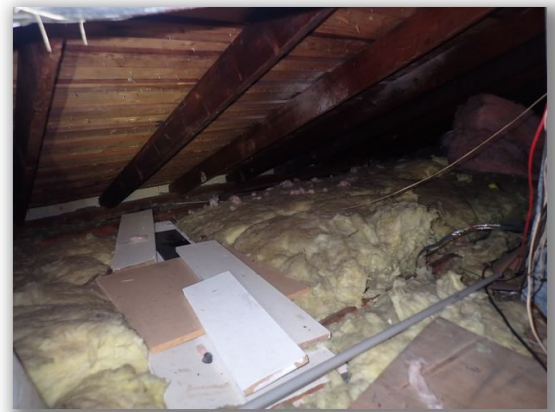
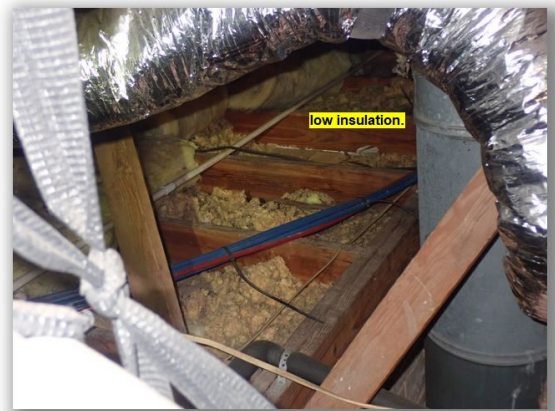
- The attic insulation is lower than typical and it is recommended to add additional insulation to achieve at least a R-30 rating.
- The attic floor insulation should be redistributed in one or more locations.

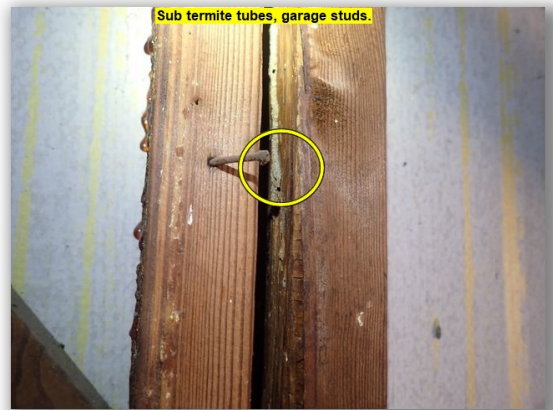
Sub termite tubes, garage studs.

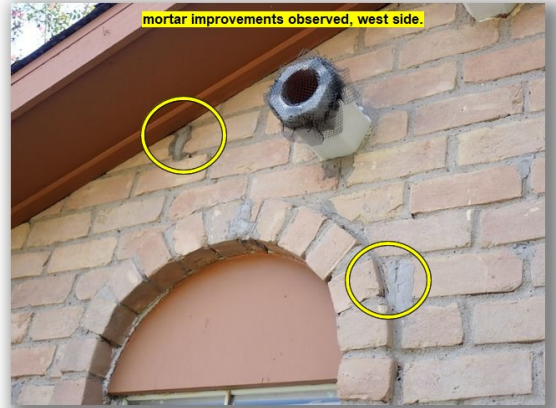
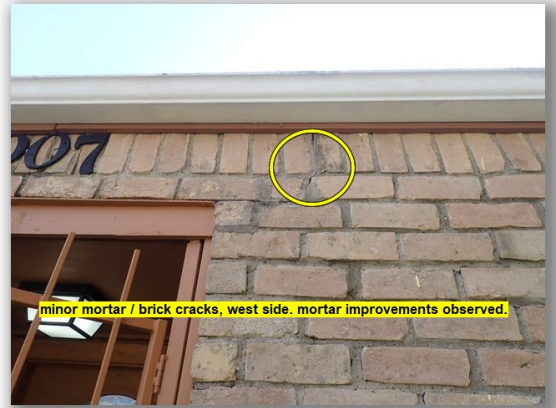
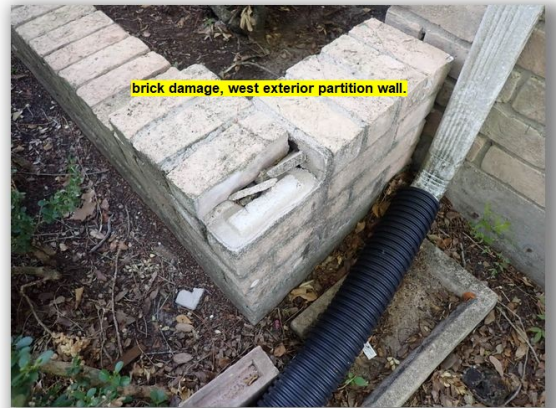
- Deflection cracks were observed in the exterior veneer on the south side of the structure.
- Mortar improvements are recommended for the exterior masonry veneer on the north, east, west and south sides of the structure.

- One or more of the exterior bricks were observed to be damaged on the west side of the structure.
- There were no weepholes observed in the lower course of the exterior masonry veneer over the window and door steel lintels. This condition does not meet current building standards and should be corrected as necessary.

- The exterior veneer / cladding has some deterioration and/or damage on the south side, east side of the garage structure.
- The exterior veneer / cladding was observed to be pulling loose and should be better secured on the south side of the garage structure.

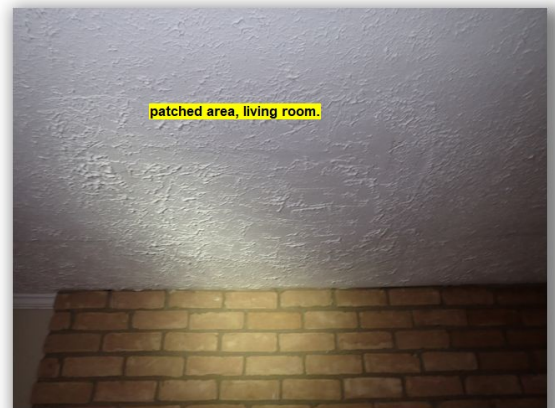
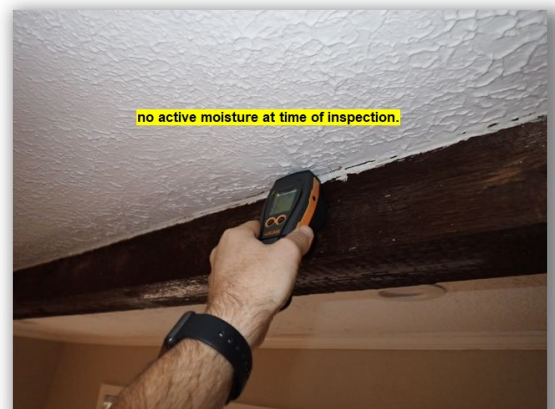
- Water stains were observed on the ceiling finish in the living room. The cause and remedy should be further evaluated and corrected as necessary.

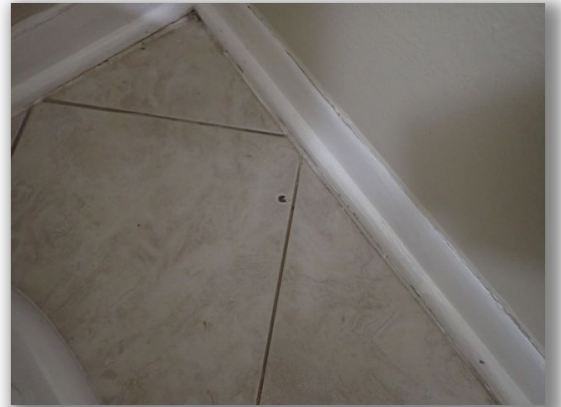
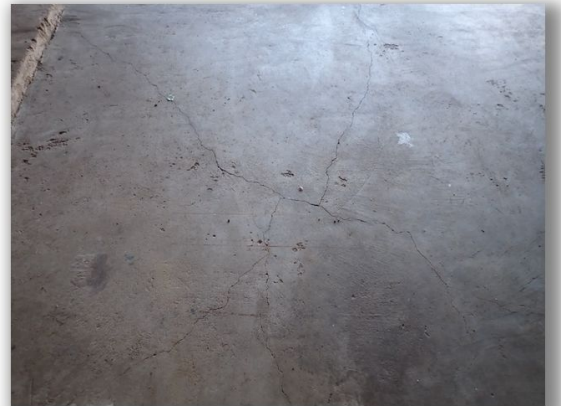
- The floor tile(s) were observed to be cracked and/or damaged in the kitchen, primary bathroom, hall bathroom.
- The floors were observed to be out-of-level in some areas of the house.

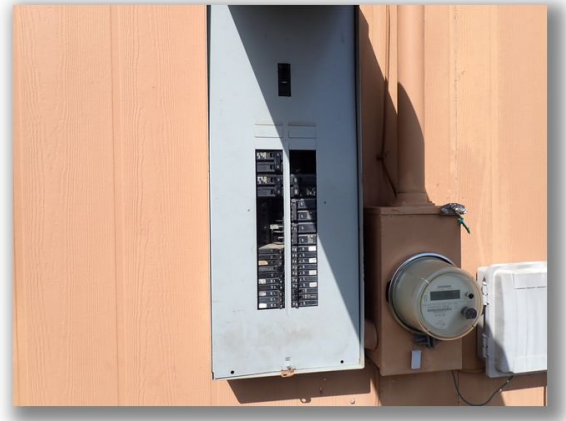
- There is no ground fault circuit interrupter type breaker for the dryer outlet, electric oven installed at the panel box. This does not meet current building standards.
- The breakers (overcurrent devices) in the electrical panel are not properly labeled.
- There is no surge protection device installed at the panel box. Under the current National Electrical Code, all electrical systems should have surge protection. This is an "as built" condition. It is recommended to add a surge protection device to the panel box.
- All openings (missing knockouts) in the electrical cabinet cover plate (dead front) and /or cabinet should have fillers.
- The electrical cabinet cover plate (dead front) should be installed with blunt tip screws and not sharp wood type screws for reasons of safety.

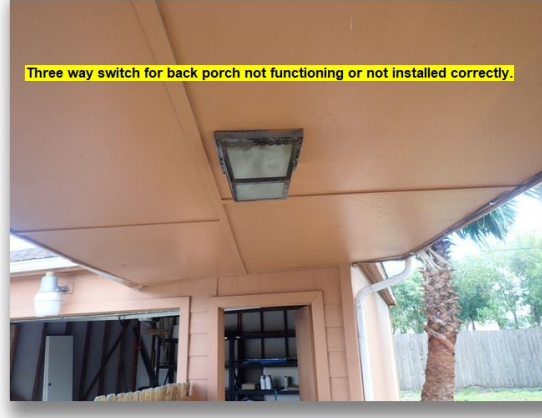
- The 3-way switch is not functioning properly in the back porch.

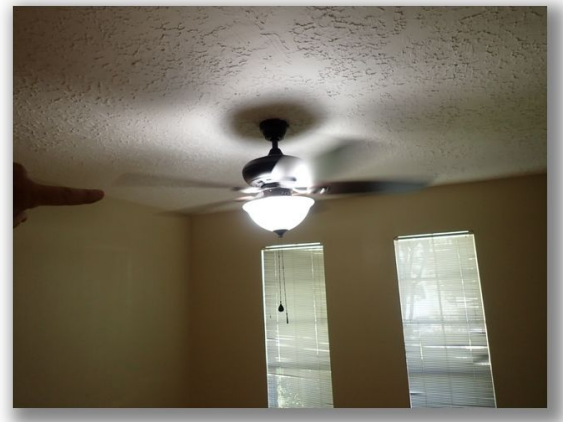
- One or more of the light fixtures are not functioning properly in the dining room.
- The ceiling fan is not balanced properly and wobbles when operated in the living room, front middle bedroom, front corner bedroom.
- One or more of the exterior light fixtures were observed to be damaged on the garage west soffit.

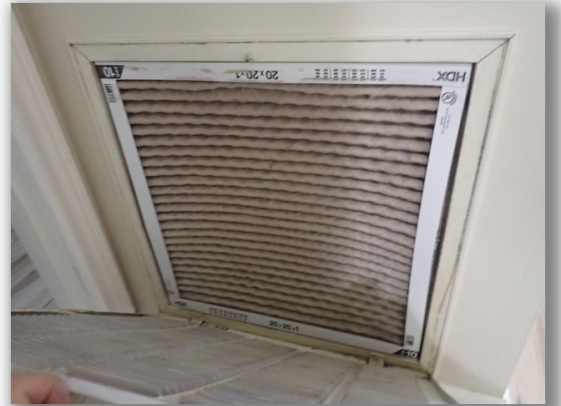
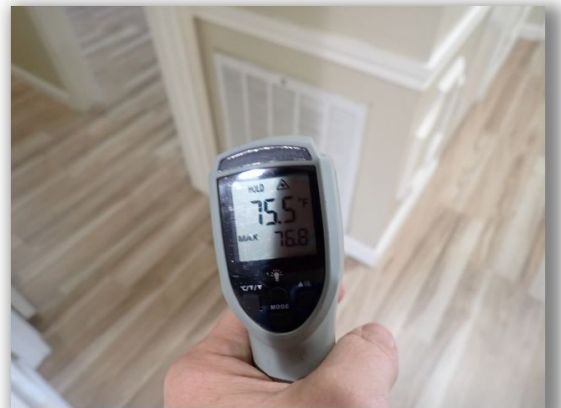
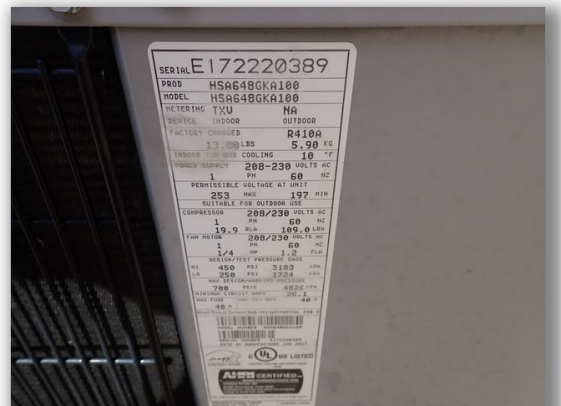
- The AC tonnage size may not be correct for the amount of air conditioned space of the property. It is recommended to have a licensed HVAC technician perform a load/size calculation to verify the correct AC tonnage size for the property.
- The dirty air filter should be replaced.

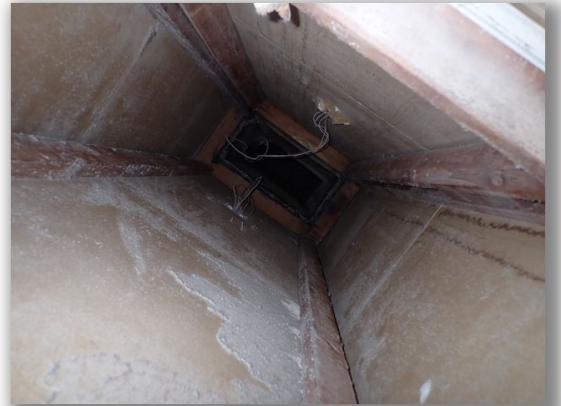
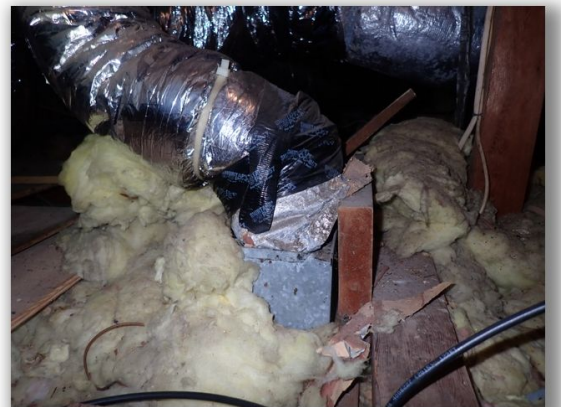
- The duct work in the attic area is not properly separated to help prevent condensation from developing. It is recommended to separate the duct work with a minimum intervals of 1.5-inches.
- The air-return chase for the HVAC system is dirty and should be cleaned to help maintain good air quality.

Additional Notice from the Inspector: The ductwork was observed to be older and in poor condition. It is recommended to replace the ductwork for improved air quality and efficiency.

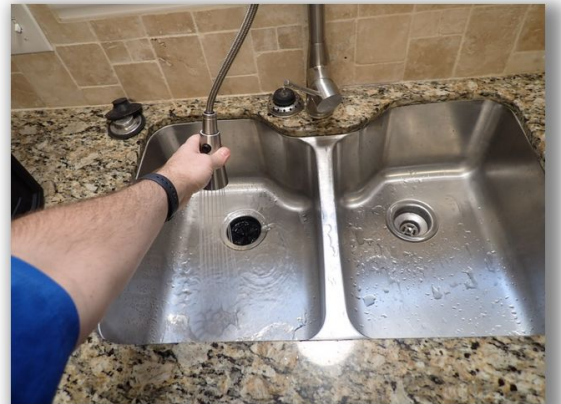
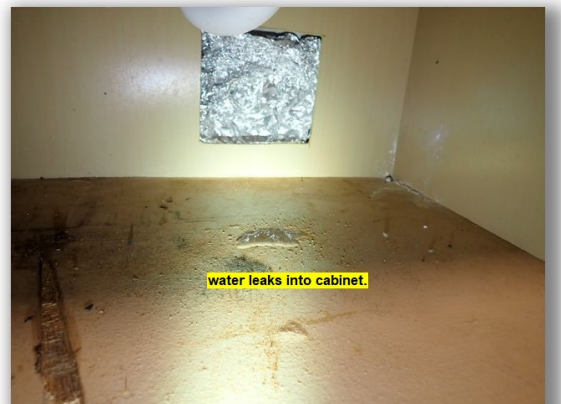
- The drain leaks water into the cabinet.
- The faucet hot/cold water orientation is reversed.

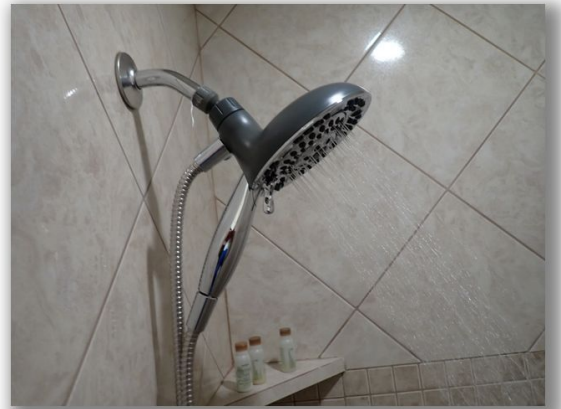
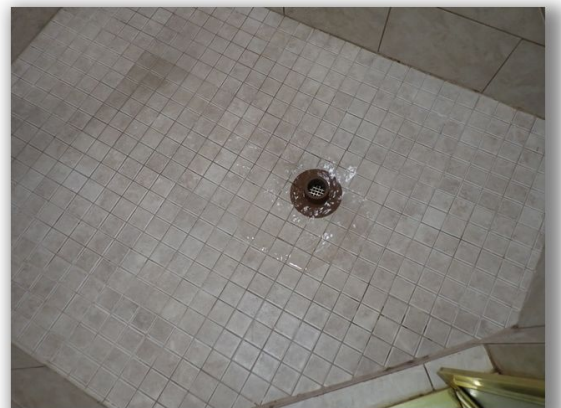
- The faucet assembly is not properly sealed at the wall. This condition has the potential to allow water to leak back into the wall cavity.
- The shower enclosure door does not function properly.
- Cracked, deteriorated and/or missing grout and/or caulking should be repaired or replaced as necessary.

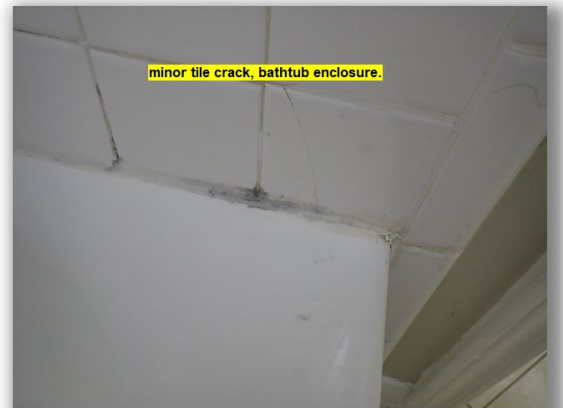
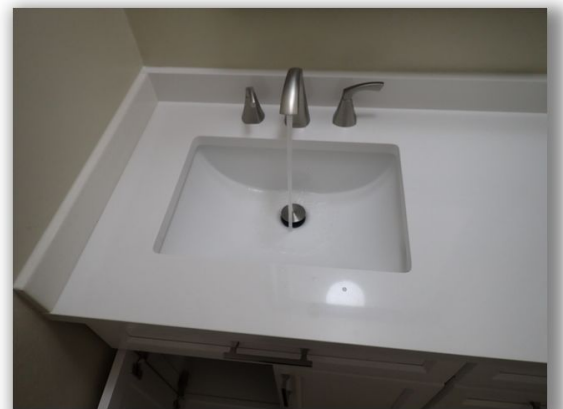
- Some of the enclosure tiles were observed to be cracked.
- The tub spout is not properly sealed at the wall. This condition has the potential to allow water to leak back into the wall cavity.

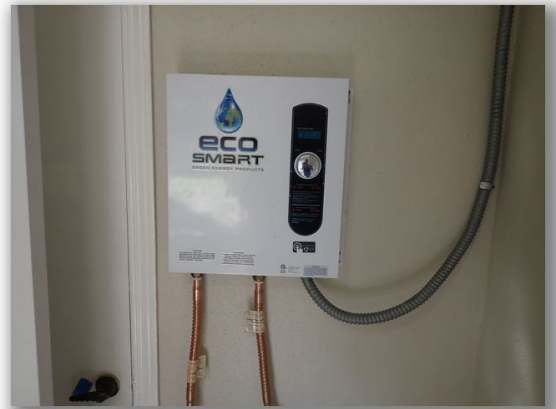
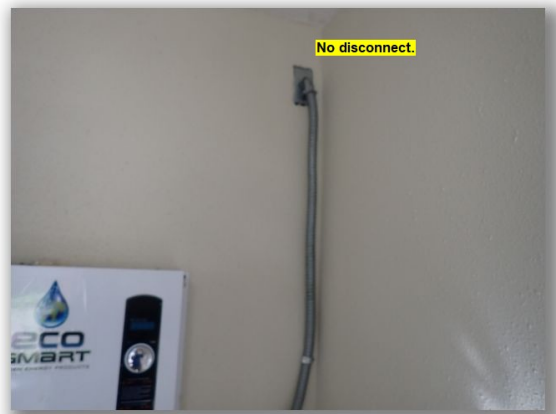
- I was unable to locate or observe a service disconnect at or around the water heater.
- There is no visible pressure relief valve in place for the water heater. This condition should be corrected to help prevent damage to the structure.

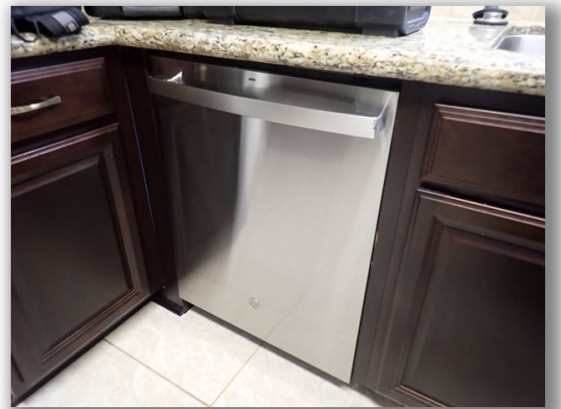
- The dishwasher drain hose is not properly installed to prevent back flow or anti-siphoning. It is recommended that an air gap device or high drain loop be installed in the drain line.

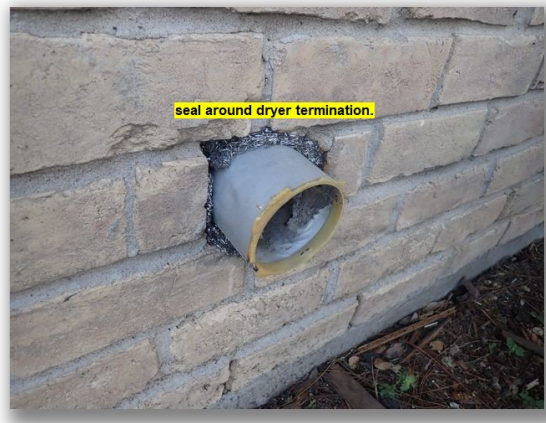
- The exterior dryer duct termination cover is missing.
