Stone Moisture Assessment

09/15/2023
Customer File # M-C-00288249-2
FICS Order # 3052907

Greg Scansen
5226 Kiam Street
Houston TX 77007

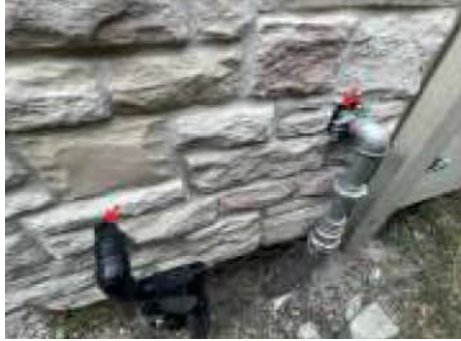
Penetrations lack sealant

Does the stucco/stone terminate above grade?	Acceptable
Are all terminations properly back-wrapped?	Acceptable
Does the stucco terminate above hardscape?	Acceptable
Is a weep screed present?	Acceptable
Are there any areas with cracking or surface damage?	Acceptable
Are sealant joints present at windows and doors?	Acceptable
Are sealant joints present at all intersections of stucco/stone and dissimilar materials (ie windows, doors, trim, fixtures)?	Acceptable
Does the stucco/stone terminate two inches above the roofing?	Acceptable
Are kick-out diverter flashings properly installed?	Acceptable
Are all exterior fixtures and utility penetrations properly installed and sealed?	Sealant-expansion joints have not been properly installed at the surface penetrations and fixtures.
Corrective Action	Contractor to install properly designed sealant joints utilizing compatible caulk-sealant at all applicable locations on the exterior.

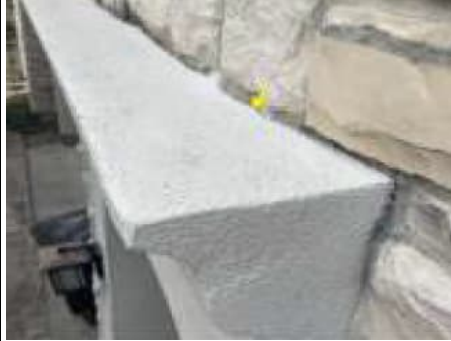
Surface Fixtures lack sealant
