## PROPERTY INSPECTION REPORT

Concerning: 1025 South Shepherd Drive #205 , Houston, TX 77019  
(Address or Other Identification of Inspected Property)

By: Terrence Foster Lic.#: TREC #5182 02/25/2020  
(Name and License Number of Inspector) (Date)

Inspection No. 52288-763

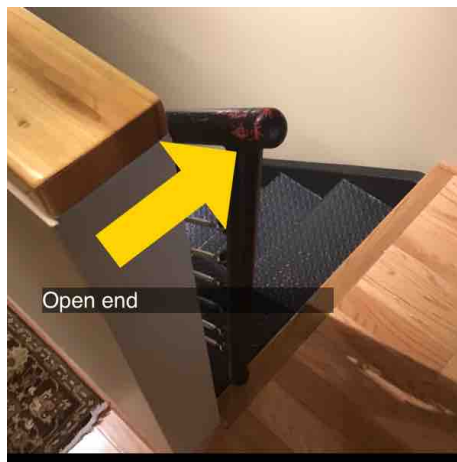
- Appear to perform their intended function at this time.
- **The hand rails on the ends of the stairs should not have open ends, the ends should turn and be up against the wall to reduce chance of something catching on it and pulling someone causing injury, needs repair.**

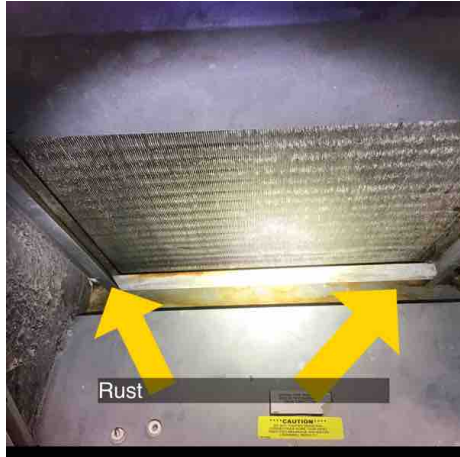
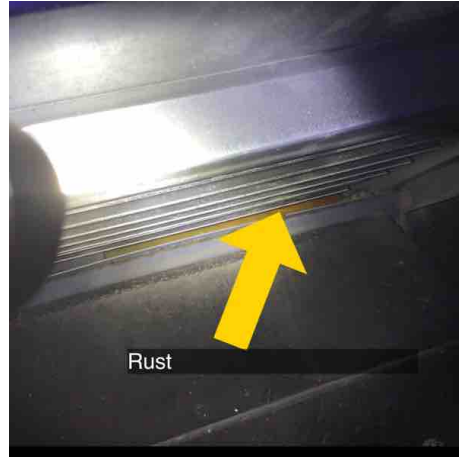
- The coil area on both of the inside units shows signs of rust and corrosion damage on them, both systems need further evaluation by a qualified HVAC contractor.

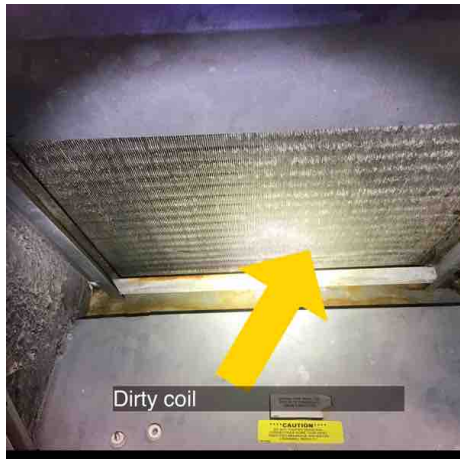
- Dirty fins on the coil downstairs, needs to be properly cleaned.

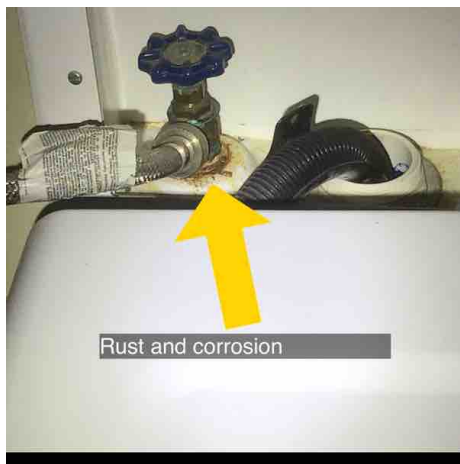
- Main supply pipes appear to be copper where visible.
- **Need to install anti-siphon devices (back flow preventer) on all of the exterior water faucets.**
- **The showers need to be re-grouted and re-caulked on the open areas to reduce chance of water damage issues, there could be issues inside the walls that are not visible at this time, if you have concerns about water damage issues inside the walls, you may want further evaluation of the inside of the walls.**
- **Rust and corrosion on the left side water valve in the laundry room, needs evaluation and repair as needed to reduce chances of water leaks.**

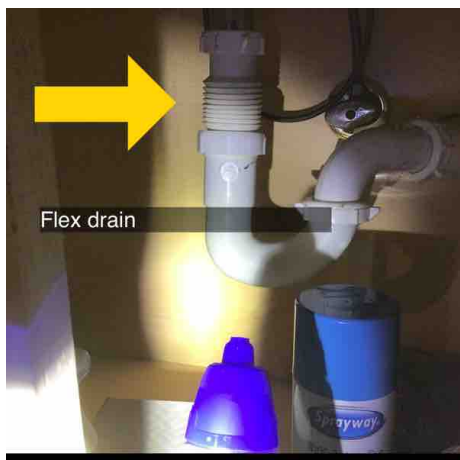
- Drain pipes are PVC where visible. No leaks observed at time of inspection. There are no bath traps in the house to view the drain pipes under the bathtub, recommend to install.
- **The downstairs bath sink drain has part of it flex type, this can be easily clogged, needs to be changed to a straight wall drain pipe.**
