JOSE R. HERNANDEZ – MESA, P.E.
TEXAS LICENSED CIVIL/STRUCTURAL ENGINEER
LICENSE 90739. TBPELS F - 10708
FOUNDATION SPECIALIST

Re: Foundation inspection at 14614 Tivoli Drive, Houston, Texas 77077

Address: 14614 Tivoli Drive, Houston, Texas 77077
Description: Elevations Diagram

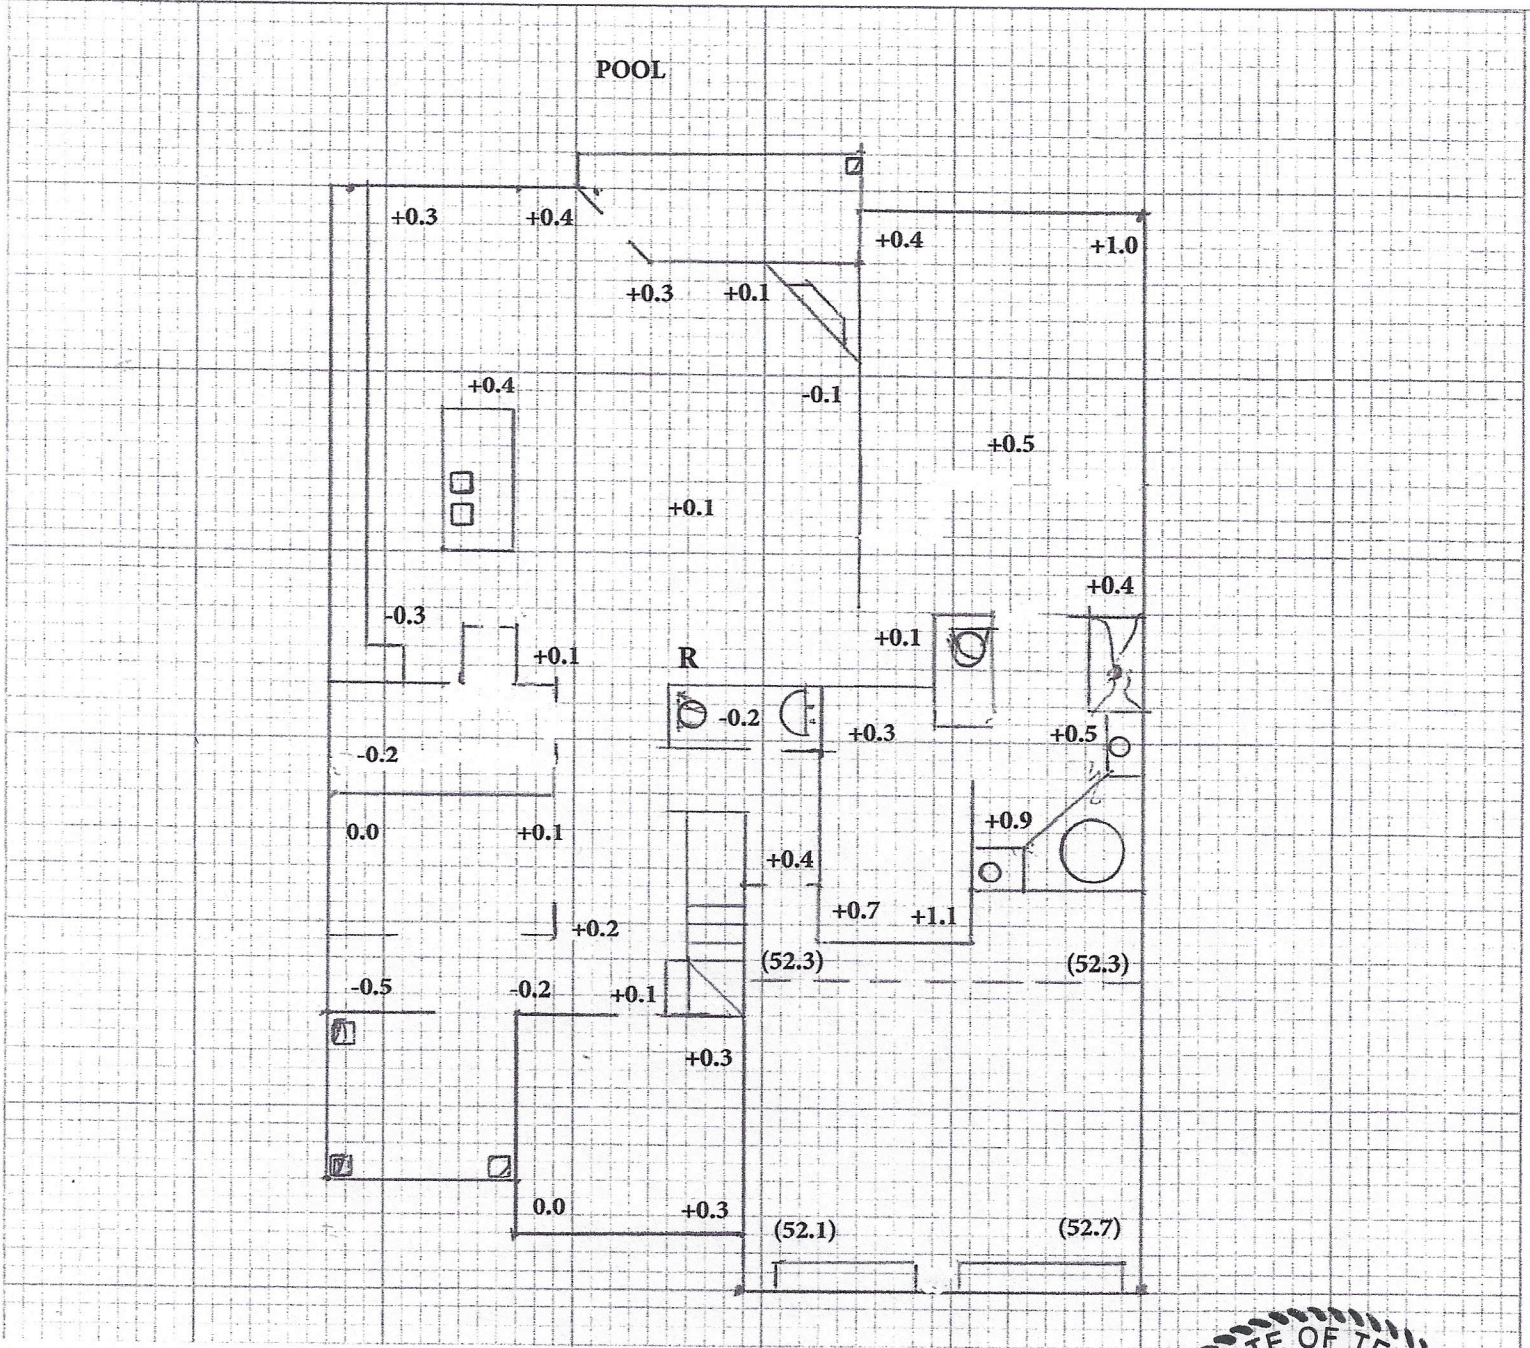
An elevation survey of the foundation was also performed as a part of this inspection. For this elevation survey, floor elevation measurements were made at random locations using a Stanley Compu-Level, which the manufacturer state's is reliably accurate to within 1/8th of an inch over a vertical range of plus or minus twenty feet. While at the home, on 12/19/2023, I took an elevation survey of the foundation. I used the elevation data to prepare the attached elevations diagram. The individual elevation readings have been adjusted for any change in flooring. The readings are all relative to the base that was set up in the family room (denoted as R). Elevations in parenthesis denote garage ceiling readings.

- 1) The lowest elevation of – 0.5 inches was located in the foyer.

- 2) The highest elevation of + 1.1 inches was located in the master closet.

Observed conditions suggest that the foundation has experienced normal settlement and seasonal movement. Elevations are within acceptable tolerances per ASCE (American Society of Civil Engineers) and L/360 Guidelines. The foundation is performing as intended.
