14902 Aspen Hills Dr, Houston, TX 77062  
Inspection prepared for: Bethany Vaccaro  
Date of Inspection: 12/6/2023 Time: 12:00 PM  
Age of Home: 1977 Size: 2154sf  
Weather: sunny/temperature 62  
Order ID: 3979

**PROPERTY INSPECTION REPORT FORM**Bethany Vaccaro*Name of Client*12/6/2023*Date of Inspection*14902 Aspen Hills Dr, Houston, TX 77062*Address of Inspected Property*Lou Wissner*Name of Inspector*7492*TREC License #**Name of Sponsor (if applicable)**TREC License #***PURPOSE OF INSPECTION**

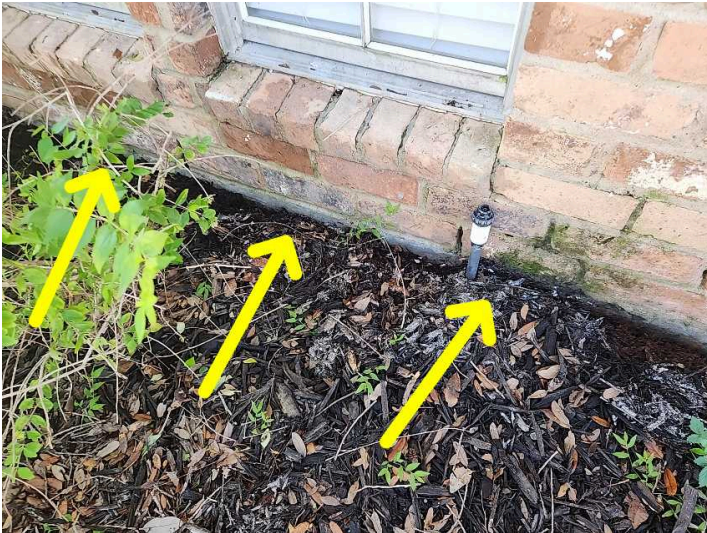
- Soil / mulch / rocks are too high on foundation in several locations. This will allow moisture and unwanted pest to enter residence. It is recommended to maintain 4-6 inch minimum of exposed foundation from finished grade.

*Dirt too high*

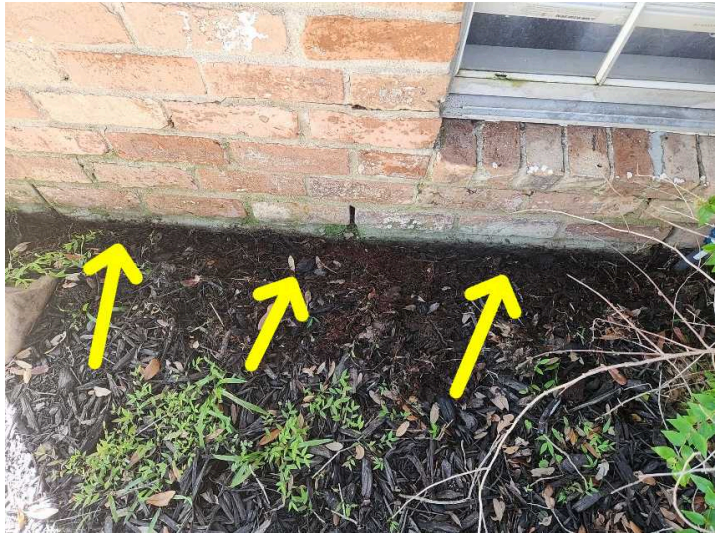
*Dirt too high*

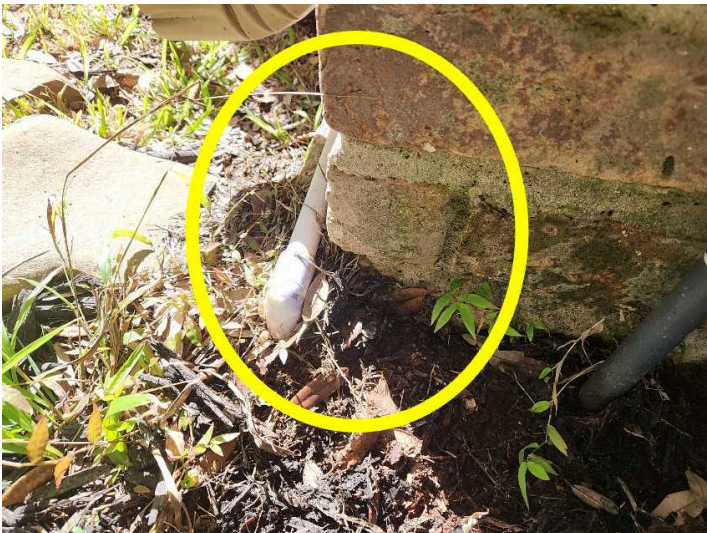
- Structural movement and/or settling noted; however, the foundation is currently supporting the structure.
- Cracks at foundation corners are not structural concerns and are not stress related. It occurs due to the expansion and contraction of concrete and brick at different rates. It is recommended to be cleaned and sealed with mortar as needed to prevent moisture and pest entry.

*Cracks at corners*

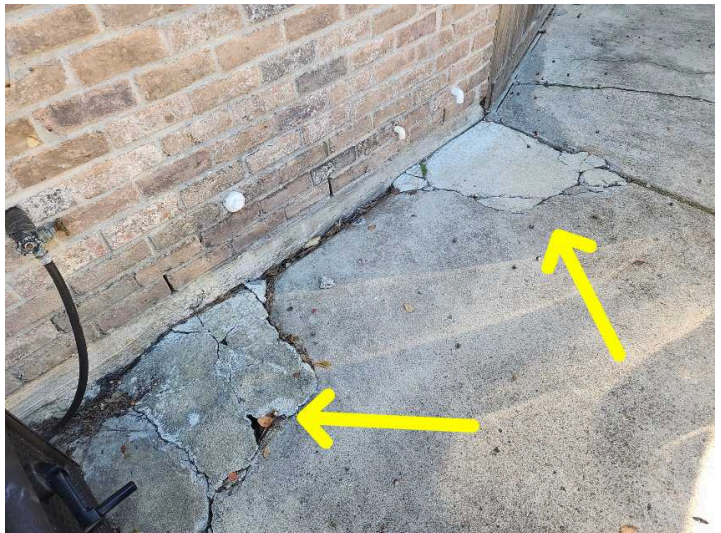
- Note: Foundation repairs were observed to have been previously performed. It is recommended to obtain the engineering report and warranty information as it may be transferable.

*Previous repairs*

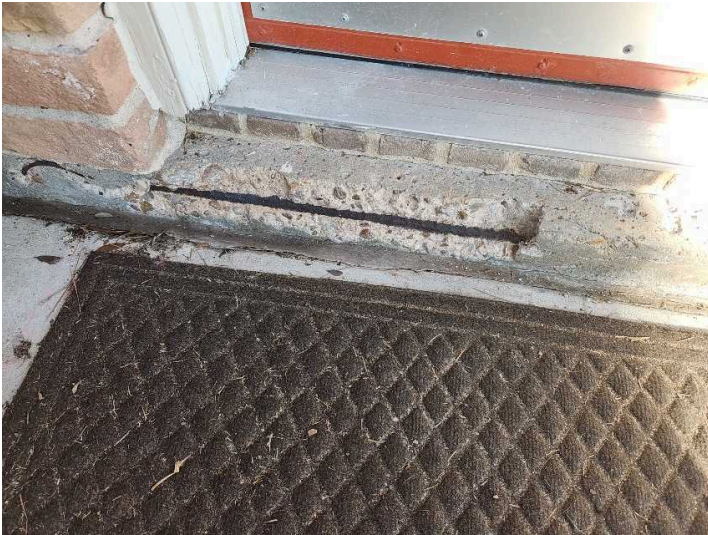
- Reinforcement bar is exposed and rusting. It is recommended to be properly cleaned, painted and sealed with mortar as needed.
- Floors throughout structure are not level as observed using a ZIP level. Upto 3" deviation in living room. It is recommended a qualified foundation company further review and evaluate the performance of the foundation.

*Reinforcement bar exposed*

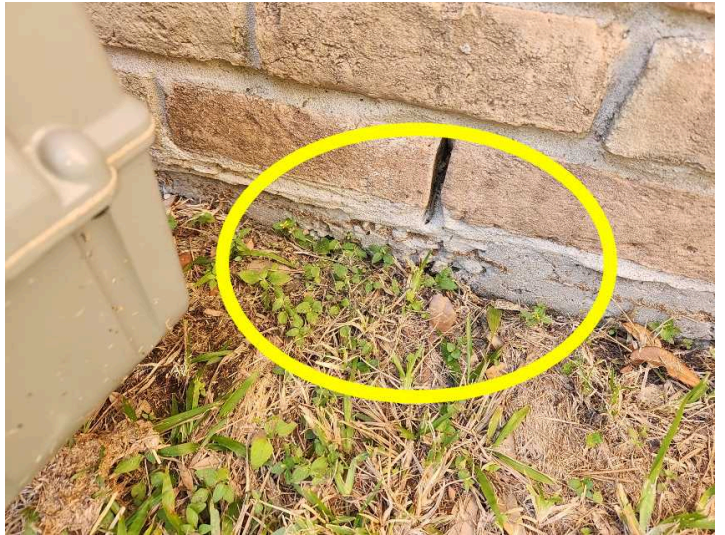
- Honeycombing was noted in several locations of the foundation. This is mostly a cosmetic condition that is found only upon the exterior face of the home's foundation. It is recommended to thoroughly clean the area to remove all dirt and loose aggregate, wet the cleaned area prior to applying non-shrink grout, texture and color should then be matched for aesthetic finish.

*Honeycombing*

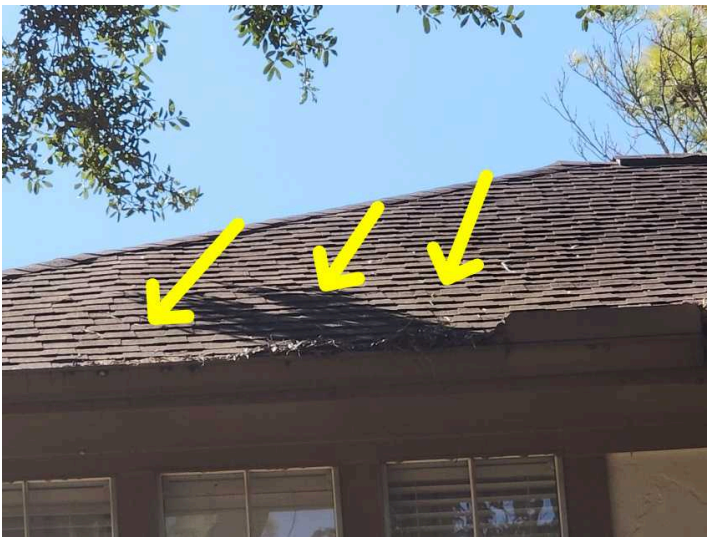
Debris

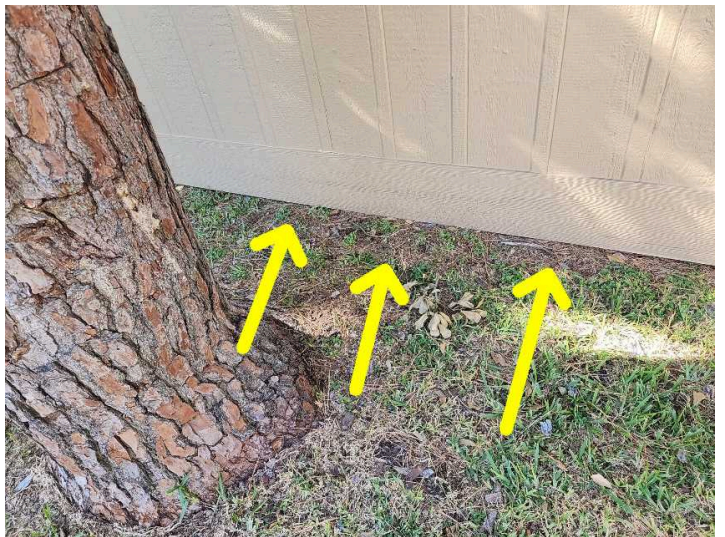
Dirt too high

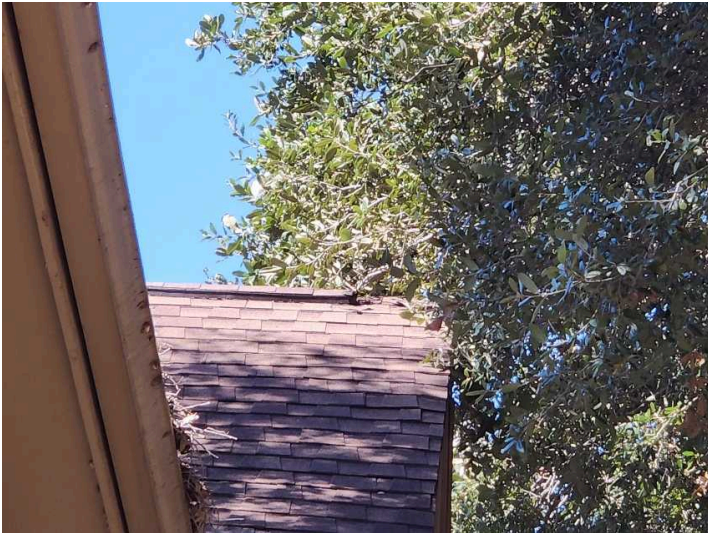
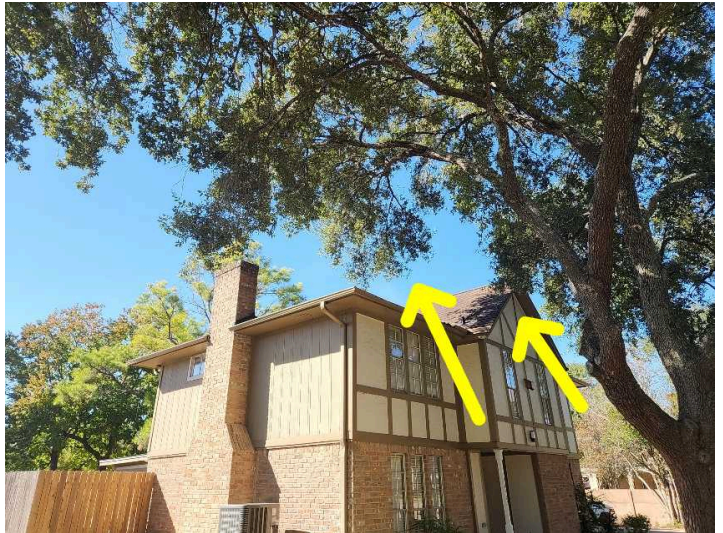
- One or more large branches are stretching over the roof of the house. If these branches were to fall they may damage the roof structure. The branches should be trimmed back to help prevent damage to the roof structure.
- There is a tree against the garage roof in the rear. It is recommended to remove the tree prior to repairing the garage roof.

*Tree limbs*

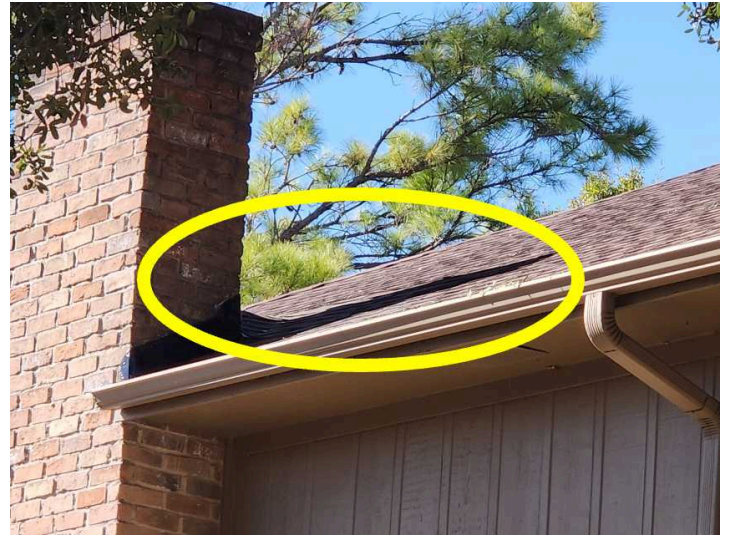
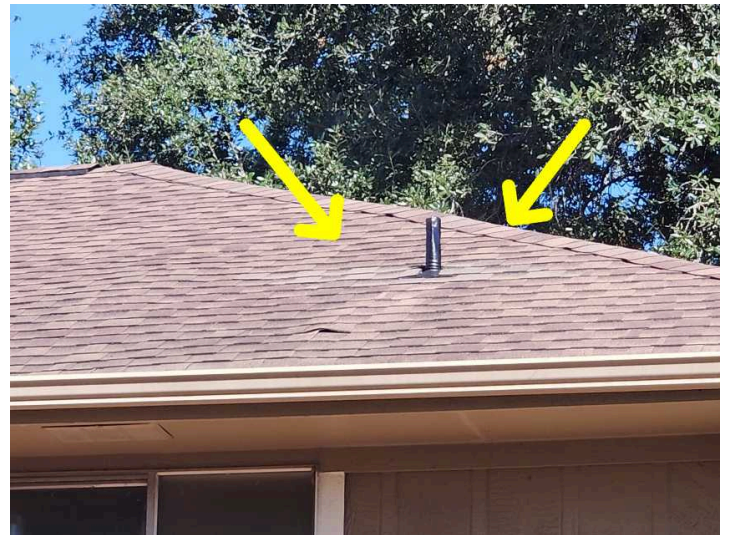
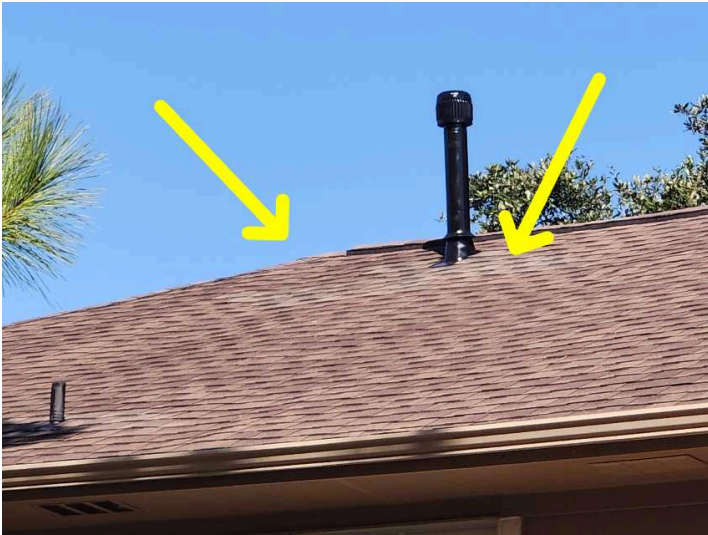
- Previous repairs observed in one or more locations of roof. Dry on day of inspection. It is recommended to be monitored.

*Previous repairs*

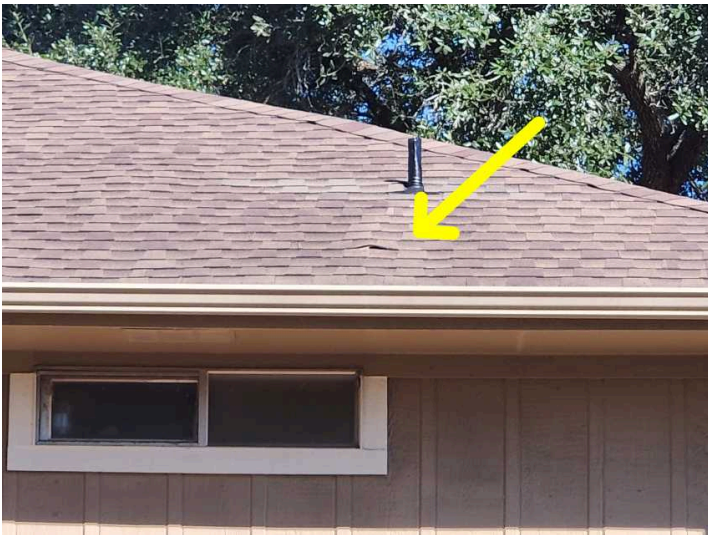
- Exposed nail heads were noted at the roof protrusions and/or ridge shingles. Nail heads at either the vent & roof flashing or at the composition shingles can allow water to penetrate past the roof covering given enough time. As the exposed portion of the nail rusts, more space will become available between the nail and the roofing material for water to penetrate. This condition can usually be remedied by sealing or caulking affected areas.

*Nail pop*

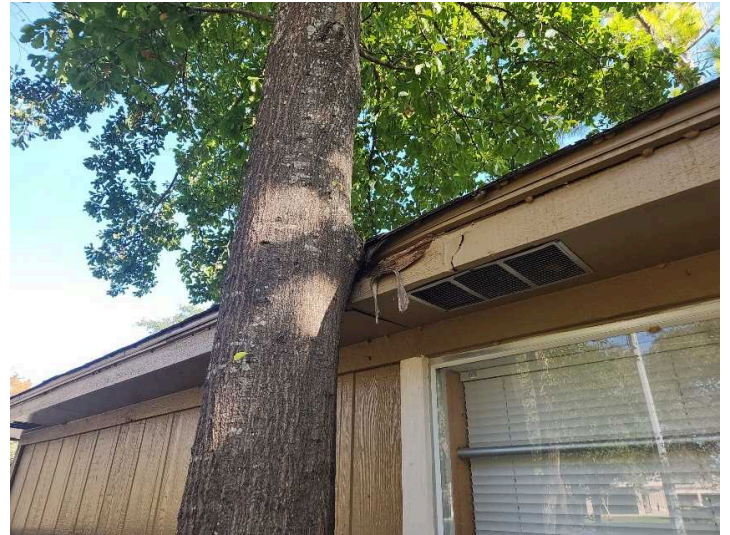
- Damaged composition shingles were observed in one or more locations of roof on garage. As evident by exposed fibers, loose shingles and missing pieces. It is recommended to properly repair and seal or replace as needed to prevent premature failure. Unable to determine condition of underlying materials.

*Damaged roof*

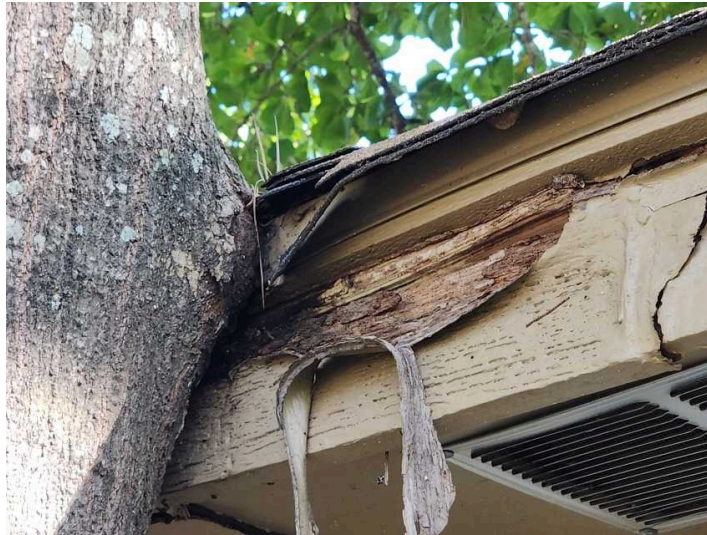
- Wood deterioration noted to fascia and soffits in one or more locations. It is recommended to properly repair or replace all affected material as well as caulk, prime and paint as needed. Observed on garage.

*Wood deterioration*

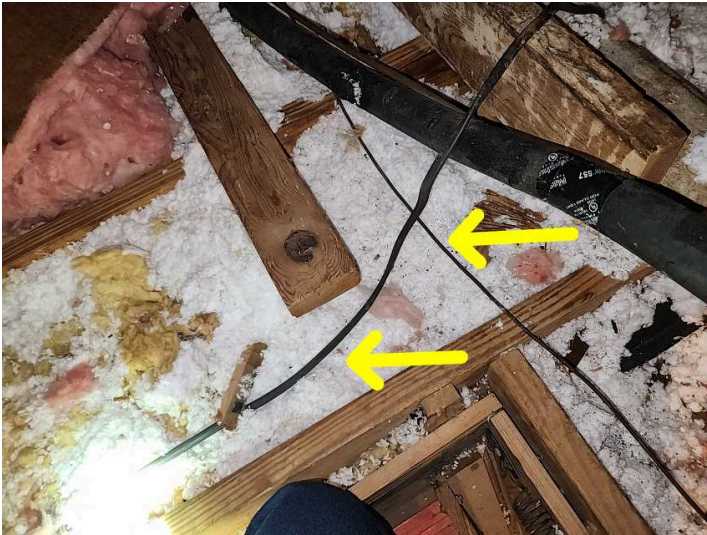
- Evidence of water penetration: NO
- Loose wiring noted in attic space in one or more locations. It is recommended to be secured/supported max. 4.5 feet (1.37 m) & within 12 inches (0.3 m) of box and cable must be protected within 6 ft (1.83 m) of attic entrance.
- Insulation compressed or missing in one or more areas of attic space. It is recommended to add insulation as needed.
- The pulldown attic ladder is not insulated or weather stripped at this time. This is an "As Built" condition that does not meet current energy standards. It is recommended to insulate and seal the door as needed.
- Vertical insulation is not secured or has fallen down in one or more locations. It is recommended to be properly installed.

*Loose wiring*

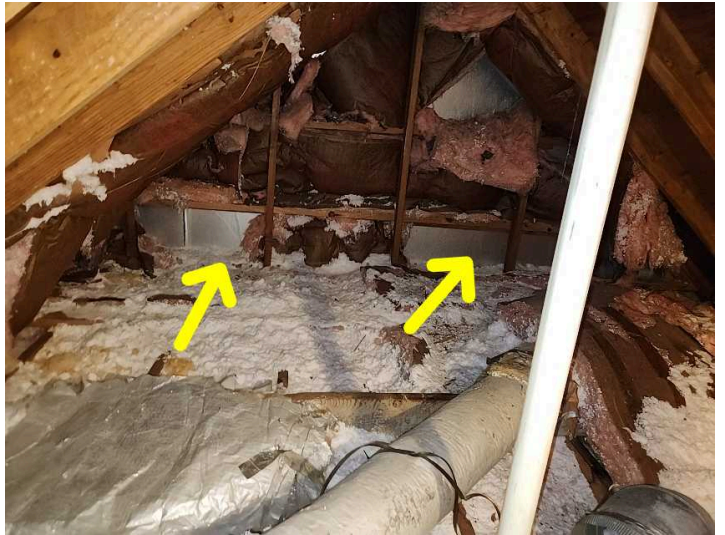
*Loosely attached*

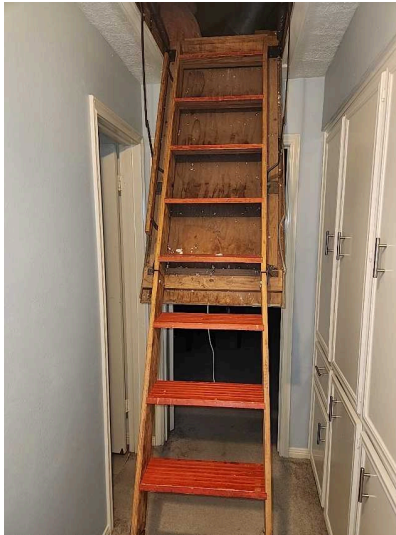
*Missing insulation*

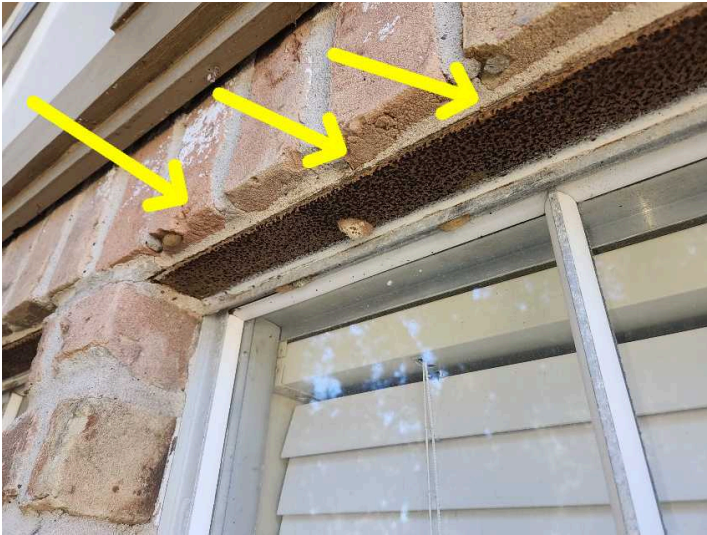
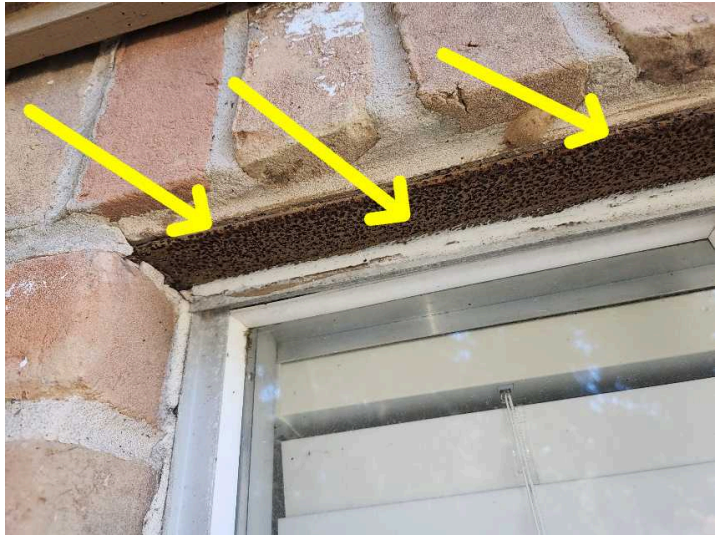
*Rusting lintel*

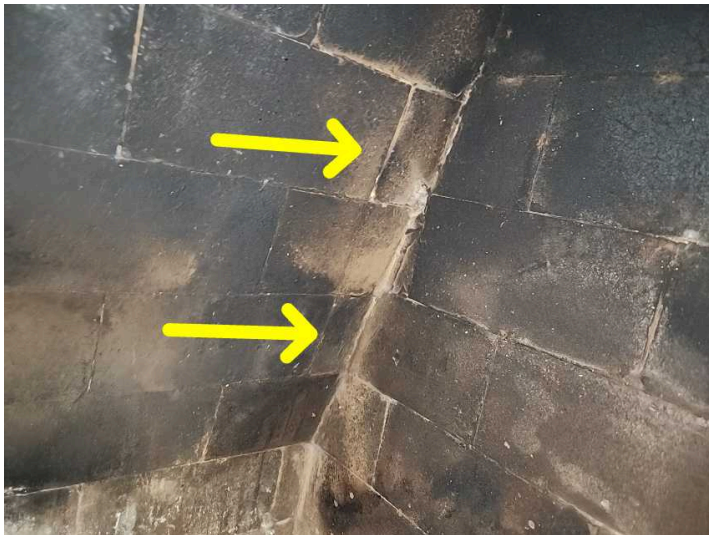
- Fireplace and flue ate dirty. It is recommended to be properly cleaned by a licensed sweep yearly to insure proper and safe operation is attained.
- Cracks in mortar and firebrick located in fireplace. It is recommended to be reviewed and evaluated further by a licensed professional chimney sweep.

Mortar cracks

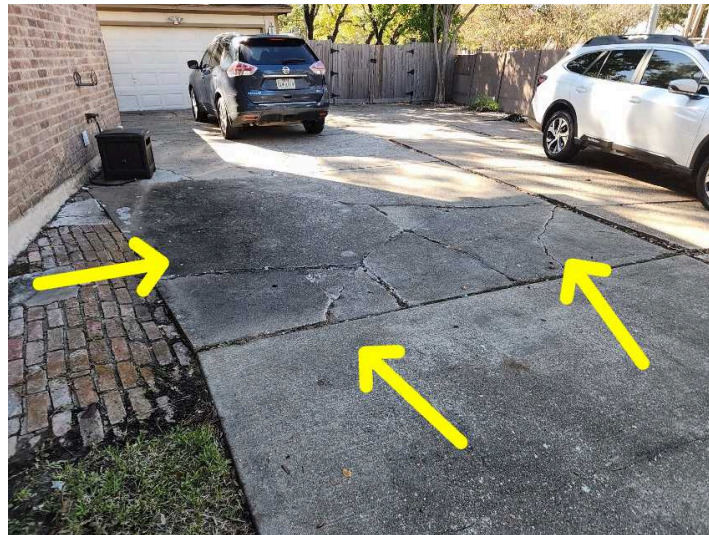
- Driveway concrete is cracking and uneven. Creating a trip hazard. It is recommended to be properly repaired or replaced as needed.

*Driveway concrete is cracking and uneven*

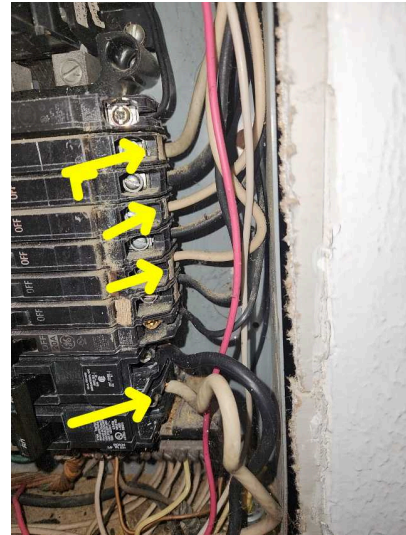
White wires unmarked

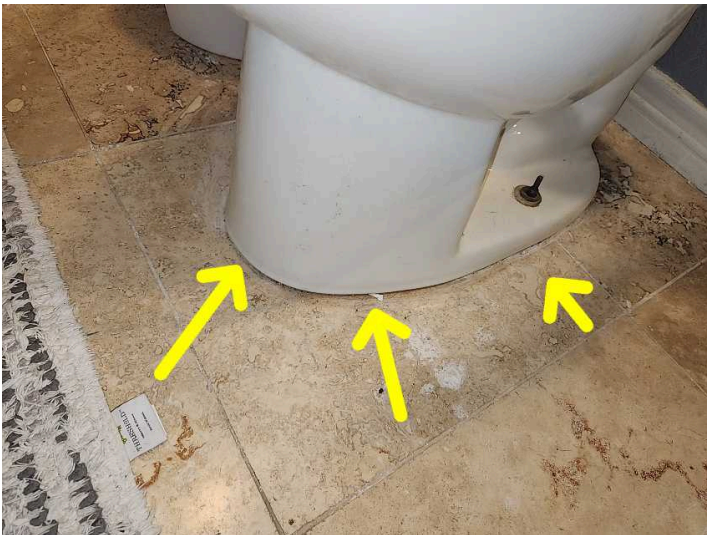
*Caulk separation*

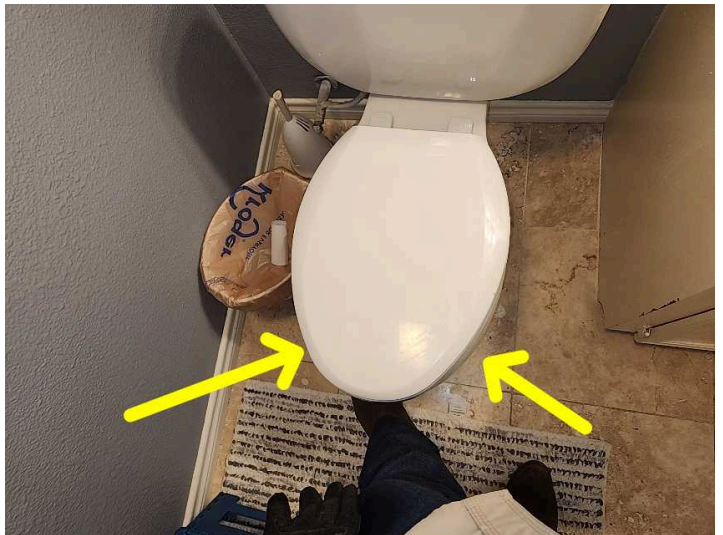
*Loosely attached*

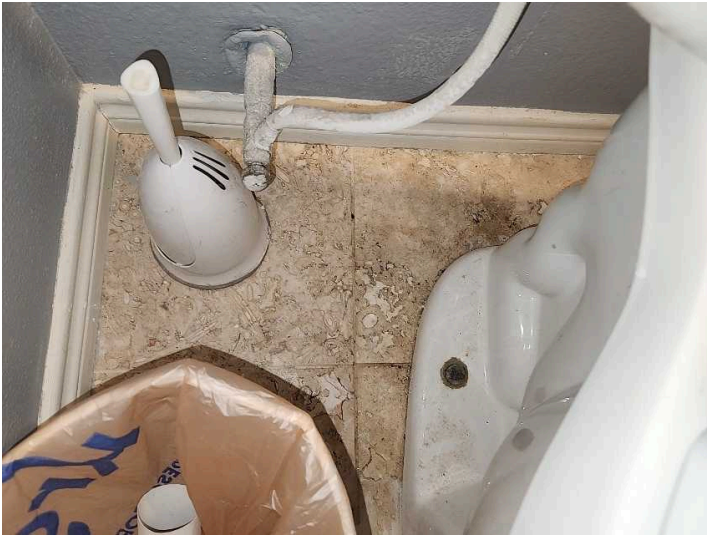
*Water leak from tank*

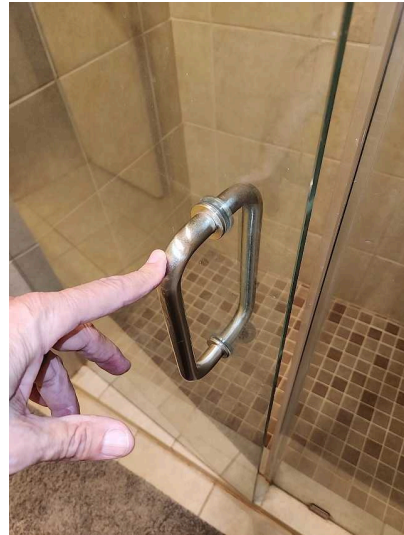
*Loosely attached*

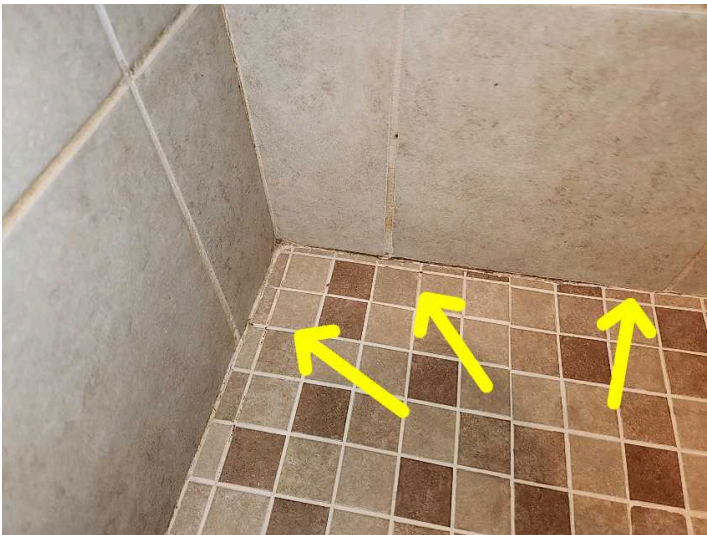
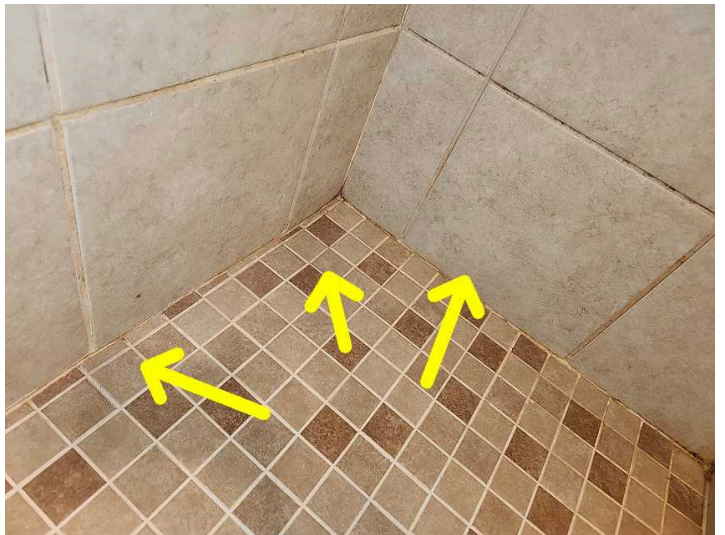
*Caulk separation*
