# **Check It Out Home Inspections**

16142 Parish Hall Dr., Spring, TX 77379

# PROPERTY INSPECTION REPORT FORM

Report Identification: 2	0231017-01, 16142 Paris	h Hall Dr., Spring, TX		
I=Inspected	NI=Not Inspected	NP=Not Present	D=Deficient	
I NI NP D

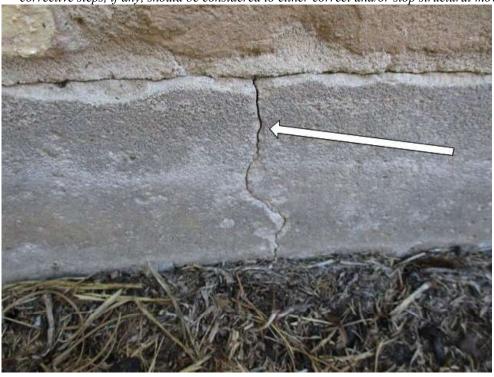
Type of Foundation(s): It appears to be a Slab-on-Grade Comments: There is a small crack in the slab on the right side of the home to the left of the

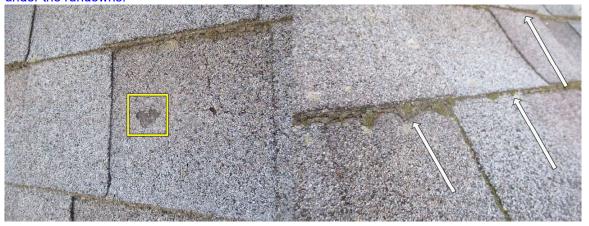
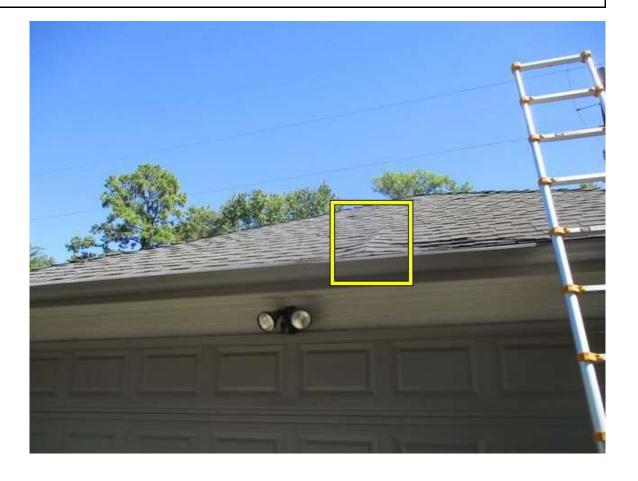
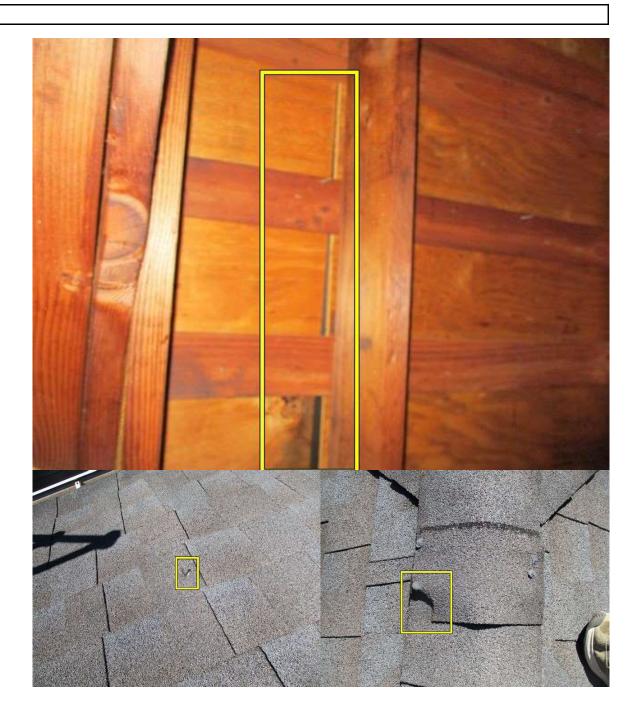
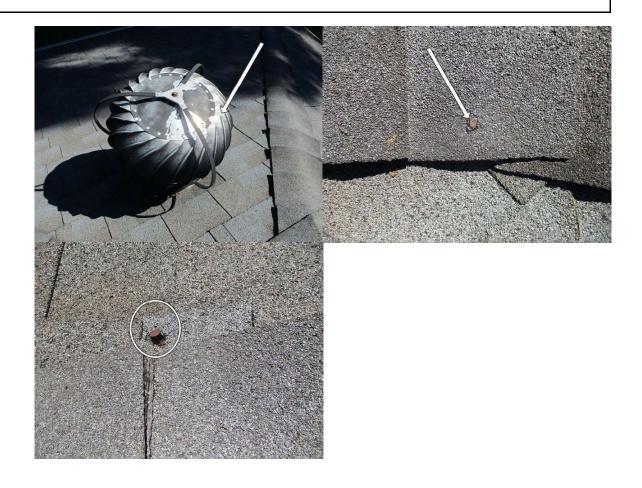
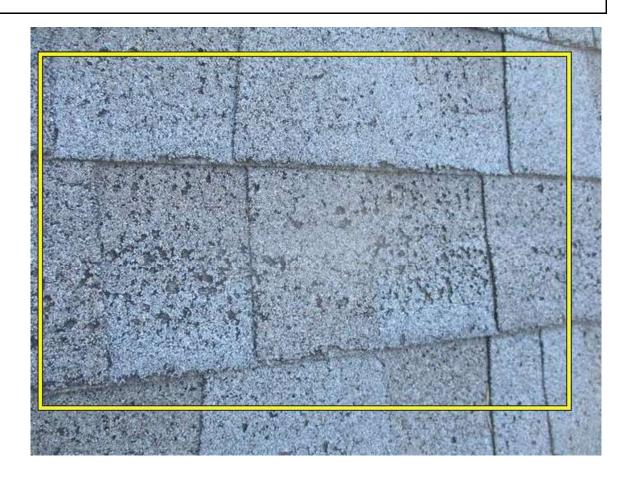
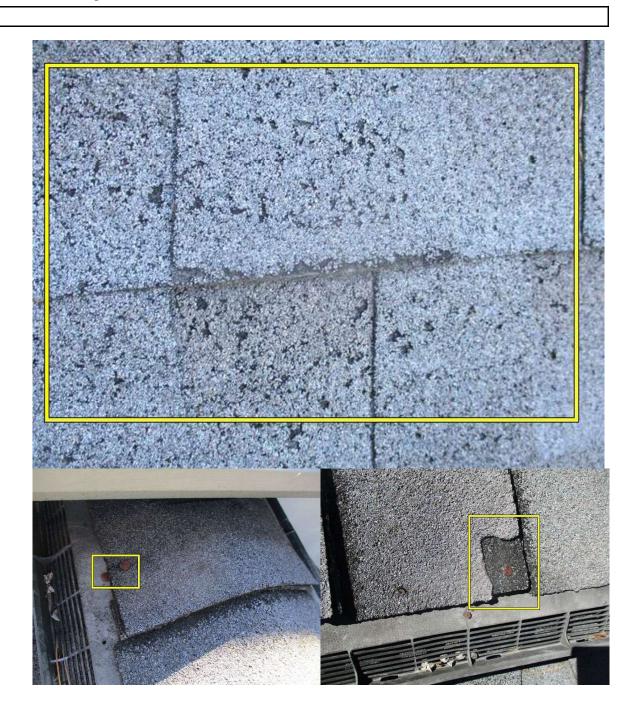
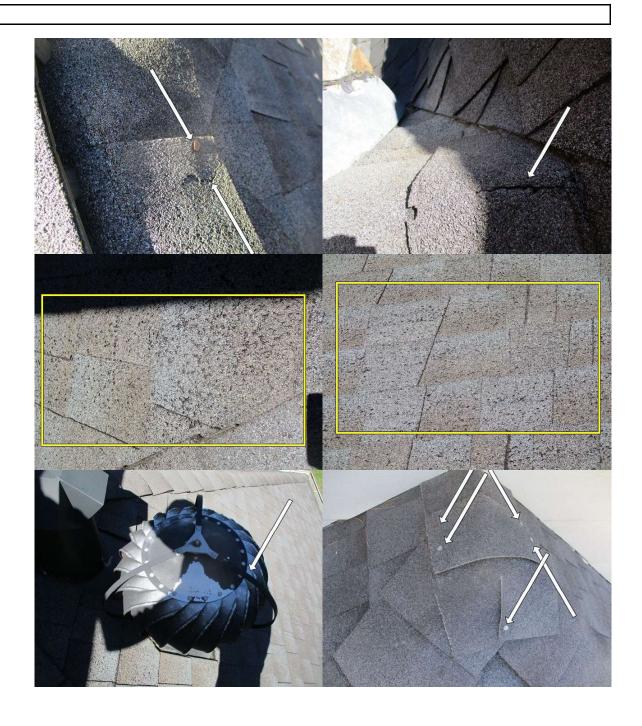
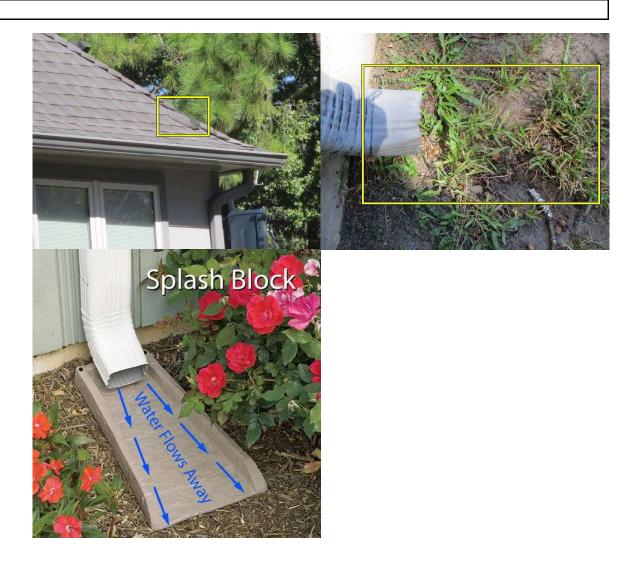
Comments: There is hail damage to shingles throughout. This roof should be check by professional roofer. There are nails exposed that should be sealed with sealant. There is something green growing on some of the shingles. Both turbines are locked up and are not able to turn to function properly. There is a raised area over the front of the garage, it appears to be a sheet of plywood not secured well on one side. There are some damaged shingles on some of the ridges. There are some loose ridge shingles near the back right corner of the home. Splash blocks are missing under the rundowns.

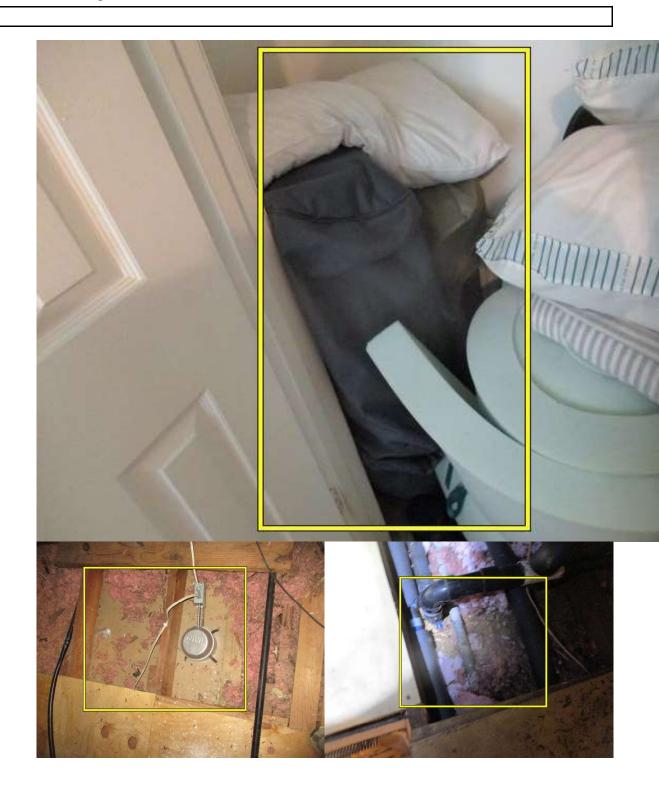
Comments: There is some insulation missing in a few areas. The attic access in the closet was not

accessible.

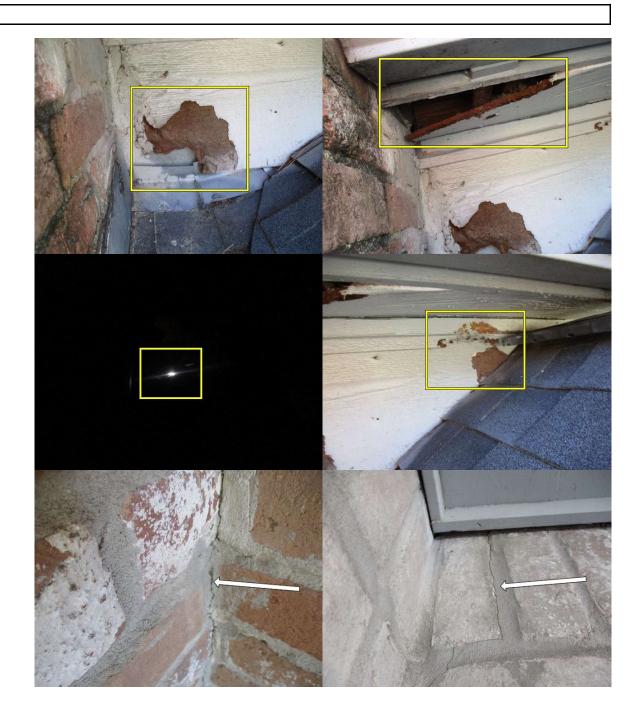
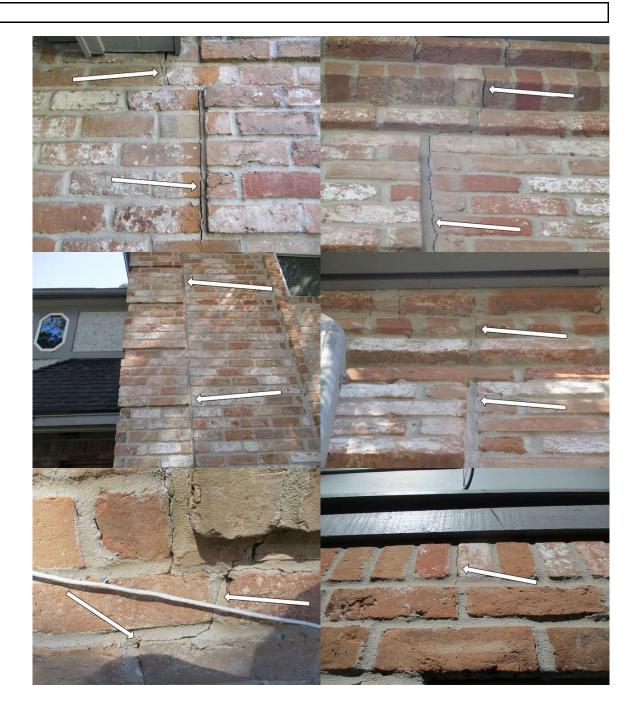
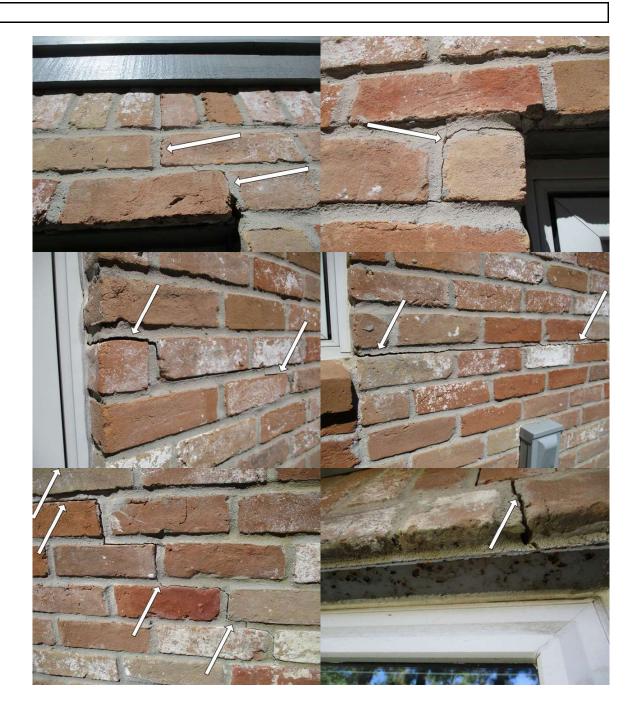
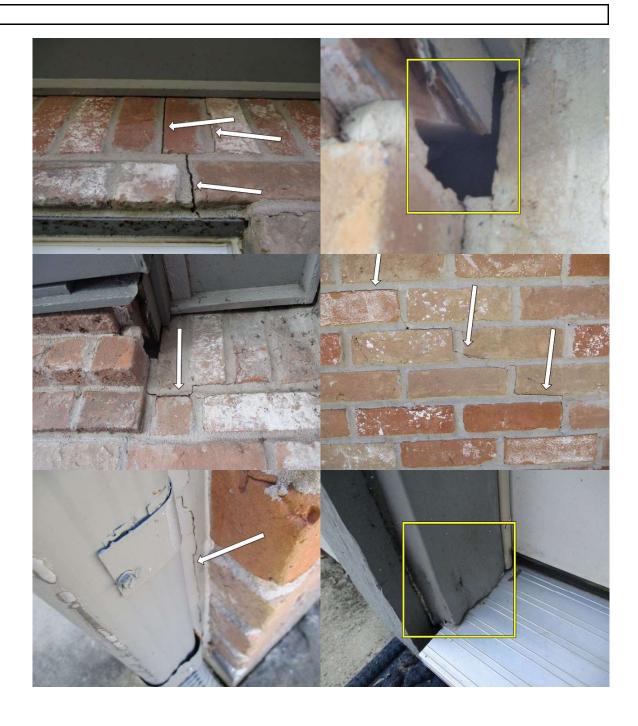
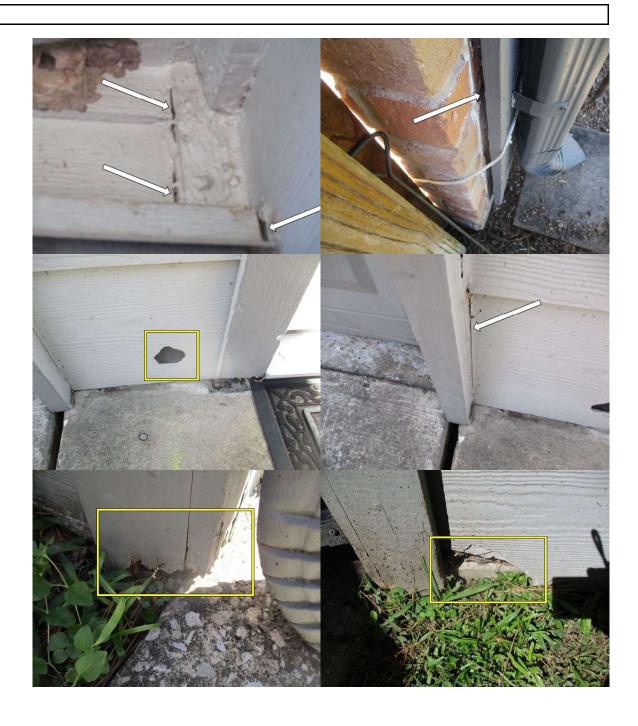
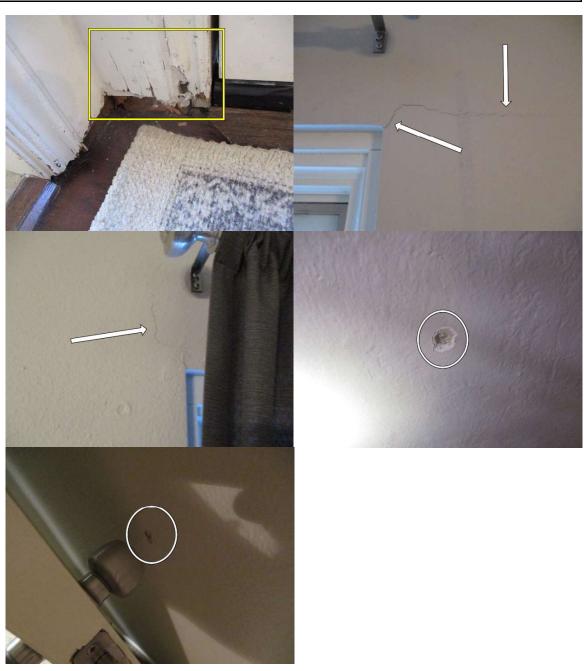
Report Identification: 20231017-01, 16142 Parish Hall Dr., Spring, TX I=Inspected NI=Not Inspected NP=Not Present D=Deficient NI NP D E. Walls (Interior and Exterior) Comments: There is caulk missing from a corner above the roof to the front porch. There is caulk missing left of the chimney. There is damage to some siding, the soffit, and trim to the right of the chimney. There is a crack in the mortar in the corner, and near the top of the wall to the right of the front door. There is a crack in the mortar to the right of the front porch, and to the right of the corner to the right of the front porch. There is a crack in the mortar on the right side of the home near the front right corner. There are cracks in the mortar above and below, and beside windows on the right side of the home. The flat bar over the window to the left of the front porch is rusting and should be painted. There is a crack in the mortar by this flat bar. There is a hole in the wall near the top to the right of the kitchen sink window. There is a crack in the mortar on the left side of the home. There is some caulk missing from the back left and right corners of the home. There is moisture damage to the trim on the left side of the back door to the living room. There is some caulk missing over the back door. There is a hole in the wall to the left of the door to the garage. There is some caulk missing around the trim to the large garage door on the right side. There is moisture damage to the trim at the front left corner of the garage. There is damaged siding near the front right corner of the garage. There is moisture damage to the trim to the left of the back door in the living room. There are cracks in the wall by windows in the master bedroom. There is a hole in the wall about midway up the stairs. There is a hole in the wall by the door in the bedroom upstairs near the back right corner of the home. **Interior Walls:** ☐ Water Stains/Damage ☐ Small Drywall Cracks ☐ Large Drywall Cracks ☐ Mildew ☐ Holes ☐ Previous Repairs Noted **Exterior Walls:** Prevalent Exterior Siding: Brick ☐ Small Cracks ☐ Water Stains/Damage ☐ Large Cracks ☐ Rotting/Exposed Wood ☐ Previous Repairs Noted ☐ Paint Chipping ☐ Weep Holes Missing/Blocked ☐ Damage to Siding, Trim, and/or Exterior Doorframes

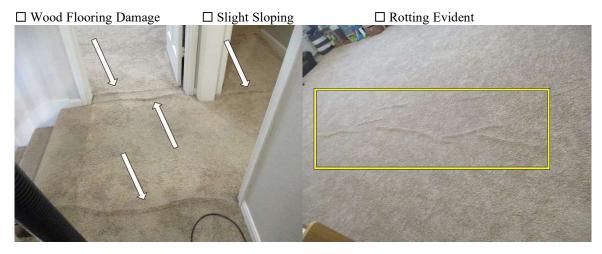
F. Ceilings and Floors  Comments: There are wrinkle should be removed.  Ceilings:	<i>Comments</i> : There are wrinkles in the carpet throughout the home. These are trip hazards, should be removed.					
	☐ Cracks in Vaulted Ceilings☐ Cracks in Crown Molding	□ Nail Pops □ Holes	<ul><li>☐ Water Stains</li><li>☐ Drywall Damage</li></ul>	☐ Crack in Drywall ☐ Cracks at Seams			
	Floors:  ☐ Water Stains/Damage ☐ Vinyl Damage	☐ Other Stains ☐ Tile Damage	☐ Holes/O <sub>j</sub> ☐ Laminate

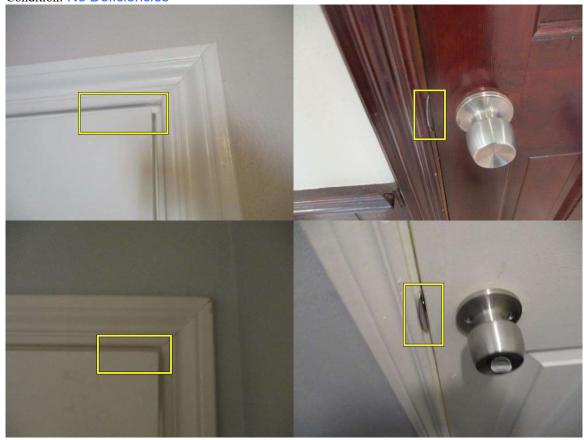
*Comments*: The laundry room door rubs on top. The closet door to the upstairs common room is not latching. The bedroom door upstairs near the front right corner of the home rubs on top. The door to the commode room upstairs is not latching.

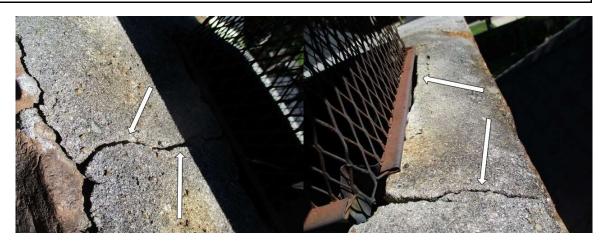
Н.	Windows  Comments:  ☐ Double-Pane Seal/s Broken ☐ Counterbalance Spring/s Malfunctioning	☐ Broken Window ☐ Water Penetration Evident	☐ Not Latching Properly ☐ Improper Height
I.	Stairways (Interior and Exterior)  Comments:		
J.	Fireplaces and Chimneys  Comments: There are some cracks in the fi  Type of Fireplace:   Factory	re place cap over the chimney

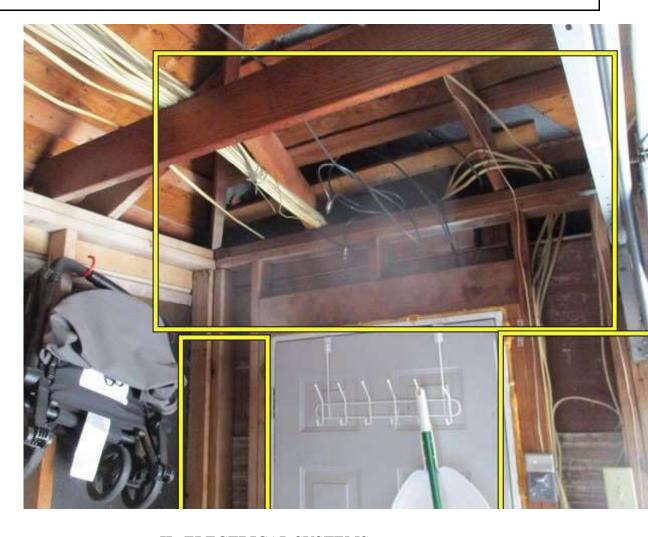
Comments: Current code requires drywall around the door from the garage to the breeze way. This will slow the spread of fire from the garage to the house, in the case of a fire starting in the garage.

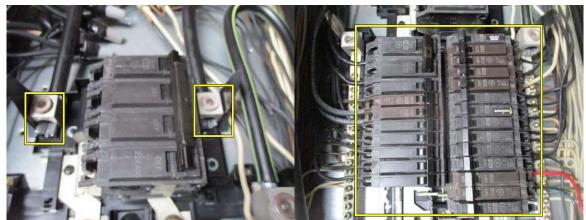
*Comments*: The aluminum service wires are missing the anti-oxidant gel that is required by current code.

Some of the breakers are not labeled.

ARC Fault Circuit Interrupting breakers are required by current code for the lights and outlets in all sleeping rooms as well as the kitchen, living room, all hallways and closets, etc. Pretty much the only rooms inside the house which do not require AFCI Breakers are bathrooms. There are currently no AFCI breakers installed. This is a safety concern and should be addressed immediately.

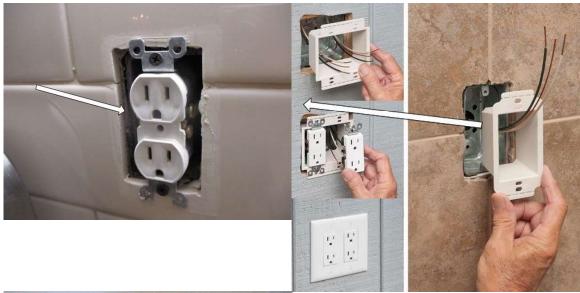
Comments: The outlet on the front porch is not G.F.C.I. protected like current code requires. The

outlet to the right of the kitchen sink has an open ground and is not tripping. The outlet to the right of the fridge is not G.F.C.I. protected like current code requires. The outlets in the kitchen mounted in the back splash are missing the extender boxes that are required by current code.

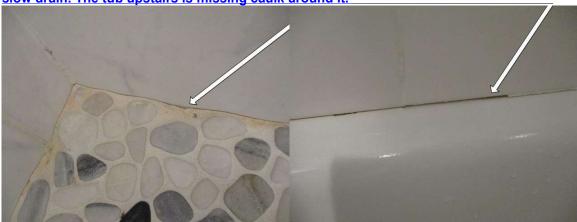
Comments: The master shower is missing some grout, or caulk. The tub upstairs has a

slow drain. The tub upstairs is missing caulk around it.

Comments: The master sink on the left has a slow drain.

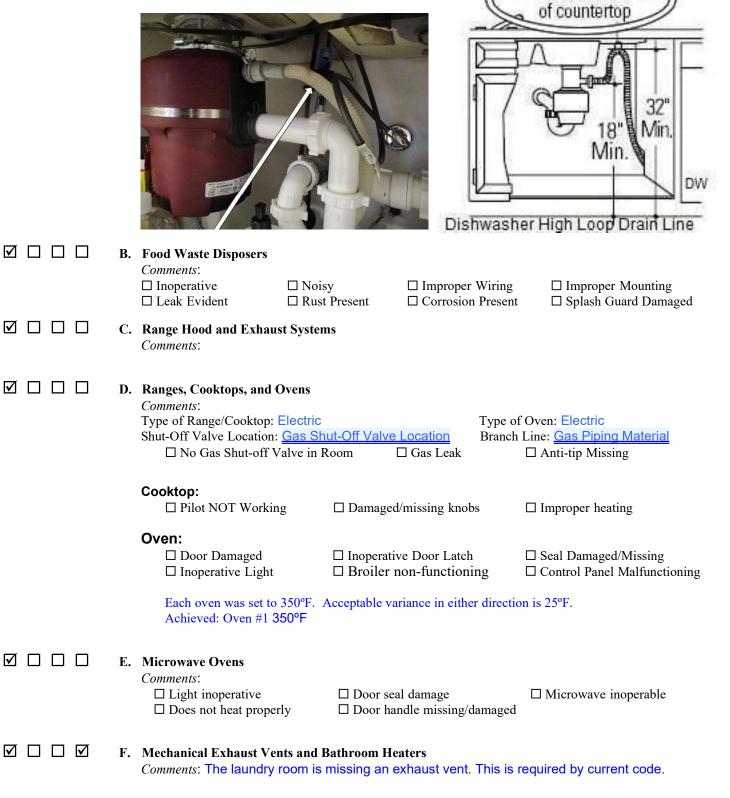
D.	Hydro-Massage Therap Comments:	y Equipment		
	GFCI condition: Hydro (Underside of Tub Readily		set Location: Hydro GFC o/Other	I Reset Location
	☐ Debris in Port Openin☐ Leak in Plumbing	gs □ Loose □ Leakin		☐ Unsafe location ☐ Hot/Cold Reversed
E.	Gas Distribution System Location of gas meter: R Type of gas distribution p Comments:	ear Exterior Wall o	f House	
F.	Other Comments:			
		V. APPL	IANCES	
A.	Dishwashers  Comments:  ☐ Inoperative ☐ Soap tray defective ☐ Loose in cabinet	□ Leak □ Rust □ Door damage	<ul><li>✓ High loop missing</li><li>☐ Rollers missing</li></ul>	g □ Noisy □ Trays damaged
