November 20, 2023

PROPERTY INSPECTION REPORT FORM

Bridget Matthews <i>Name of Client</i>	11/20/2023 <i>Date of Inspection</i>
16015 Sunbeam River Dr., Houston, TX 77084 <i>Address of Inspected Property</i>	
Joshua Donaho <i>Name of Inspector</i>	23369 <i>TREC License #</i>
<i>Name of Sponsor (if applicable)</i>	<i>TREC License #</i>

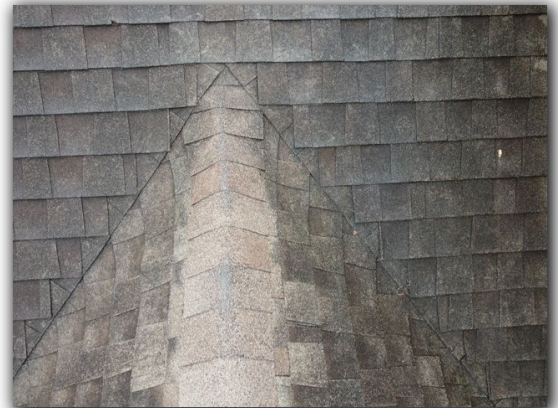
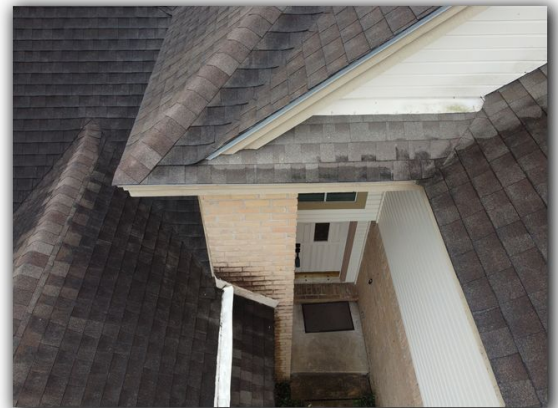
- One or more of the ridge cap shingles were observed to be damaged.
- The composition roofing material has experienced granular loss in various locations throughout the roof.

You are strongly encouraged to have a properly certified roofing contractor to physically inspect the roof, prior to the expiration of any time limitations such as option or warranty periods, to fully evaluate the condition of the roofing material. The observation made to support the rendering of this opinion are listed but not limited to the following:

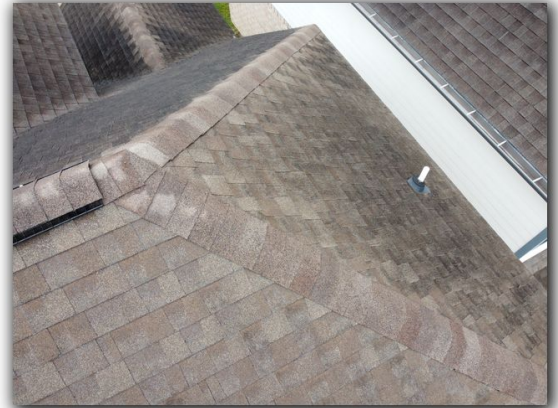
Flashing Details

- Some of the metal flashing details were observed to be rusted.
- It is recommended to paint the flashing details to prevent rust and/or UV damage.
- There was no kickout flashing details observed at the lower bottom edge of the roof line interface and the sidewall that continues past the edge of the roof. The lack of this kickout flashing could allow water to penetrate at these points.

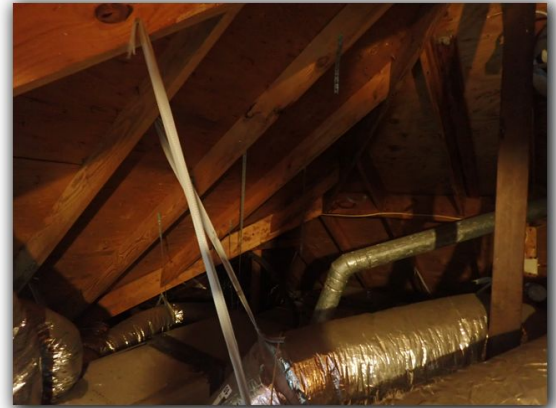
- The attic insulation is lower than typical and it is recommended to add additional insulation to achieve at least a R-30 rating.

Note: Visible evidence of rodent activity was observed in the attic area. It is recommended to have a Certified Pest Control Operator further evaluate this condition and make corrections as necessary.

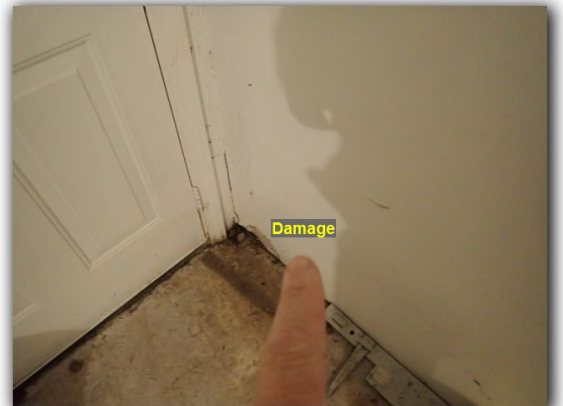
- Wall surface damage was observed in the garage.
- The baseboards were observed to be water stained and/or damaged in the half bathroom. The cause and remedy should be further evaluated and corrected as necessary.
- Interior wall joint cracks were observed in the several locations throughout the house.

Note: Nail heads were observed to be pushing through the interior finish in one or more locations.

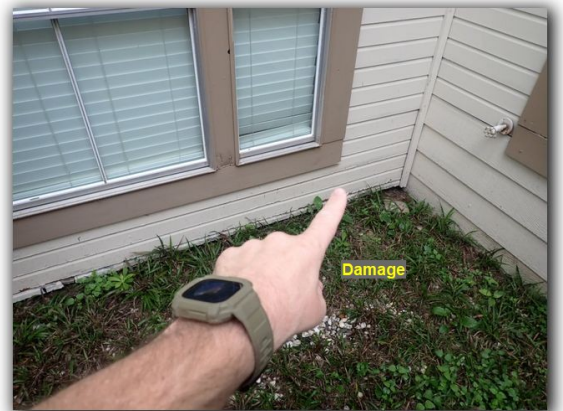
- The exterior veneer / cladding has some deterioration and/or damage on the north, east, west and south sides of the structure.
- The wood veneer trim has some deterioration or damage on the north, east, west and south sides of the structure.

- All wood to ground contact at the base of the siding should be eliminated. Rotted or damaged siding that is uncovered should be repaired. The siding was observed to be in contact with the finish grade (ground) on the north, east, west and south sides of the structure.

- Caulking improvements are recommended for the area between the exterior veneer and the window frames. It is recommended to use an elastomeric sealant.

- All joints between two different types of siding should be properly sealed. It is recommended to use elastomeric sealant.
- The area between the exterior cladding / veneer and all of the wall penetrations / openings should be properly sealed. Areas such as utility connections, downspouts, hose bibbs, lighting fixtures, receptacles, vent termination covers, etc. It is recommended to use an elastomeric sealant.

- Caulking improvements are recommended for the area between the exterior veneer and the garage door trim boards. It is recommended to use an elastomeric sealant.

- The exterior veneer trim board is missing on the chimney.
- The garage door trim has some deterioration and/or damage at the bottom.

Note: Mortar and/or brick cracks were observed in the exterior veneer on the north, east, west and south sides of the structure.

Notice: There is Masonite siding in place at the time of this inspection. This is an older siding system that is prone to failure and moisture intrusion into the property. Full evaluation of all of the siding components and the siding integrity is recommended. It is recommended to budget for replacement of all the older siding to prevent further damage to the structure.

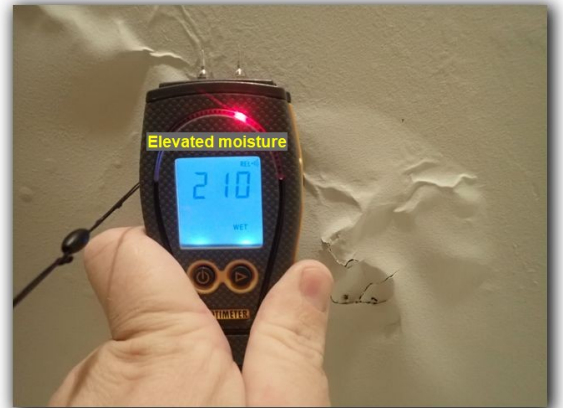
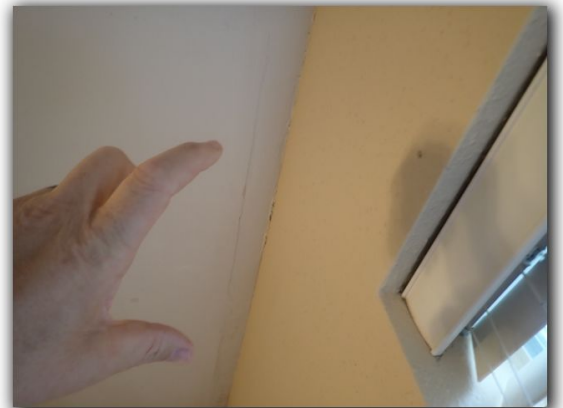
- Elevated moisture levels were detected in the ceiling finished surfaces in the garage, laundry room. The cause and remedy should be further evaluated and corrected as necessary. **Additional Note:** Due to the elevated moisture, other adverse conditions such as mold-like substance growth, wood rot/deterioration and wood destroying insects are possible.
- Water stains and water damage was observed on the ceiling finishes in the garage. The cause and remedy should be further evaluated and corrected as necessary.
- Ceiling joint cracks were observed in the several locations throughout the house.

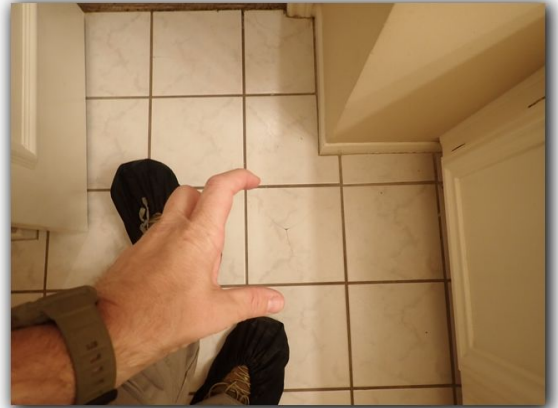
Floors

- The floor tile(s) were observed to be cracked and/or damaged in the living room.
- The floor covering is stained in one or more locations of the home.

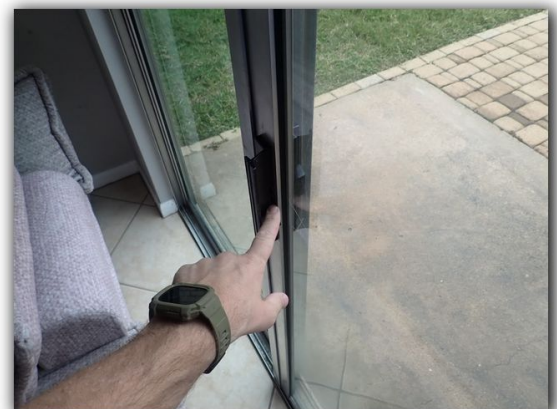
Sliding Glass Door

- The primary bedroom, living room sliding glass door is not rolling smoothly in its tracks. Improvements are recommended so the door will function properly when operated.
- The living room sliding glass door lock is not functioning properly.

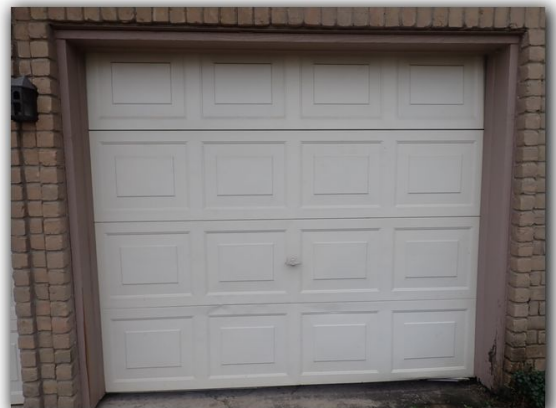
Overhead Garage Door

- Some damage to the overhead garage door was observed.
- The locks were observed to not be functioning properly.

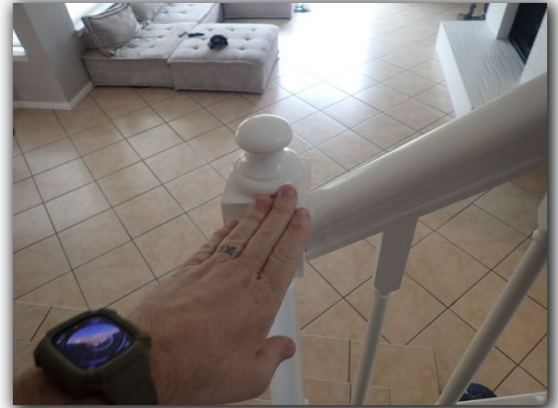
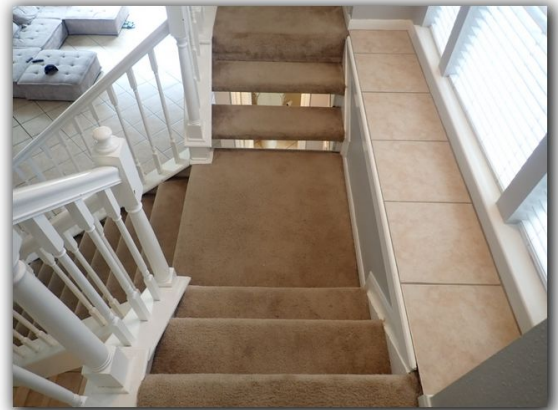
- The stairway guard balusters and/or spindles are installed too far apart under current building standards. This may be an “as-built” condition but per TREC standards of practice we are required to report this condition as a deficiency. You may consider corrective measures for improved safety.
- The handrail and/or guardrail for the stairway is loose and should be better secured for reasons of safety.

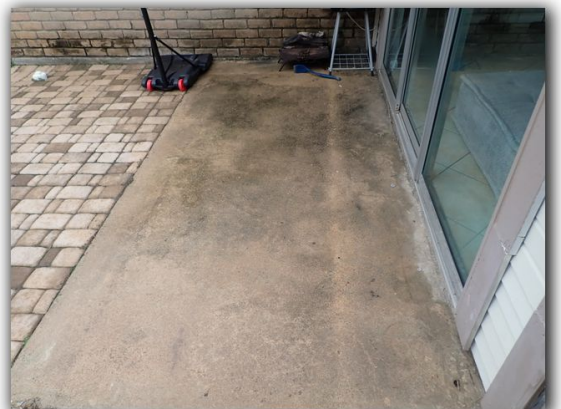
Porches / Patio

- Minor cracks and/or deficiencies were observed in the patio.

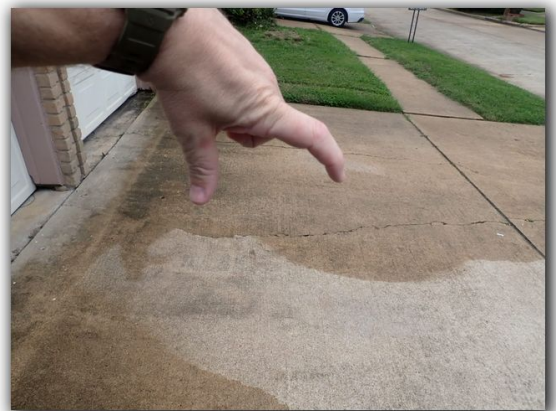
Driveway

- Larger than typical cracks and/or deficiencies were observed in the driveway.

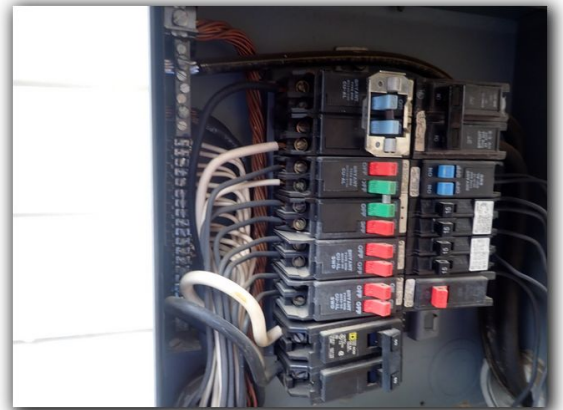
Note: There were circuit breakers in the main electrical service panel that were not listed by the panel manufacturer. Because circuit breakers were made by different manufacturers, they vary in design. Panel manufacturers typically require that breakers manufactured by their company be used in their panel unless otherwise indicated on the panel label. Breakers from one manufacturer used in the panel of another manufacturer may result in poor connections which can create a potential fire or shock hazard. I recommend correction by a licensed electrician.

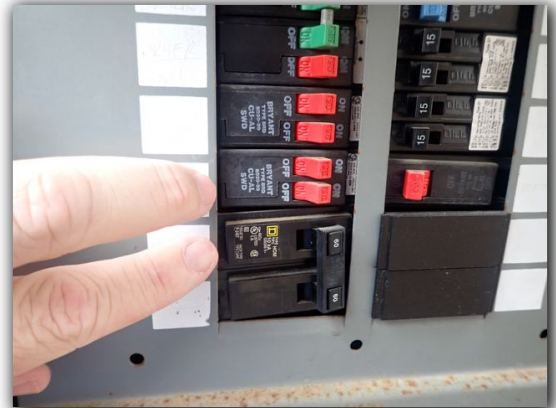
Arc-Fault Circuit Interrupter Protection (AFCI)

- None of the required dwelling unit devices, receptacle and lighting outlets (switches, receptacles and fixtures) are connected to an arc-fault circuit-interrupter (AFCI) circuit device. AFCI devices were first required under the 1999 National Electrical Code and under the 2014 NEC, all living space, kitchen and laundry room devices, receptacle and lighting outlets (switches, receptacles and fixtures) should be connected to an arc-fault circuit interrupter (AFCI) device.

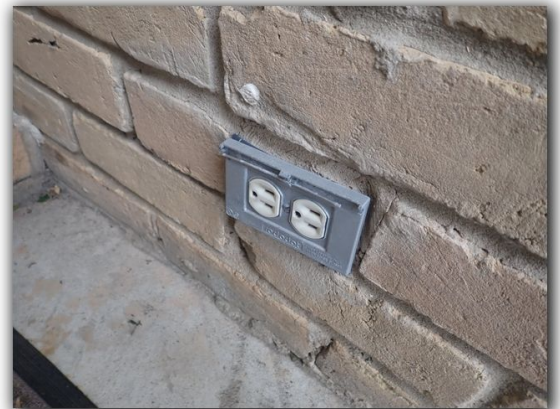
- All exterior receptacles should have weather tight covers. The receptacle weather cover plate is damaged and/or missing on the front porch.
- One or more of the receptacles were observed to have an open ground connection in the kitchen.

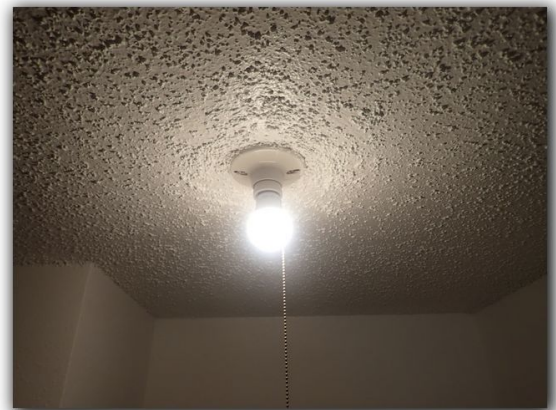
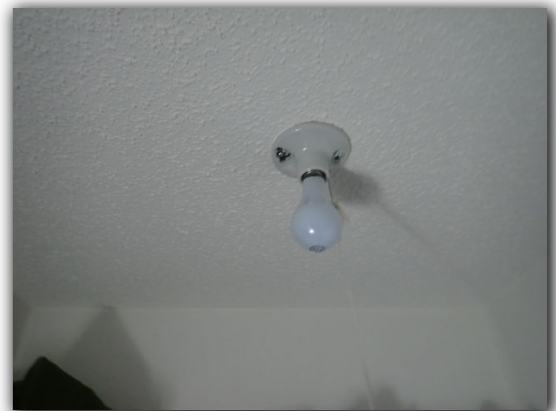
Fixtures

- One or more of the light fixtures are inoperative in the several locations throughout the house. This may be due to a bad bulb or some other unknown condition. This condition should be further evaluated and corrected as necessary.
- The ceiling fan is not balanced properly and wobbles when operated in the upstairs front corner bedroom.
- One or more of the ceiling fan blades are warped in the upstairs side middle bedroom.
- One or more of the closet light fixtures are installed without globes and/or covers. Safety precautions should be taken around these light fixtures.

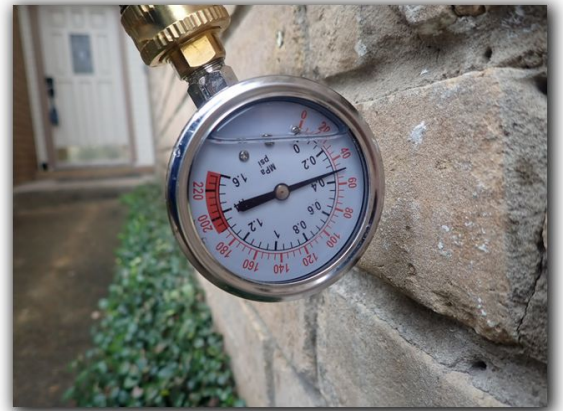
Water Supply System

- There are galvanized water lines in use at the time of this inspection. This is an older obsolete water supply system that is prone to water leaks. Full evaluation of all of the galvanized water line components and the integrity of those components are beyond the scope of this inspection. You are strongly encouraged to have the integrity of all of the galvanized water line components further evaluated by a qualified plumber prior to the expiration of any time limitations such as option or warranty periods. All plumber recommended repairs should be made. It would be wise to budget for replacement of all the older galvanized water supply system and to make a conversion over to a newer type of water supply system as soon as it is financially feasible.

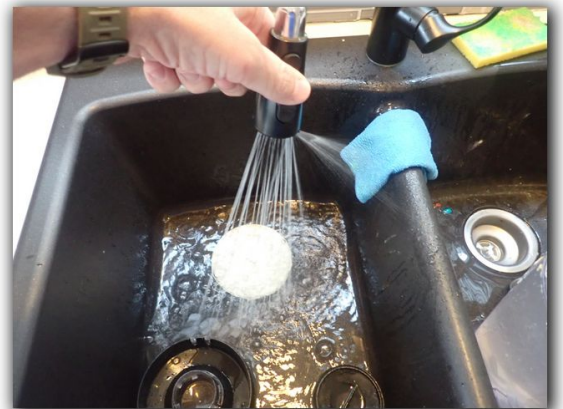
Kitchen Sink

- The faucet assembly is loose.
- The sprayer head is damaged.

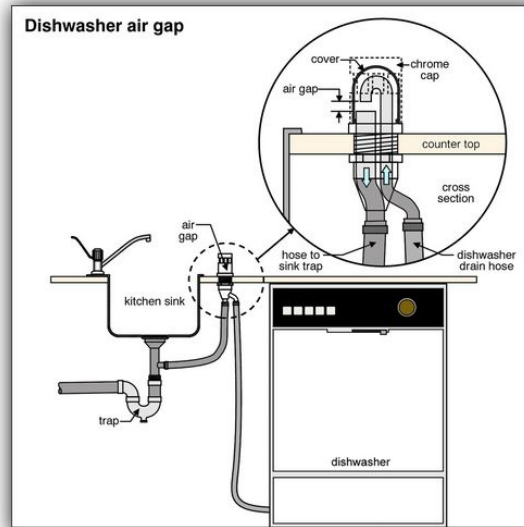
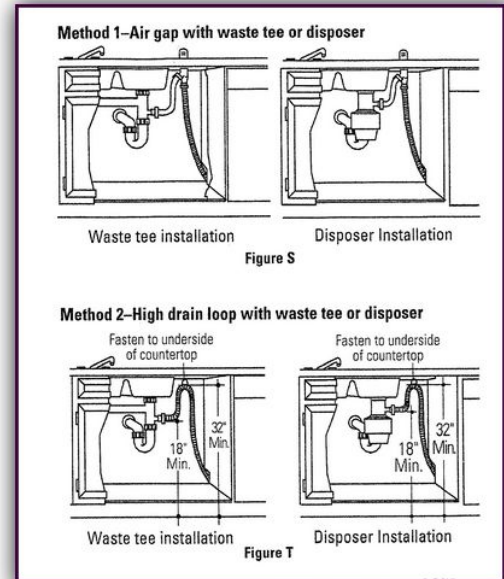
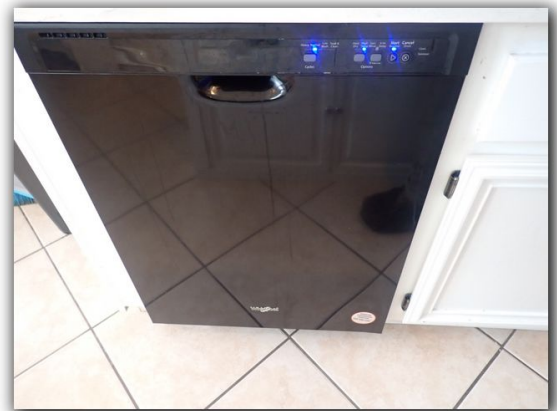
- The dishwasher drain hose is not properly installed to prevent back flow or anti-siphoning. It is recommended that an air gap device or high drain loop be installed in the drain line.

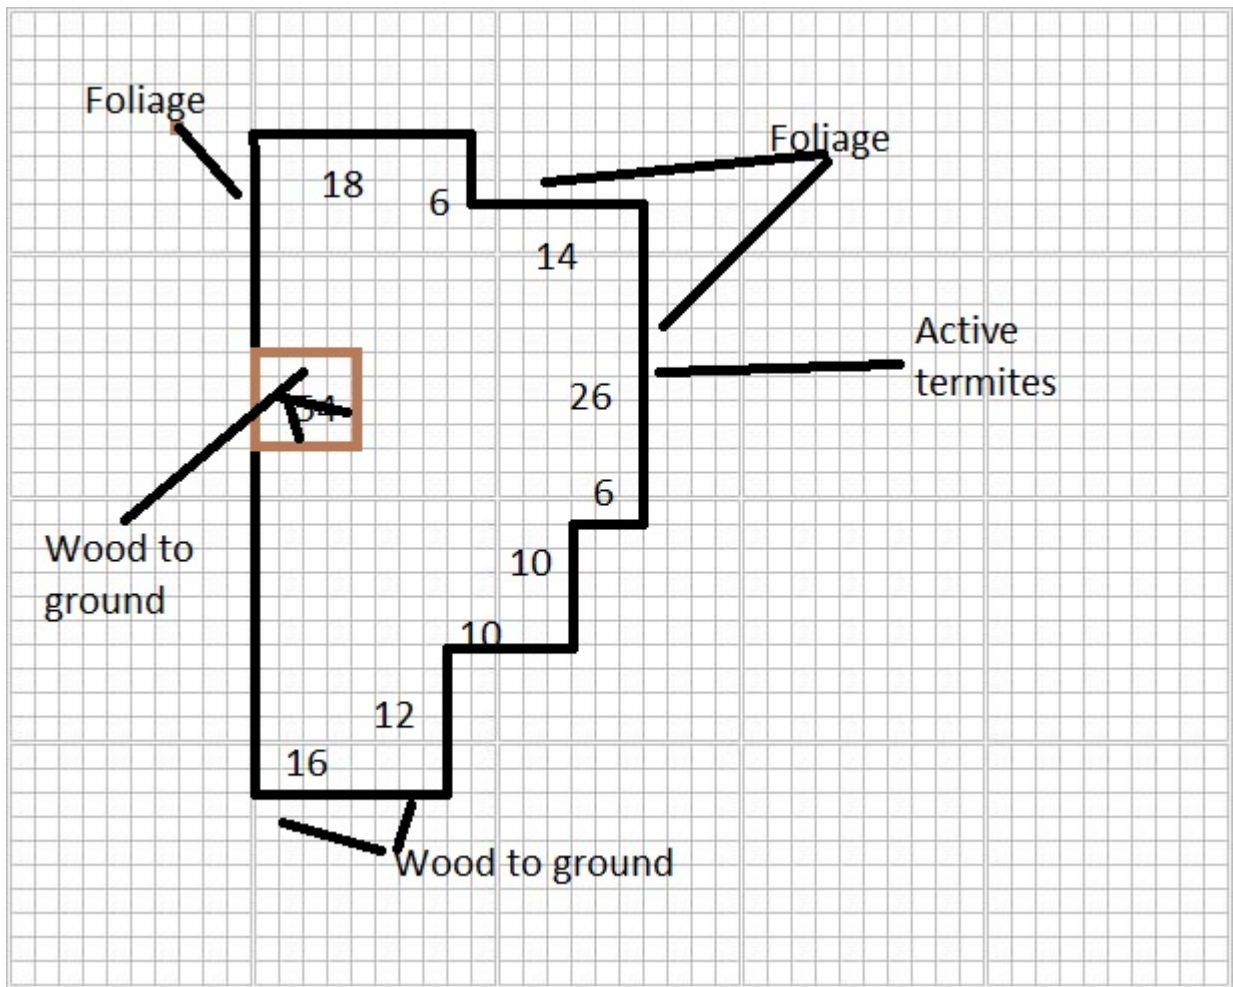
Diagram of Structure(s) Inspected

Additional Comments An ACTIVE Infestation of termites was discovered at the time of this inspection. See diagram for location(s). Treatment Recommended.
