SUMMARY
11711 Cabot Hill St, Houston, TX
77044
Isidro Maldonado
September 19, 2023

Gabriel Salazar
TREC#24171
Lakeside Home Inspections
832-827-4727
gabe@lakeside-inspections.com

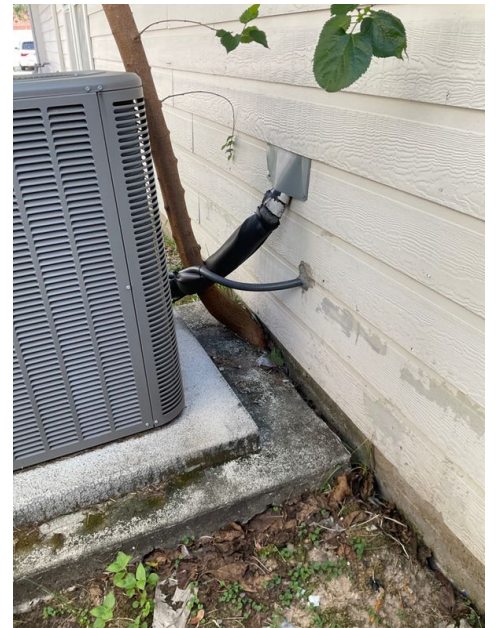
Right

FOUNDATION: TREE NEAR FOUNDATION

Area observed where large trees are planted/growing near foundation. Trees adjacent to foundations are prone to cause issues with excessive settlement. Recommend contacting a structural engineer or professional foundation contractor to evaluate and determine the extent of repairs needed.

Contact a qualified professional.

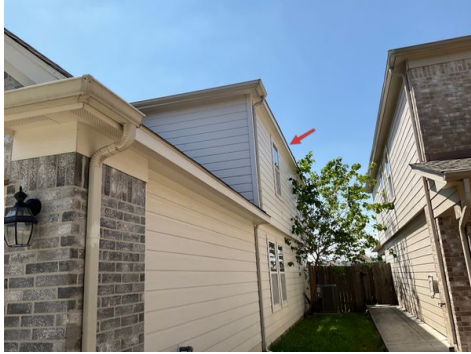
Right

GRADING AND DRAINAGE: GUTTERS ABSENT

Missing gutters were observed during the home inspection. Gutters are an essential component of the home's drainage system, and their absence can cause water damage to the foundation and exterior walls. The lack of gutters can also result in soil erosion and damage to landscaping. It is recommended that the missing gutters be installed by a qualified professional to prevent water damage and maintain the integrity of the home's structure."

Contact a qualified professional.

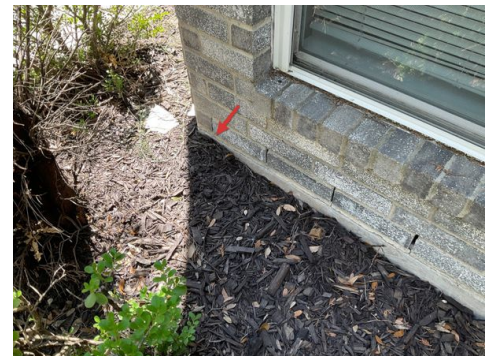
Front

LANDSCAPING: HIGH SOIL

High soil conditions were observed at various locations around the structure. The soil level should be reduced to allow for a minimum of 4" of foundation exposure, while still providing positive drainage away from the home. Recommend correction by a professional landscaping contractor.

Contact a qualified professional.

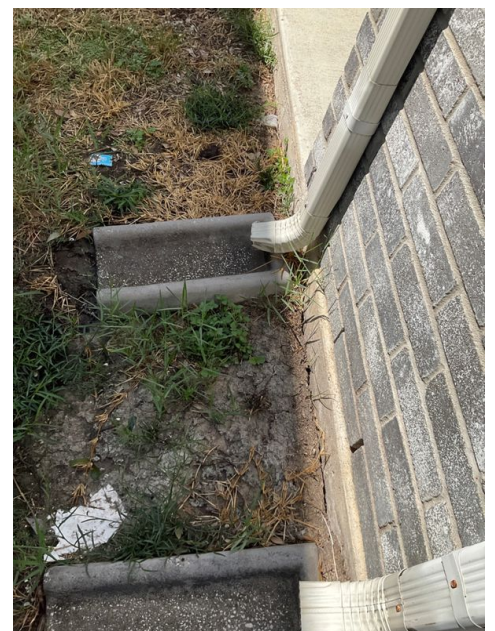
Front

GRADING AND DRAINAGE: SOIL EROSION

Soil erosion was observed at various locations around the home, likely being contributed to the lack of gutters. This condition can lead to grading issues and standing water. Recommend further evaluation and correction as needed to prevent erosion and ensure proper drainage conditions.

Contact a qualified professional.

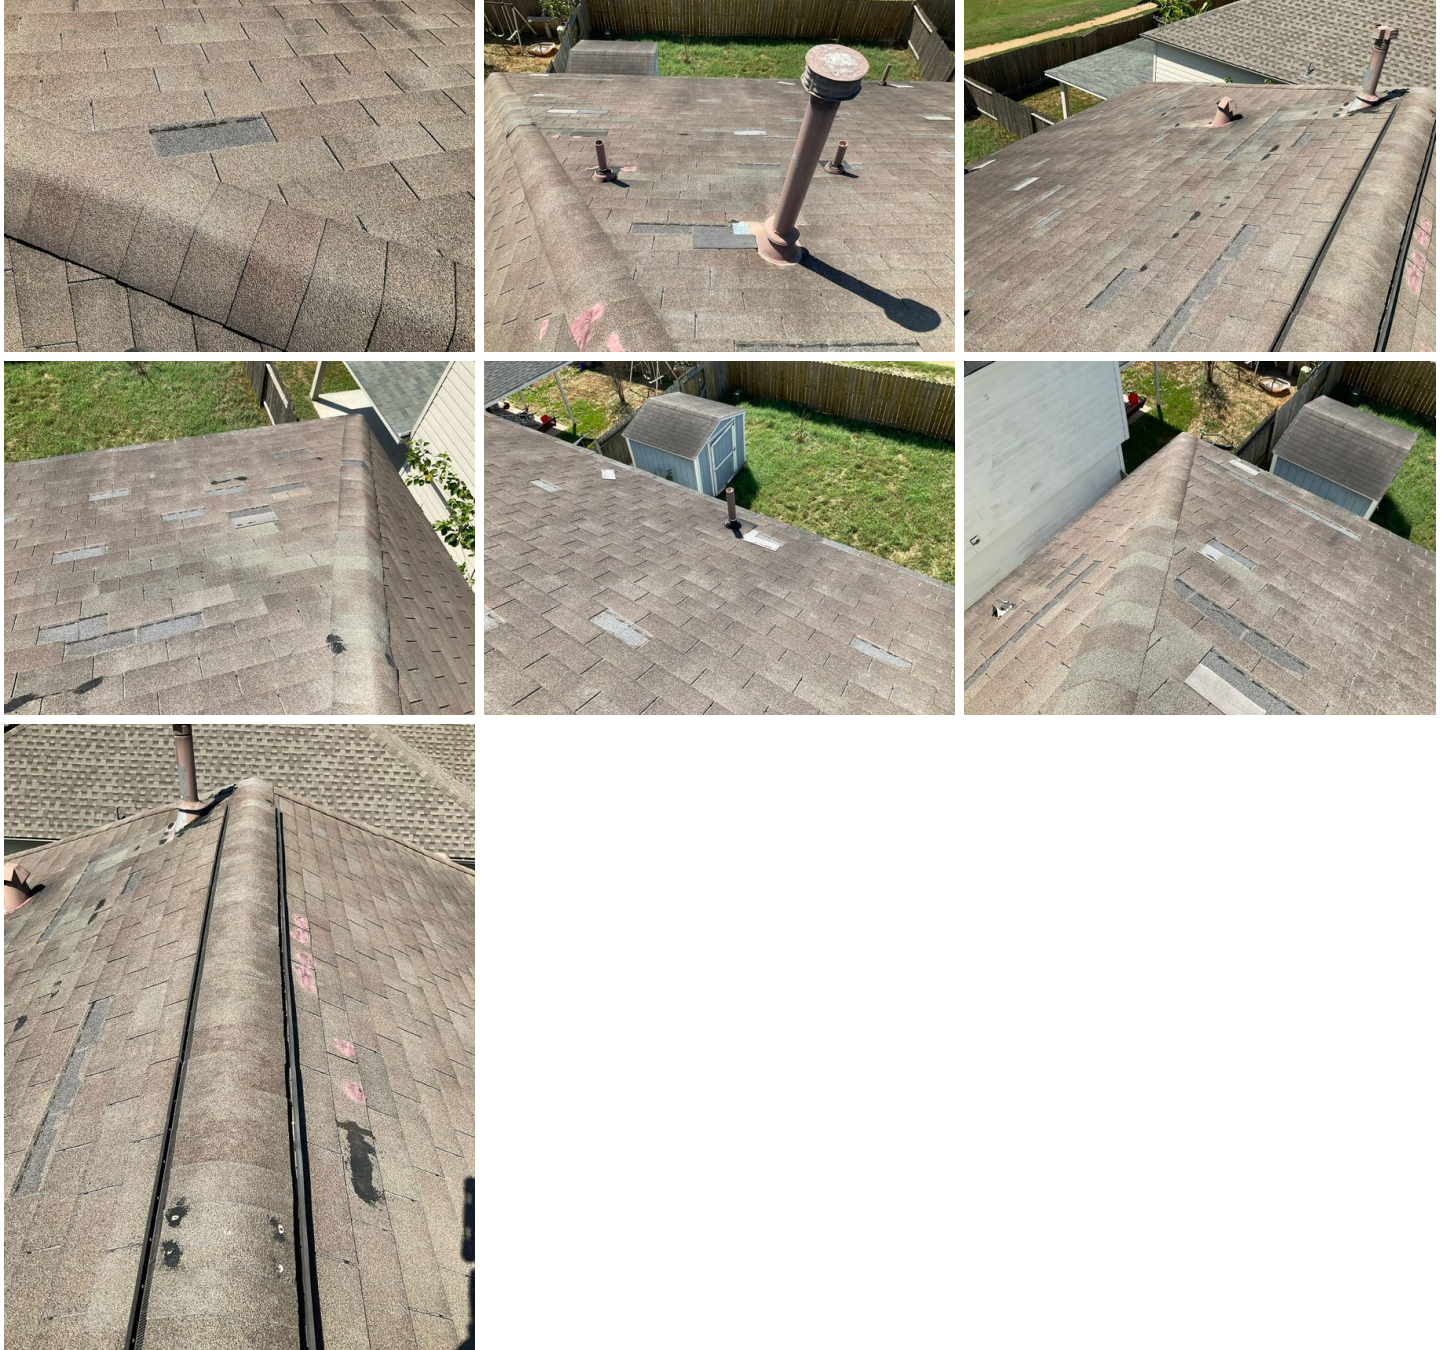
2.3.2 C. Roof Covering Materials
SHINGLES: DAMAGED/MISSING

Damaged/missing shingles were observed to the roof covering at the time of the inspection. These conditions can compromise the integrity of the roof covering. Recommend contacting a professional roofing contractor to evaluate and determine the extent of the repairs needed.

Recommendation
Contact a qualified professional.

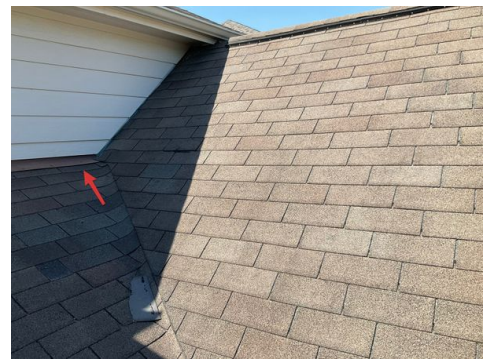
FLASHING: LOOSE/RAISED FLASHING

Raised or loose flashing areas were observed around the roof covering. This condition leaves the covering exposed to potential moisture or pest intrusion. Recommend all areas be evaluated secured and sealed as needed.

Contact a qualified professional.

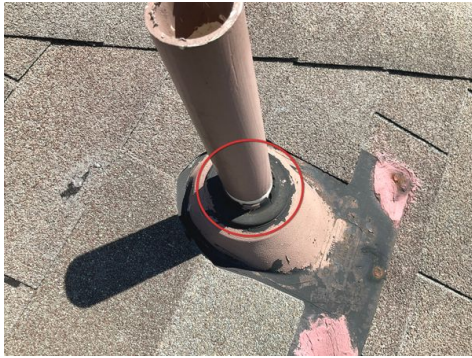
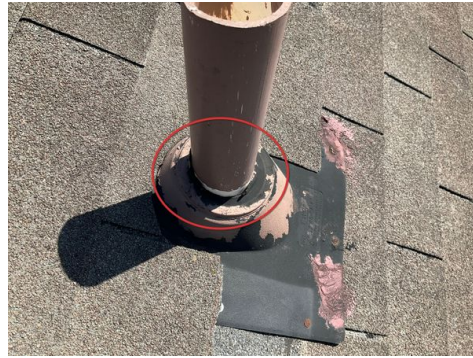
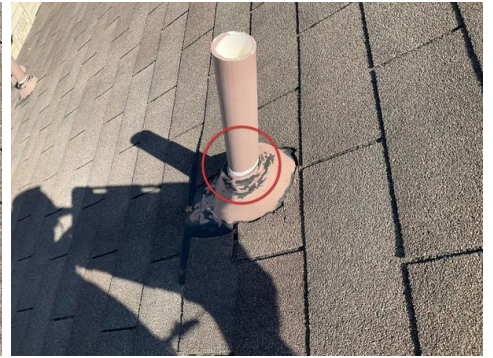
ROOF COVERING: DAMAGED/DETERIORATED ROOF JACK

A roof boot jack was observed to be deteriorated around the collar. This can lead to water retention and intrusion. Recommend contacting a professional roofing contractor to evaluate and determine the extent of repairs needed.

Contact a qualified professional.

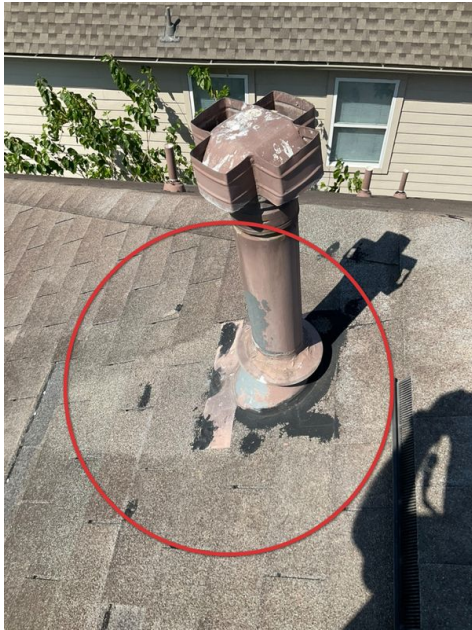
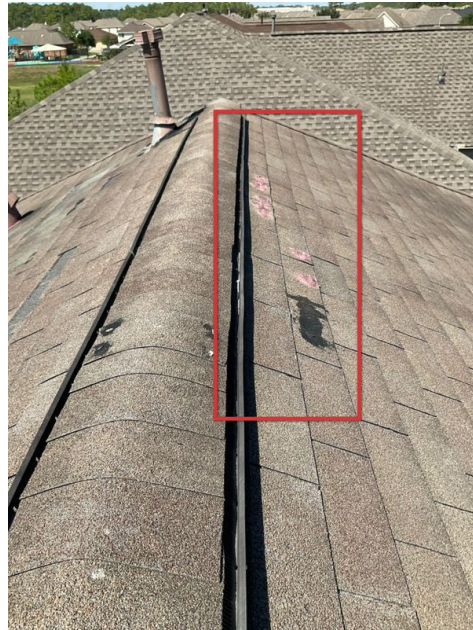
ROOF COVERING: IMPROPER REPAIR

During the inspection, it was observed that there has been an attempt to repair the roof shingles. However, the repair appears to be improper and not in compliance with common roofing standards. Therefore, it is recommended that the roof be further inspected and repaired by a qualified roofing contractor to ensure the safety and integrity of the roof."

Contact a qualified professional.

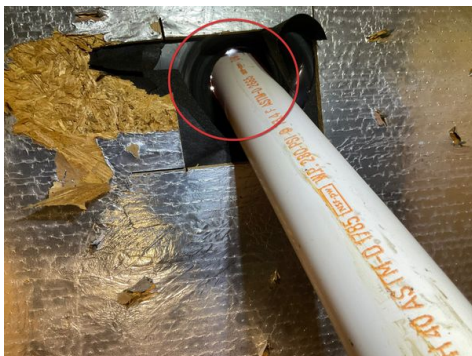
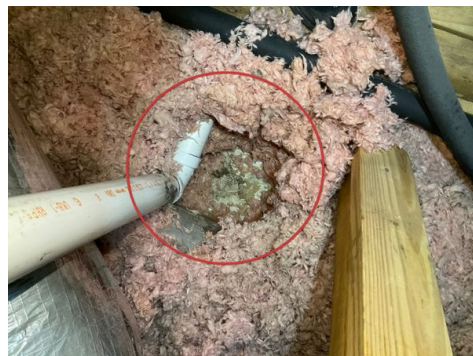
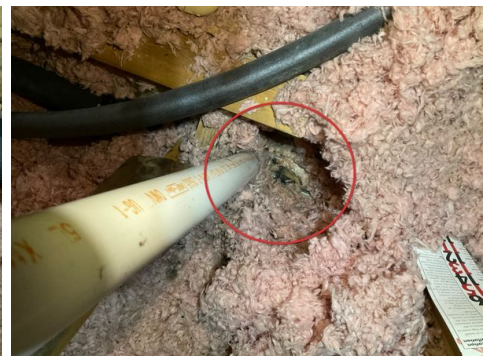
ATTIC: ACTIVE MOISTURE INTRUSION

Active moisture intrusion was observed in the attic at the time of the inspection. A surface moisture meter was used and revealed elevated levels of moisture to this area along with moisture to area directly below. Recommend contacting a professional roofing contractor to evaluate and determine the extent of repairs needed.

Contact a qualified professional.

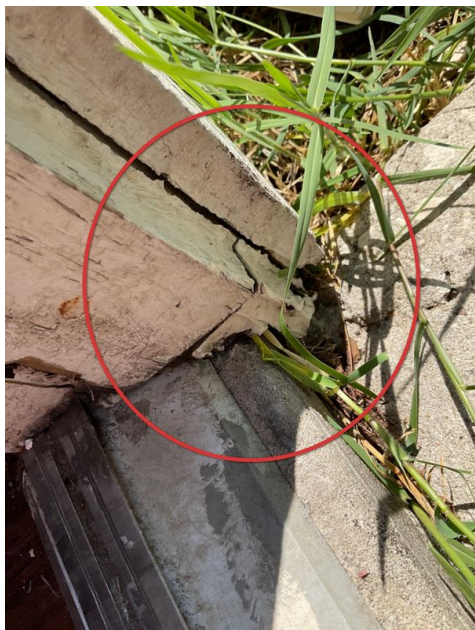
Rear

WALLS: WOOD ROT/MOISTURE ISSUES

Moisture penetration was observed to multiple sections of the interior baseboard and wooden siding/trim. While not uncommon, these areas will deteriorate and lead to other issues. Recommend replacement by a qualified contractor to avoid further deterioration.

Contact a qualified professional.

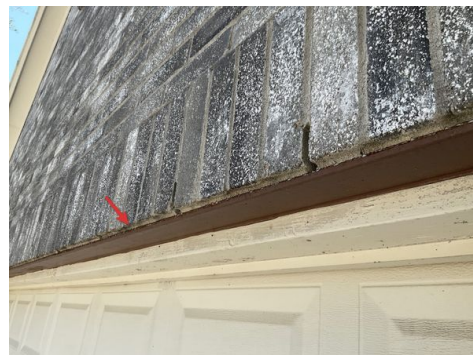
Front

MASONRY: LINTELS RUSTED/MAINTENANCE NEEDED

Steel lintels above the windows/doors were observed to be unpainted and displaying signs of corrosion. Corrosion will cause expansion leading to cracking of brick/mortar to the surrounding areas. Recommend properly painting/sealing to prevent deterioration.

Contact a qualified professional.

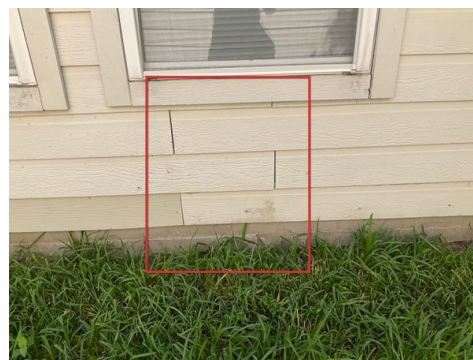
Right

WALLS: SEPERATION/VOIDS BETWEEN SIDING JOINTS

Sections of the siding was observed to have excessive separation/voids that can lead to potential moisture intrusion. Cement fiber siding joints shall have minimal separation along with flashing to divert moisture away. Recommend contacting a qualified contractor to evaluate and install per manufacturer recommendations.

Contact a qualified professional.

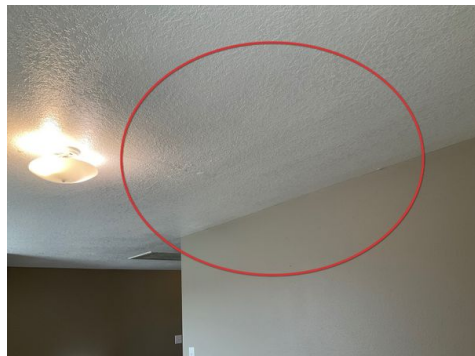
Game room

CEILING: ACTIVE MOISTURE INTRUSION

Thermal imaging revealed active moisture to the ceiling in the game room. Recommend contacting a professional contractor to evaluate and determine the extent of repairs needed.

Note: the darker areas of the thermal imaging pictures are areas with moisture

Contact a qualified professional.

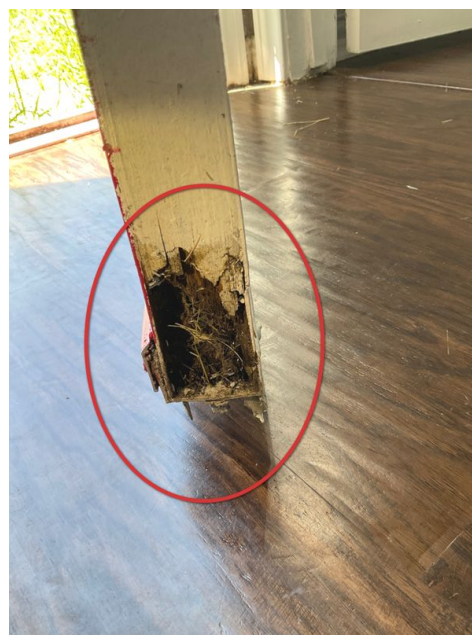
Rear

DOORS: WOOD ROT/EXCESSIVE MOISTURE AT BASE

During the inspection, wood rot was found on the exterior door of the property. The wood rot appears to be localized to the bottom of the door frame, and may be due to moisture infiltration over time. Wood rot can compromise the structural integrity of the door frame and may lead to further damage if left untreated. A qualified contractor should be contacted to assess the extent of the damage and recommend appropriate repairs or replacement.

Contact a qualified professional.

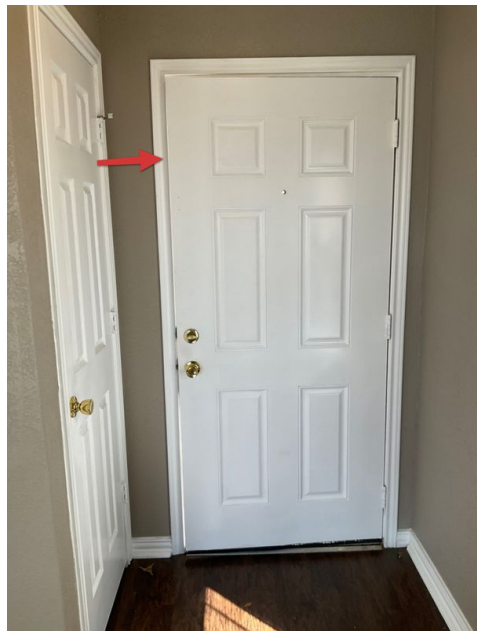
Front

INTERIOR DOOR: BINDING/RUBBING

Multiple doors were observed to bind/rub when attempting to close. Binding can be caused by several factors, such as hinges that are loose, worn, or improperly installed as well as door frames that are out of square or warped. Recommend contacting a qualified contractor to evaluate and determine the extent of repairs needed.

Contact a qualified professional.

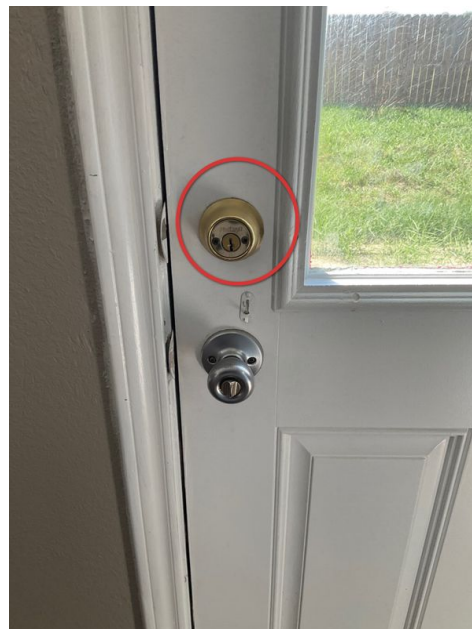
Rear

EXTERIOR DOOR: KEYED DEADBOLT

A deadbolt lock was in use at one or more exterior doors. Recommend it be updated to a thumb latch type as the current set up as a hazard in the event of an emergency.

Contact a qualified professional.

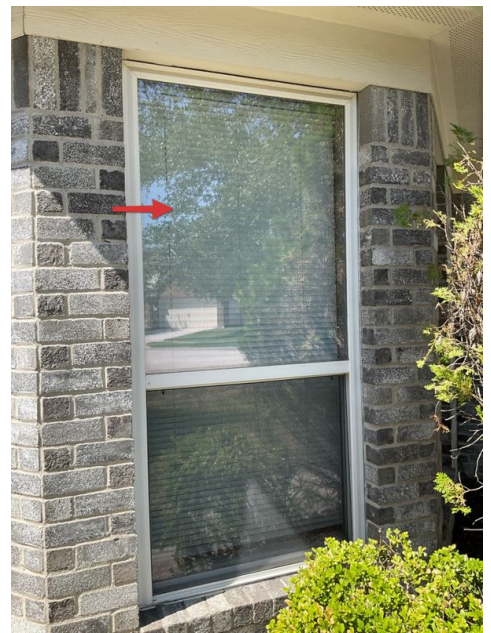
Front

WINDOWS: FAILED WINDOW SEAL

Failed window seals was observed at the above stated locations at the time of the inspection. This is indicated by the haze or moisture in between the window panes. Failed seals on windows can lead to energy loss and air seepage. Recommend contacting a professional contractor to evaluate and determine the extent of repairs needed.

Contact a qualified professional.

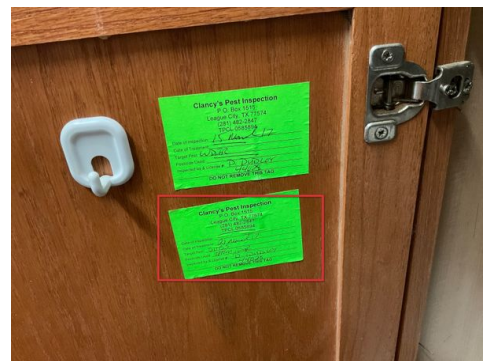
NOTE: PREVIOUS SUBTERRANEAN TERMITE TREATMENT

Note: A previous subterranean termite treatment has been performed on this property as indicated by the drill holes observed in the concrete around the foundation. Recommend you consult with the seller to try and obtain information on the extent of repairs and a possible transferable warranty.

Note: no drill holes were observed at the exterior of the property

Contact a qualified professional.

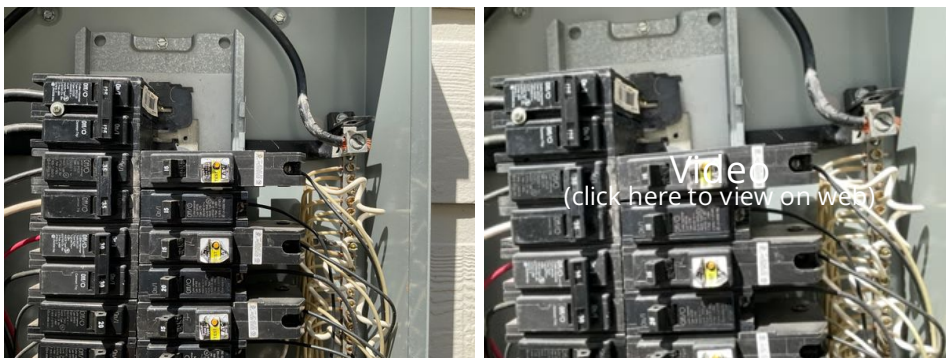
ELECTRICAL PANEL: FAULTY AFCI BREAKER

AFCI breakers were faulty when tested at the time of the inspection. Recommend contacting a licensed electrician to evaluate and determine the extent of repairs needed.

Contact a qualified professional.

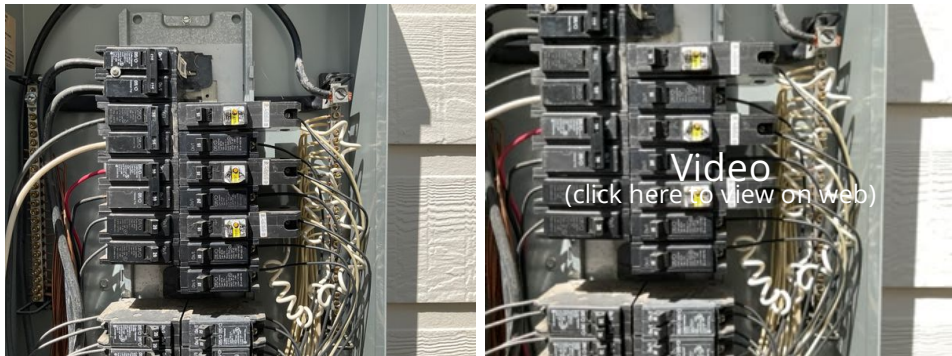
ELECTRICAL PANEL: LOOSE BREAKERS

Multiple electrical breakers was observed to be loose in the electrical panel. Loose breakers can lead to tripping of the breakers or potential arcing. Recommend contacting a licensed electrician to evaluate and determine the extent of repairs needed.

Contact a qualified professional.

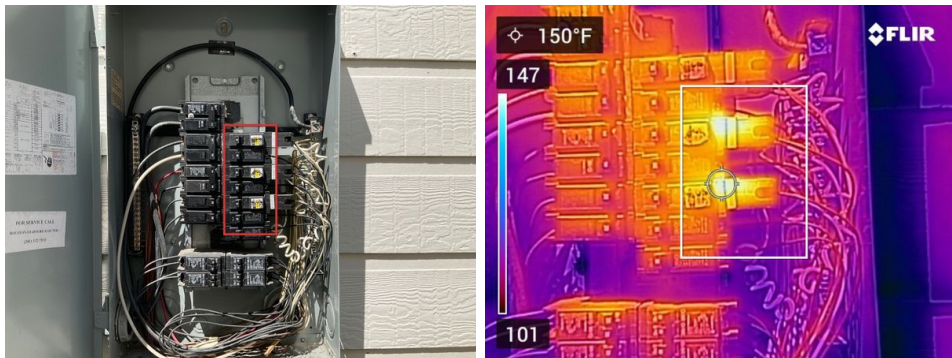
ELECTRICAL PANEL: OVERHEATING

Thermal imaging of the electrical panel revealed excessive heat at portions of the electrical panel. Overheating inside the electrical panel can result in a potential fire hazard if not corrected. Recommend contacting a licensed electrician to evaluate and determine the extent of repairs needed.

Contact a qualified professional.

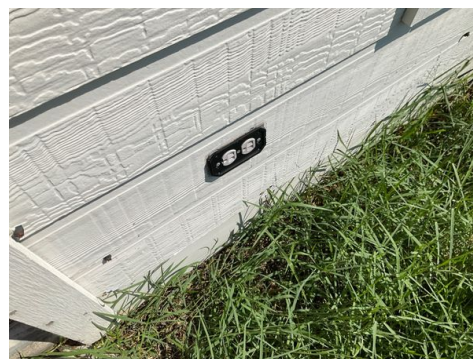
Rear

ELECTRICAL FIXTURES: MULTIPLE ISSUES

Missing exterior weathercovers

Multiple issues were observed to the electrical fixtures at the time of the inspection. Recommend contacting a licensed electrician to evaluate and determine the extent of repairs needed.

Contact a qualified electrical contractor.

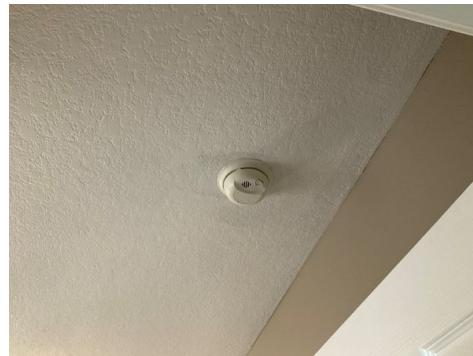
SMOKE DETECTORS: PAST LIFE EXPECTANCY

The smoke detectors in the home appeared to be more than 10 years old. It is recommended that they be replaced every 10 years to ensure that they will operate properly. Remedy as needed.

Contact a qualified professional.

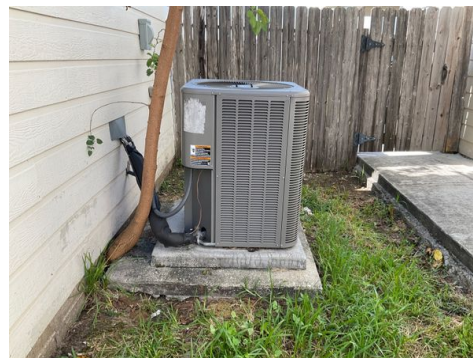
CONDENSER: UNIT NOT LEVEL

Concrete pad supporting the outdoor condensing unit is not level. This can cause accelerated deterioration of components. Recommend licensed HVAC contractor level the unit.

Contact a qualified HVAC professional.

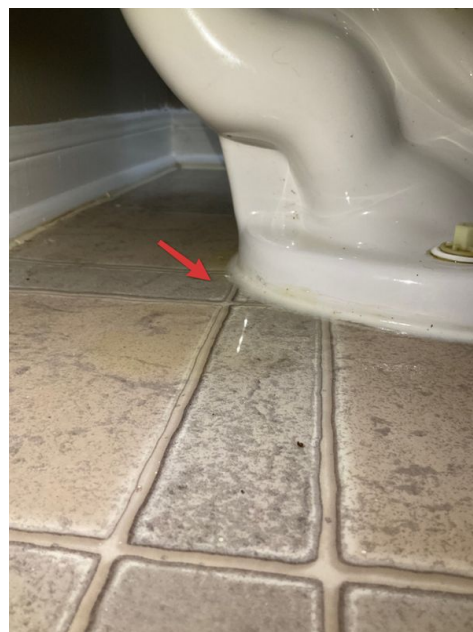
2nd Floor Hallway Bathroom

TOILET: LEAK FROM BASE

A slow leak was observed to come from the base of the toilet. This is indicated by the moisture at the base after several flushes. Recommend contacting a professional plumber to evaluate and determine the extent of repairs needed.

Contact a qualified professional.

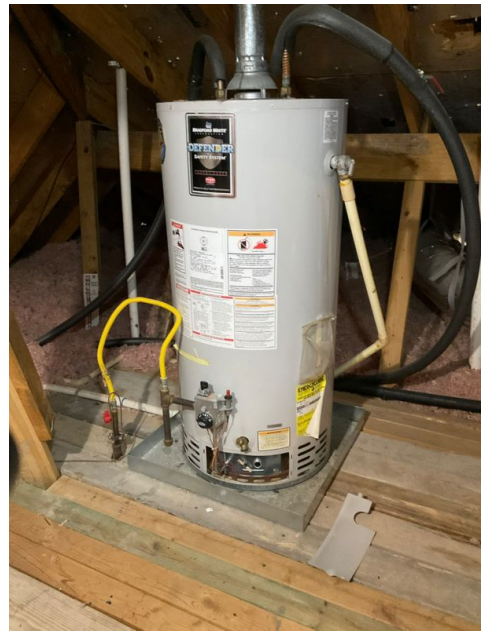
5.4.1 C. Water Heating Equipment
WATER HEATER: INOPERABLE

The water heater was inoperable at the time of the inspection. Recommend contacting a professional plumber to evaluate and determine the extent of repairs needed.

Note: The units pilot light was off upon inspection. Multiple attempts were made to ignite the unit but were unsuccessful. All valves were opened and breaker was on at the time of the inspection.

Recommendation
Contact a qualified professional.

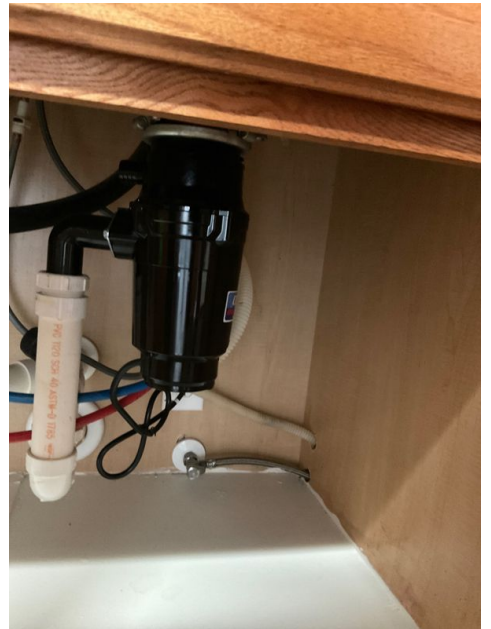
6.2.1 B. Food Waste Disposers
FOOD DISPOSAL: INOPERABLE

Garbage disposal was inoperable at the time of inspection. Recommend contacting a professional plumber to evaluate and determine the extent of repairs needed.

Recommendation
Contact a qualified handyman.
