ANDERSON HOME INSPECTIONS

1227 Avenue H Garage Apt and Game Room
Galveston, TX 77550

PROPERTY INSPECTION REPORT FORM

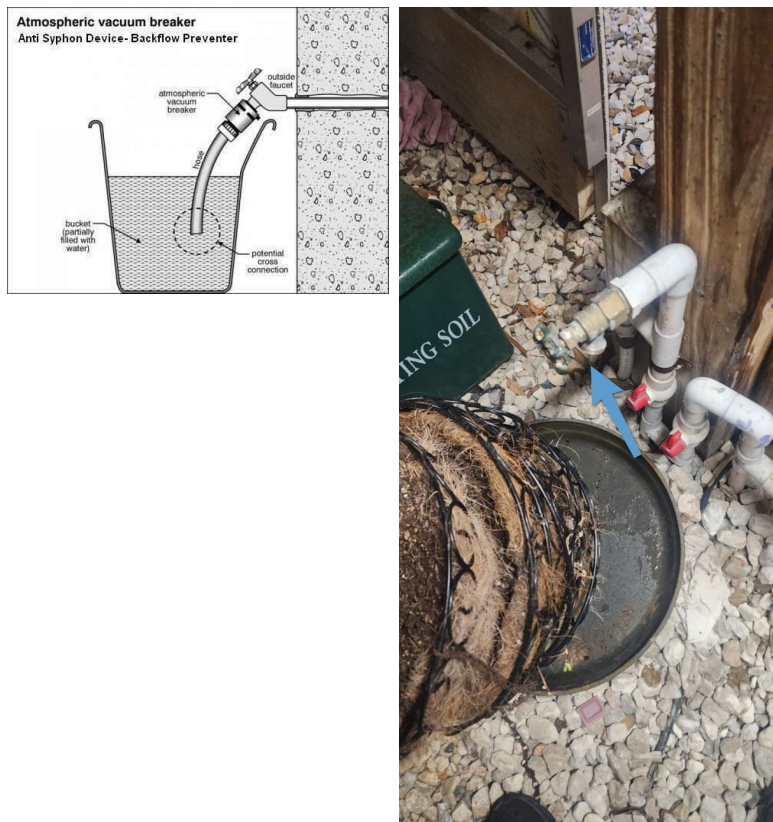
Water hose bib's (spigots) on the exterior of the home should have anti-siphon/ back flow prevention devices installed on them to keep the supply lines from being contaminated with trash or severe flood waters.

Recommendation: Contact a handyman or DIY project

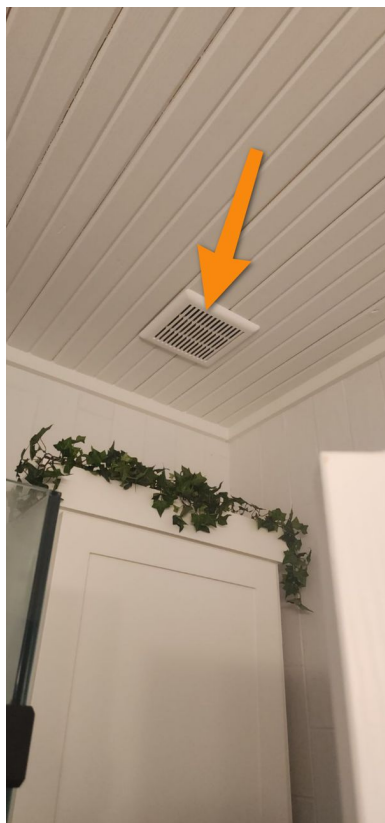
Garage apartment bathroom

There are one or more exhaust fans that are loud or not operating in the home that should be repaired or replaced.

Recommendation: Contact a qualified electrical contractor.

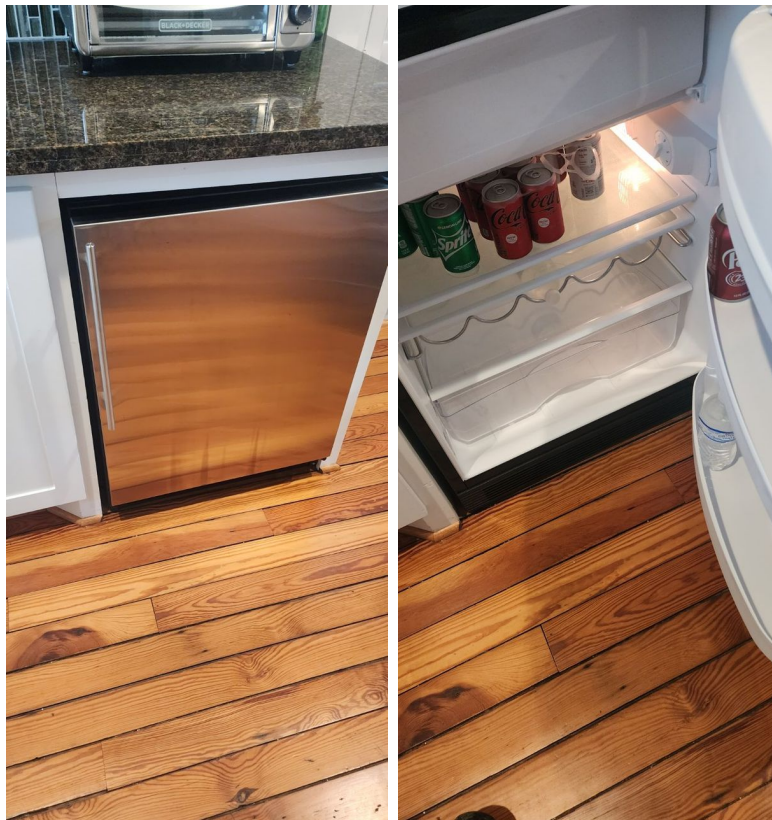
1: Freezer needs to be thawed

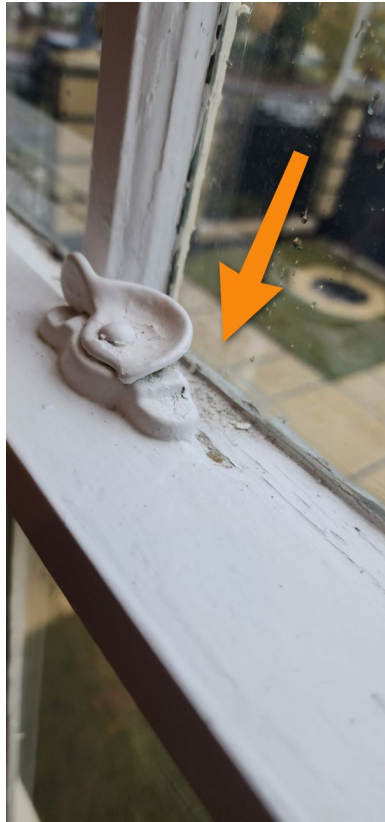
There are one or more windows that have latch hardware that is either damaged or missing.

Missing lock at living room Southeast corner

Recommendation: Contact a qualified professional.

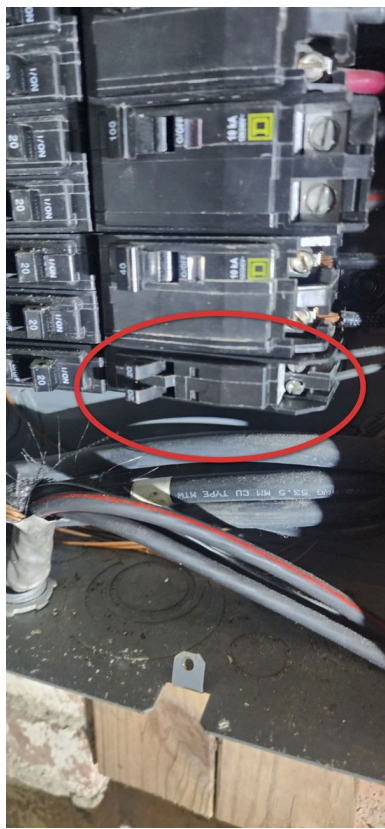
First subpanel box at Southwest corner of crawlspace

The bottom left double breaker on the first subpanel at the Southwest corner of the crawlspace was covered by the service front because the knockout was not removed. Highly recommend that a qualified electrician remove the knockout so the breaker functions properly.

Recommendation: Contact a qualified electrical contractor.

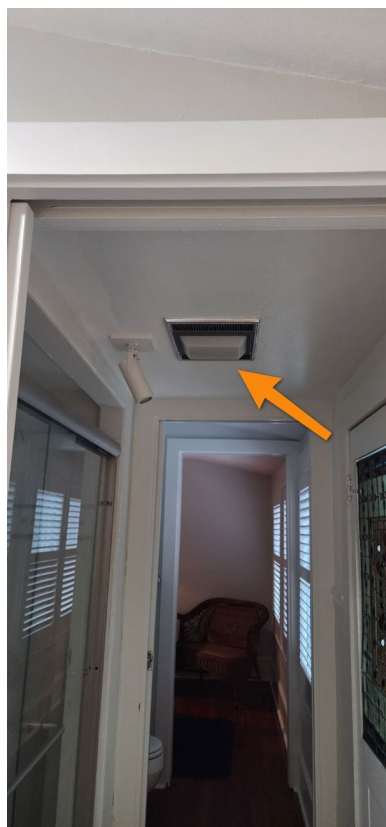
2nd Floor not functioning

Recommendation: Contact a qualified professional.
