Total Home Inspection

Property Inspection Report

1859 E Lake Dr, Huntsville, TX 77340 Inspection prepared for: Mario A. Marquina Zulyema E. Avelar Real Estate Agent: Rolando Martinez -

Date of Inspection: 11/13/2023 Time: 1:00-3:30PM Age of Home: 2017 Size: 2217 Weather: 60's intermittent light rain Order ID: 3611

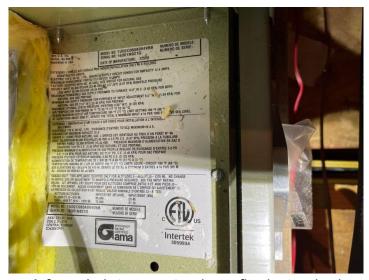
Heating, Ventilation and Air Conditioning Systems Heating Equipment

A forced air type, natural gas fired, standard efficiency furnace located in the attic was manufactured by Trane in 2016. Furnace serviced the home with 80k btu's. Furnace was operated, covers were remove and interiors observed.

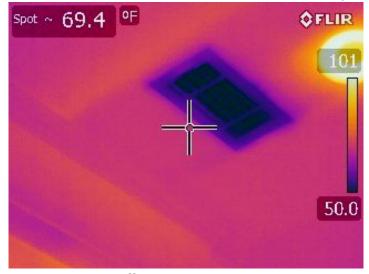
Evaporator unit manufactured by Trane in 2016. The Condensing unit manufactured by Trane. Unit appeared to be 3.5 ton. The Condensing unit manufactured by Trane. Unit appeared to be 3 ton, 14 SEER, using 410a refrigerant. Per the manufacturer's label, max amps on breaker should be 25. Per the labeling on the electrical panel, AC was connected to a 25 amp breaker.

AC was cooling properly. Temperature differential measured 70-50=20 degrees between air supply and registers. Typical range should be 14 to 21 degrees.

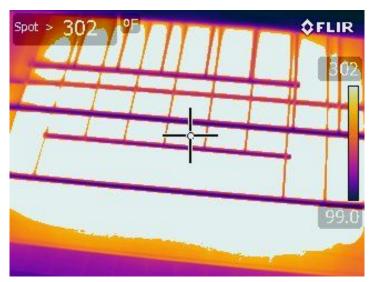
Appliances Ranges, Cooktops, and Ovens

Kenmore four burner gas powered cooktop oven combo.
