# HVAC Report

**Property Address:**  
18522 Royal Mist Lane  
Tomball Texas 77377

**Date of Inspection**  
1/15/2020

**AIM Air Conditioning**

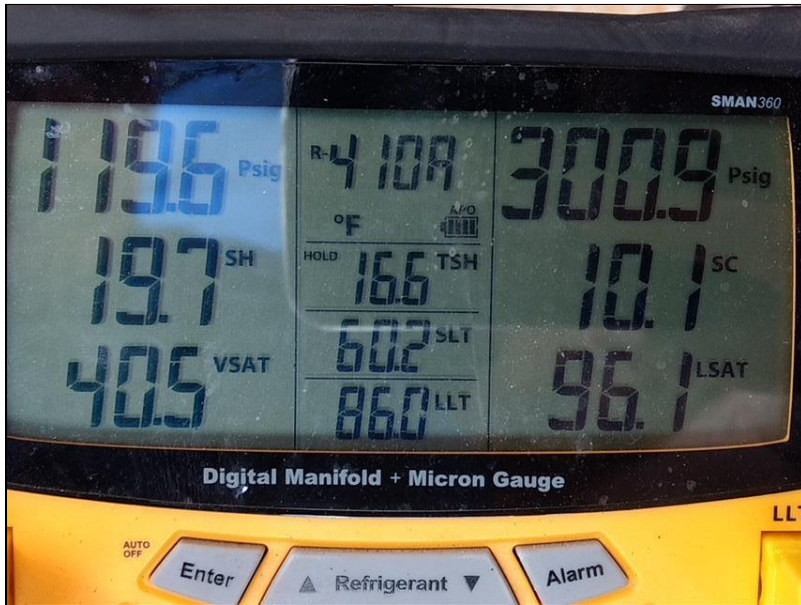
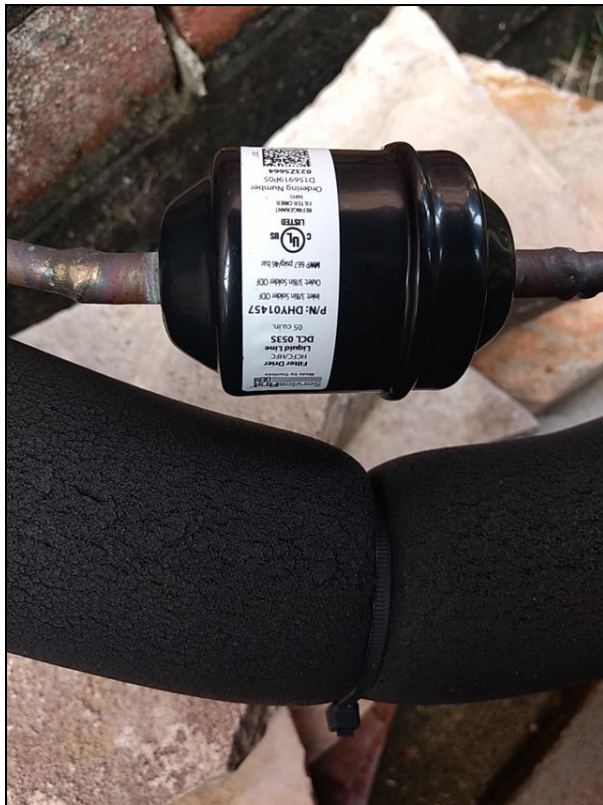
**B. Gauge readings.**

Operating pressures are excessive for the ambient temperatures. It is possible the system is over charged. If adjusting the refrigerant charge cannot bring the pressure to an acceptable level without negatively affecting the subcool and superheat, it is likely the dryer is restricted or other defect exist causing a restriction.

Liquid line dryer

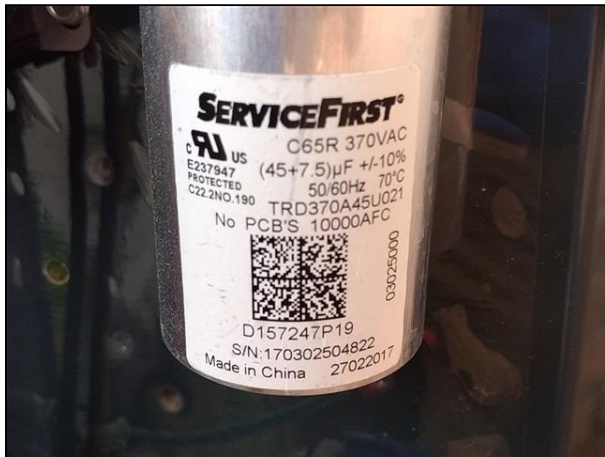
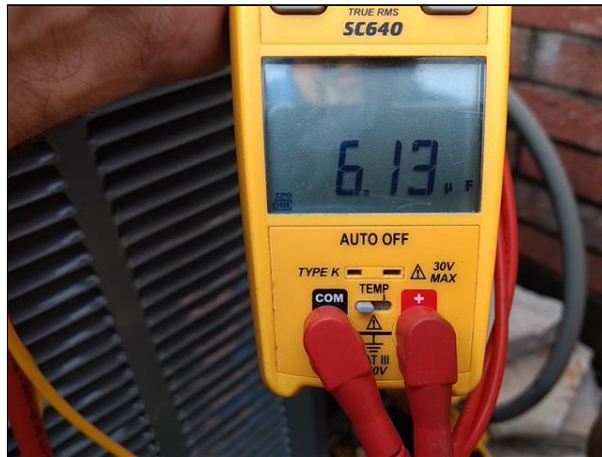
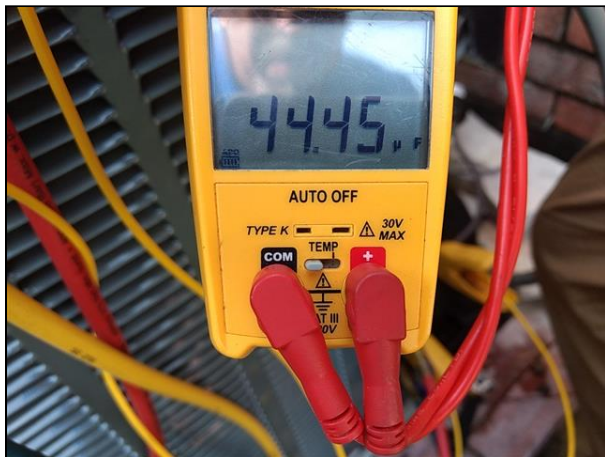
B. The compressor capacitor tested in acceptable parameters. This component appears to be functioning as intended..

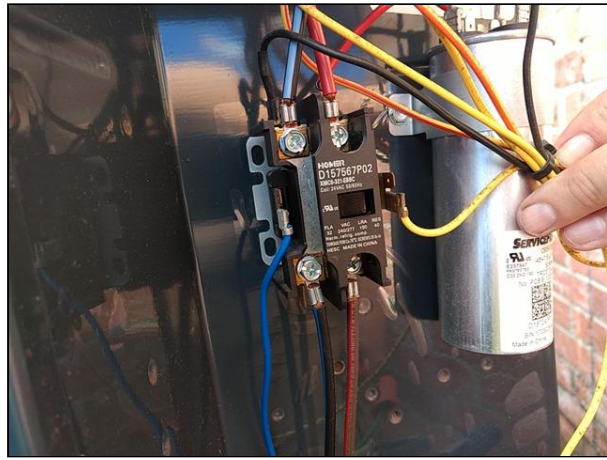
B. The contactor is sealed and not accessible for inspection.

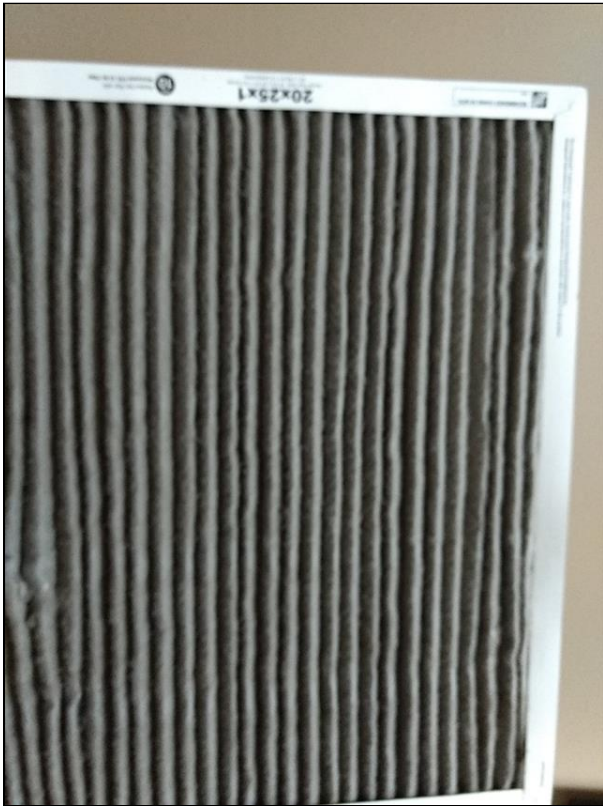
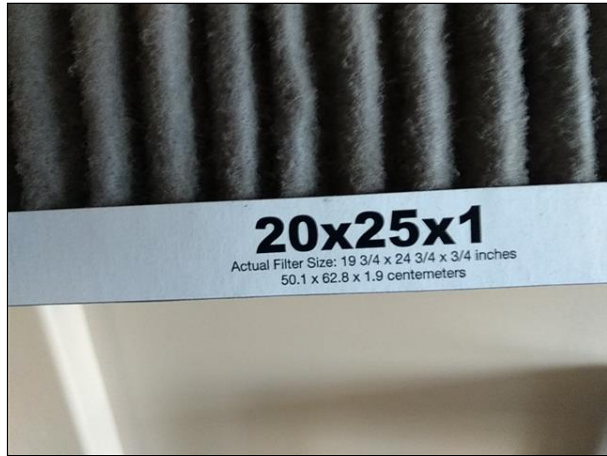
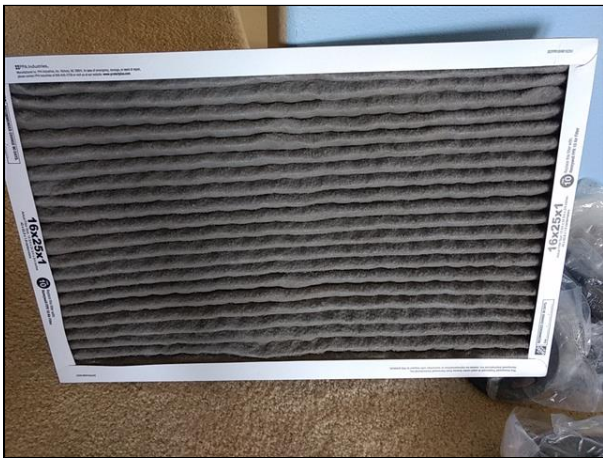
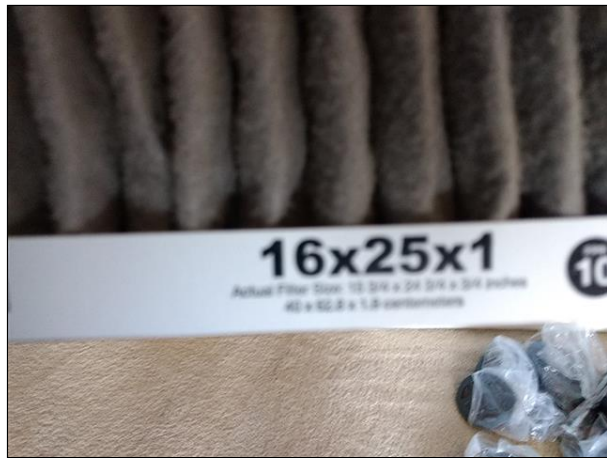
E. Air filter(s) are dirty. The filter(s) should be replaced.

#### 2. Air filter(s) are dirty. The filter(s) should be replaced.

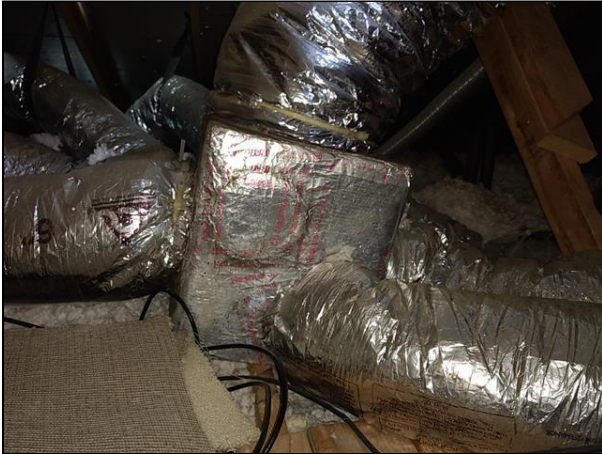
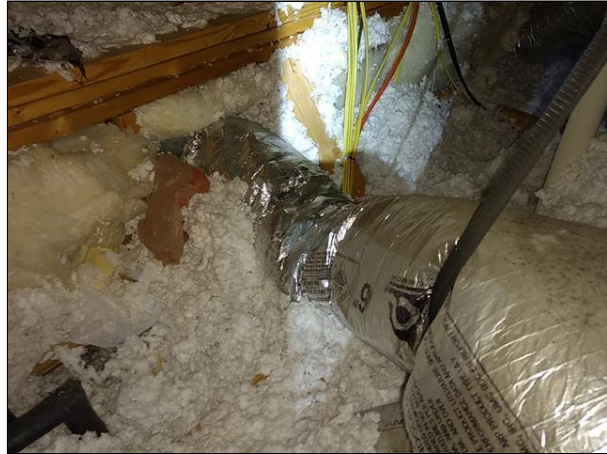
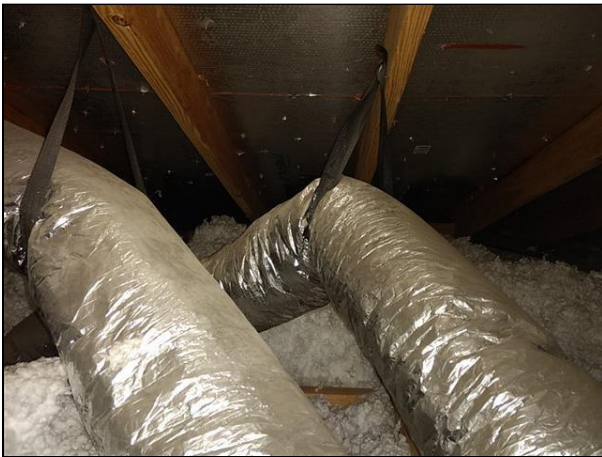
**E.** Ductwork in the lower attic is not properly supported. The ductwork has excessive bends restricting air flow. Ductwork is in contact with other ductwork. Typically ductwork should be separated to prevent condensation between ducts. The conditions should be corrected.

#### 3. Ductwork in the lower attic is not properly supported. The ductwork has excessive bends restricting air flow. Ductwork is in contact with other ductwork. Typically ductwork should be separated to prevent condensation between ducts. The conditions should be corrected.
