GREATER HOUSTON AREA - NOBLE PROPERTY INSPECTION REPORT

5915 Cypresswood Green Dr Spring, TX 77373

PROPERTY INSPECTION REPORT FORM

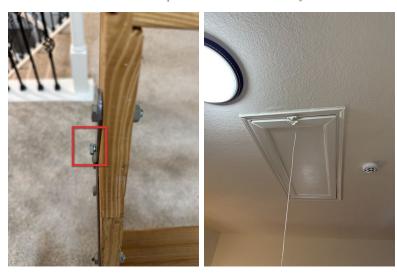
2: Attic ladder damaged

▲Safety Hazard

The attic ladder is damaged or was installed at an incorrect height. Unsafe. Recommend replacement of the ladder.

Recommendation: Contact a qualified Houston - Handyman Service

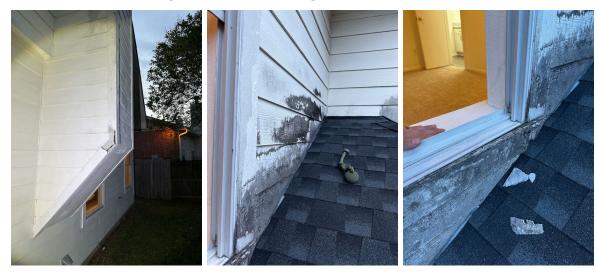
Wall exhibits an area where water intrusion can occur and has likely occurred in the past. The is a large crack, hole, or other area that will likely leak during a rain event. This deficiency, if not resolved, could eventually lead to more serious structural damage and wood rot. It is also an area where insects can enter. Recommend contacting a qualified professional to seal.

Recommendation: Contact a qualified Houston - Roofing Professional

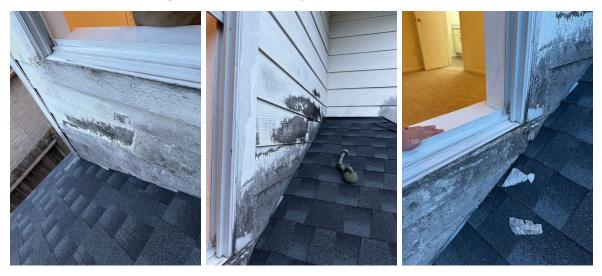
6: Mildew / moss / algae stains present

Mildew, moss, or algae stains are present in areas of the structure's exterior. Areas that build up these green stains and growth are often higher in moisture and relative humidity and will need to be cleaned more frequently. Recommend power-washing and/or cleaning of the stain off of the exterior. Monitor and clean frequently.

Recommendation: Contact a qualified Houston - Handyman Service

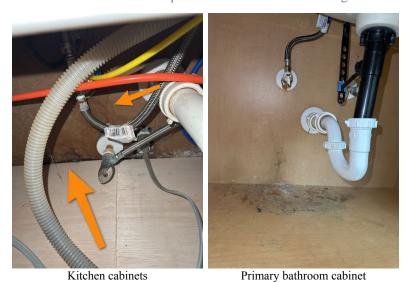
7: Cabinet - water damage

One or more areas of the cabinet show signs of water damage. This may be caused by rain water inundation or leaking of the plumbing fixtures from above. Particularly in older structures, signs of water damage under the sink cabinets including stains, warping, and sagging flooring could be from previous leaks and are common discoveries. An active leak could mean the presence of mold. Recommend monitoring for future leaking, repainting, mold testing, and replacement depending on clients opinion and severity.

Recommendation: Contact a qualified Houston Area - Painting Contractor

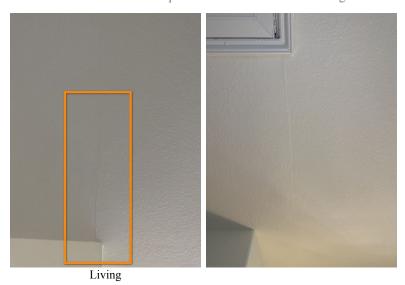
1: Ceiling - sheetrock cracks minor

Minor sheetrock cracking was observed on the ceiling. This is common in structures this age and is often determined to be cosmetic, most often the separation of drywall tape joints. Recommend patching, repainting, monitoring these locations for further cracking.

Recommendation: Contact a qualified Houston Area - Painting Contractor

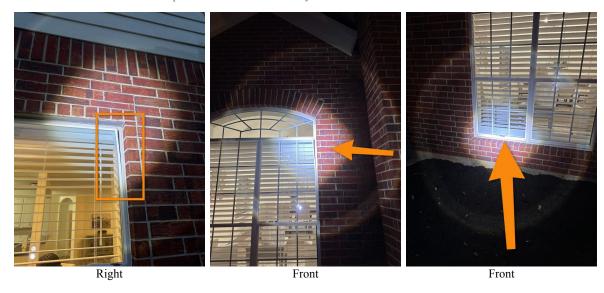
1: Window glazing has deteriorated

The window glazing (glazing is the material that holds the window glass in the frame) has deteriorated. Recommend replacement of the window and/or glass.

Recommendation: Contact a qualified Houston - Handyman Service

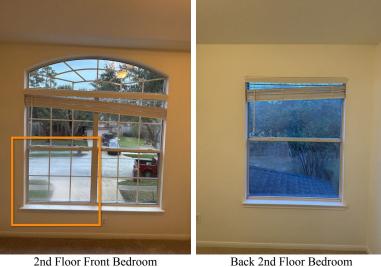
Back 2nd Floor Bedroom

7: Window leaks at sill

The window sill shows signs of a window leaking water down the walls and onto the sill. This is common in structures that lack the correct flashing or necessary caulking on the exterior siding to prevent water intrusion. Recommend re-caulking the windows exterior trim or having a siding contractor evaluate a remedy as necessary.

Recommendation: Contact a qualified Houston - Handyman Service

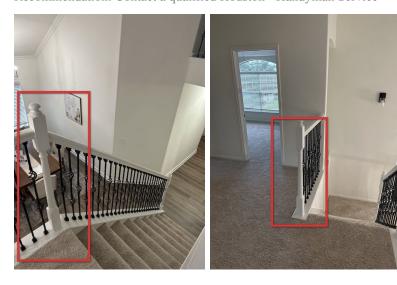
1: Loose handrail structure

▲Safety Hazard

The stairway and/or balcony handrail is loose and unsupported. This is considered a safety issue and should be strengthened or replaced with a sufficient handrail structure, handrail, and baluster system.

Recommendation: Contact a qualified Houston - Handyman Service
