Date: June 28, 2023

Subject: Standard Initial Foundation Repair Evaluation
Slab Foundation
520 Rs County Road 3445, Emory, TX

LIMITED REPAIR PLAN

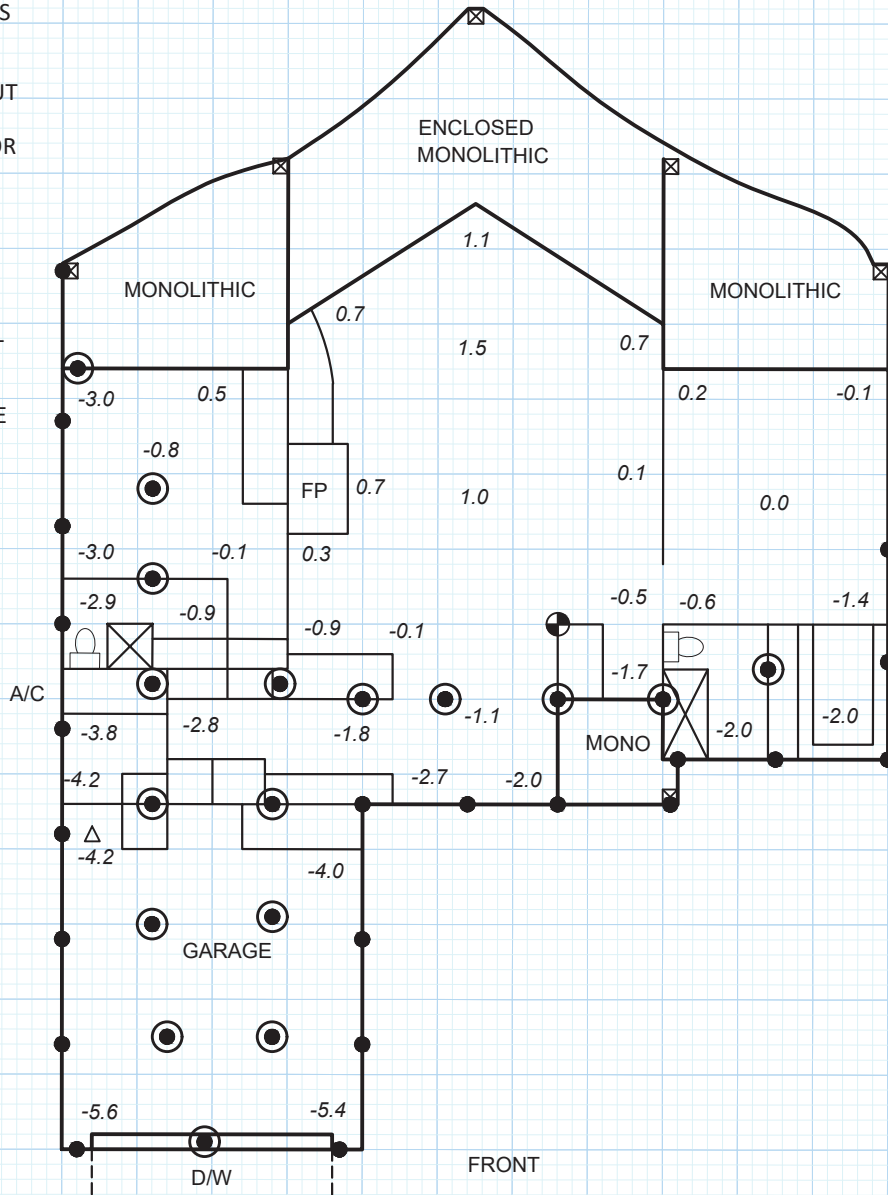
Based on the current elevations recorded and observations of damages there is a significant tilt in the foundation with the rear being highest and sloping towards the front and front-left garage area being lowest. Using the measurement recorded the actual calculated tilt does not exceed the 1% maximum allowable tilt as provided by the Texas ASCE Guidelines for the Standard performance of a Slab Foundation, however, this residence fails L over 360 for the flexion and there is a significant existing corresponding damage pattern along the front and left side. Brick cracks, drywall cracks, ceiling cracks, frieze board separations, garage brick separations, trim separations and a possible plumbing heave were observed. Based on our observations of the structure, the structure’s physical damage, and review of the elevation map, we believe the structure has experienced foundation movement over the life of the structure, resulting in differential movement of the slab-on-grade foundation.

Damage observations were notable on all sides and on the interior of the structure and are correlated with floor elevation data.

- Obtain a ground penetrating radar scan to identify interior concrete beam within the slab.
- Install 38 total pilings (21 exterior, 17 breakouts).
- Mud-jack/inject Uretek foam for void filling.
- Obtain a current plumbing leak test.

- OBTAIN A GROUND PENETRATING RADAR SCAN TO IDENTIFY INTERIOR CONCRETE BEAM WITHIN THE SLAB.
- INSTALL 38 TOTAL PILINGS (21 EXTERIOR, 17 BREAKOUTS).
- MUD-JACK/INJECT URETEK FOAM FOR VOID FILLING.
- OBTAIN A CURRENT PLUMBING LEAK TEST.
