## Mold Assessment Inspection Report

**Concerning:** 6900 Hansen Blvd, Groves, TX 77619

**By:** Curtis Carr on Friday, October 6, 2023

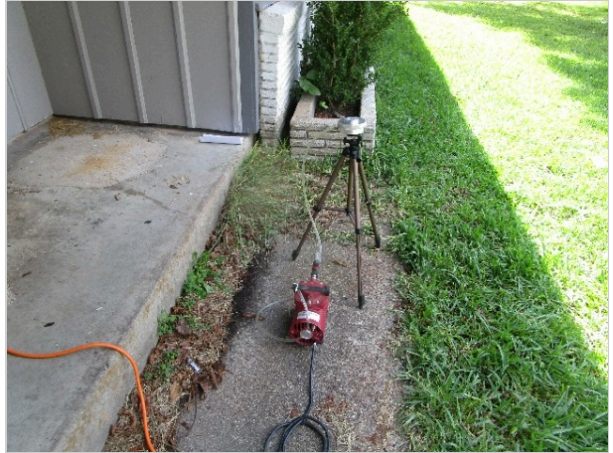
**Photo 2**

The overall total spore count was higher on the interior (14,000) than on the exterior (11,000). In the opinion of this consultant there exists a “**red flag**” regarding the interior levels of several molds.

exterior air sample

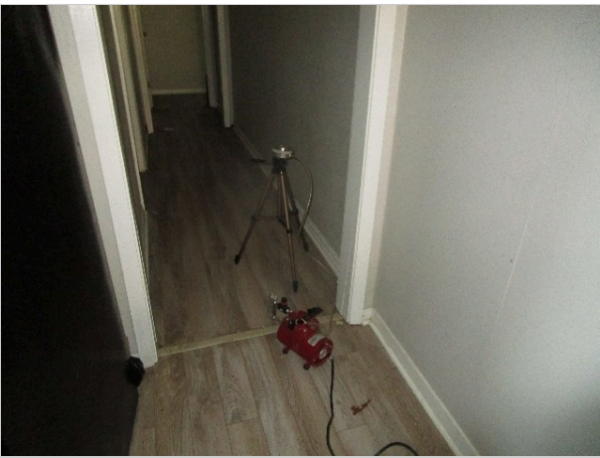
**Photo 3**

There is a particular concern of the Penicillium / Aspergillus group spore count which detected a 11,000 count on the interior with a 1400 count on the exterior.

interior air sample

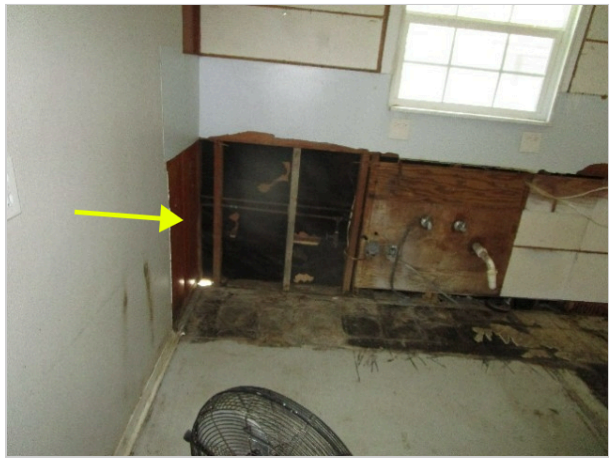
**Photo 4**

We were informed by the client that the home had sustained water penetration from a previous plumbing leak and had been partially gutted in the kitchen and utility room. We were asked to do a Mold Assessment of the home.

kitchen partially gutted

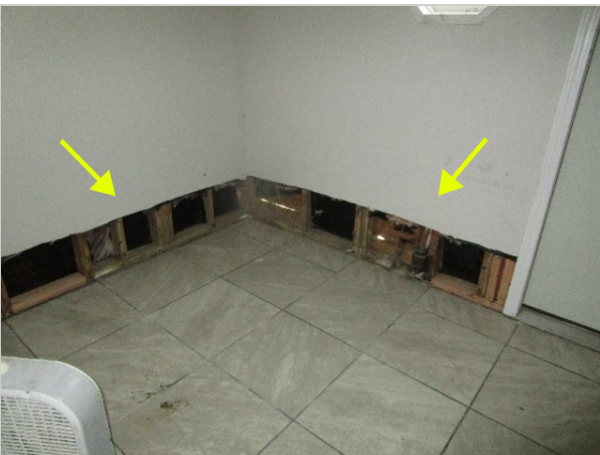
**Photo 5**

utility room partially gutted

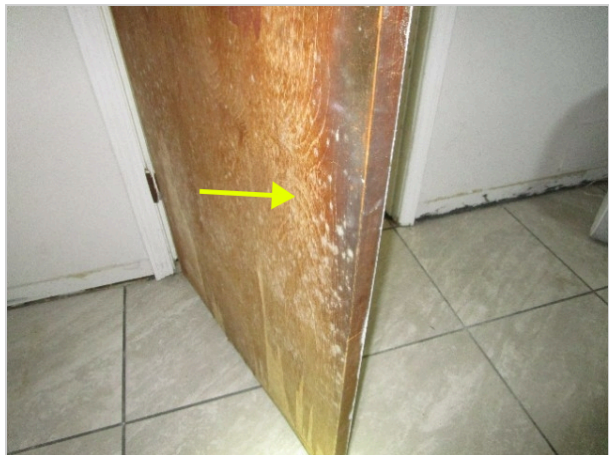
**Photo 6**

- The laboratory identified the growth on the door as Penicillium / Aspergillus group spores and Cladosporium spores.
- The laboratory identified the growth in the bathtrap as Penicillium / Aspergillus group spores.

In the opinion of this consultant there exists a “**red flag**” regarding the area(s) noted.

swab sample taken from door

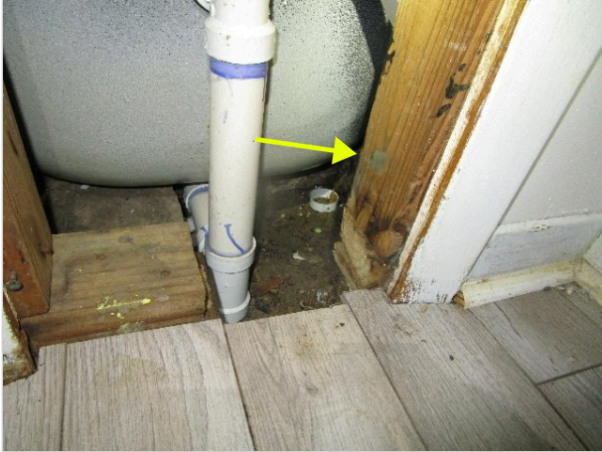
Photo 7

swab sample taken from bathtrap
