# Inspection Report

**Property Address:**  
16747 Village View Trail  
Sugar Land TX 77498

## PROPERTY INSPECTION REPORT FORM

12/13/2023

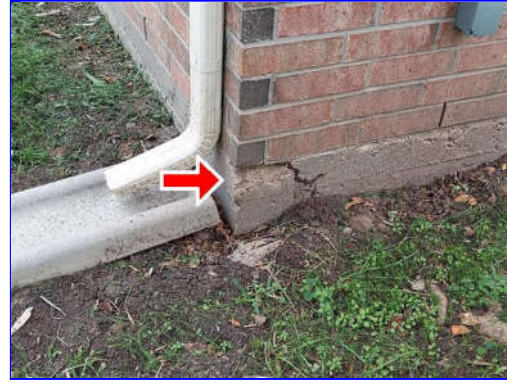
A. Item 37(Picture)

(6) Crack(s) was/were observed in the foundation wall(s). The crack(s) should be monitored. If significant changes occur a foundation specialist should be consulted.

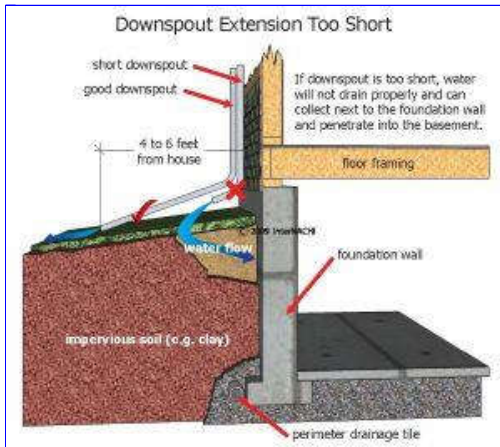
B. Item 4(Picture)

(2) The downspout need an extension with splash block to carry water away from the foundation. Failure to add these extensions may potentially adversely affect the foundation performance long term.

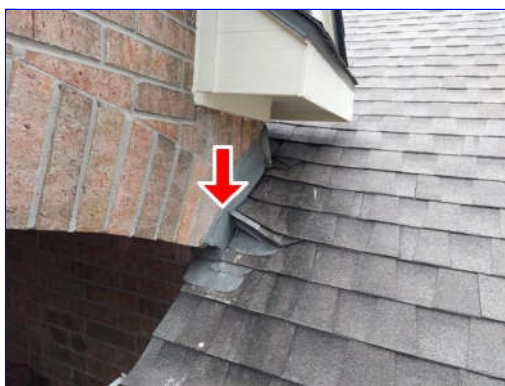
C. Item 31(Picture)

(5) Kick out flashings were observed to be missing. Kick out flashings should be installed to help direct the water away from the home. Bent counter flashing is not a substitute for proper kickout flashings. A qualified, verified roofing contractor should be consulted regarding repairs.

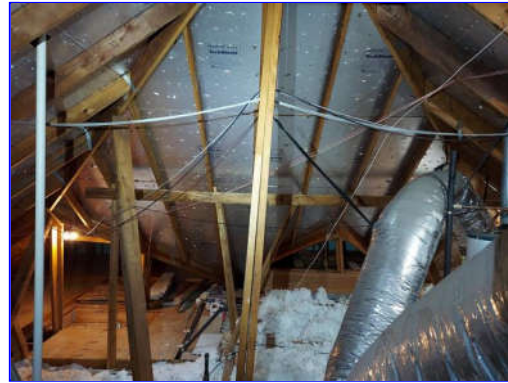
D. Item 8(Picture)

(3) The pull down stairs were observed to have the following defect(s): missing insulation, missing weather stripping and weak and not stable. This can be a potential SAFETY HAZARD.. Repair or replacement should be made.

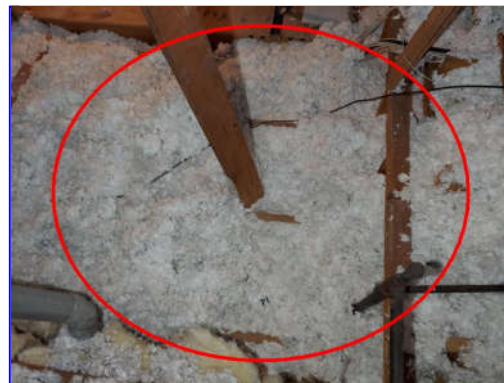
D. Item 14(Picture)

(5) Vent baffle(s) was/were observed to be dislodged or missing. Vent Baffle should be replaced/repared to prevent insulation from obstructing the soffit venting.

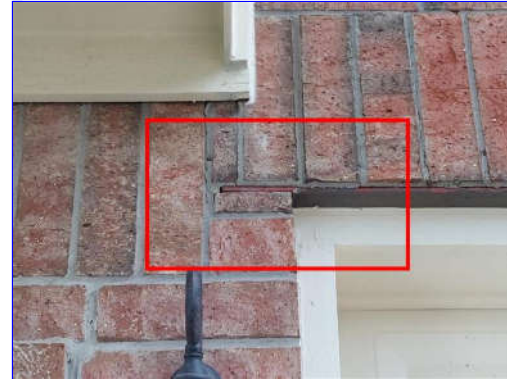
E. Item 21(Picture)

(6) Brick repairs were observed. The reason for these repairs is unknown. Some repairs maybe potentially related to foundation movement or repairs from foundation movement. There is no way for the inspector to determine the exact cause for these repairs.

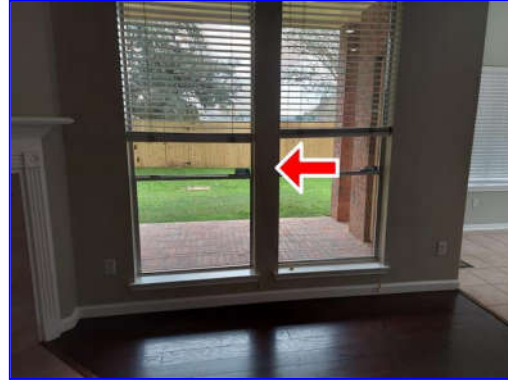
H. Item 7(Picture)

(4) Loose "sprung" window balancers were observed at various locations. This affects proper operation of the window.

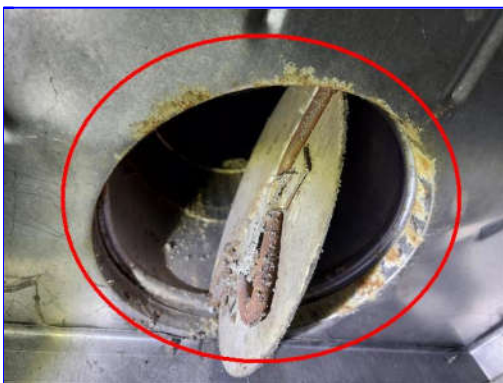
J. Item 7(Picture)

(5) The metal firebox was observed to be rusted at the time of inspection. The degree of this rust is unknown and there is potential for safety and fire hazards should the rust penetrate the firebox during a fire. A qualified, verified chimney sweep/professional should be consulted for a more in depth inspection prior to use.

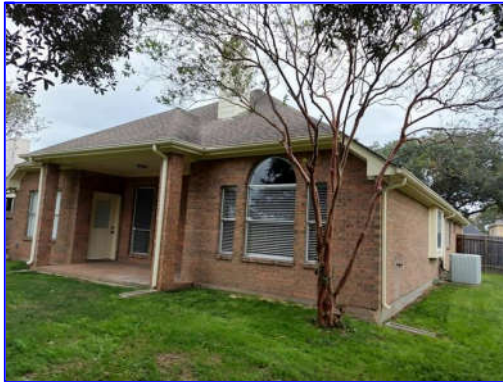
L. Item 6(Picture)

(2) Ants were observed at the foundation. A licensed pest control professional should be contacted regarding this condition.

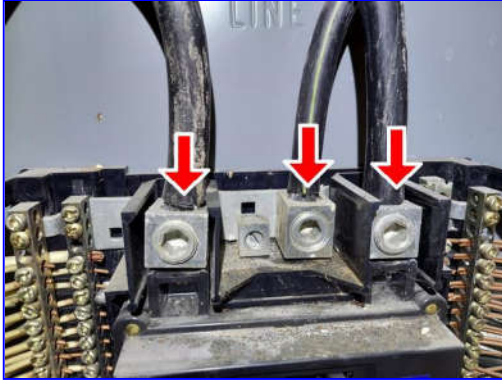
A. Item 5(Picture)

(4) Cables at breakers are white, an improper color code for these cables.

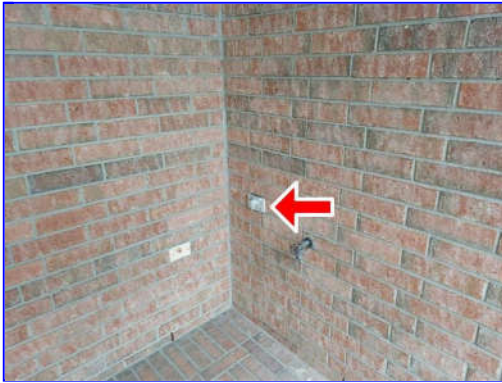
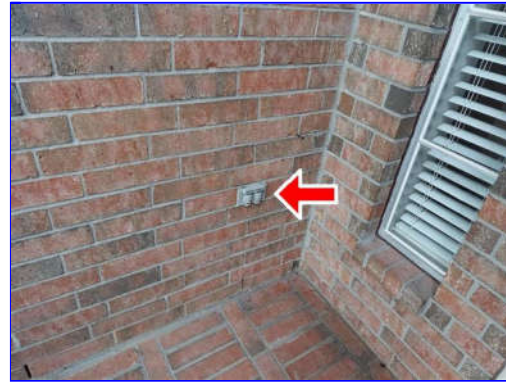
(4) One or more receptacles was/were observed to have the following defect(s): loose in wall. A qualified, verified, licensed electrician should be consulted regarding further evaluation.

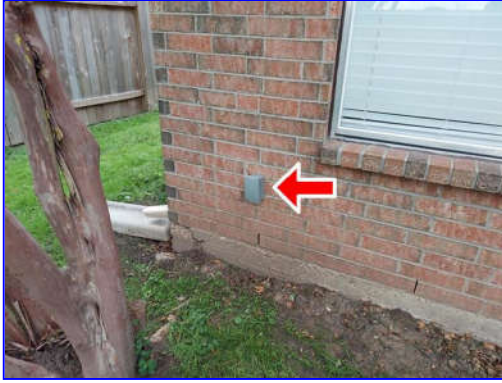
B. Item 3(Picture)

(5) One or more receptacle(s) in various locations was/were observed to have the following defect(s): are inoperative. Repairs should be performed by a qualified, verified, licensed electrician.

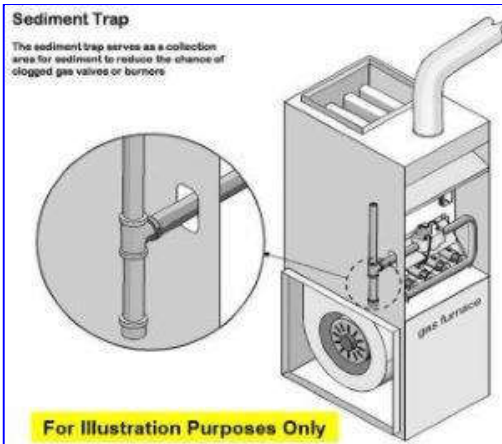
A. Item 9(Picture) Sediment trap

(4) The heater/furnace gas supply line is not equipped with a sediment trap just before the appliance connector. This condition does not meet current installation requirements and should be corrected. Sediment traps prevent debris from entering the gas controls and causing hazardous malfunctions. A licensed, qualified plumber should be consulted regarding this condition.

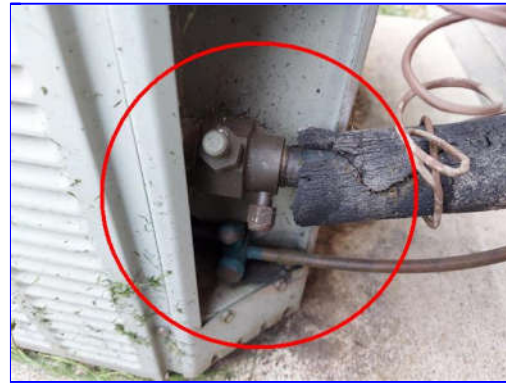
B. Item 10(Picture)

(6) The refrigerant hood is in need of caulking improvements to prevent moisture or insect/vermin entry points. The top and sides should be caulked, as well as any opening sealed, but the bottom should not be caulked to allow any trapped moisture to escape.

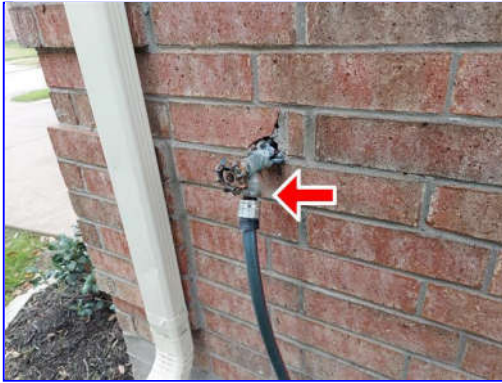
A. Item 3(Picture)

The hose bib(s) was/were observed to have the following defect(s): leaks at anti-siphon and valve when turned on.

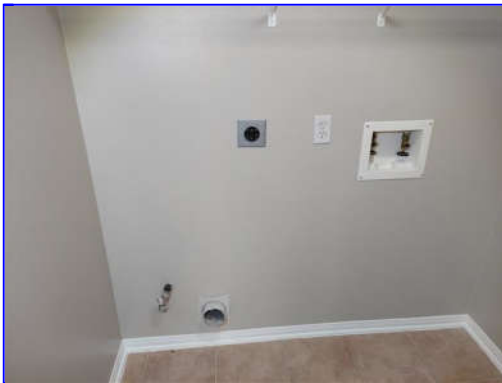
A. Item 5(Picture)

Corroded fitting(s) was/were observed. Fitting(s) was/were not observed to be leaking at the time of inspection but should be monitored. A qualified, verified, licensed plumber should be consulted regarding repairs as needed.

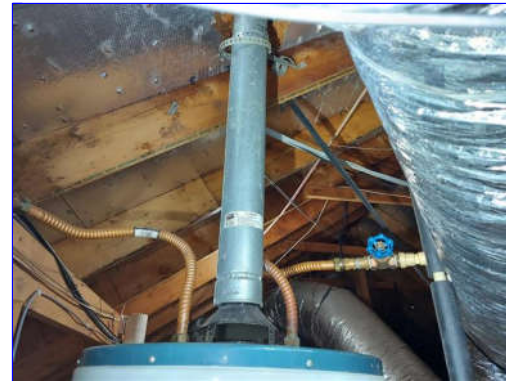
C. Item 4(Picture)

(2) Excessive water temperature was observed at the time of inspection. Temperatures above 120°F are a scald risk and a safety concern. Burns are possible with excessive water temperatures. In the event ill advised temperatures above 120°F are maintained, thermostatic mixing valves shall be installed at the out flow of the water heater supply piping or at all individual appliance fixtures to prevent scald injuries. As the homeowner you are responsible for the regulation of your water temperature and all of the effects encountered from this action.

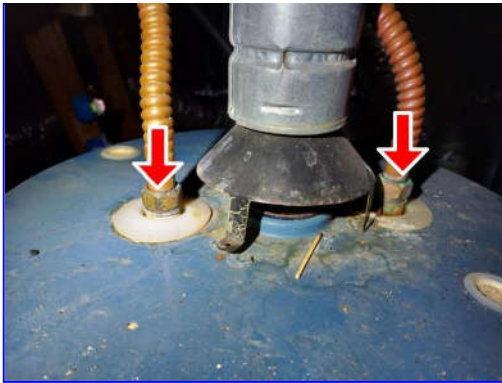
C. Item 7(Picture)

(3) Corroded fitting(s) was/were observed. Fitting(s) was/were not observed to be leaking at the time of inspection but should be monitored. A qualified, verified, licensed plumber should be consulted regarding repairs as needed.

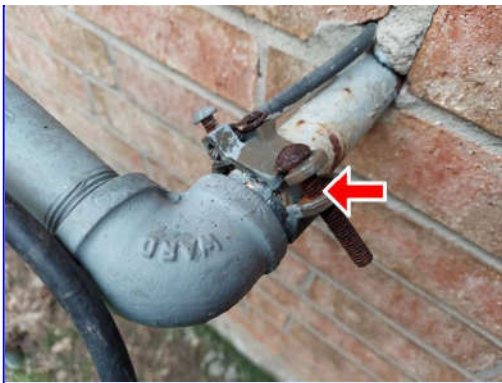
E. Item 2(Picture)

(2) The gas meter and/or clamp were observed to be painted. Direct metal to contact is required for this system to function properly. A potential safety hazard exists if this is not corrected. Repair should be made.
