## RESIDENTIAL INSPECTION

46962 US-290 BUS  
Hempstead, TX 77445

# PROPERTY INSPECTION REPORT FORM

Abel Peña <i>Name of Client</i>	03/25/2024 2:00 pm <i>Date of Inspection</i>
46962 US-290 BUS, Hempstead, TX 77445 <i>Address of Inspected Property</i>	
Nicholas Ramos <i>Name of Inspector</i>	9041 <i>TREC License #</i>
<i>Name of Sponsor (if applicable)</i>	<i>TREC License #</i>

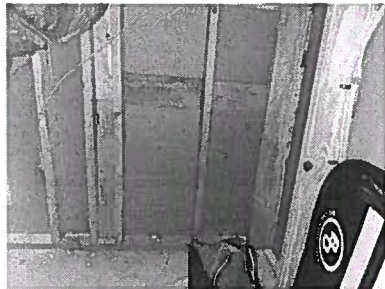
**2: Under-Stair Protection**

Fire block not present under stairs. Enclosed space under stairs that is accessed by a door or access panel shall have walls, under-stair surface and any soffits protected on the enclosed side with 1/2-inch (12.7 mm) gypsum board.

*We did not complete this project. We were going to make this a secret hiding place for our son and ~~to~~ install the walls.*

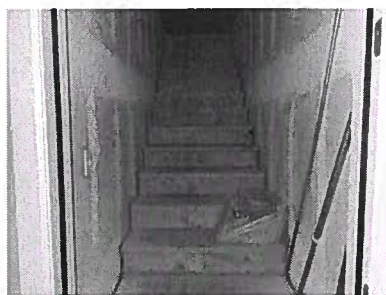
1: Handrail not Present

Handrails shall be provided on at least one side of stairways of three or more risers.

We use this space as an attic, not a living area. If space was completed we were going to add.

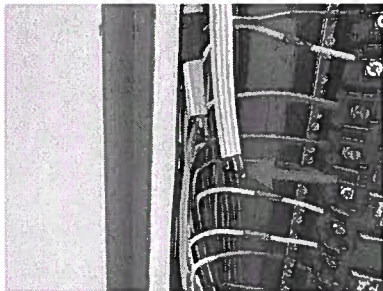
### 1: Abandoned Wires

Disconnected/abandoned electrical conductors observed in panel box, unable to determine prior use. Recommend consulting sellers for more information or have a licensed electrician review.

Wire is not abandoned. It was left intentionally as a spare for future use.

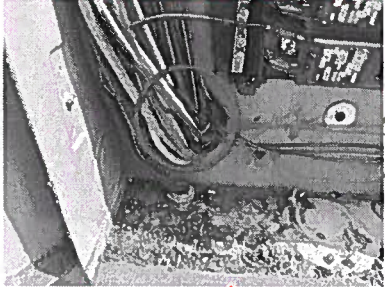
### 4: Bundling

Numerous branch circuit cables are improperly entering the main service entrance panel through a single large knock out located at the bottom of the panel box. Under current and past electrical

standards branch circuit cables shall be individually secured to the panel box, cabinet, cut out box, or meter socket enclosure with appropriate clamps at the knock out interface. The panel, as installed, does not comply with current and past fire regulations.

Per the local electrician that wired the house: This is a common argument between code requirements and what is considered by local authority having jurisdiction. The number of wire allowed to enter thru a single knockout depends on the manufacturer. This a 2" bushing. The practice of using a single chase nipple for a bushing is an industry standard and acceptable by local authority having jurisdiction (local city inspectors and utility companies). Otherwise, you would have a seprate hole in the panel and in the wall of the home for each wire which would cause water problems and rotten wood in the wall behind the panel.

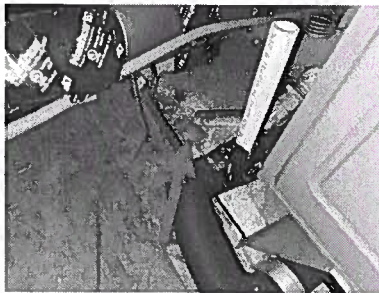
**1: Rusty Drain Pan**

Rust stains observed in the emergency overflow drain pan under the evaporator coil. Unable to determine if there is a leak present at A/C coil condensation pan/drain line, clogged condensate drain line or if due to previously corrected problems, suggest client consult with seller to determine if or when repairs were completed or a qualified HVAC specialist should be called for further review.

Bleach was split on the drain pan during routine maintenance causing the rust.

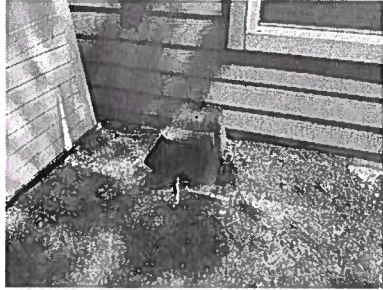
This picture is not of the supply valve. We used this "water main cover" to cover and hide the copper line that comes out of the wall for a third AC unit to be used if the attic space was converted to a liveable space.

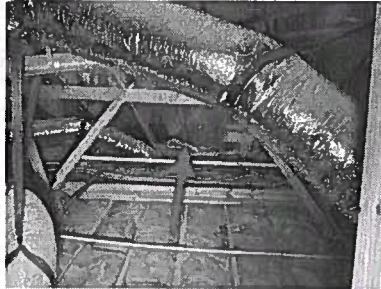
The mechanical exhaust fans vent into the soffit. The fans should vent outside to prevent moist air buildup in the attic. Venting to the soffit was common practice when this house was built. Standards changed to require the vents to terminate outside the building envelope. Later standards were further

clarified to require the vents to be directly vented to the exterior. Vents terminating into the soffit can result in back drafting and possible moisture damage to the soffit boards. This standard is reflected in the 2015 International Residential Code as follows: M1501.1 Outdoor discharge. The air removed by every mechanical exhaust system shall be discharged to the outdoors in accordance with Section M1506.3. Air shall not be exhausted into an attic, soffit, ridge vent or crawl space.

We did vent the master bath vents into the attic so there would not be one single vent pipe coming out of the roof in the front roof.
