Professional Real Estate Inspector Sam Hestand TREC #24118

Prepared for: Emmalee Webster

Date: 07/12/2023

18603 Canyon Cove Dr., Crosby, TX 77532

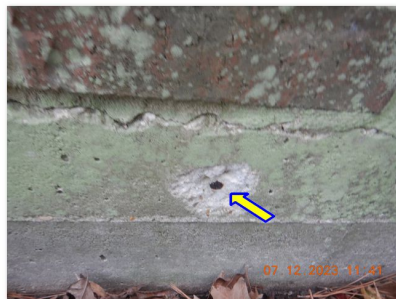
EXPOSURE:

Exposed or deteriorated slab reinforcing or rebar observed

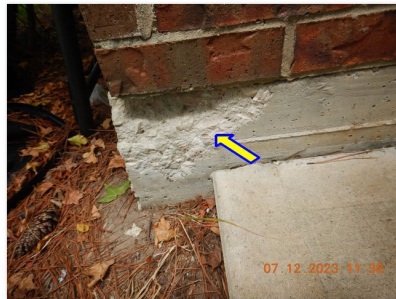
CORNER FRACTURES:

Corner fractures (possible insect penetration)

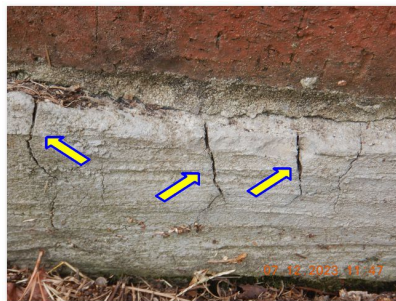
SLAB CRACKS:

Hairline cracks observed at the slab perimeter.

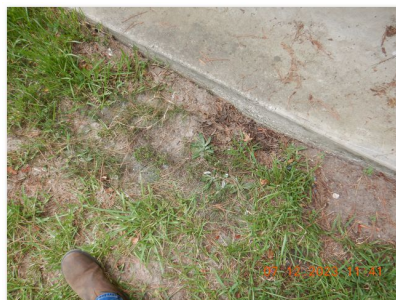
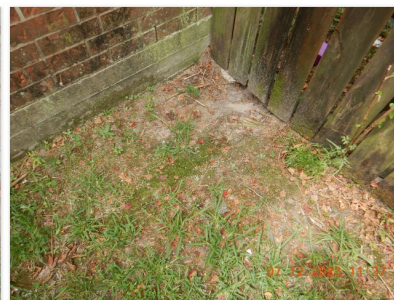
GRADING:

Evidence of ponding water was noted.

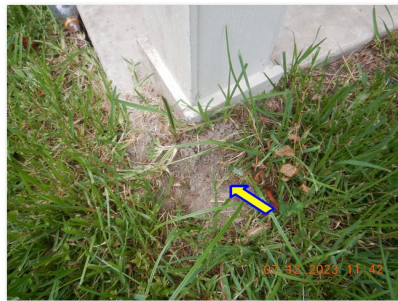
Insect activity was noted at some exterior locations.

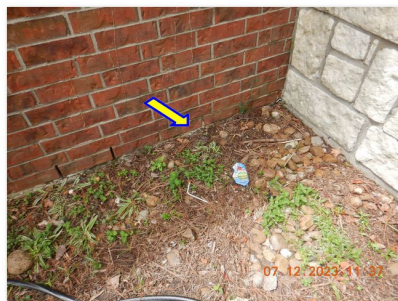
High soil levels exposed under brick surfaces.

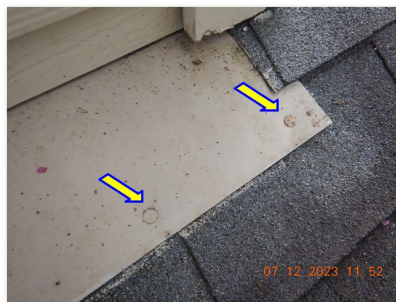
SHINGLES:

- Nail heads are exposed at the flashing and/or composition shingle.

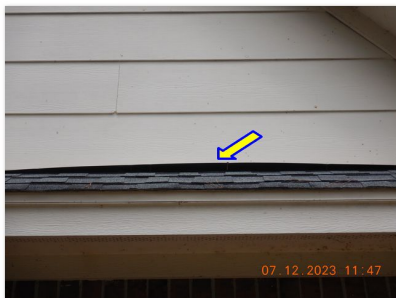
Some of the flashing has come up from the roof surface and should be re-secured.

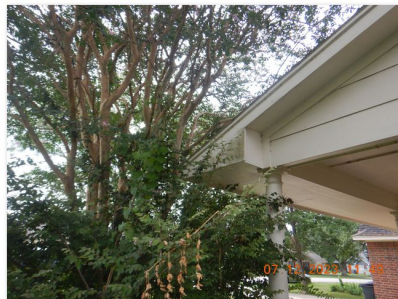
TREES:

The roof has tree limbs coming in close contact with the roof covering. Tree limbs can cause damage to the covering and allow access to the roof for unwanted pest. I recommend trimming back all tree limbs away from roof.

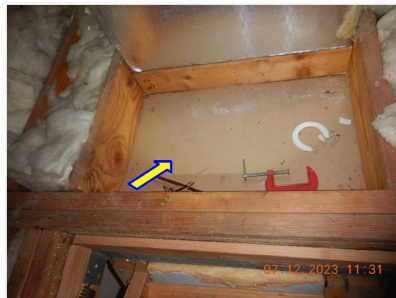
- There were areas that appear to be open between the attic floor and ceiling below.

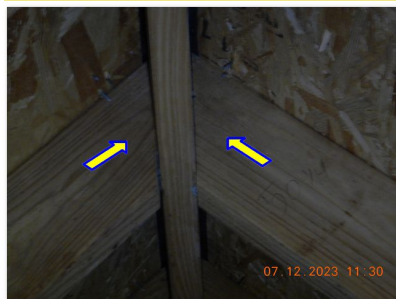
- ☑ Purlins at the attic are undersized. The purlins should be the same size as the roof rafters.

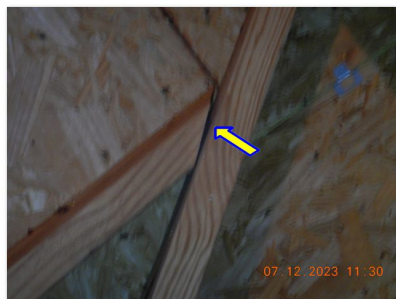
- ☑ Rafters cuts not flush at the ridge, hip and or valley boards in the attic.

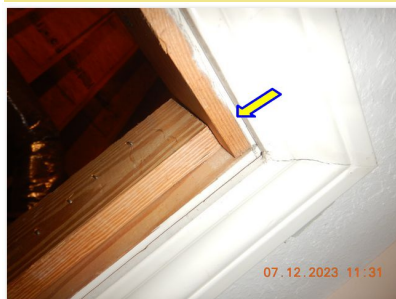
- ☑ Disappearing attic access ladder is not sealing properly at the attic. There is no weather strip installed at this location.

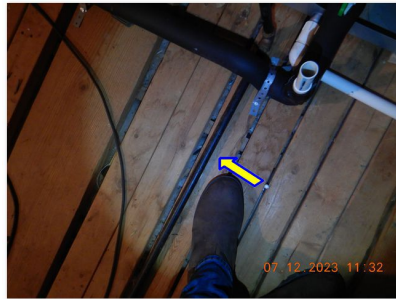
Gas pipes and/or wires and/or water lines are crossing directly over the top of the attic service walkway.

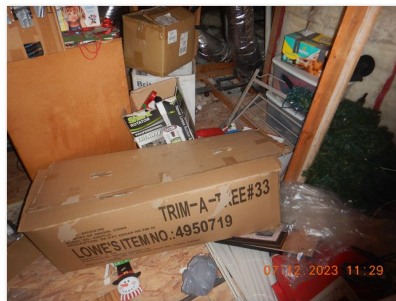
The construction debris and other material should be removed from the attic, or appropriately placed out of the way.

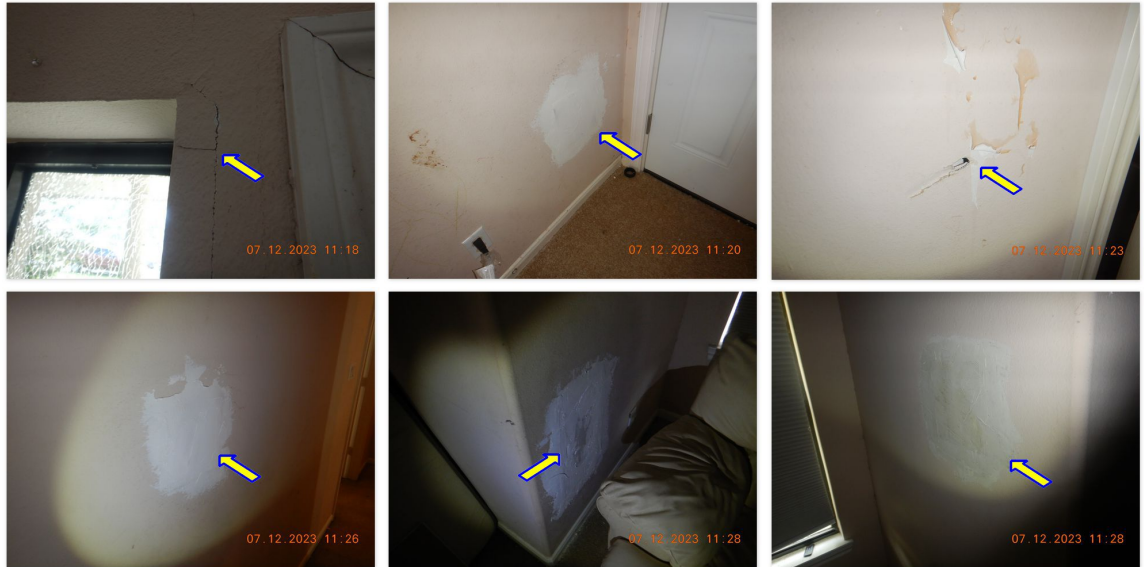
Cracks/damage/repairs in the drywall observed.

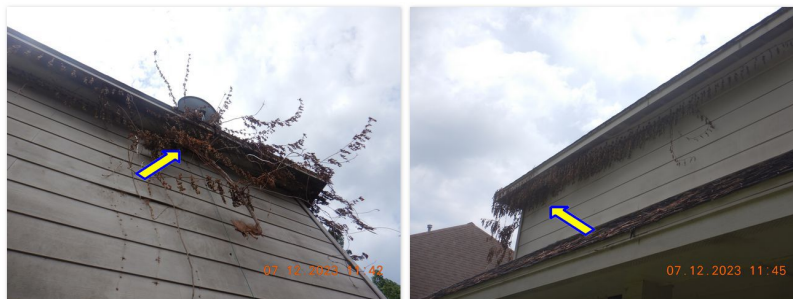
Ivy or vines observed attached to the exterior dwelling walls at the following locations: Right side, Back side. Ivy or vines attached to the dwelling can deface or deteriorate the exterior veneer, trap moisture against the exterior wall of the dwelling and create conducive conditions for wood destroying insects.

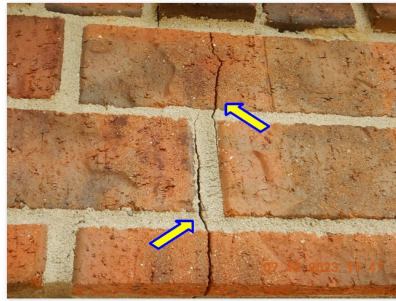
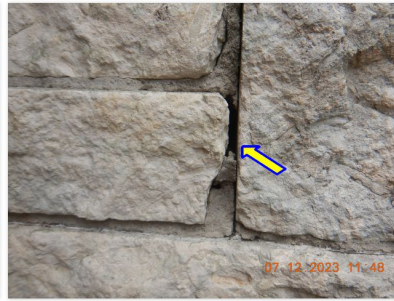
Cracks observed in the brick veneer and/or mortar were noted.

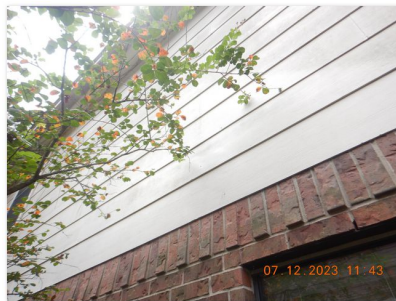
Vegetation should be trimmed away from the exterior.

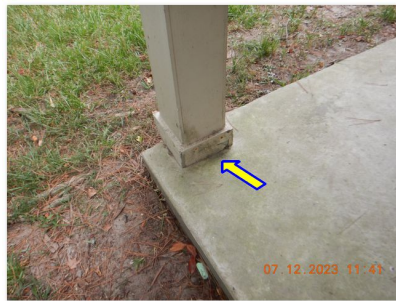
Siding at the patio is in direct contact with the flatwork. Water that accumulates at this location can cause the siding to rot/deteriorate.

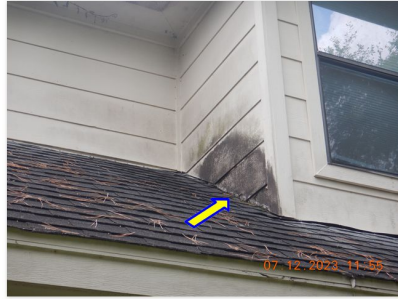
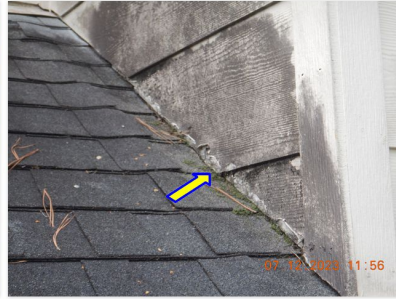
Exterior siding is in contact with the roof. Separation between the siding and roof covering will minimize moisture entrapment and deterioration of the siding.

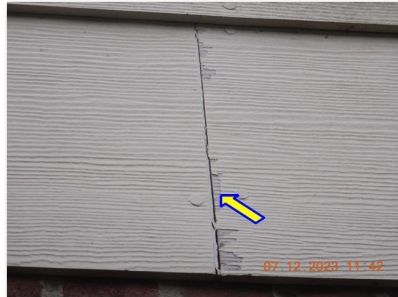
Caulking is needed at all joints and unsealed seams in the siding.

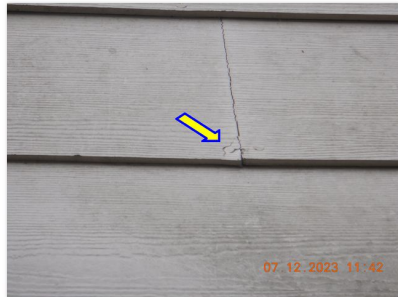
Cement board siding damaged at corner fasteners.

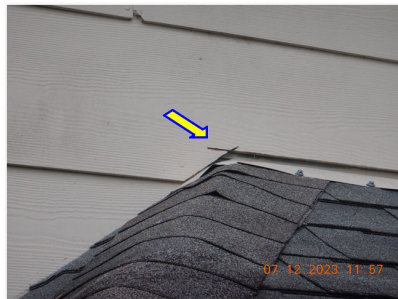
Areas where siding was over cut should be caulked.

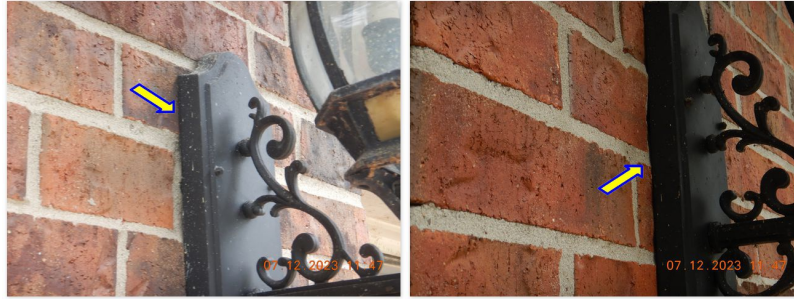
Caulking/sealant is missing around the exterior light fixtures where missing/deteriorated.

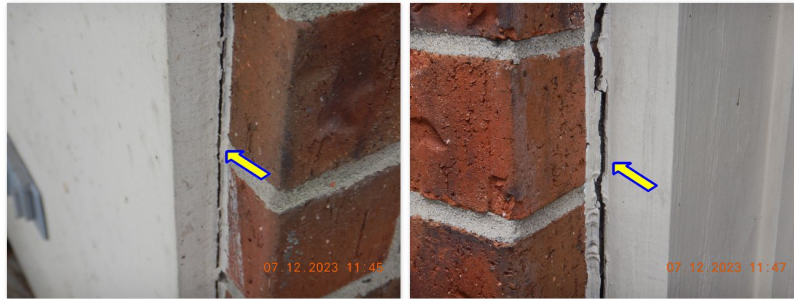
Vertical trim caulking missing or deteriorated.

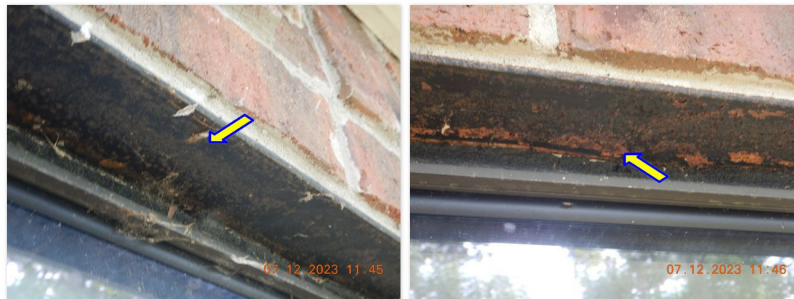
LINTELS:

Metal lintels are rusting above the doors and windows.

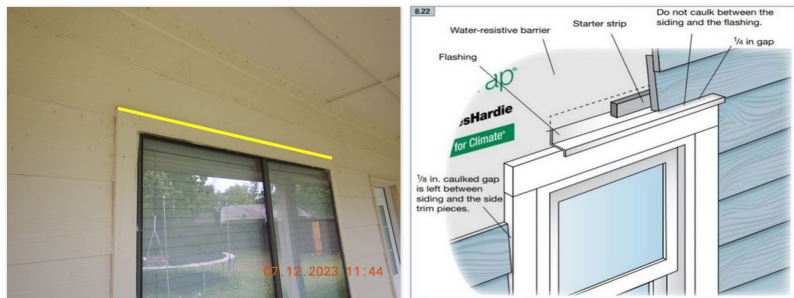
FLASHING

The window and/or door and/or other wall penetrations installed through the wood fiber products siding were not properly flashed.

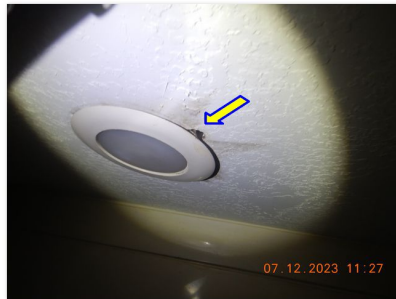
Cracks/damage/repairs in the ceiling drywall observed.

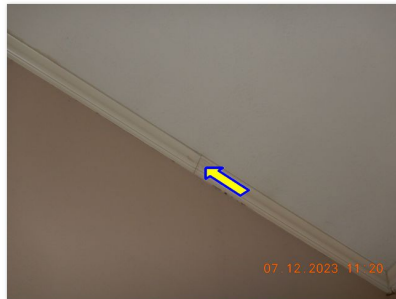
Ceiling trim is separated at some locations.

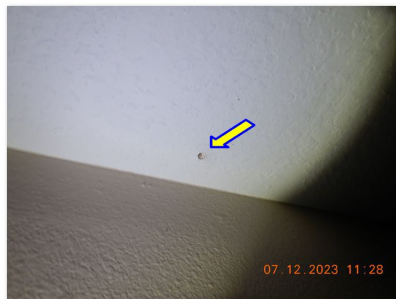
Nail pops in the ceiling drywall were noted.

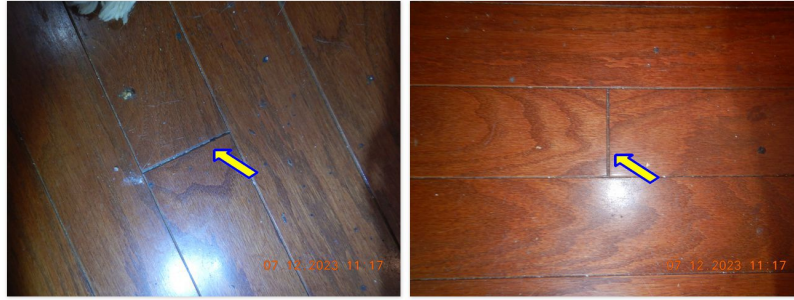
Flooring members are separated at some locations.

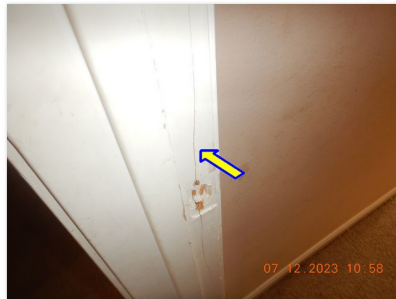
Door frame is cracked at the 2nd floor front left bedroom.

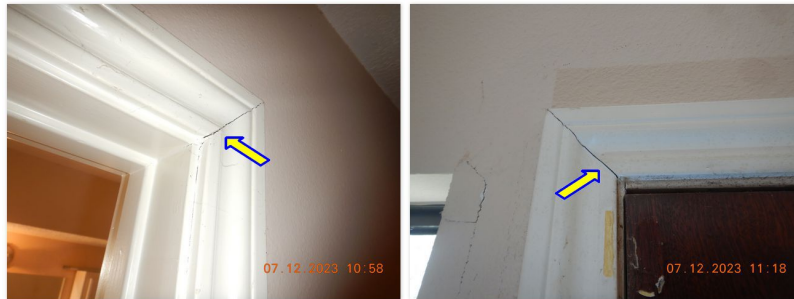
Door miter joints are separated at some locations.

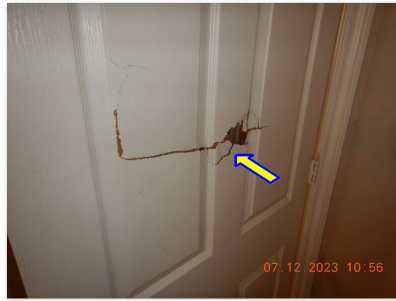
Door damaged at the following locations: 2nd floor back left bedroom.

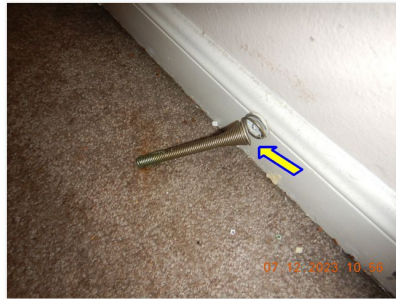
Door stop springs are missing at some locations.

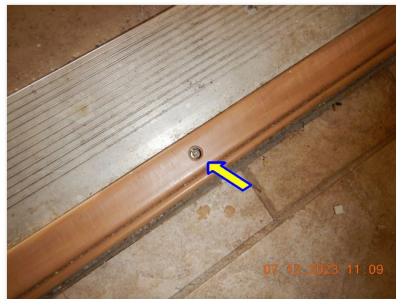
Door sweep screw covers are missing at some locations.

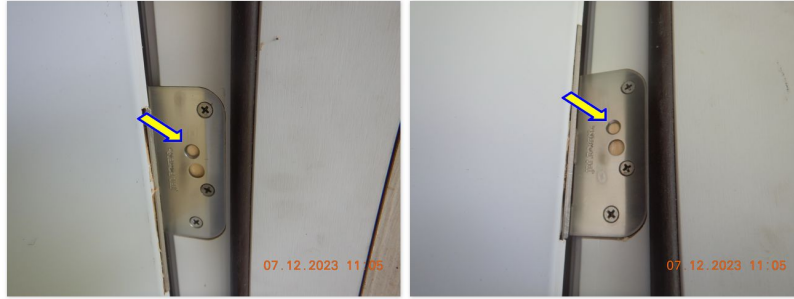
- Door hinge fasteners missing at some locations.
- Door knobs are loose at some locations.

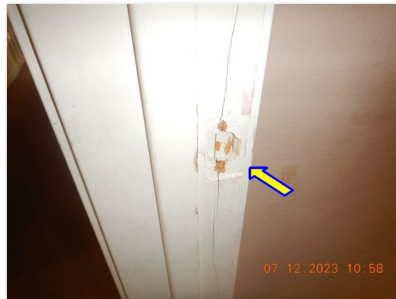
- Door strike plate missing at the following locations: 2nd floor front left bedroom.

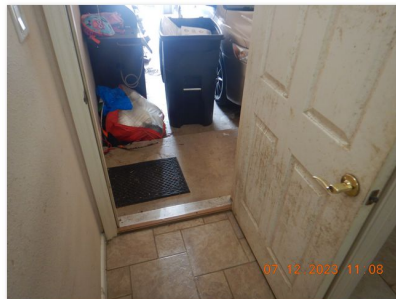
- Self closing hinges not properly tensioned at the garage entry door.

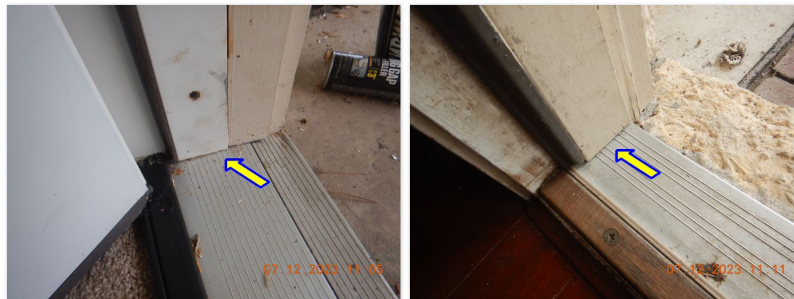
- Caulking around the door missing or deteriorated. Some Examples: Back patio, Front entry.

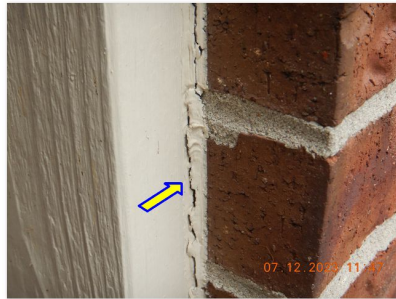
Caulking is deteriorated at the garage door trim.

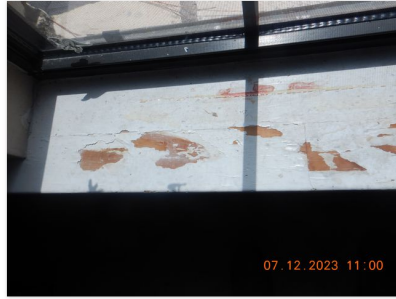
Signs of moisture staining on the window sills were present on the windows at the time of the inspection.

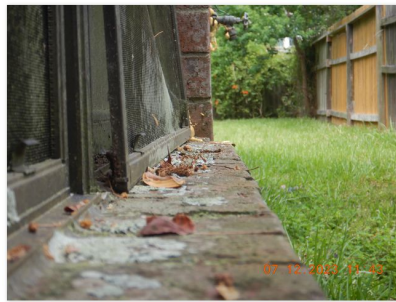
Window brick ledges are not properly sloped to shed water. The brick ledge should be installed with a 3/4" slope or at least a 15 degree angle.

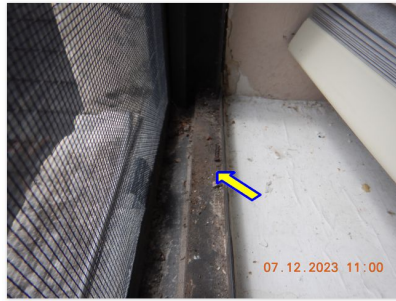
Window drainage ports obstructed with dirt and debris. Window drainage ports and other components should be cleaned on an annual basis. Otherwise, drainage ports can be blocked allowing water to back up into the wall area below the windows.

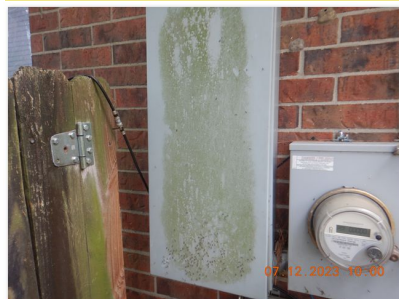
The new NEC changes state that the emergency electric shut off should be labeled with a non-removable plaque.

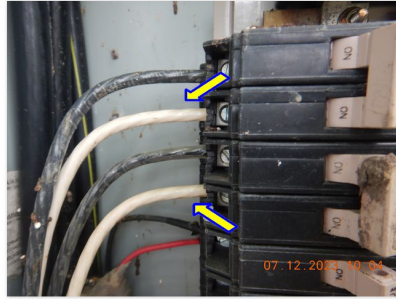
☑ The white wire connected to the 240 volt circuit breakers should be marked with a color (red or black).

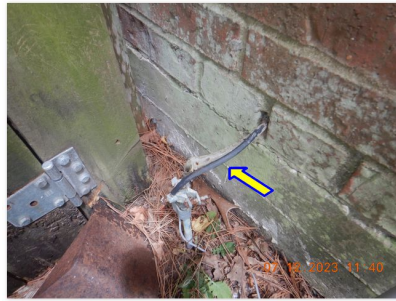
The grounding electrode conductor connected to the grounding electrode is not protected from physical damage.

Two means of grounding are required for the service equipment for residential structures. A second means of grounding should be installed. The presence of a proper grounding electrode system should be verified by a licensed electrician or a proper grounding electrode system should be installed for safety.

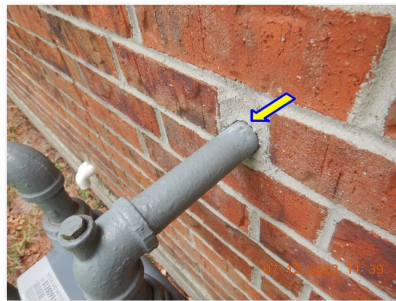
The metal gas distribution pipe entering the building should be bonded to the electrical system. The metal gas pipe is not bonded or could not be verified at the time of inspection.

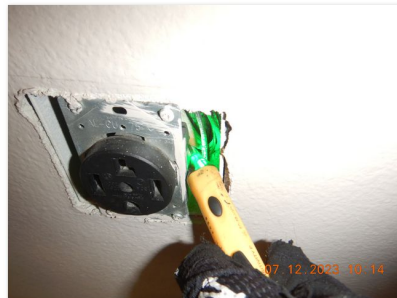
The 220V dryer outlet did not have electrical current at the time of inspection.

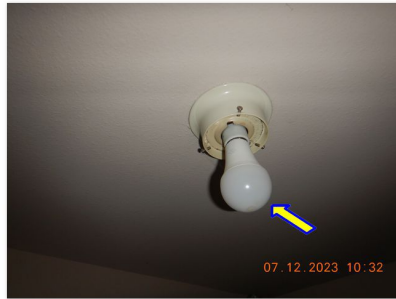
- Light fixture globes missing at the following locations: 2nd floor front left bedroom closet, Garage, Master bathroom, Attic.
- Light inoperable, possible bulb, at the following locations: Garage, Garage exterior, Dining room, Front entry, Front office, Living room, Back exterior, Stairwell, 2nd floor hallway, 2nd floor front bathroom, 2nd floor front left bedroom, 2nd floor back left bedroom, 2nd floor back bathroom, Master bedroom Master bathroom.
- Ceiling fans are out of balance at the following locations: 2nd floor front right bedroom, 2nd floor front left bedroom.
- The living room ceiling fan was not responding to controls.
- A light switch at the garage is installed upside down.

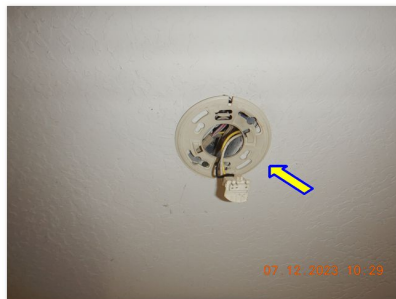
Smoke alarms missing at some locations.

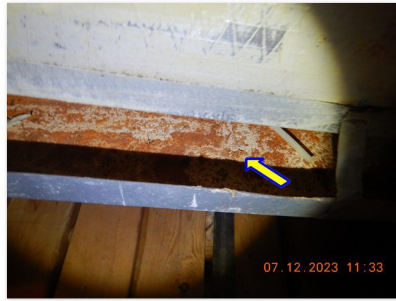
Rust observed at the A/C auxiliary drain pan. Continue to monitor.

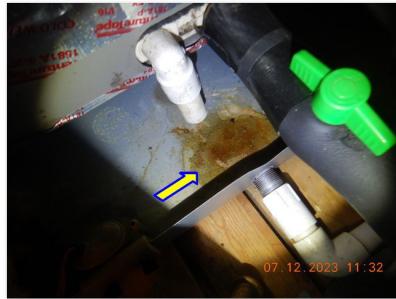
Condensate observed standing in the A/C auxiliary drain pan. Further evaluation by a licensed HVAC technician is recommended.

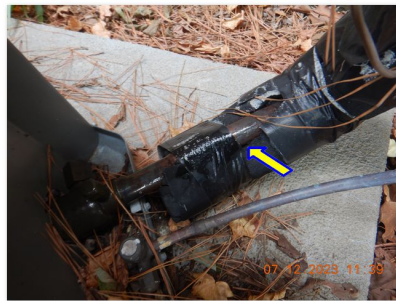
Insulation is missing or deteriorated on the A/C suction line at the condensing unit.

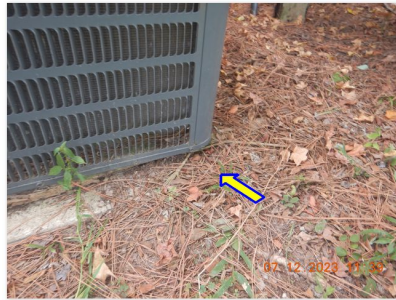
Condensing unit is not installed the proper distance above grade.

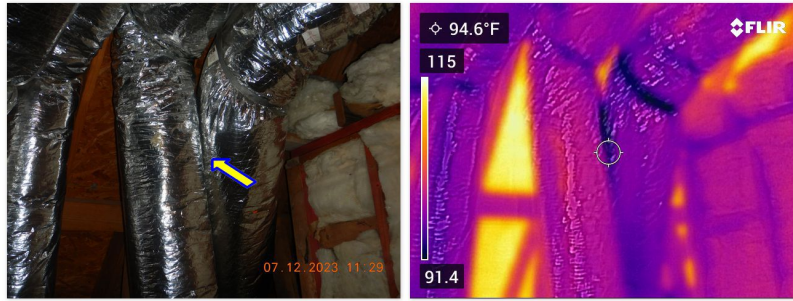
☑ Separate ductwork where touching at attic to prevent thermal bridging. Thermal bridging causes condensation to form between the duct lines and can drip into the attic.

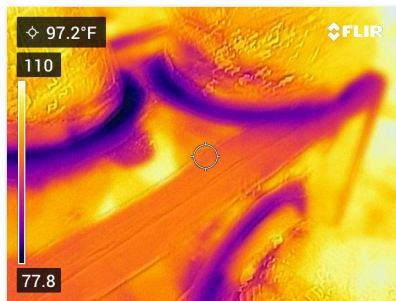
☑ Air leaks observed at the ductwork transition joints at the plenum.

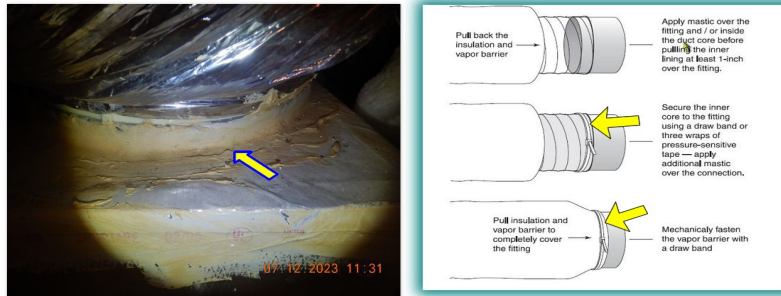
☑ Mastic has been applied to the outside of the ductwork. Normally, the inner ductwork liner should be sandwiched between two layers of mastic.

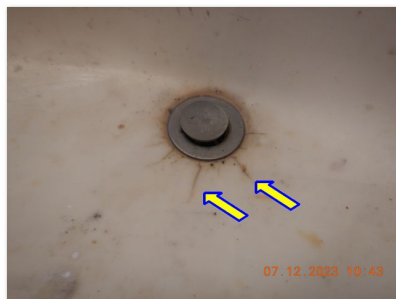
- Cracks at the base of the sink observed at the following locations: Master bathroom.

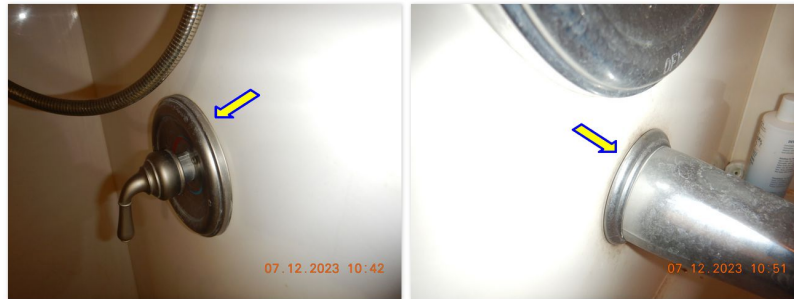
- Caulk the bathtub/shower enclosures and around fixtures where missing or deteriorated.

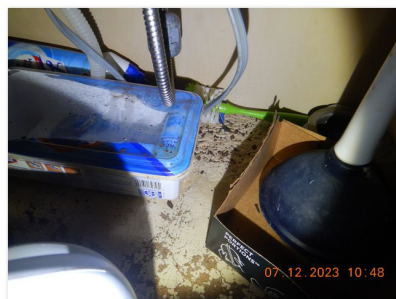
- Moisture damage was noted at the kitchen sink cabinet.

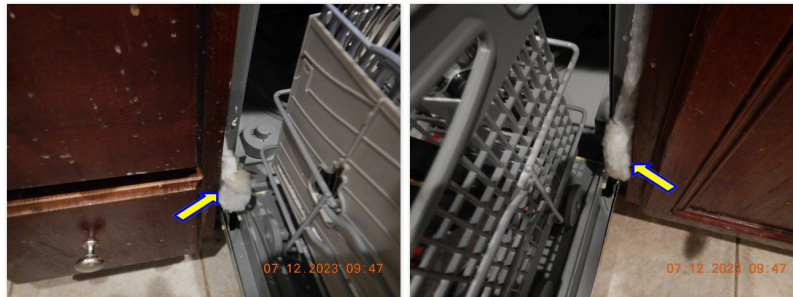
Insulation is sticking out of the sides of the dishwasher compartment.

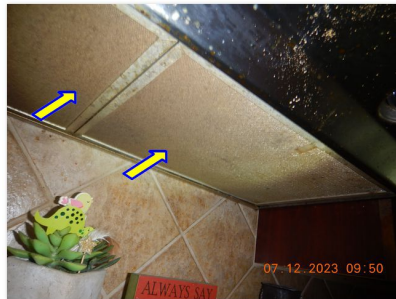
- Filter for range hood is dirty or blocked with debris.
