PROPERTY INSPECTION REPORT

Concerning: 7805 SHILOH CT., COLLEGE STATION, TX 77845

By: THOMAS RIKE TREC# 20478 / Tucker Inspections

4/24/2020

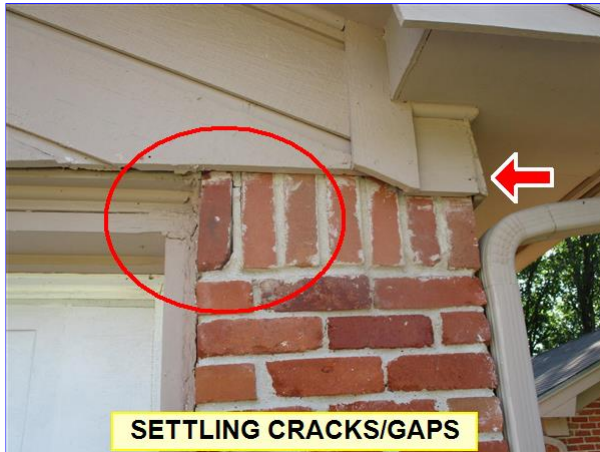
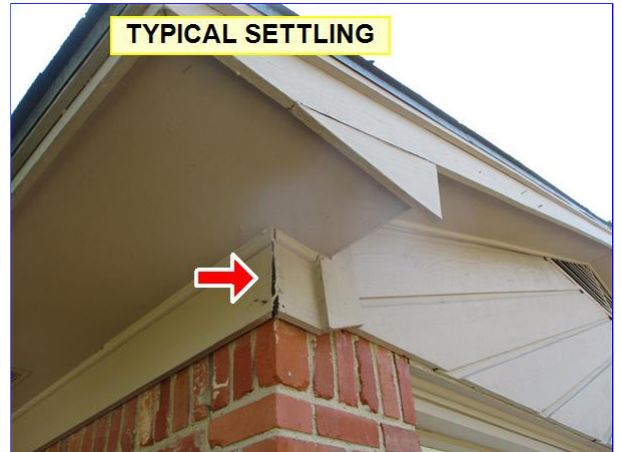
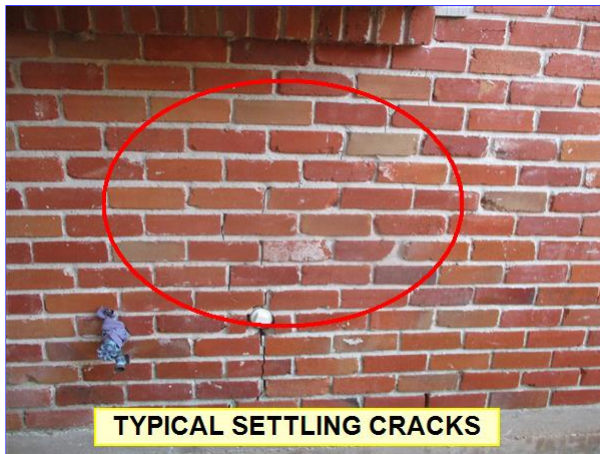
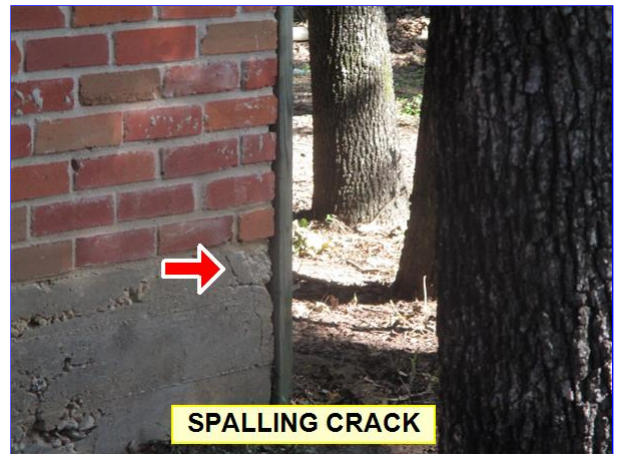
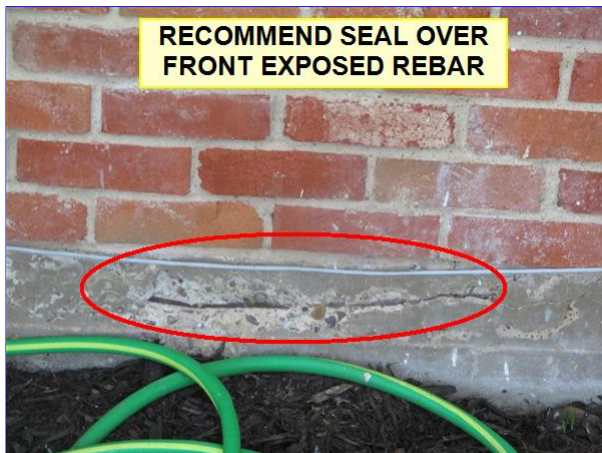
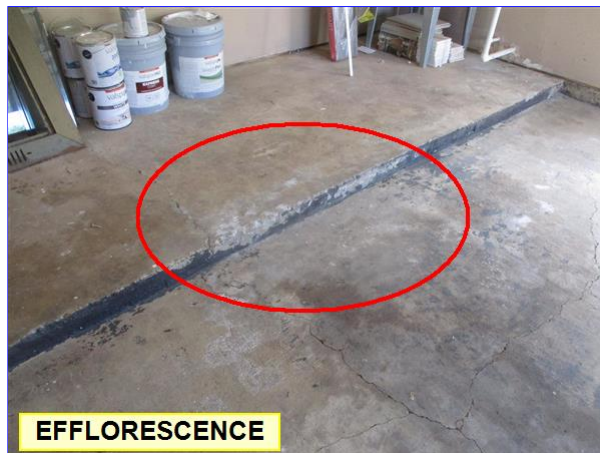
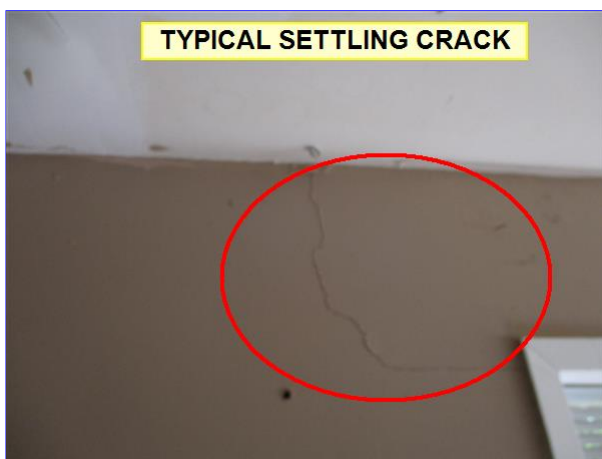
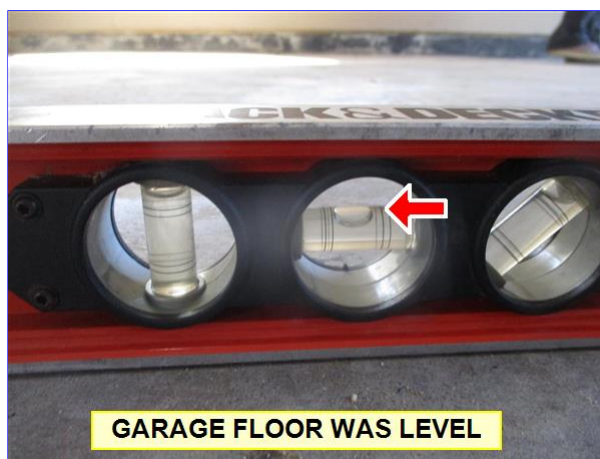
This foundation has had some pier work performed. No significant problems were observed, only signs of what is considered typical movement for the area. As a buyer you should be given all paperwork pertaining to this work and also find out if any warranty is in place for this work.

Spalling cracks were noted at the corners. This type of cracking is common and does not compromise the integrity of the foundation.

There was evidence of efflorescence in the garage. This means the garage floor may sweat at times. Be careful when walking on slipper surfaces. Be mindful of stored items in the garage as they may be subject to moisture.

Recommend sealing over the front exposed rebar.

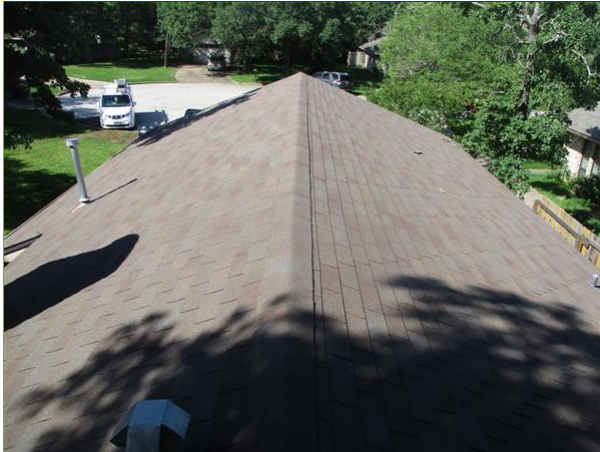
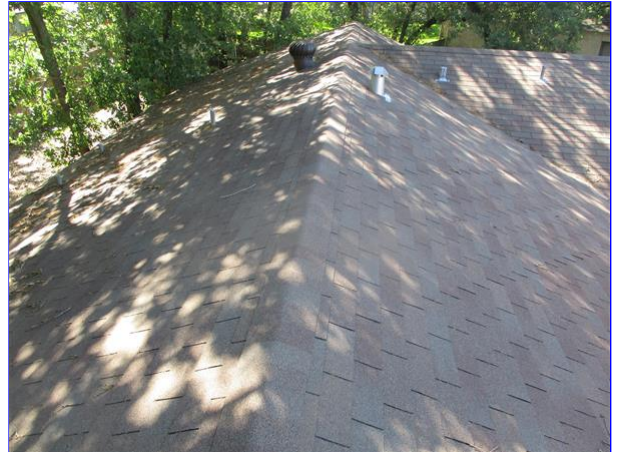
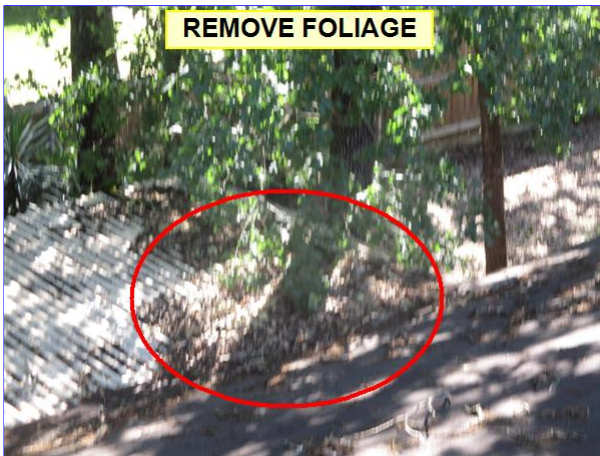
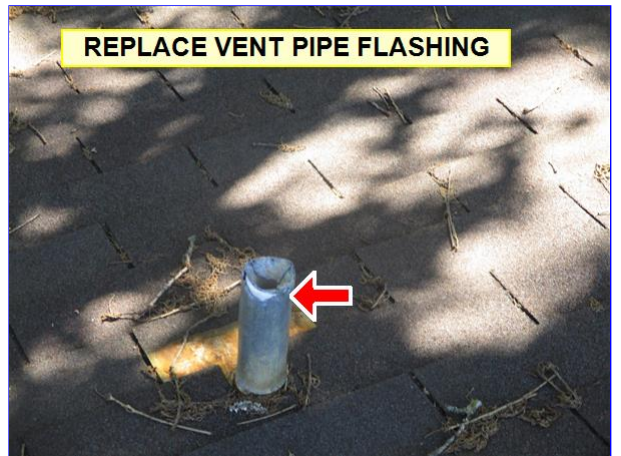
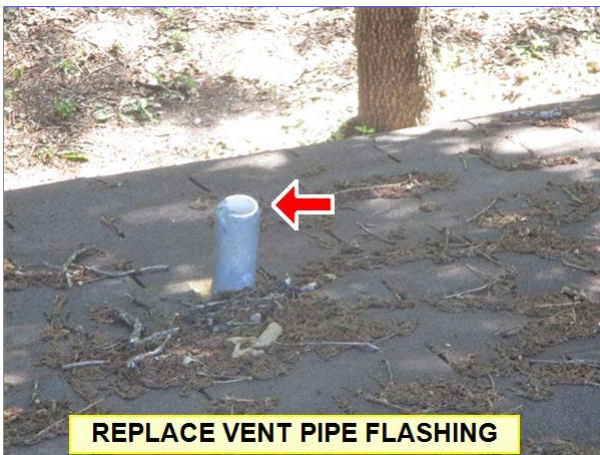
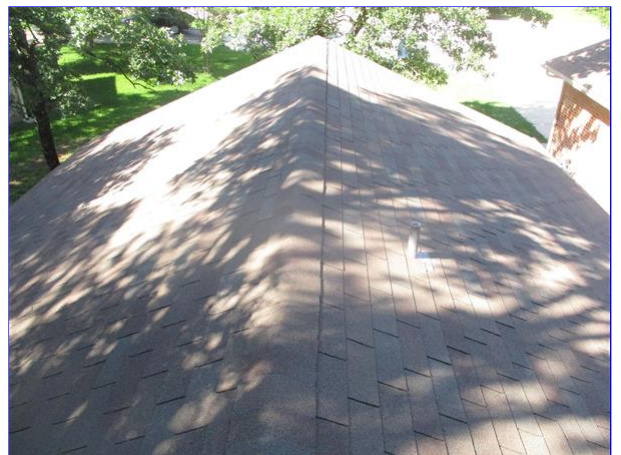
This is a composition shingled roof that was found in good condition at the time of this inspection.

There were two plumbing vent pipe flashings that need to be replaced. Squirrels have chewed the tops off.

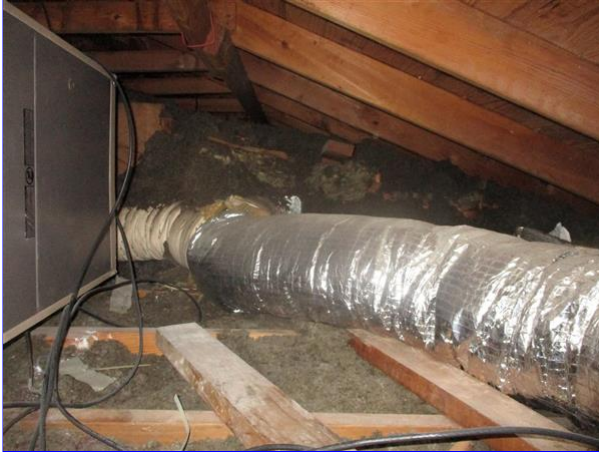
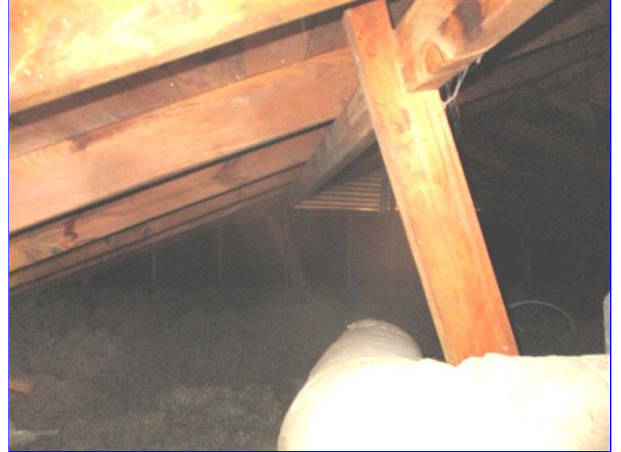
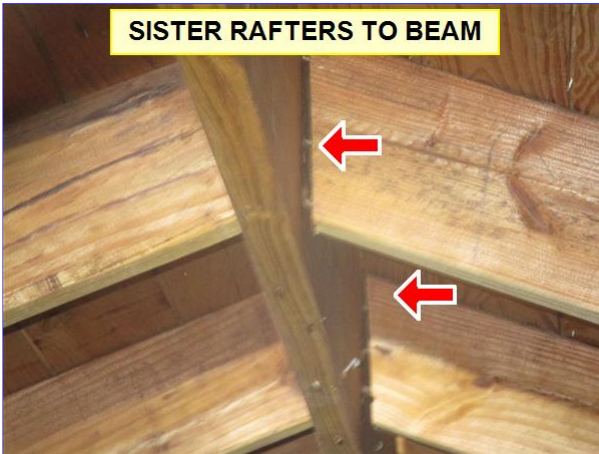
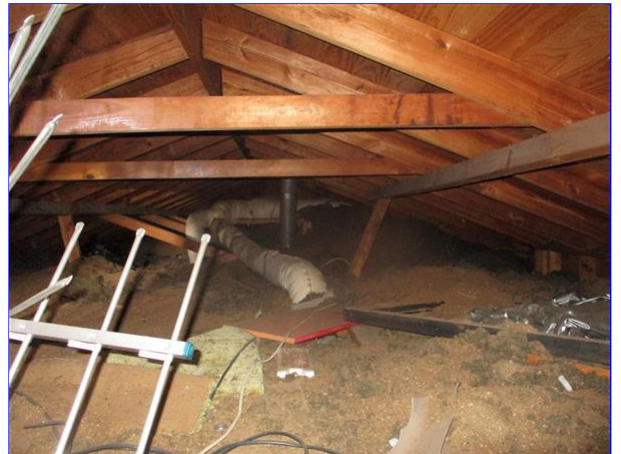
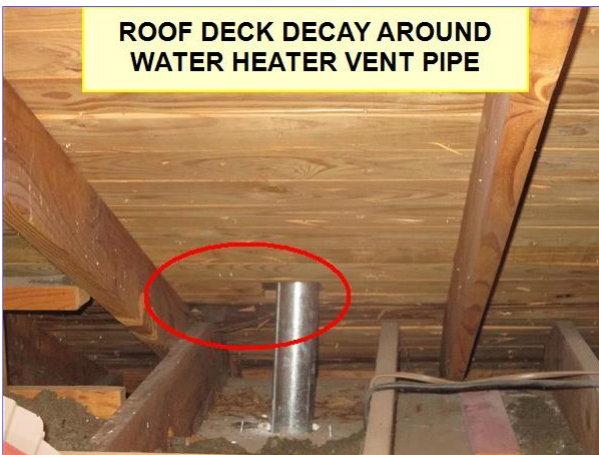
There were approx (13) rafters that had a 1"+ gap from the beam. Recommend sistering (bracing) these rafters to the beam.

There was decay in the roof deck around the water heater vent pipe. Will point out a newer roof was present.

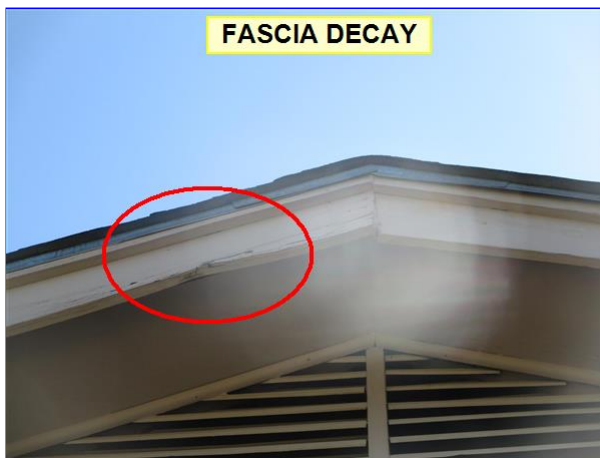
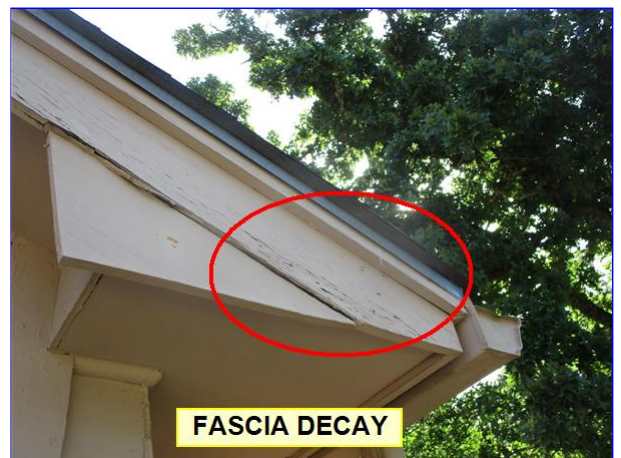
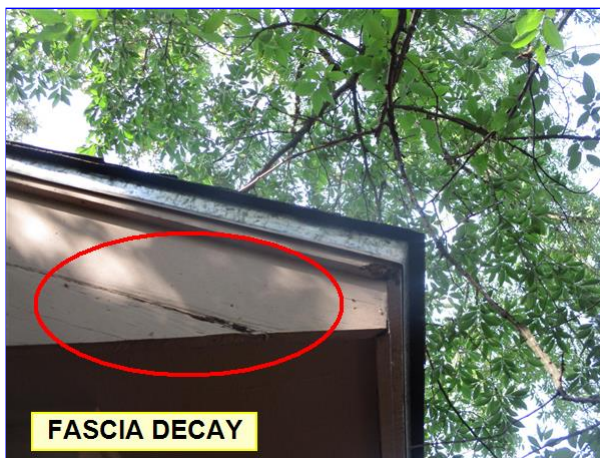
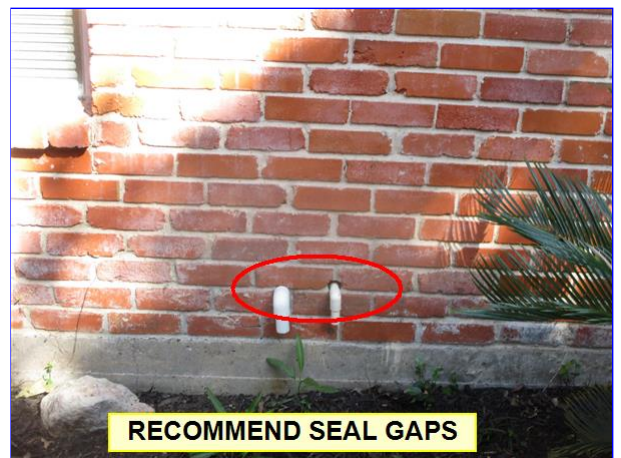
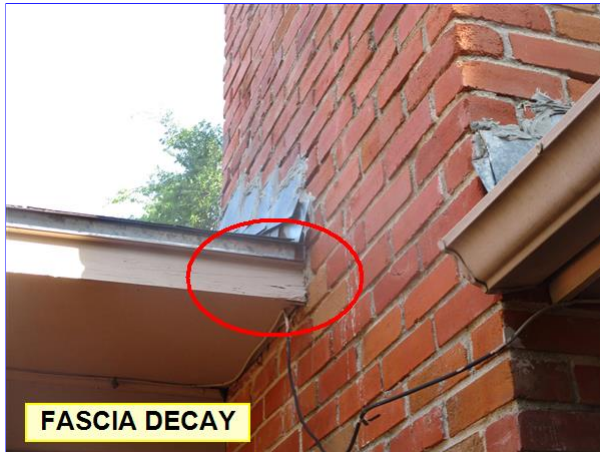
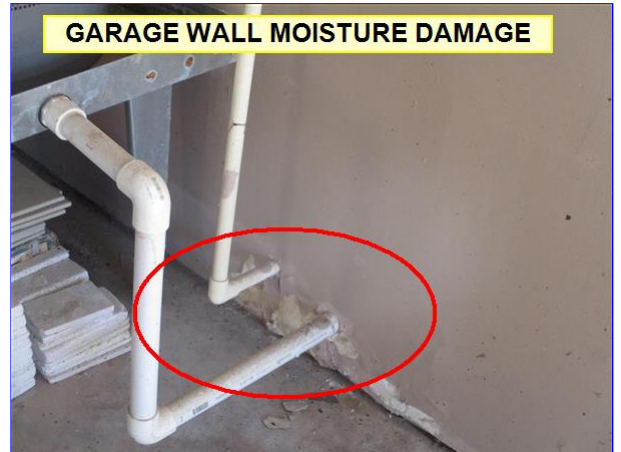
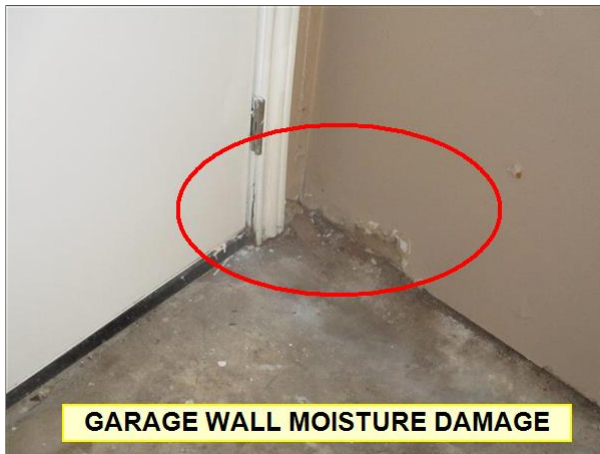
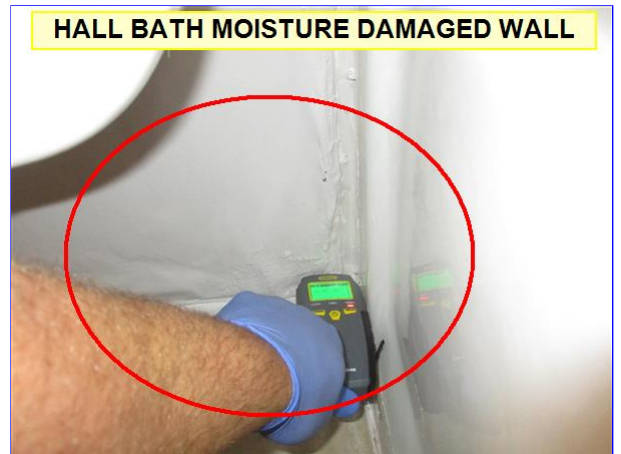
There was fascia decay in multiple areas around the unit.

There was moisture damage to the hall bathroom wall next to the tub. The moisture meter readings were high at the time of this inspection. Recommend removing the moisture damaged sheetrock and installing new sheetrock.

There was moisture damage to the garage wall below the water heater. *Will point out that a newer water heater was present.*

There was moisture damage along the base of the garage wall next to the left exterior door. *You may consider installing a storm door.*

Recommend sealing the gaps between the water heater drain pipes and brick.

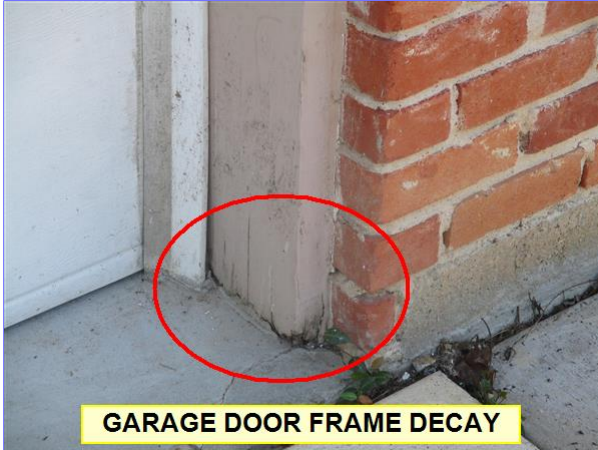
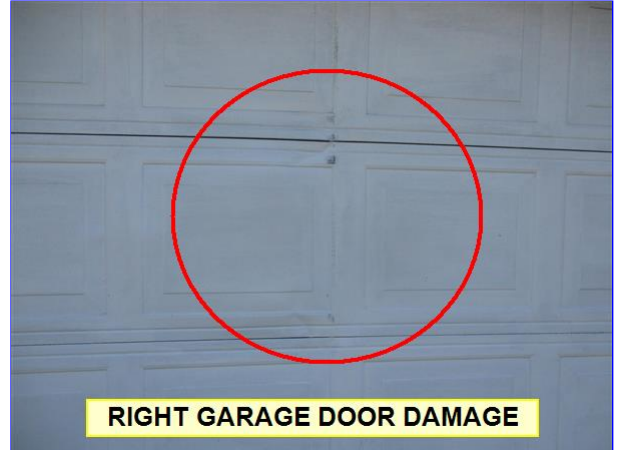
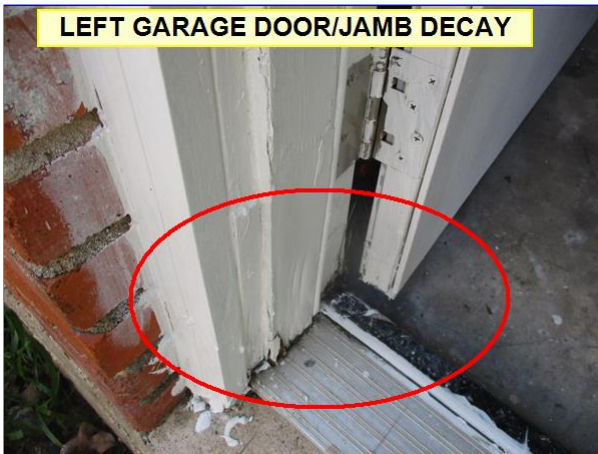
The occupant door from inside garage to inside the home is not a fire rated door. This means that should a fire occur in garage, the occupant door does not afford protection until fireman arrive. This door should be replaced with a fire rated door.

There was damage to the right overhead garage door.

There was decay at the base of the left garage door/door jamb.

The living room and master bedroom sliding glass door screens were missing.

There was decay at the base of the garage door frame.

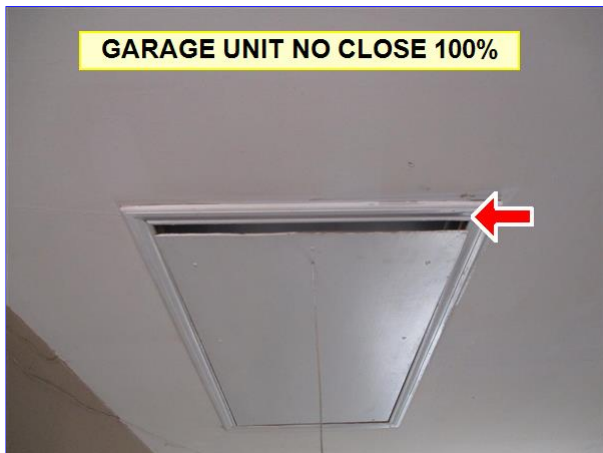
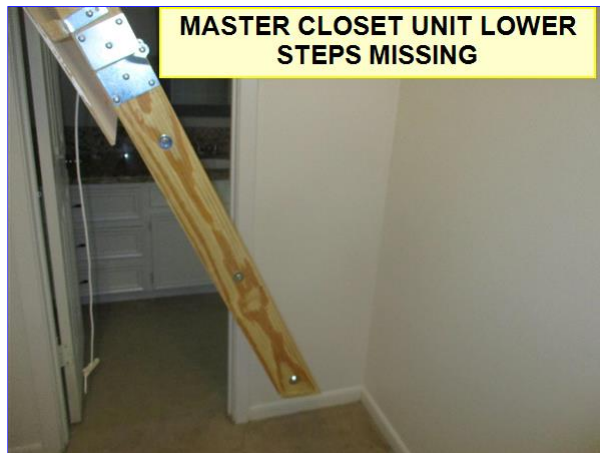
The master closet uni lower steps were missing.

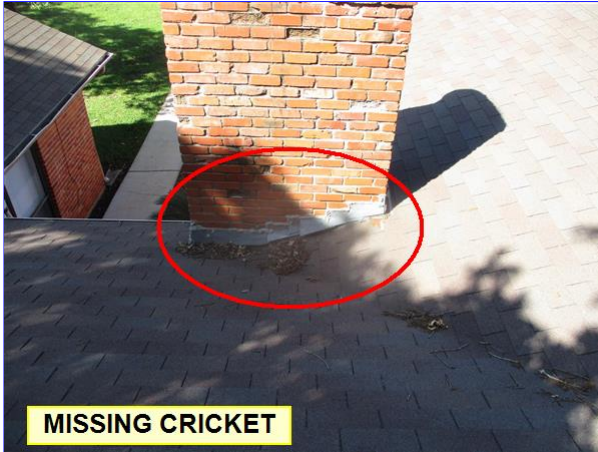
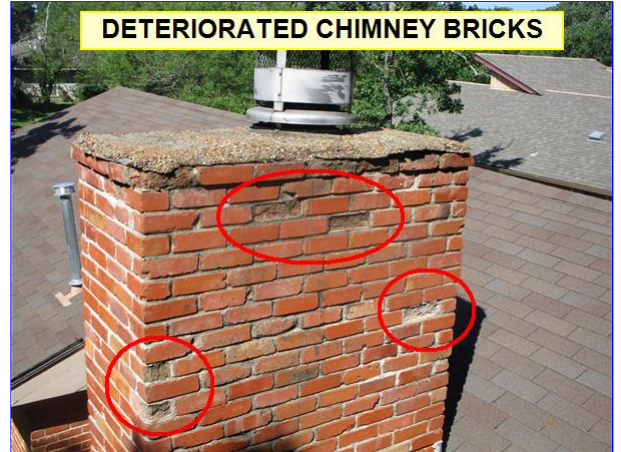
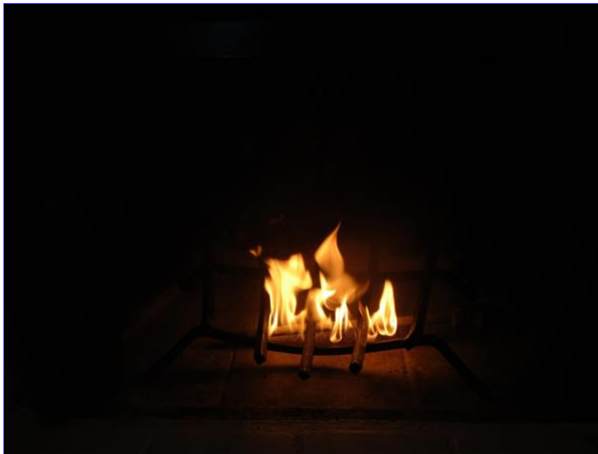
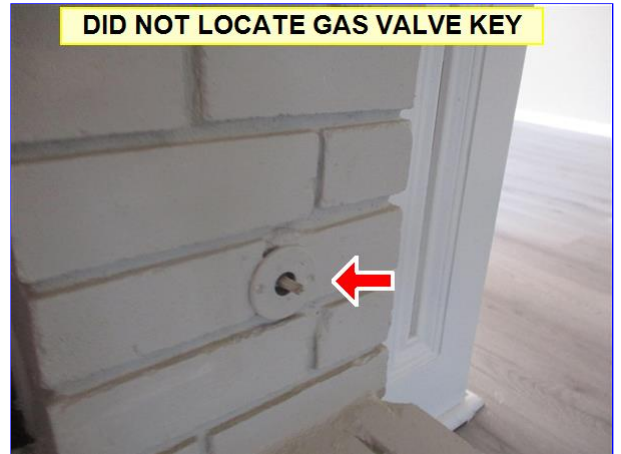
This is a metal pre-fabricated unit that was found in acceptable condition at the time of this inspection.

Note: There were multiple bricks that have deteriorated. The bricks are still performing as intended at the time of this inspection.

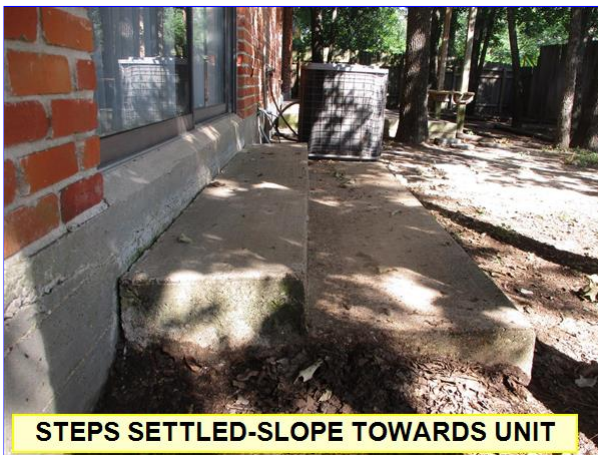
K. Item 1(Picture)

The master bedroom exterior steps have settled and slope towards the home.

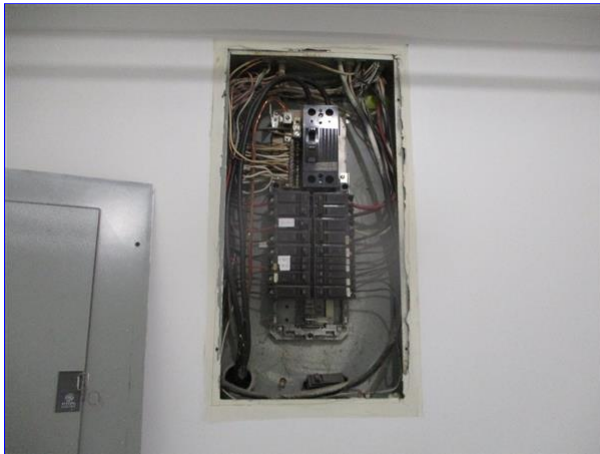
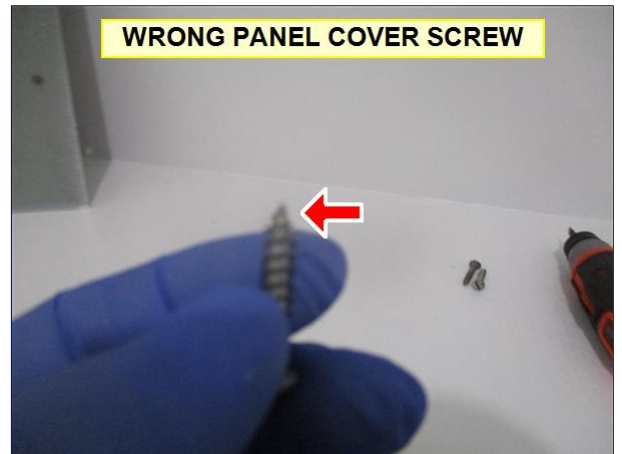
The main panel is located in a closet. This was common installation when this home was built. However, the current building standards does not allow this. The panel was found in good condition and does not need to be relocated.

The panel cover screws were not the correct material. The screws should be flat tip.

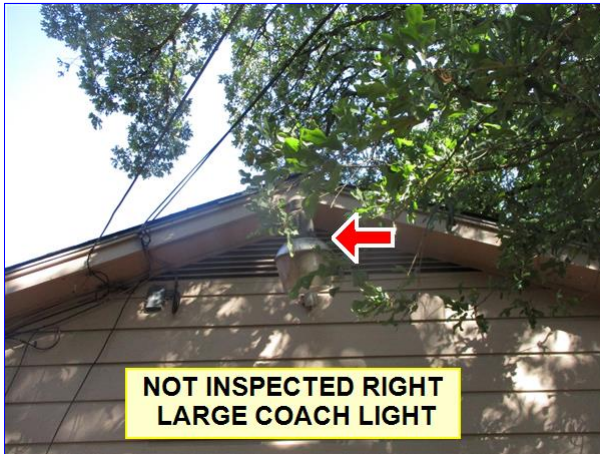
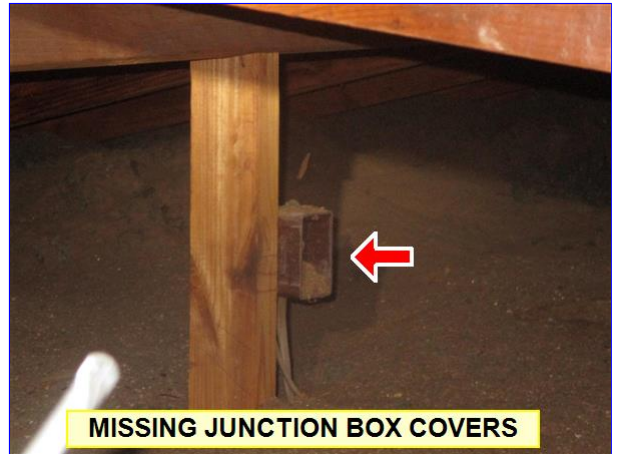
There were smoke detectors with low batteries. Recommend installing new batteries in all units.

There were junction box covers missing in the attic.

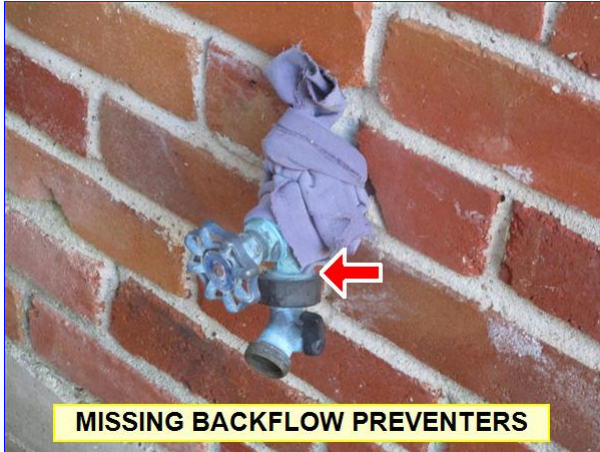
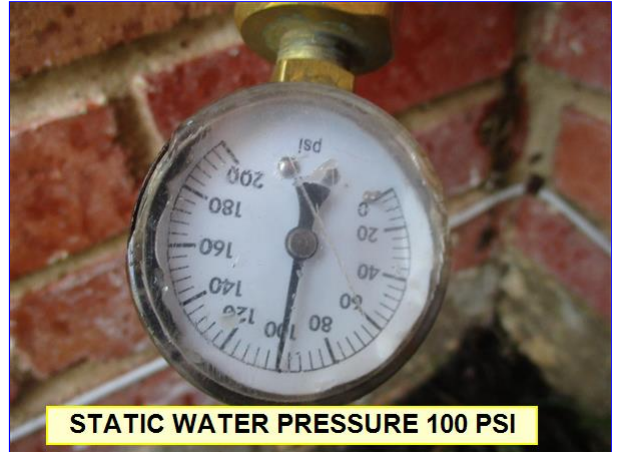
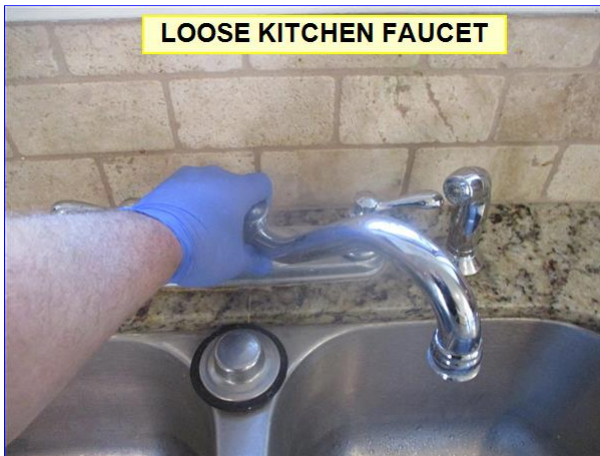
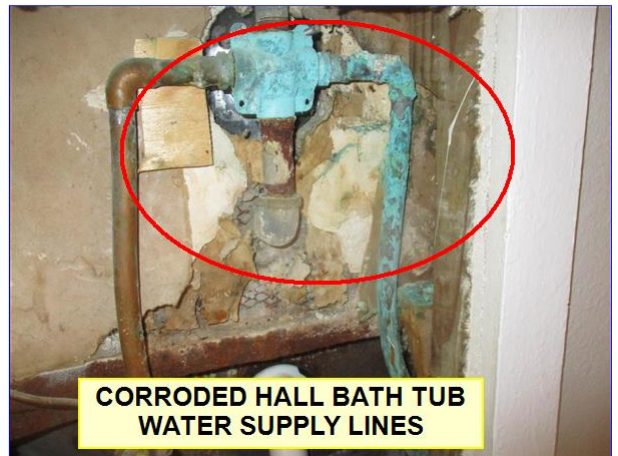
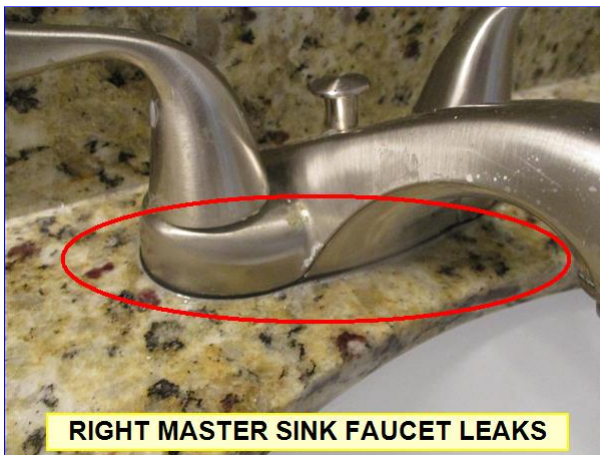
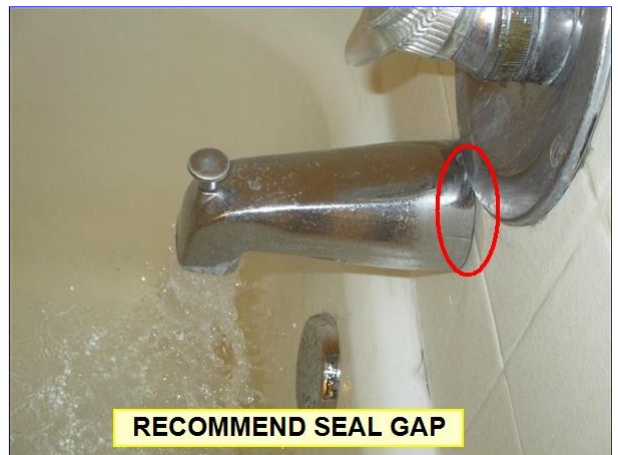
There were missing back flow preventer on the exterior hose bibs.

The static water pressure should range between 40-80 PSI. The static water pressure was over 80 PSI at the time of this inspection. **Recommend installing a pressure regulator at the meter.** *There is a higher risk for leaks at the plumbing fixtures and/or water supply lines when the water pressure exceeds 80 PSI.*

There was a slow leak along the right master bathroom sink faucet when the fixture was operating.

The kitchen faucet was loose from the countertop.

The hall bathroom tub water supply line was corroded. **Recommend further review by a professional plumber.**

Recommend sealing the gap between the tub wall and faucet.

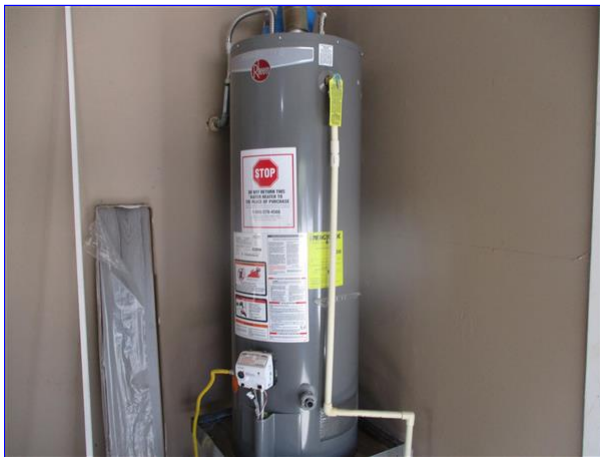
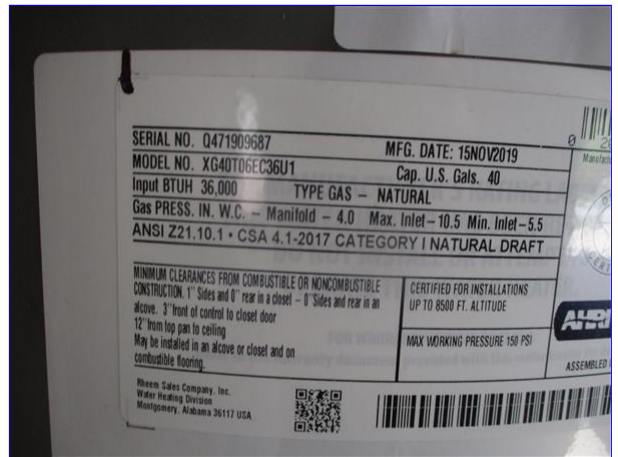
This unit was operational at the time of this inspection. This unit was located in the garage and meets current building standards.

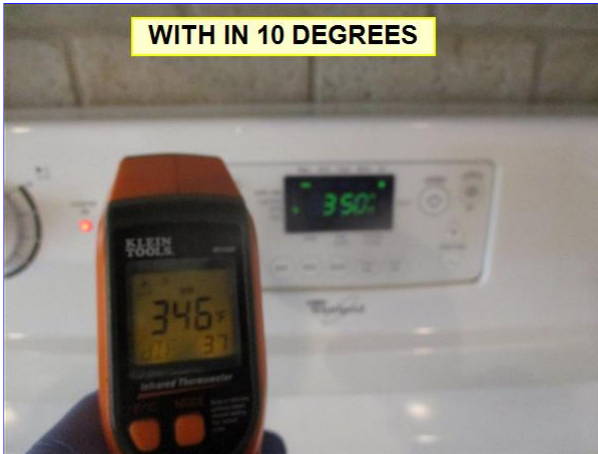
D. Item 1(Picture)

This is a stand alone range. There was not an anti tip brace in stalled. *This is a safety hazard.*
