HVAC Inspection Report

Performed a visual HVAC inspection at **7805 Shiloh Court, College Station**. All visual accessible components of the HVAC system were evaluated and found to be in serviceable condition at the time of inspection with exception of service recommendations below:

2000, 5.0-ton Heil condenser
1999, 5.0-ton York furnace and evaporator coil

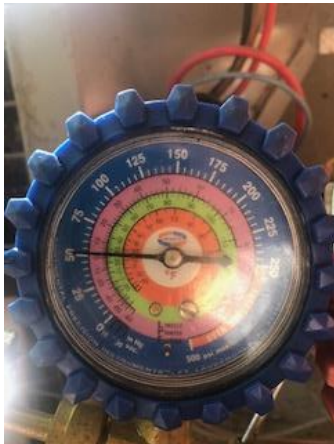
Freon pressure: 55 psi (low)

Low freon pressure and evaporator coil split due to freon leaking from the evaporator coil.

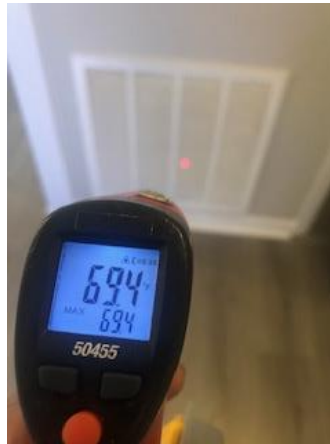
69° return air

Evaporator coil split: 10° (low)
Normal split: 15 degrees and over

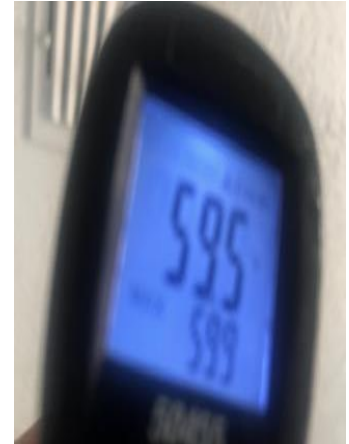
59° supply air

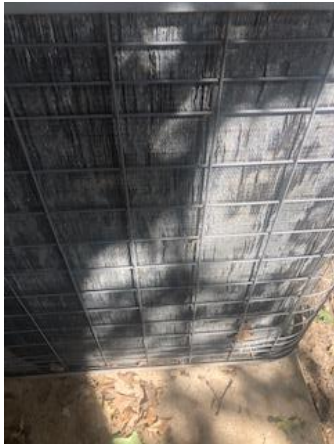
Smashed condenser coil fins.
This will prevent the AC
from working efficiently.

OPTION 1: Due to smashed condenser coil fins and freon leaks in the evaporator coil, we recommend replacing the condenser and evaporator coil and perform the other recommended repairs above.

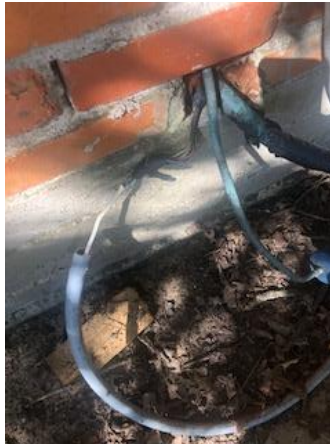
Secure low voltage wire.

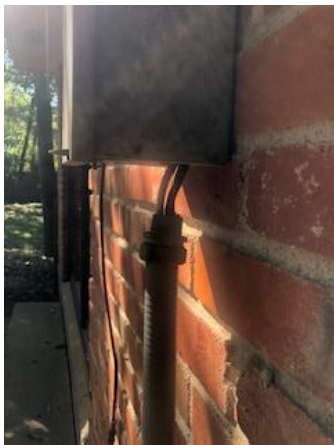
Install an electrical washer
on electrical whip.

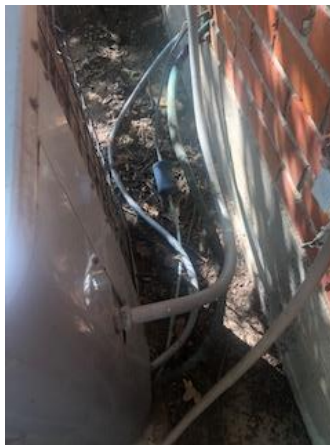
Insulate suction line at
condenser.

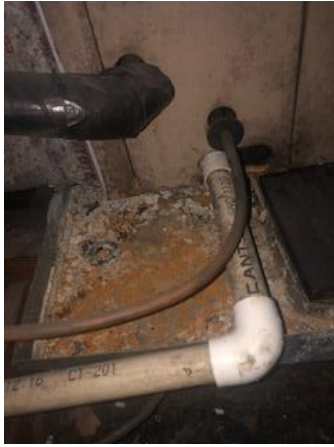
Insulate primary drain line per code. Install secondary drain pan and Inline safety float switches to prevent the coil pan from overflowing if both AC drains are clogged. A float switch detects water backup and turns off the unit before the pan can overflow and spill out onto your attic floor and through the ceiling. Clear AC drain line.

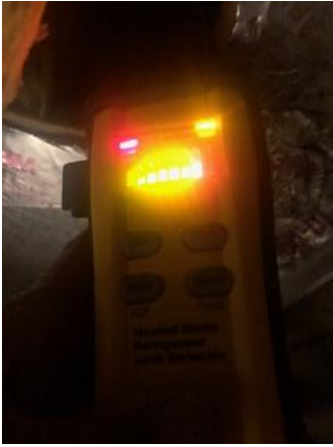
Detected freon leaks in the evaporator coil.

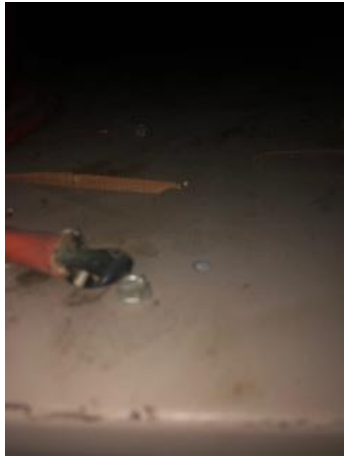
Install Romex connector on furnace electrical.

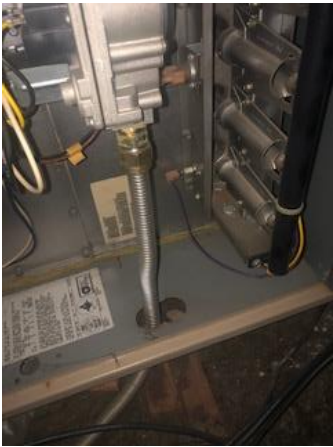
Upgrade furnace gas line to rigid pipe per code,

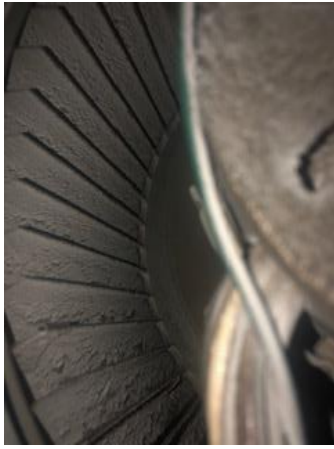
Dirty blower wheel.

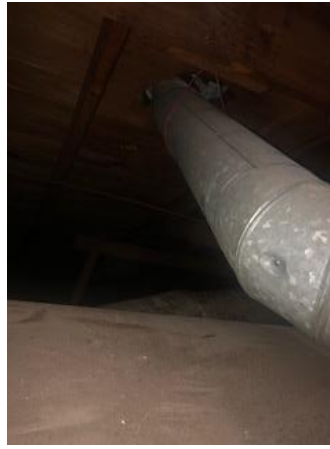
Extend flue pipe through the roof with caps and collar.

Install CO detector per building code.

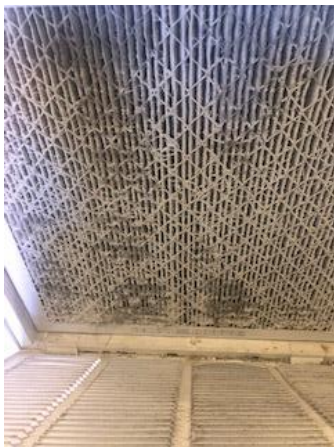
Replace dirty filter.

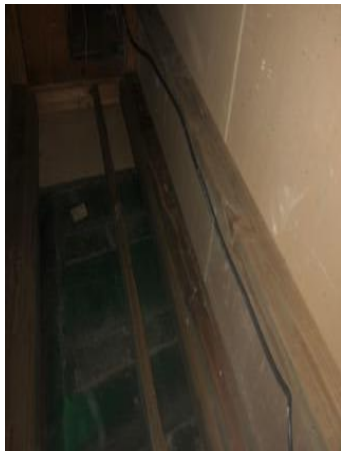
Seal return air chute with duct board.

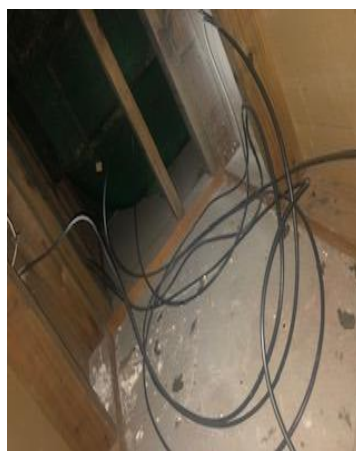
Seal return air chute with duct board.

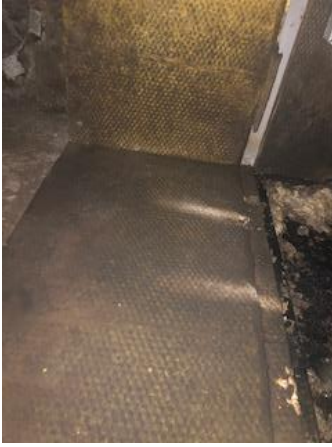
Black growth present in the supply plenum.

Consult with an air duct cleaning contractor to evaluate the plenums, and flex and/or duct board for cleaning.

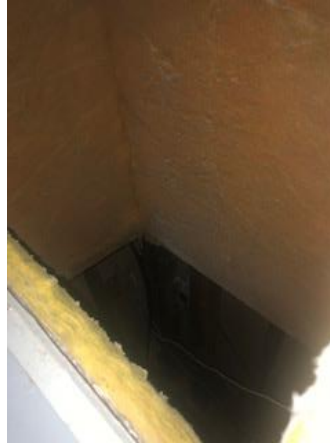
Dust present in the return plenum.
