HOME INSPECTION REPORT

Prepared For:	Ken Goolsby
	(Name of Client)
Concerning:	6075 Fm 222 Loop S, Shepherd, TX, 77371
	(Address or Other Identification of Inspected Property)
By:	David Jones (# 22116) Charles Rowden (# 22155)
	(Name and License Number of Inspector)
	10-8-2019
	(Date)
	(Name, License Number of Sponsoring Inspector)

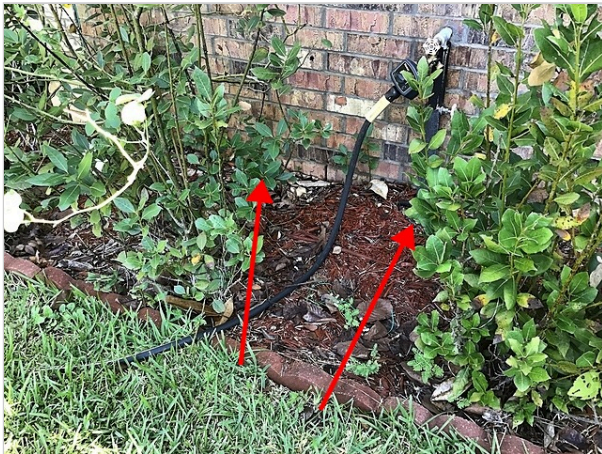
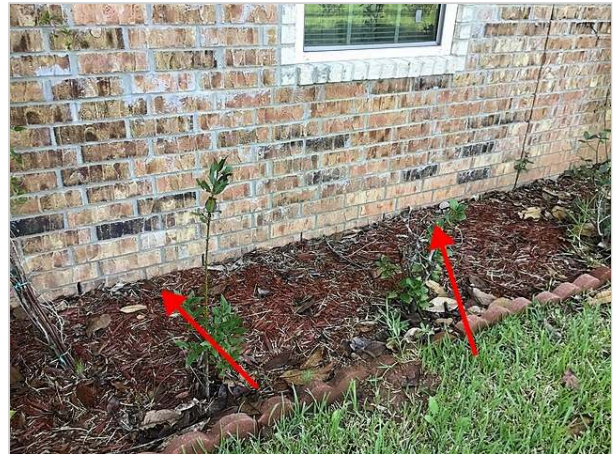
Portions of the slab edges were not viewed due to soil and vegetation build up. High soil level is considered a conducive condition to termite activity, water penetration and limits visual observation of the foundation slab. Common industry practice recommends a clearance of at least 4 inches from bottom of brick veneer to soil.

High soil

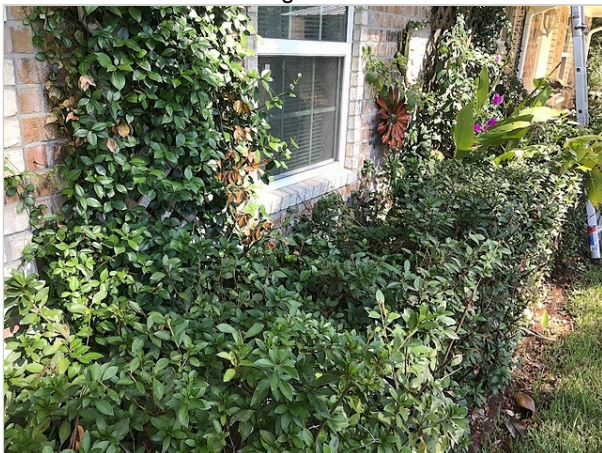
Vegetation buildup

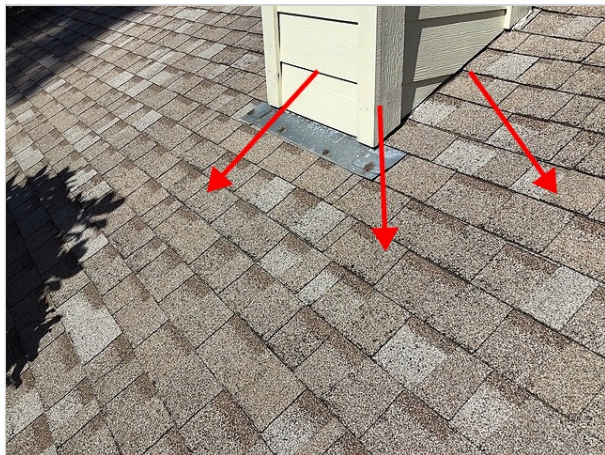
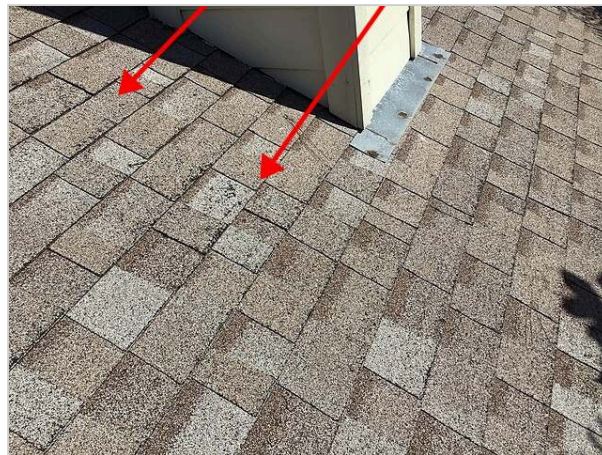
Accelerated granule loss observed in areas adjacent to the chimney chase.

Accelerated granule loss

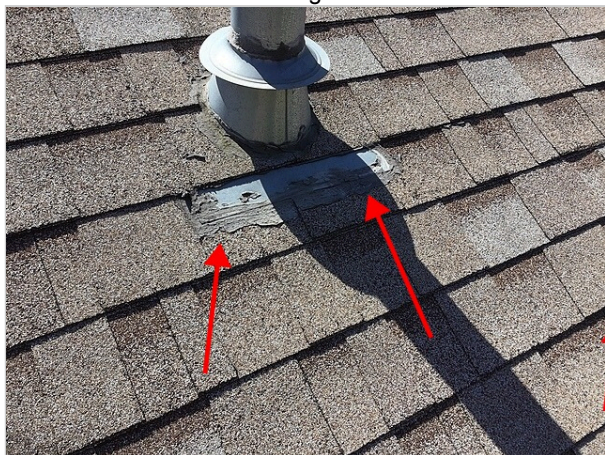
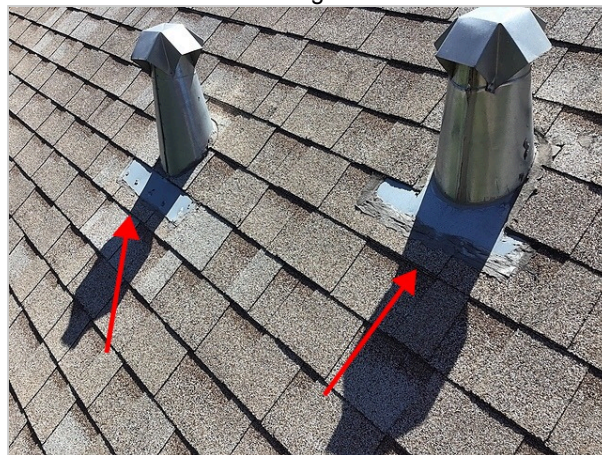
Improper installation/repair technique was used at the apron of the roof vent flashings. The bottom of the apron should be free and clear to allow moisture to exit the flashing. Properly installed roof vent flashings do not need to be caulked, only the exposed nail heads.

Caulked at the apron

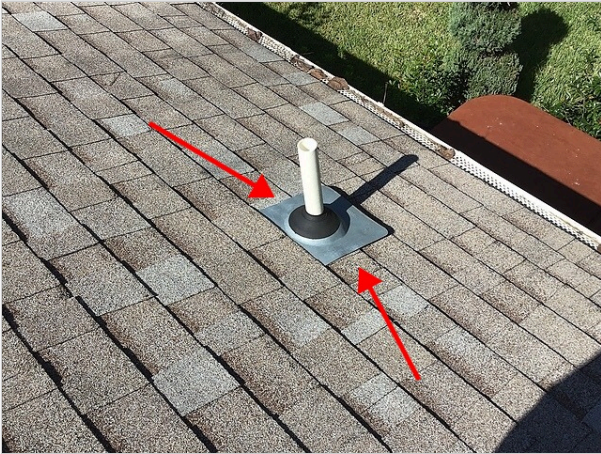
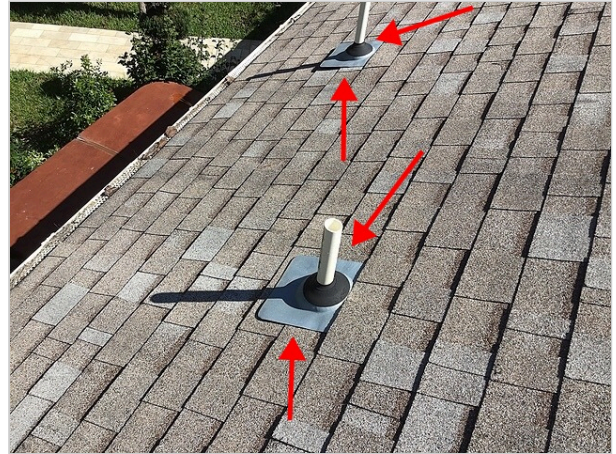
Flashings for the plumbing vents were not secured properly and were installed with sides over the shingles. Possibly allowing water penetration during wind driven rains.

Sides over shingles

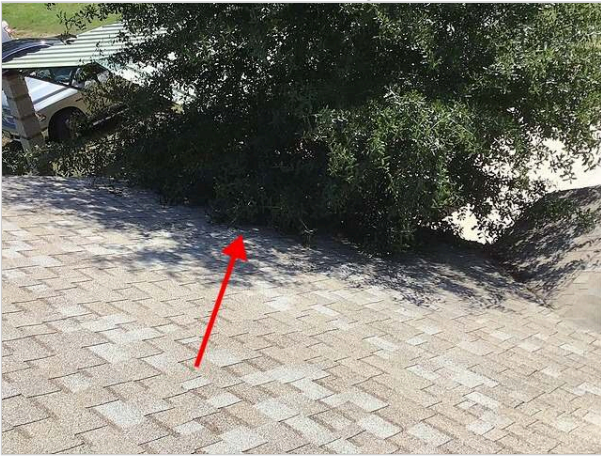
Tree limbs were making contact with the roof. Tree limbs should be cut back at least 6' from the roof.

Tree in contact with the roof

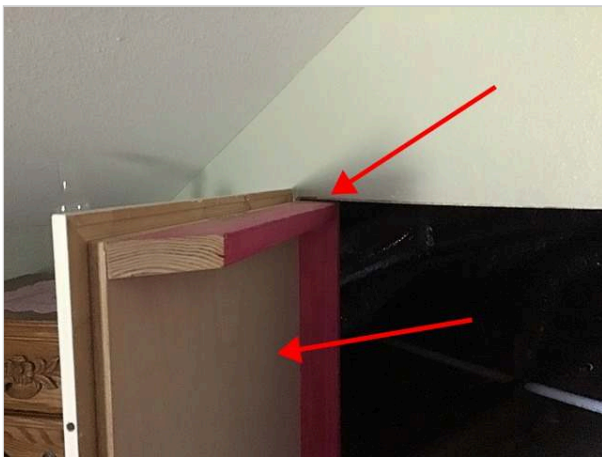
The attic access was installed in the upstairs living area via doors, which were not properly insulated and/or had weatherstripping present. The attic doors should be sealed the same as any other exterior door, helping prevent treated air from escaping into the untreated attic space.

Not insulated/no weather stripping (attic HVAC access)

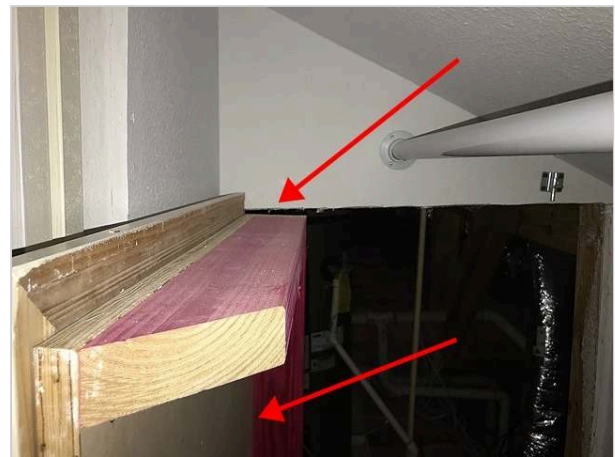
Not insulated/no weather stripping (attic water heater access)

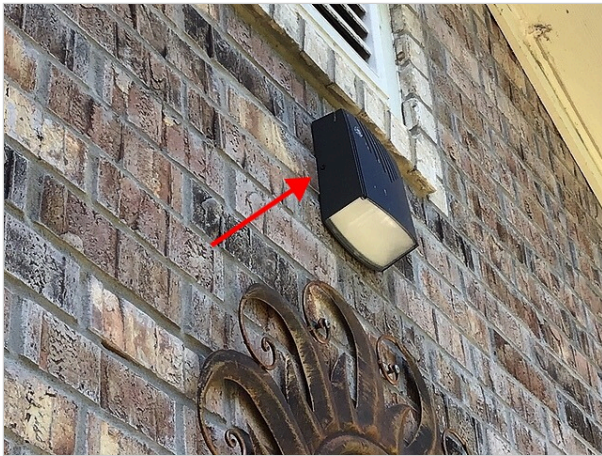
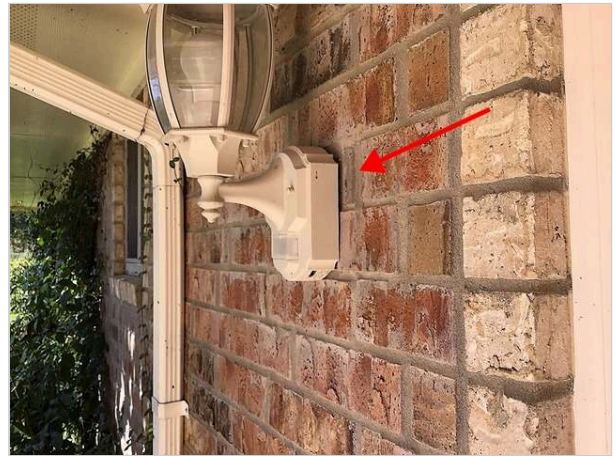
Exterior light fixtures were not caulked at the wall penetrations/mounts. Stone/brick veneer walls are uneven and caulk helps prevent excessive moisture/water penetration during wind blown rain.

Not caulked

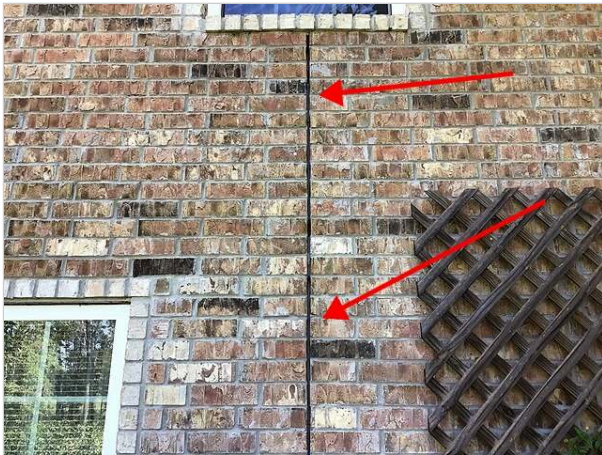
Expansion joints did not have a foam backer rod and flexible sealant like silicone in the gaps.

Not properly sealed (expansion joint)

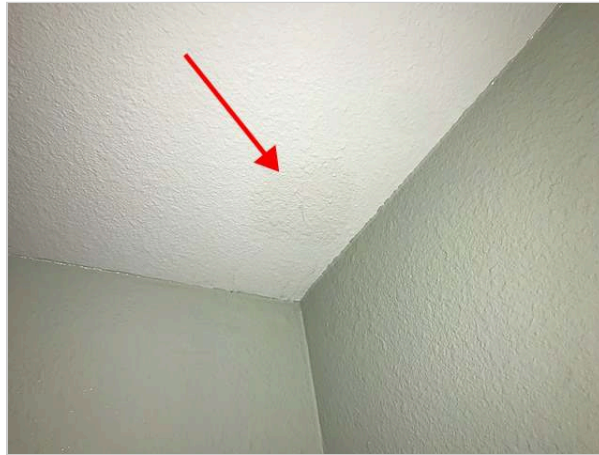
There were signs of previous leaks (staining) to the ceiling in the first floor bedroom .

Staining (master bedroom)

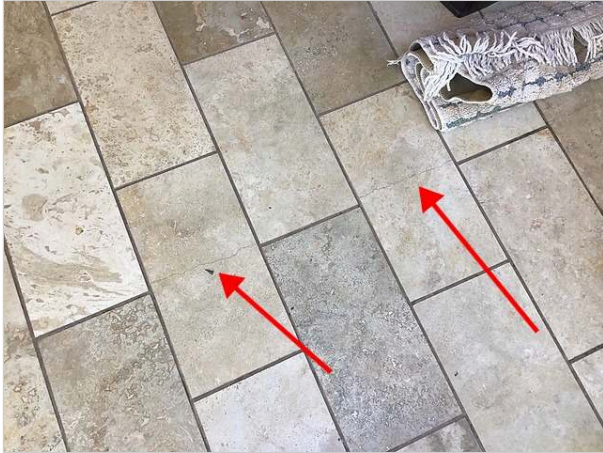
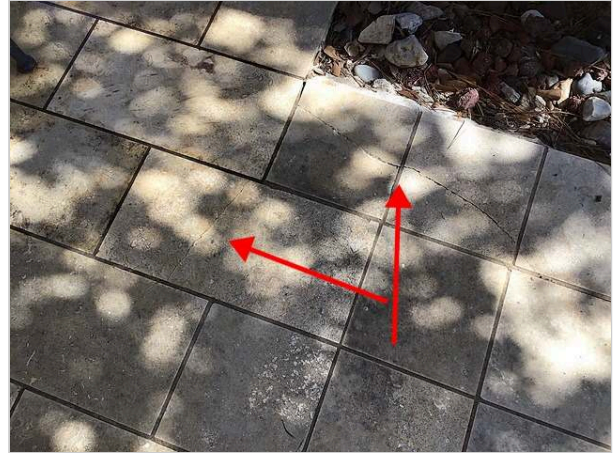
Several floor tiles of the porch/walkway were cracked/damaged.

Cracked/damaged tiles

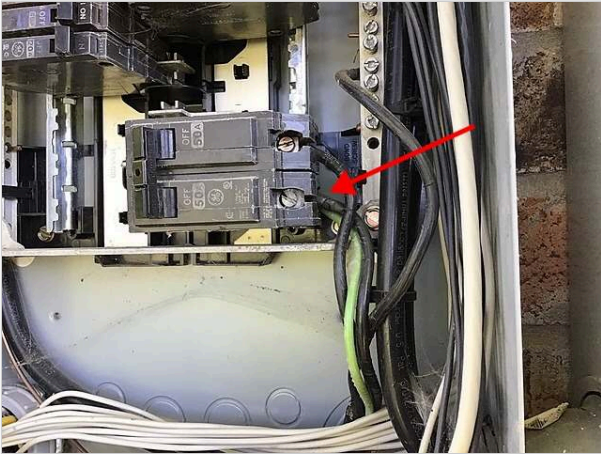
There were improper wiring connections. Connecting multiple wires to a breaker not designed for multiple wire connections creates the possibility for a loose connection.

Improper wiring connections

As a precaution, it is recommended that an electrician be contacted.

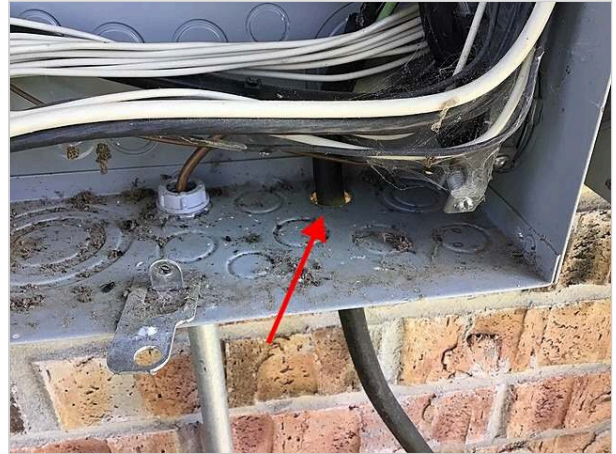
Not protected from abrasion (no grommet)

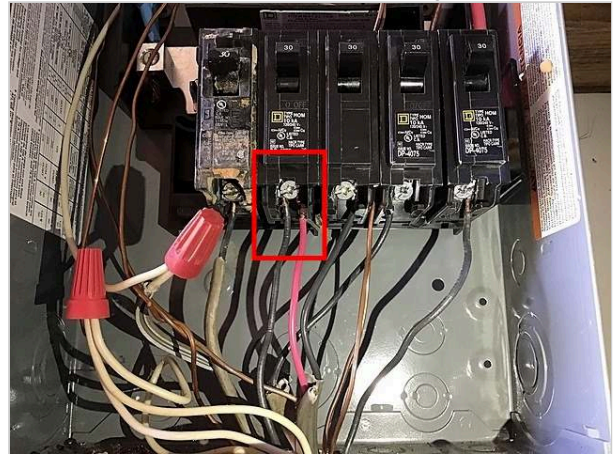
Double lugged breaker

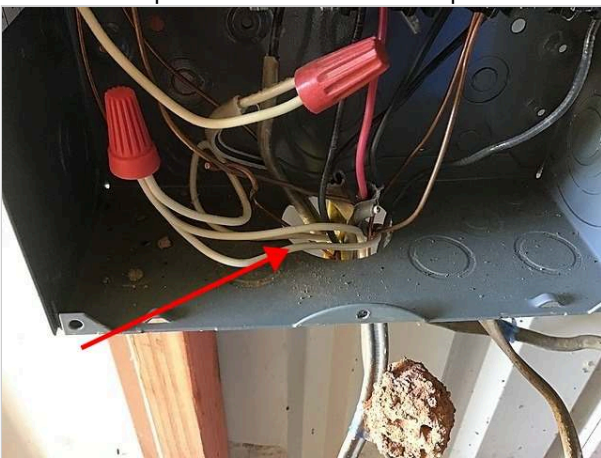
Not protected from abrasion (no grommet/bushing)

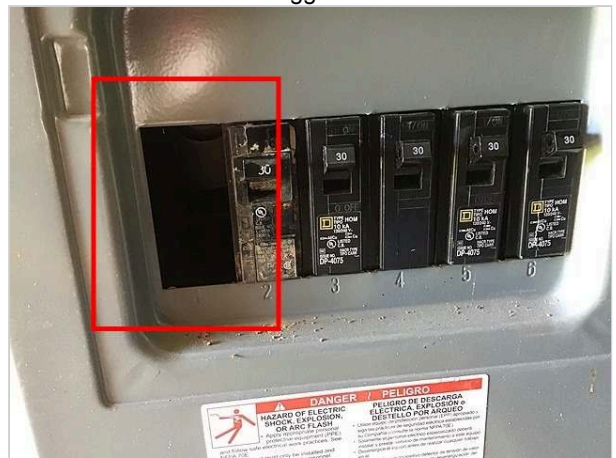
A knockout was missing.

Knockout missing

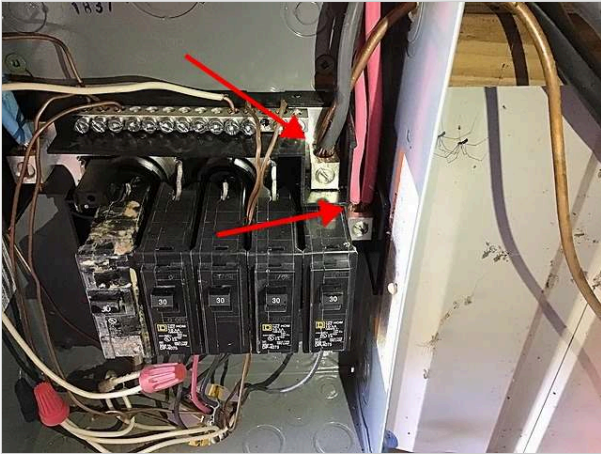
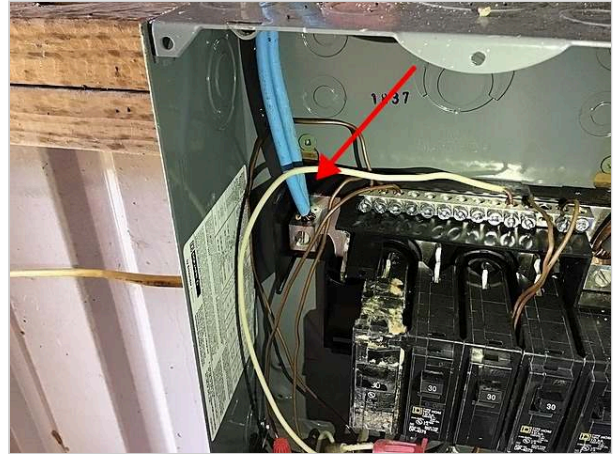
There were improper wiring connections. Connecting multiple wires to a component not designed for multiple wire connections creates the possibility for a loose connection.

Improper wire connections

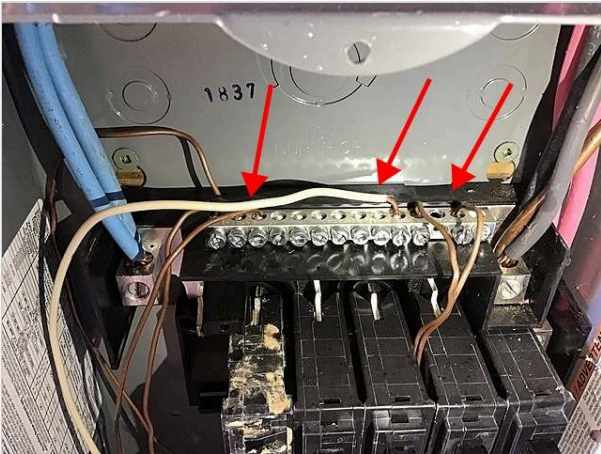
Neutrals and grounds on shared bus bar (sub-panel)

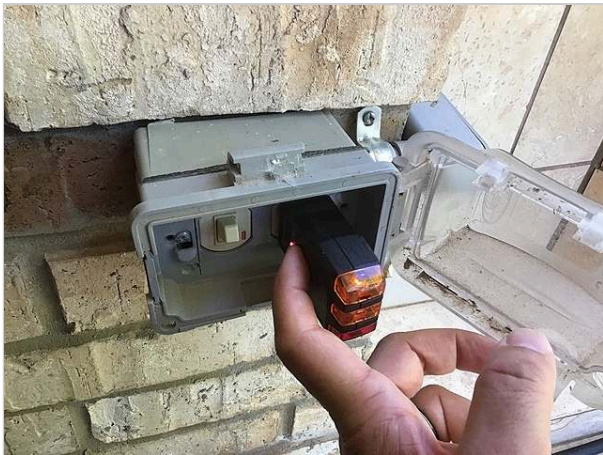
Tester showing not GFCI protected (exterior)

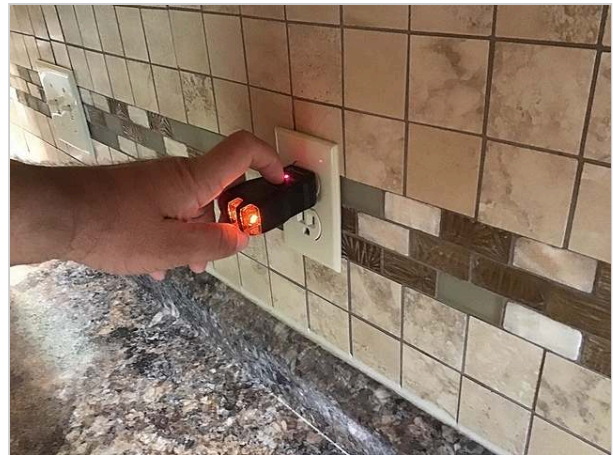
Tester showing not GFCI protected (kitchen)

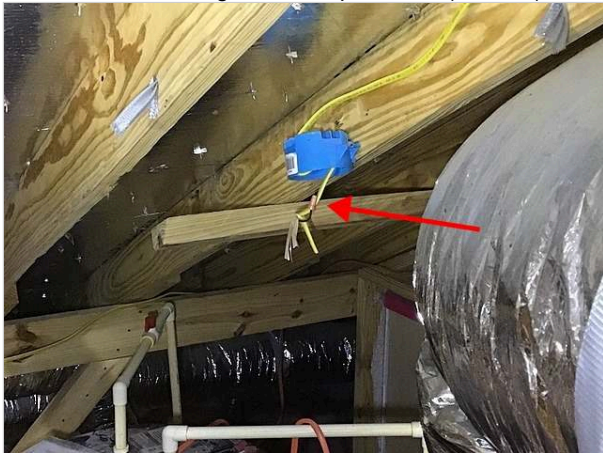
Not in junction box (attic)

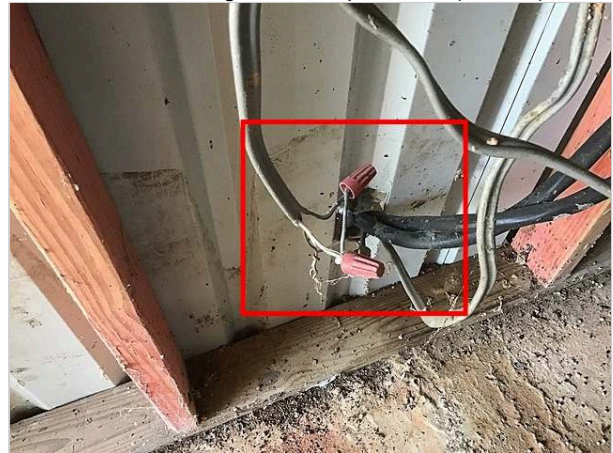
Not in a junction box (well house)

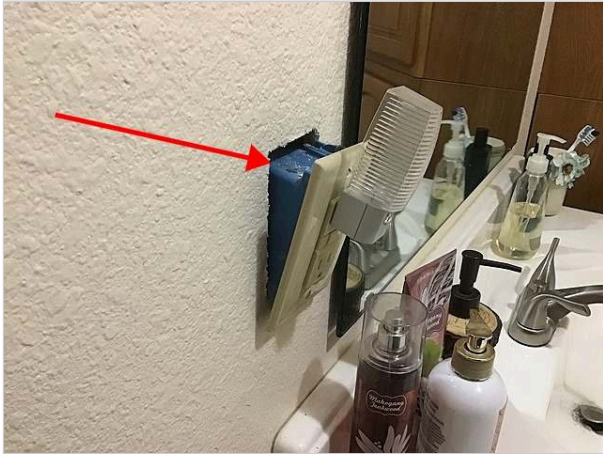
Gang box in the hall bathroom was improperly installed (loose).

Loose (hall bathroom)

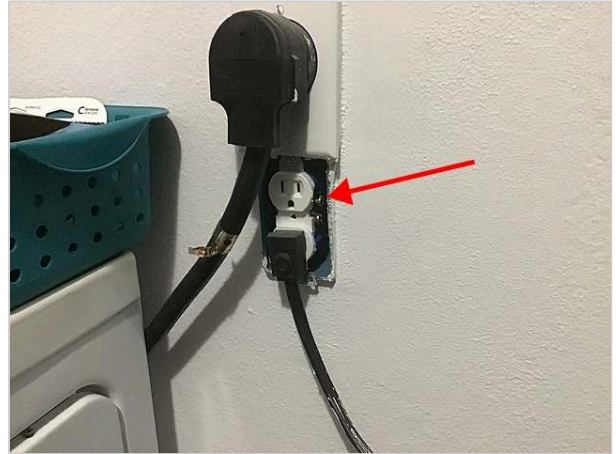
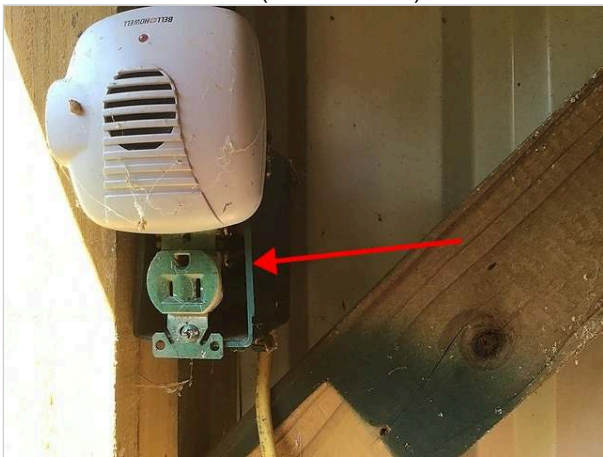
One or more receptacles were missing cover plates.

No cover plate

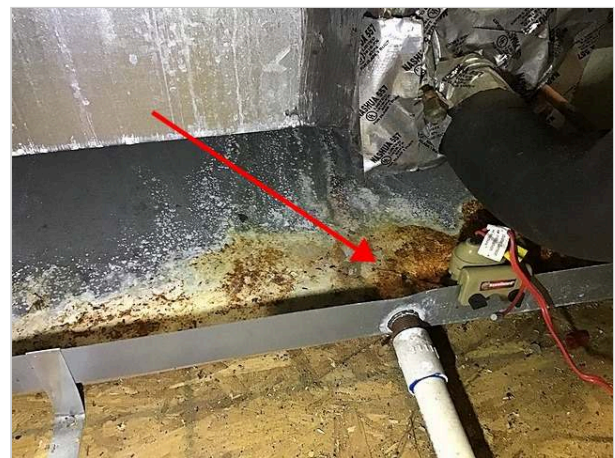
There was rust in the secondary drain pan. Once the galvanized coating is used up and rust sets in, it will continue to rust even without liquid water present.

Rust in the pan

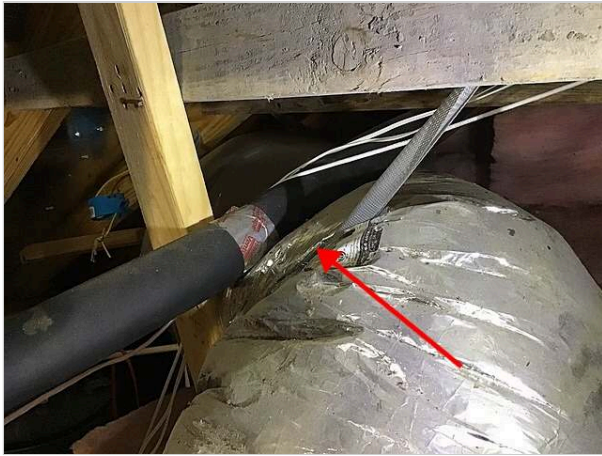
Ducts in the attic space were in contact with refrigerant line. Points of contact between these items has been known to create condensation in the attic space. Common industry standard calls for supply ducts to be elevated over insulation, not in contact with refrigerant lines/other flex ducts and/or HVAC units in the attic space.

In contact with the refrigerant line

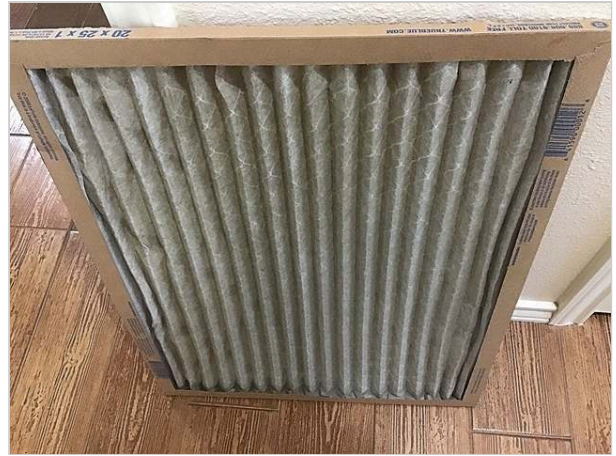
The filter was dirty and needed to be replaced. Dirty filter(s) indicate that the system had not been properly maintained and may require the need for cleaning/service.

Needed to be replaced

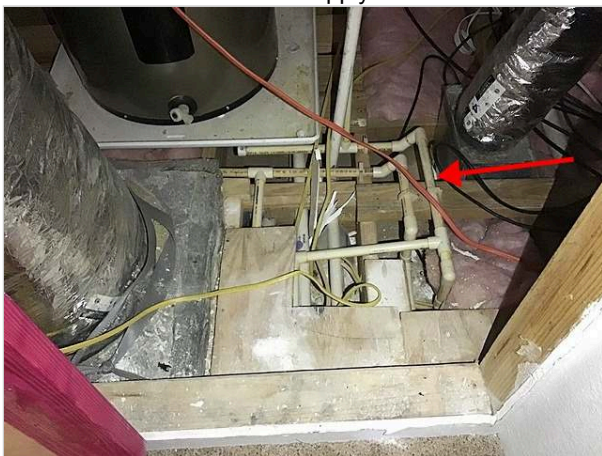
Visible, exposed water supply piping was not sufficiently insulated. Exposed water lines should be insulated against freezing temperatures.

Not properly insulated

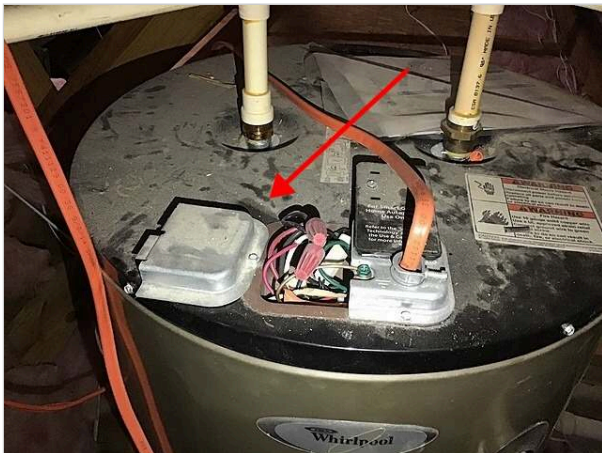
The cover plate for the designated junction box was not installed at the time of inspection.

Not installed (cover plate)

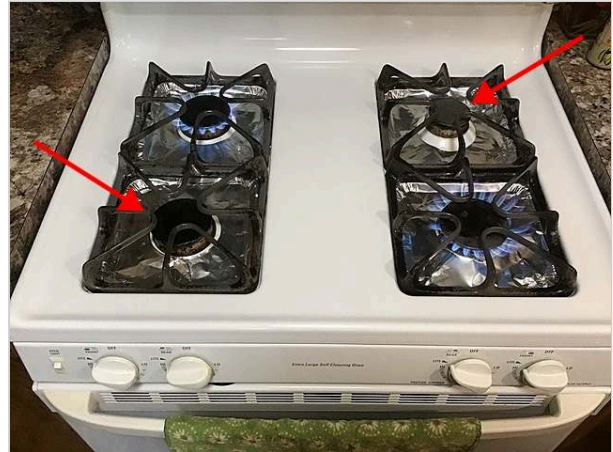
Nonfunctional

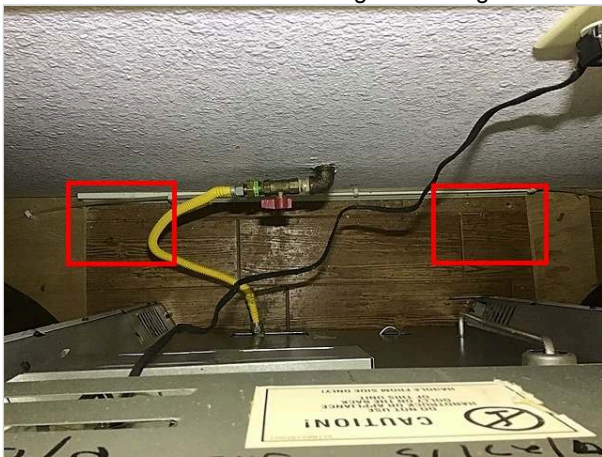
No anti-tip device

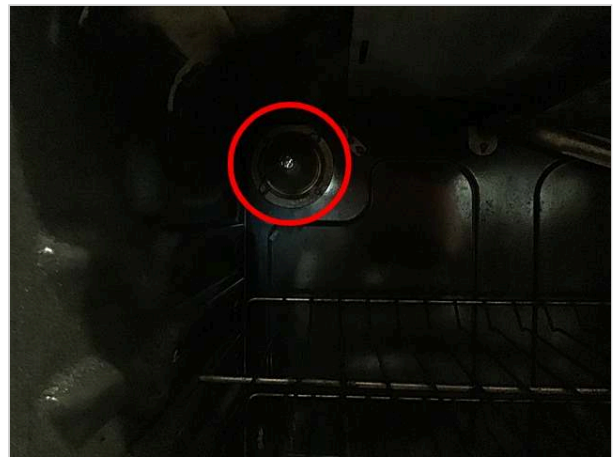
Would not illuminate

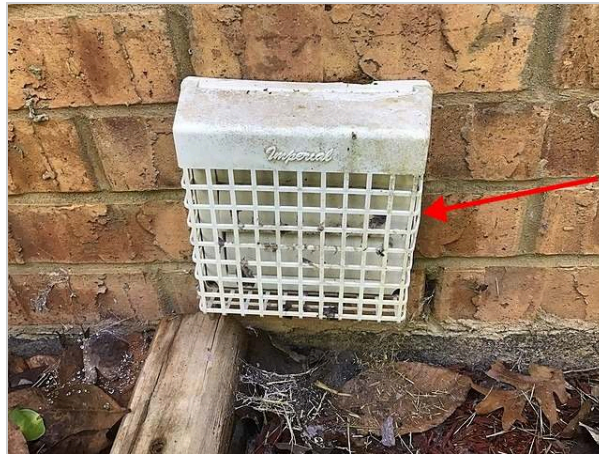
The dryer vent had a screened termination. The Texas Real Estate Commission (TREC) considers this to be a deficiency according to the standards of practice (SOP).

Screened termination
