# ART BYRD REAL ESTATE INSPECTIONS

## PROPERTY INSPECTION REPORT

**250 El Dorado Blvd. #121 / Webster, Texas 77598**

March 11, 2022

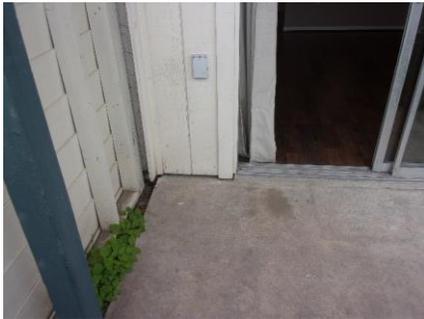
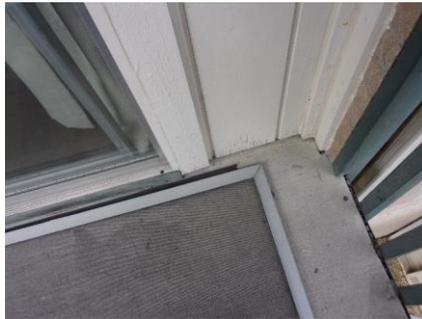
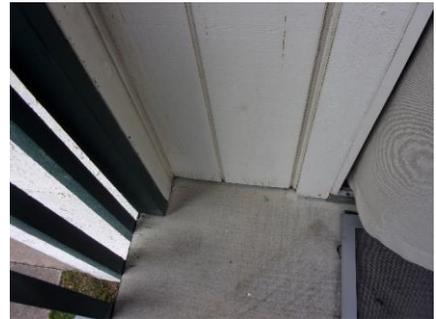
**E. Walls (Interior and Exterior) –**  
*Comments:*  
**Exterior:**  Brick  Stone  Stucco  cement fiber board  other wood  
**Interior:** *The wood at both glass sliding doors are cracking. Repair or replace damaged wood*

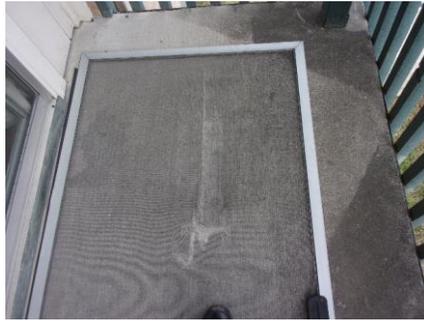
**G. Doors (Interior and Exterior) –**  
*Comments: The upper balcony screen door is off. Reinstall the screen door.*  
 Is garage barrier door self-closing?  Yes  no  N/A

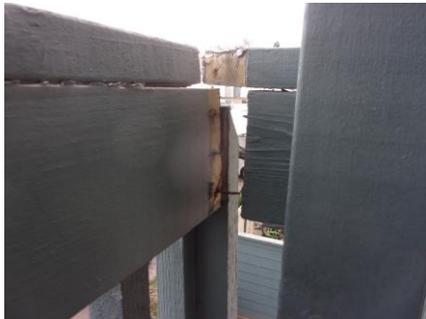
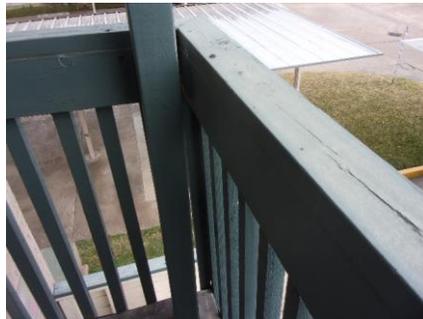
- K. Porches, Balconies, Decks and Carports –**  
*Comments: The front rail on upper balcony is loose. Repair the safety rail.*

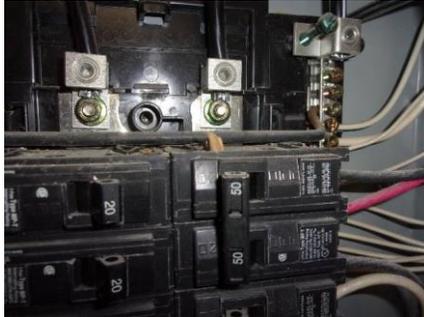
*Install anti-oxidant paste to service wire connections.*
