GREATER HOUSTON AREA - NOBLE PROPERTY INSPECTION REPORT

7414 Canary Cir
Texas City, TX 77591

PROPERTY INSPECTION REPORT FORM

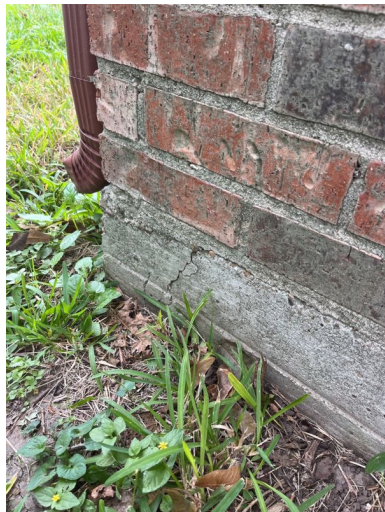
Left Back

1: Slab - foundation cracks - corners

Corner cracks are visible in the foundation slab but are of minimal structural concern. Shrinkage is a natural part of the curing process of concrete and cracks located in corners of structures are common. Recommend patching the corner cracks to prevent moisture/pest intrusion. Also recommend monitoring to confirm the cracking does not worsen.

Recommendation: Contact a qualified Houston - Foundation Contractor

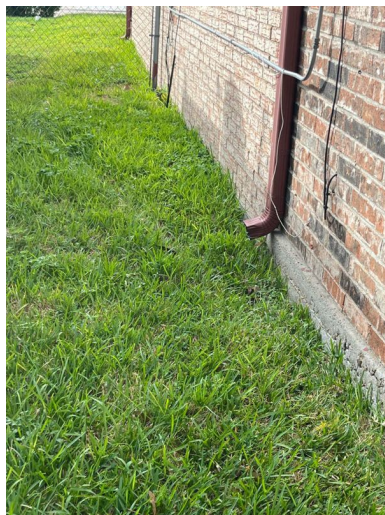
Right

3: Low clearance to grade

The clearance from the finished floor elevation (i.e. top of slab) to the exterior grade (i.e. ground) should be 6-inches or greater. This will prevent pooling surface water runoff from storm events from entering the structure. Recommend regrading the build-up of material to expose the foundation and create a greater clearance.

Recommendation: Contact a qualified Houston Area - Landscaping Contractor

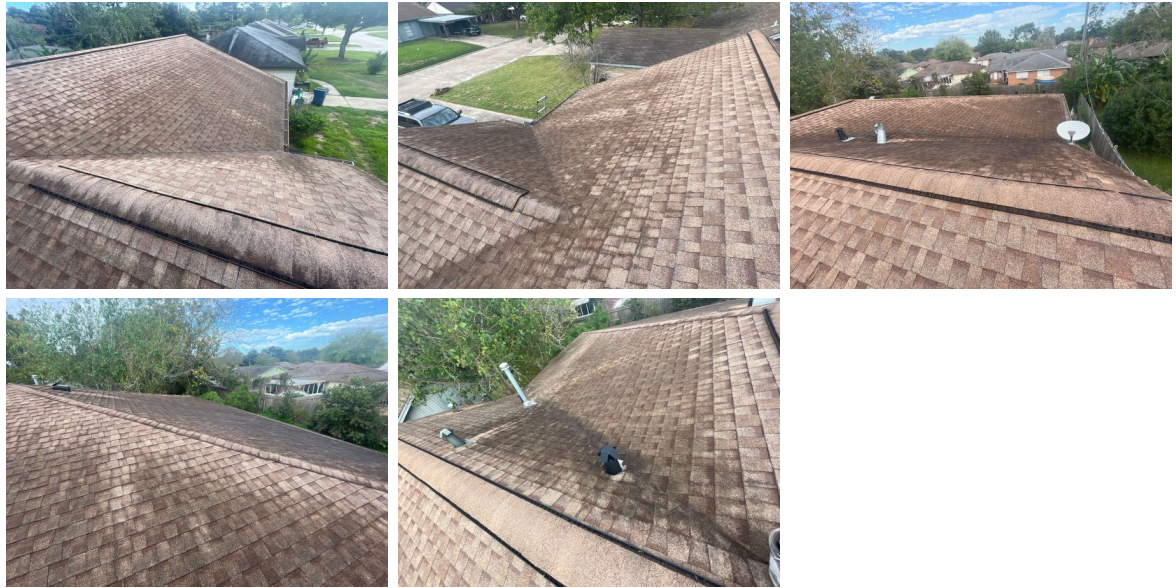
1: Damaged coverings

Roof coverings exhibited general damage that could affect performance. Recommend a qualified roofer evaluate and repair.

Recommendation: Contact a qualified Houston - Roofing Professional

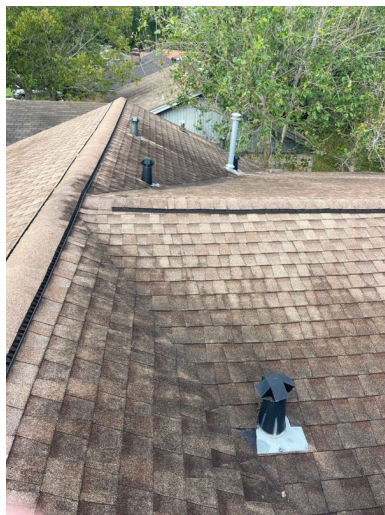
6: Improper plumbing vents

No plumbing vents can be seen indicating improper vents are being used to cover the plumbing vents.

Any other installation may not allow for sufficient venting and will lead to an eventual leaking around the outside of the pipe material and water intrusion into the structure. Vents that depend on sealant alone to prevent moisture intrusion are considered incorrect installations. Recommend replacing all these vents with proper vent boots.

Recommendation: Contact a qualified Houston - Roofing Professional

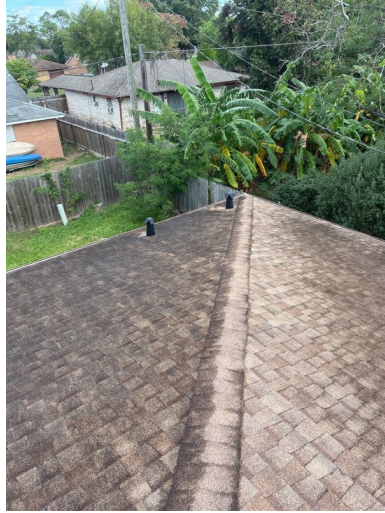
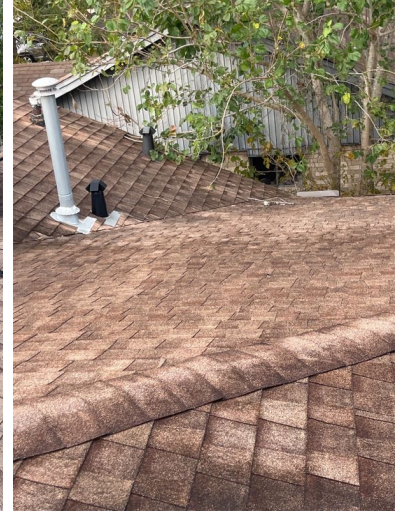
7: Vent damage

Vent gas been damaged and needs to be replaced to prevent further water intrusion, mold growth and damage to home

Recommendation: Contact a qualified roofing professional.

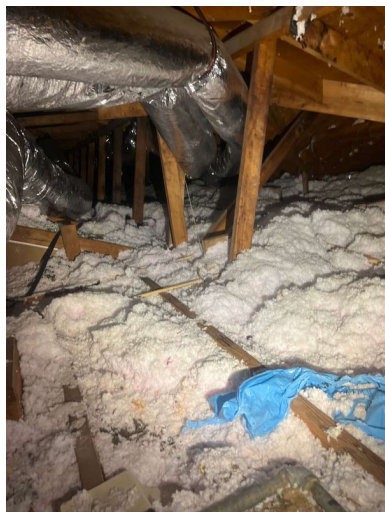
1: Damaged / missing insulation

Insulation appears to have been pulled out and/or damaged by contractors and/or pests. Recommend a qualified insulation contractor evaluate and repair.

Recommendation: Contact a qualified Houston - HVAC Professional

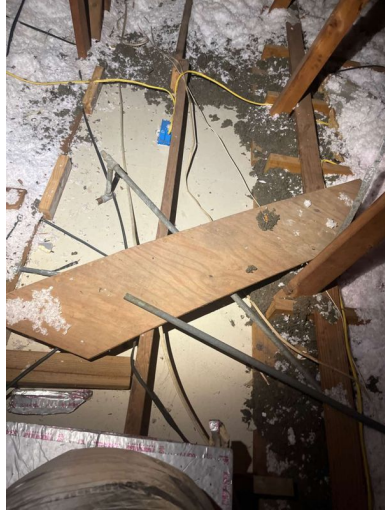
2: Roof leakage

Visible roof leaks were observed in the attic. Recommend a qualified roofer evaluate and repair.

Recommendation: Contact a qualified Houston - Roofing Professional

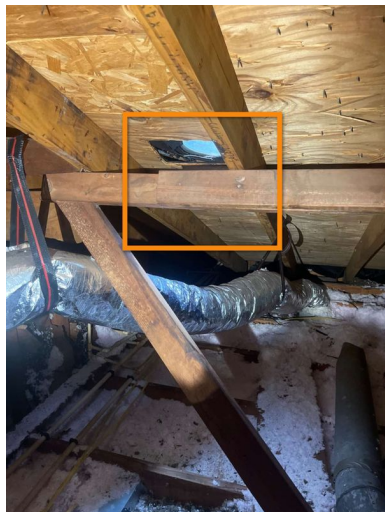
3: Water line insulation damaged / missing

Water line insulation is important to keep distribution lines from freezing and bursting in cold weather. Water lines should be insulated regardless of their type. Missing or damaged water line insulation was discovered and should be replaced.

Recommendation: Contact a qualified Houston - Plumbing Contractor

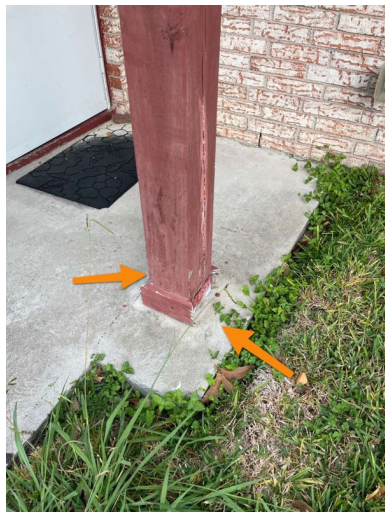
Front Porch

2: Cracks major

Major cracking observed in wall structure that is likely due to structural foundation issues and is considered evidence of a structural deficiency. Recommend a qualified foundation contractor evaluate and advise on course of action.

Recommendation: Contact a qualified Houston - Foundation Contractor

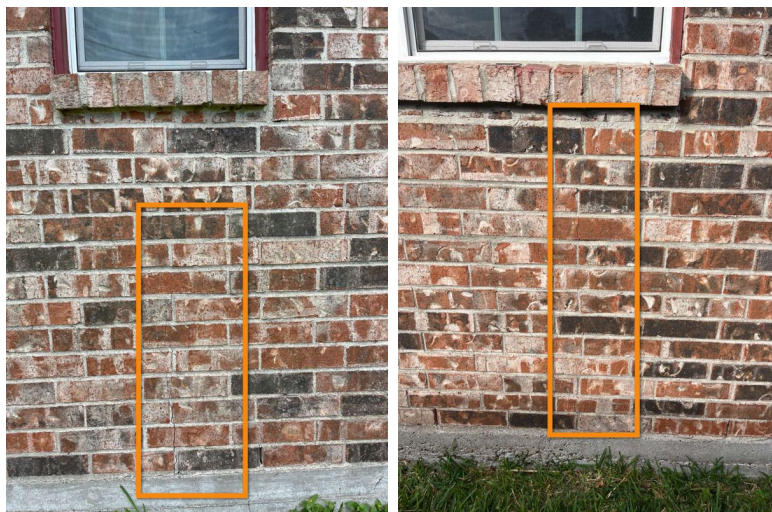
3: Cracks minor

Minor cracking was observed in wall structure. This is common in structure this age and is often determined to be cosmetic. That said, cracking is a first sign of foundation failure and cracks can grow over time; recommend monitoring. The best way to monitor a crack is to patch it (with mortar or caulk) and repaint it, to see if the crack reappears.

Recommendation: Contact a qualified Houston Area - Painting Contractor

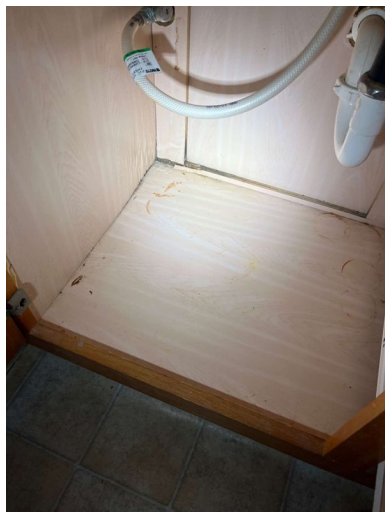
Back Right Bedroom Bathroom

1: Flooring - evidence of possible water intrusion / damage

Flooring showed signs of water intrusion / damage (stained areas, baseboard warping, tile popping, mold odor, etc.), which could lead to the discovery of present mold and/or more serious structural damages. Recommend a qualified flooring contractor identify source or moisture and remedy.

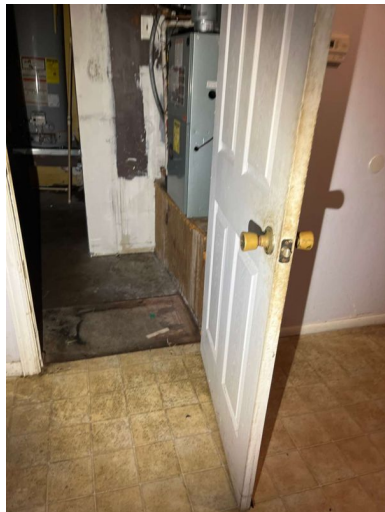
3: Door is rotting

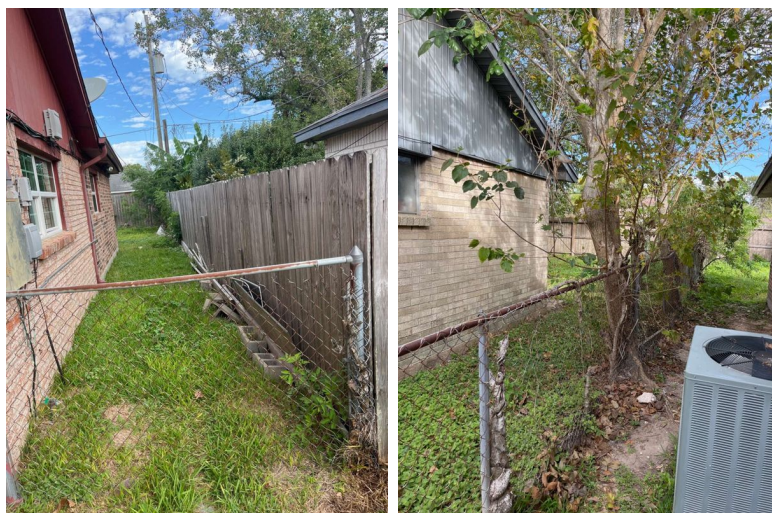
3: Heavy vegetation and/or high grass

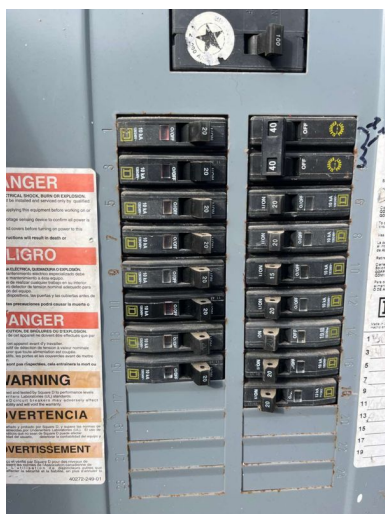
2: Double lug neutral wires

Recommendation: Contact a qualified Houston - Electrical Contractor

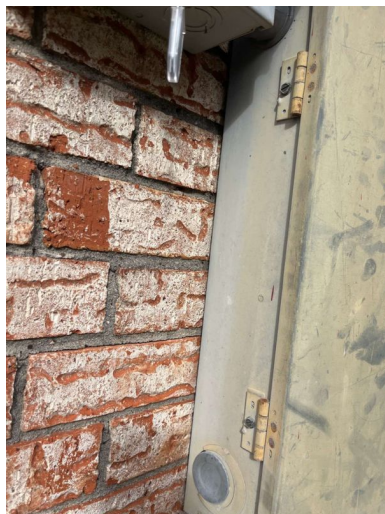
4: Panel cover / dead front missing screws

Recommendation: Contact a qualified Houston - Electrical Contractor

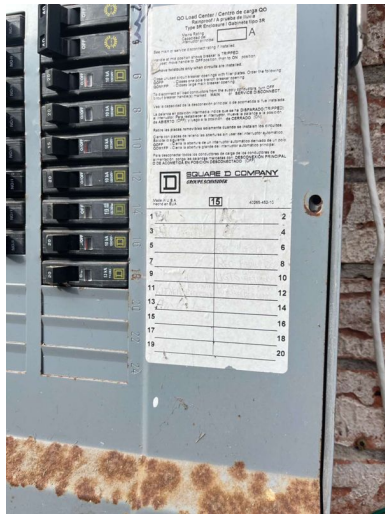
6: Panel is corroded / rusted

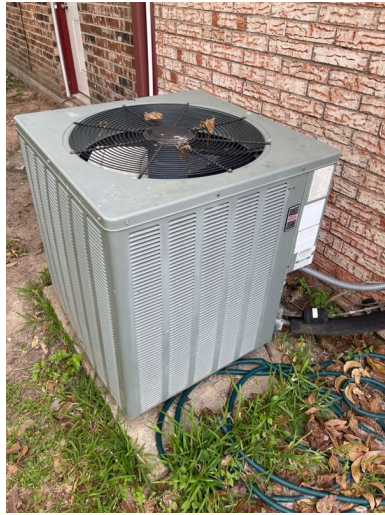
4: Evaporator - freon line insulation missing or damaged

Recommendation: Contact a qualified Houston - HVAC Professional

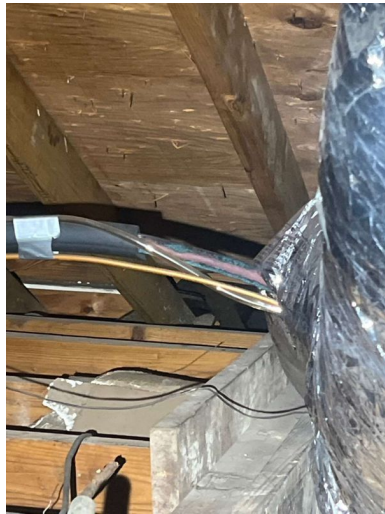
5: Evaporator - cooling equipment nearing end of its useful life

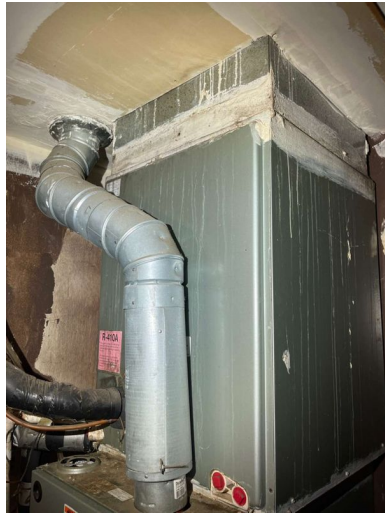
6: Water damage beneath HVAC

Recommendation: Contact a qualified HVAC professional.

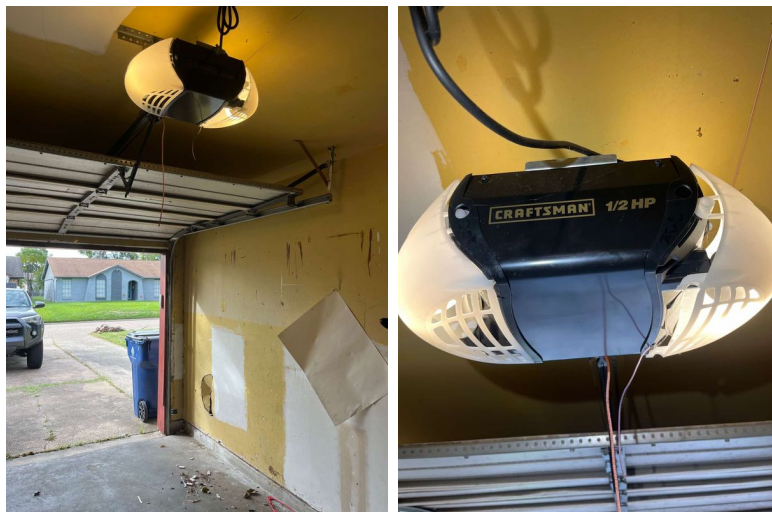
1: Auto reverse sensors are too high
