Web Presentation

Stanley Garment

Property Address: 20006 Ambervine Circle, Katy, Texas 77450

ABET Inspections

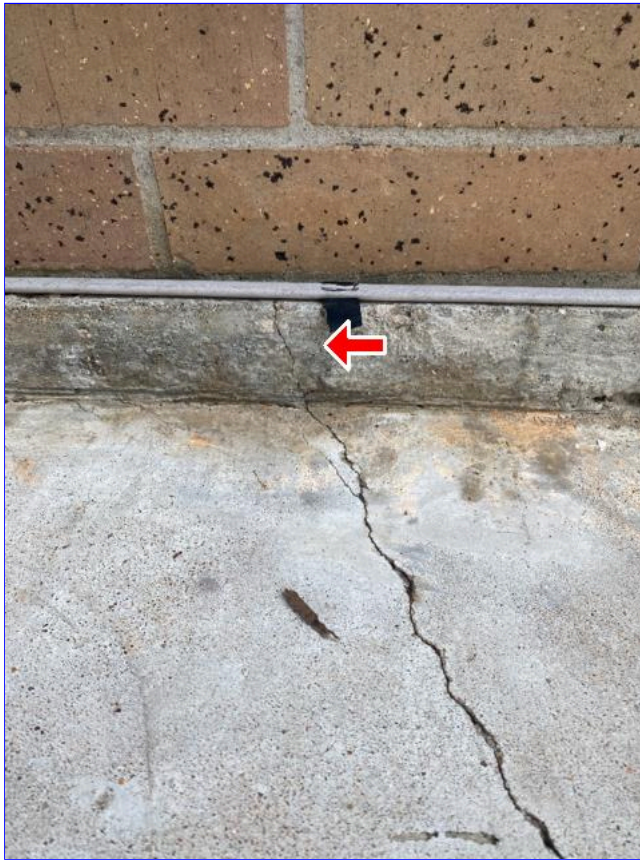
A. Item 1(Picture)

(2) Visible cracks in foundation observed at front entry

(4) Signs of structural movement noted; suggest that an expert in this field be consulted for further evaluation of the foundation and to provide suggestions as to what corrective actions should be taken if any are needed.

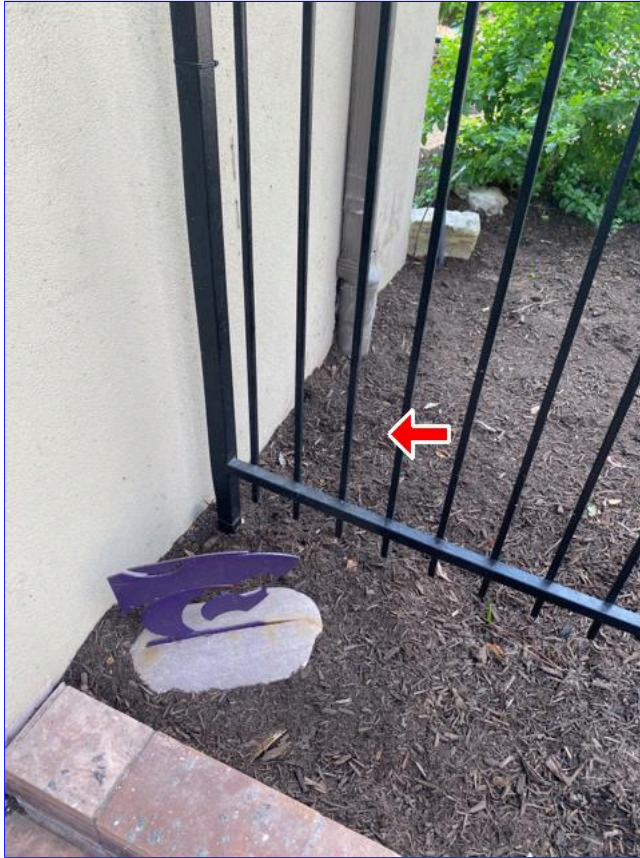
B. Item 1(Picture)

(2) Foundation lacks 6" exposure below siding/stucco.

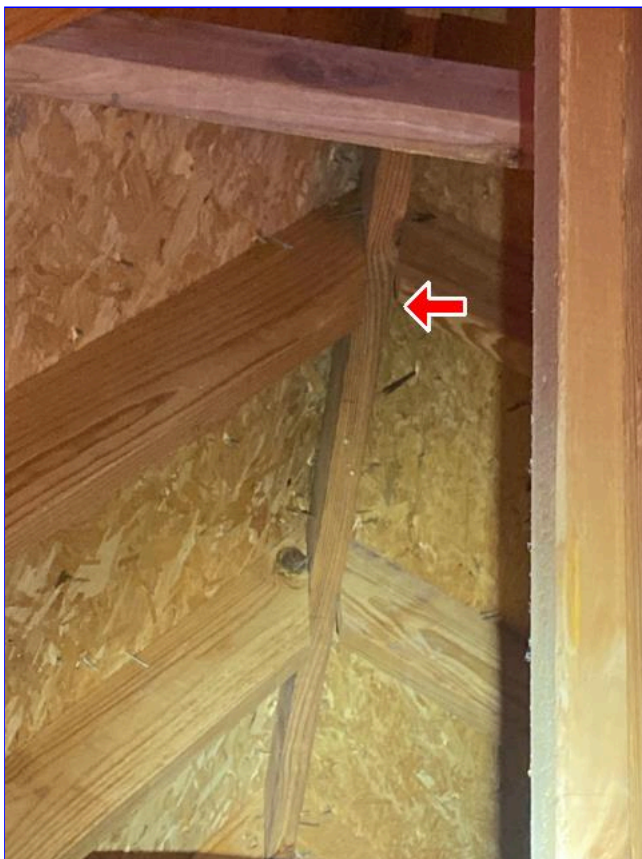
D. Item 1(Picture)

(2) Purlin boards are inadequately sized for rafters.

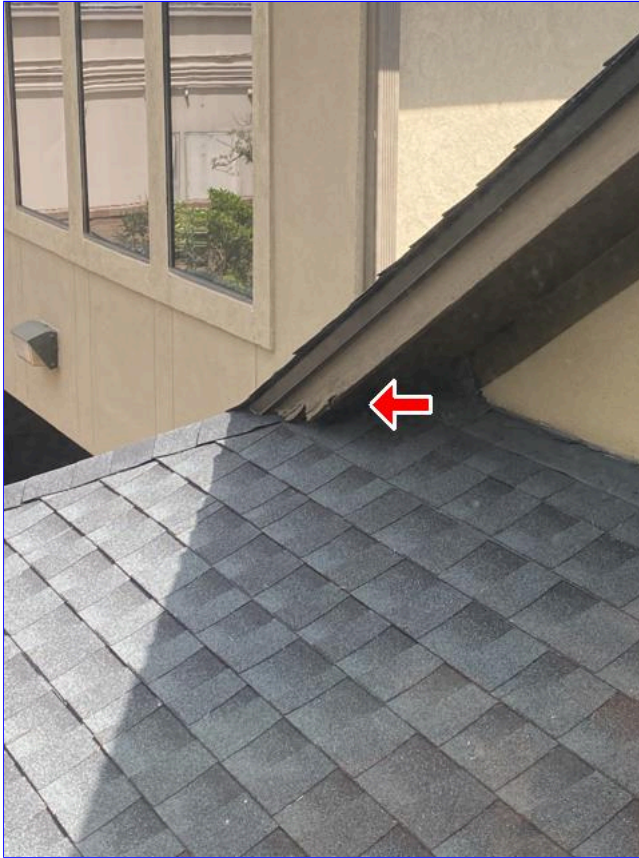
D. Item 2(Picture)

(3) Deteriorated wood observed at fascia and/or soffits.

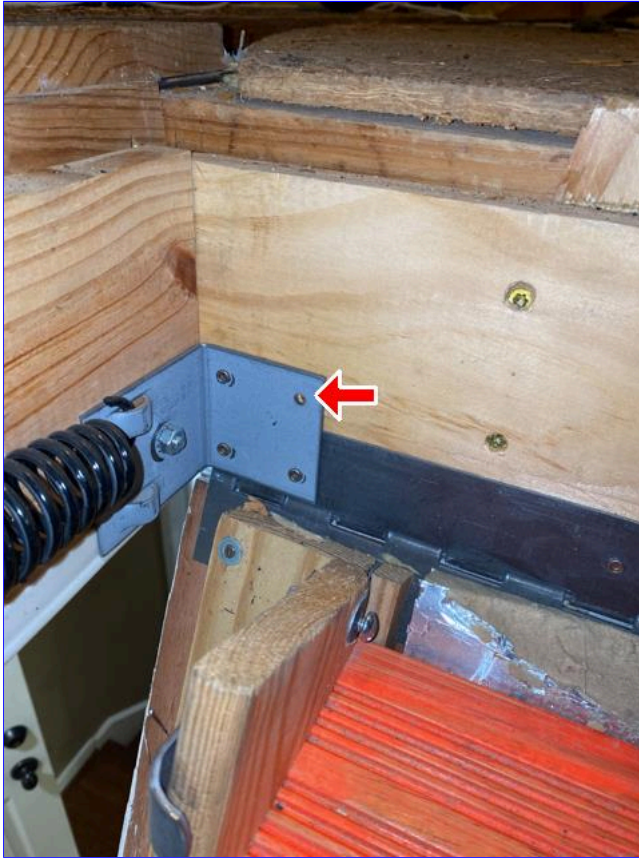
D. Item 5(Picture)

(4) Attic pulldown stairway is not properly nailed through metal brackets.

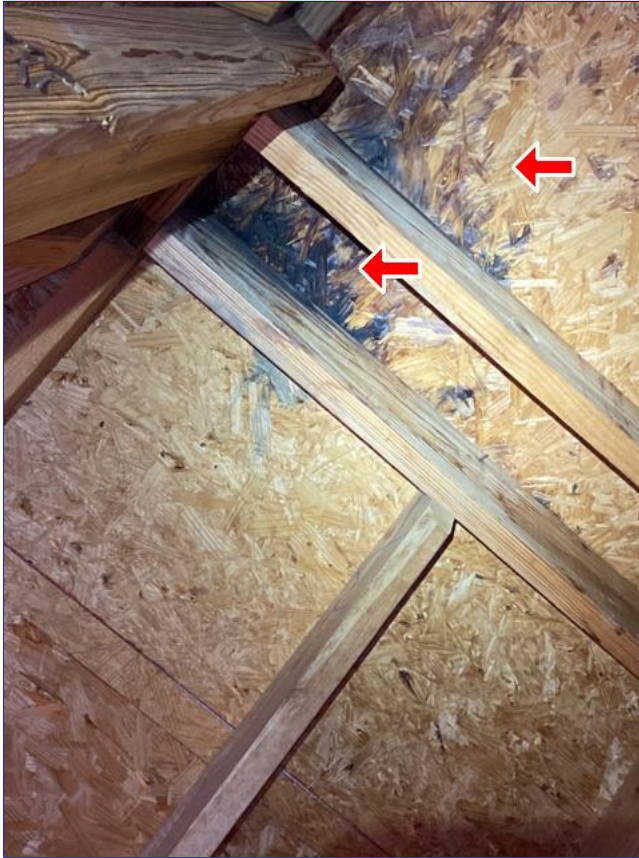
D. Item 6(Picture)

(5) Visual evidence of moisture penetration on roof decking. Further evaluation recommended.

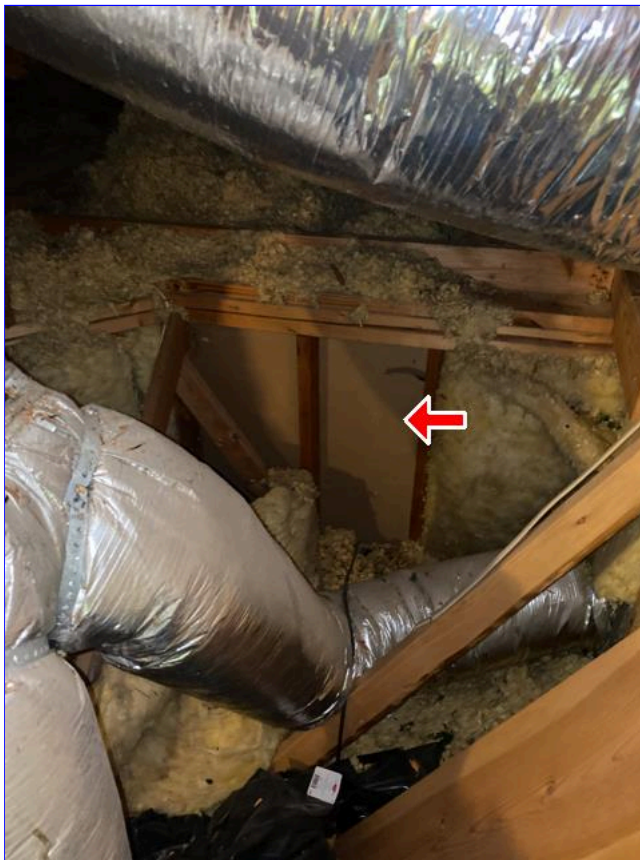
D. Item 13(Picture)

(6) Vertical insulation sections are loose and/or missing.

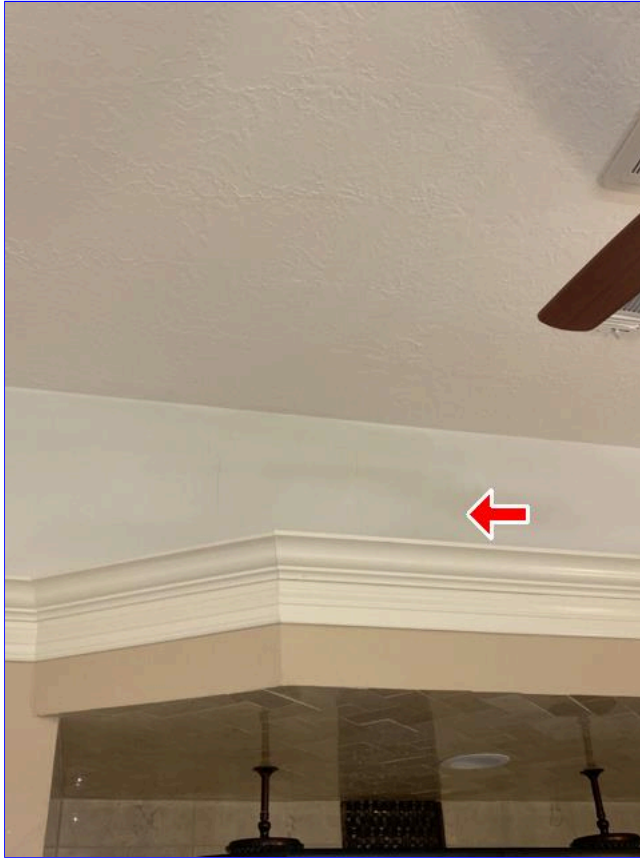
E. Item 1(Picture)

(2) Previously repaired sheetrock observed at master bathroom

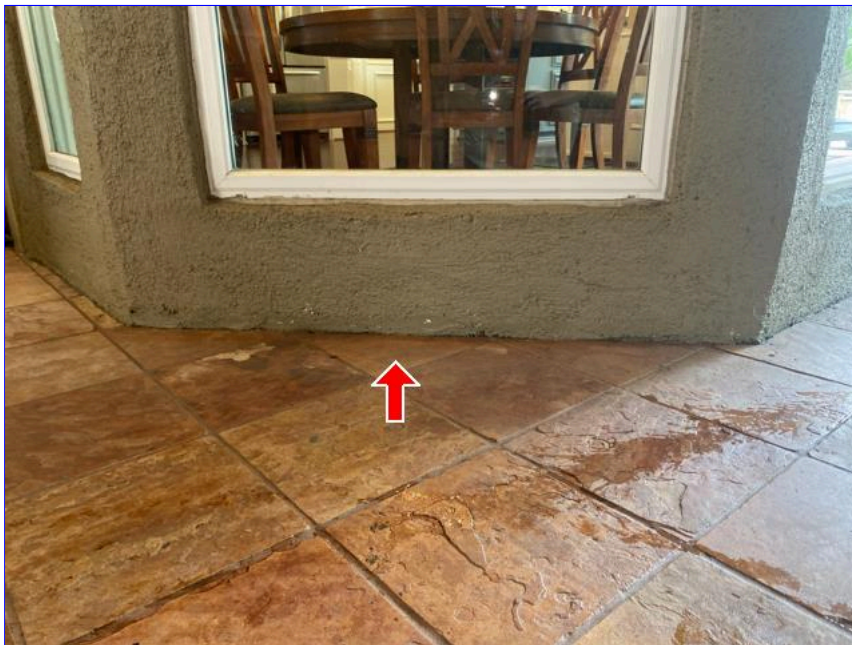
E. Item 2(Picture)

(3) Stucco lacks 2" clearance to flatwork.

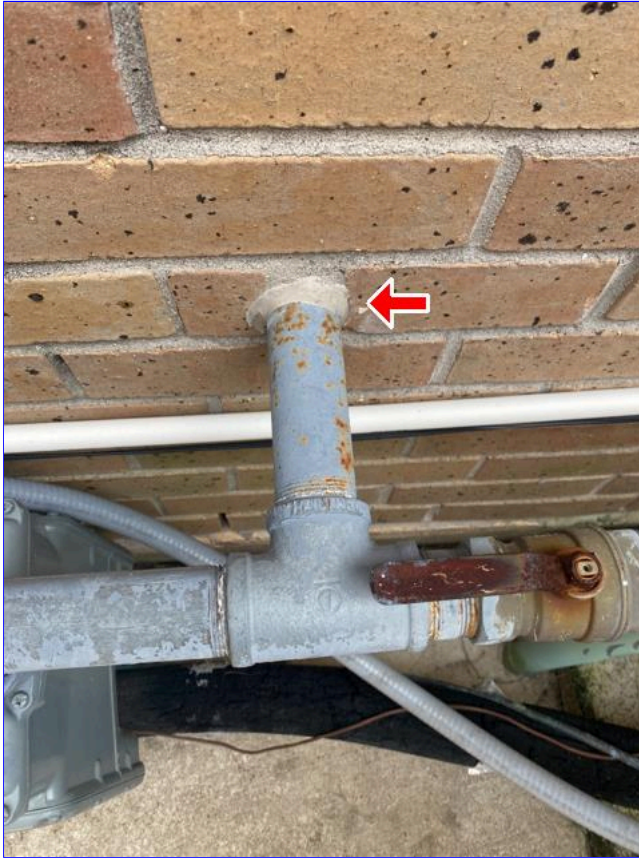
E. Item 7(Picture)

(5) Gas line is not sleeved at exterior wall penetration point.

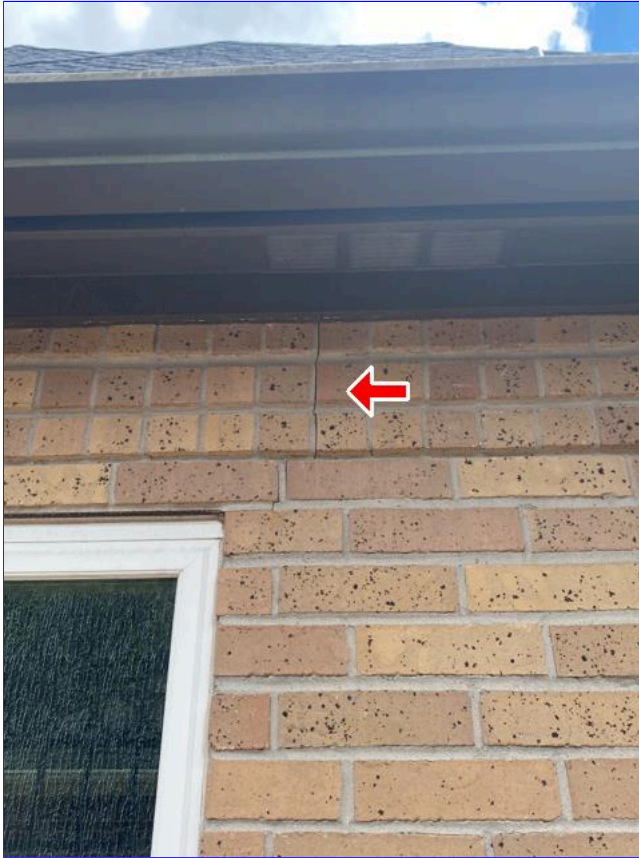
E. Item 8(Picture)

(6) Cracks observed at brick.

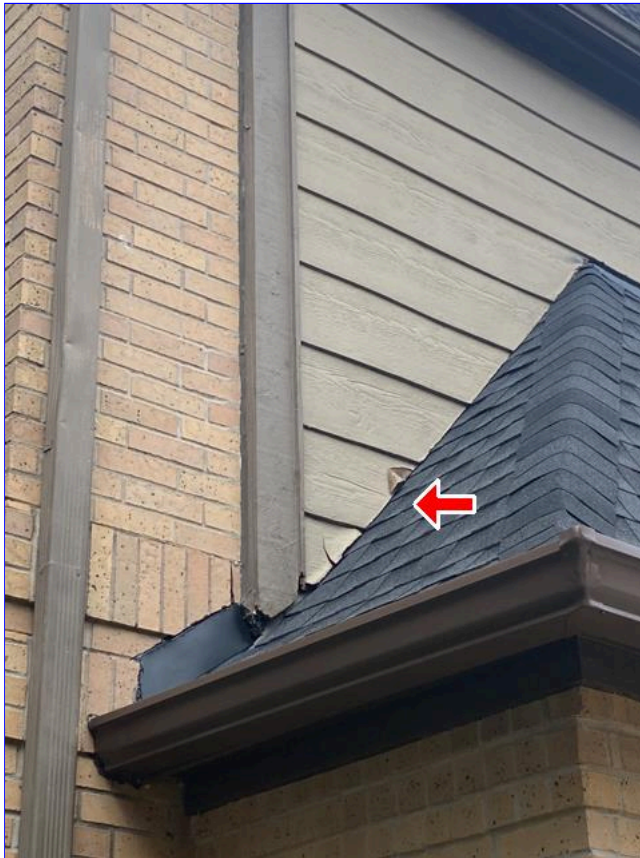
E. Item 13(Picture)

(7) Deteriorated or rotten wood observed at siding

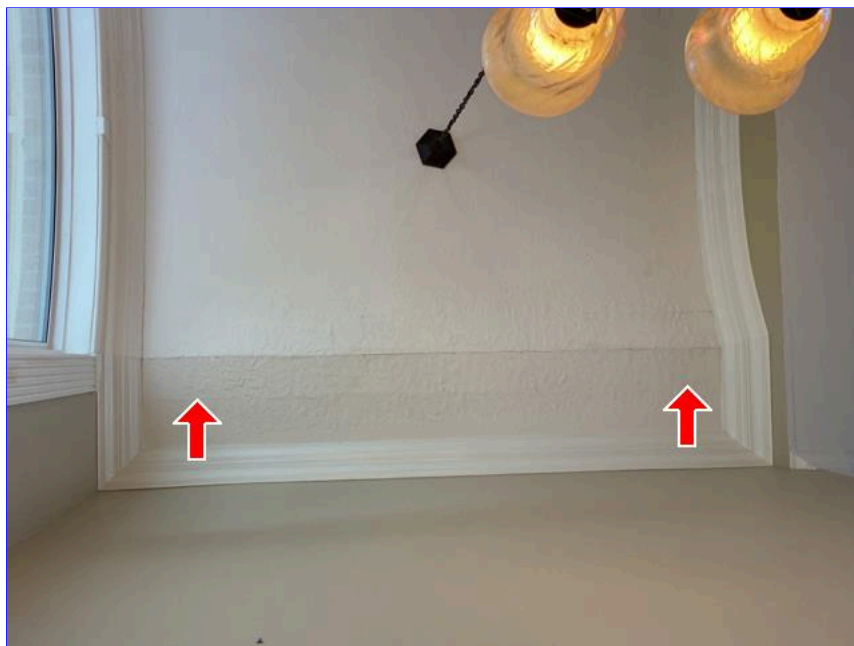
F. Item 1(Picture)

(2) Cracks in sheetrock observed at front entry, upstairs kitchen

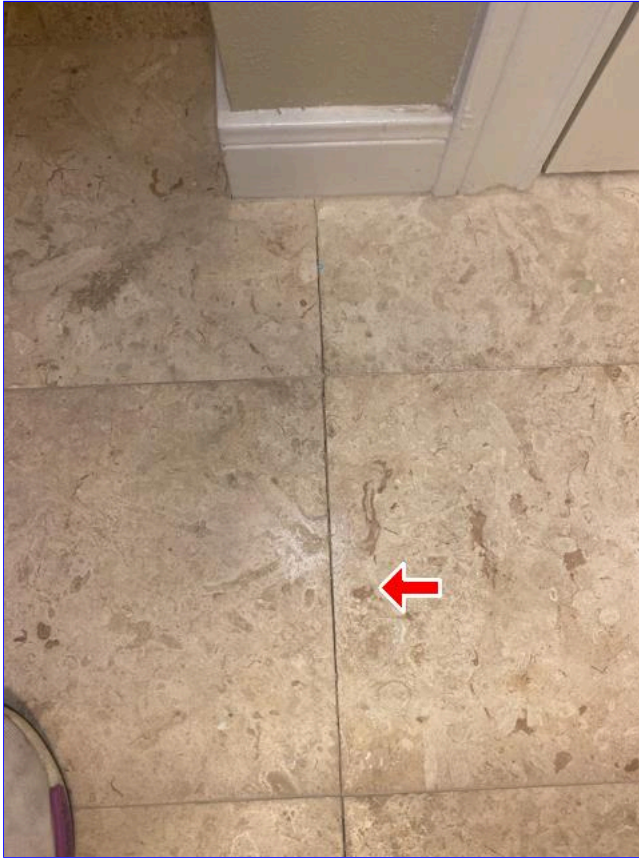
F. Item 3(Picture)

(3) Grout is cracked at upstairs bathroom

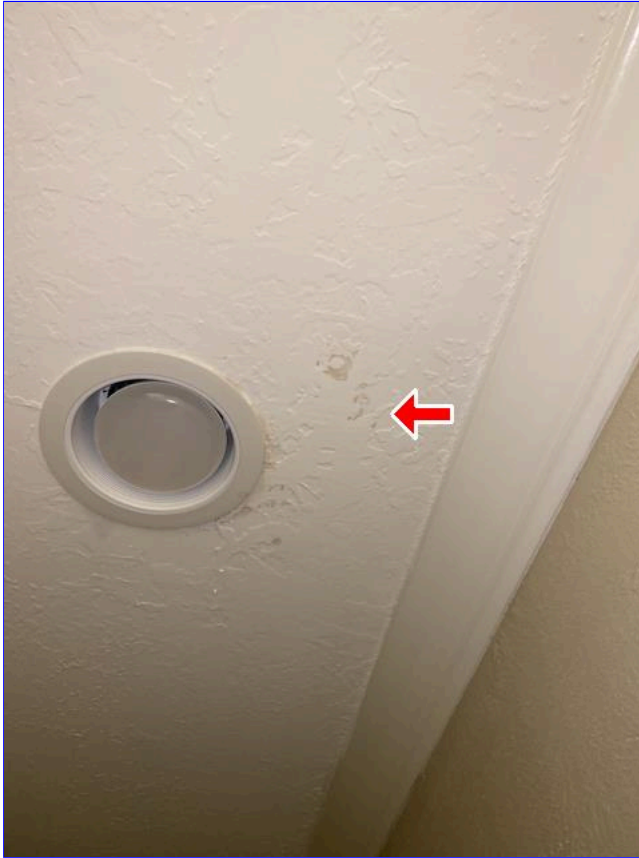
F. Item 4(Picture)

(4) Water stains observed on ceilings at upstairs movie room bathroom

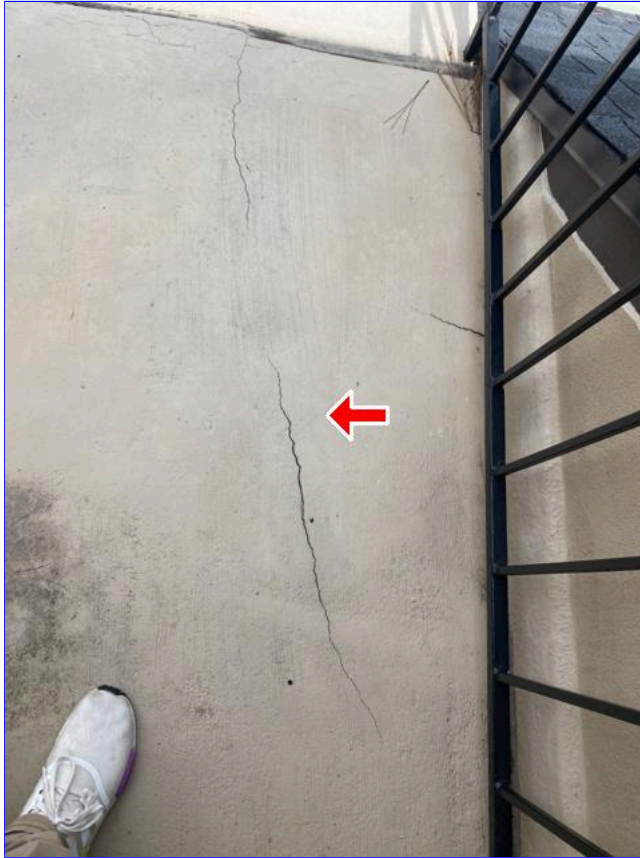
K. Item 1(Picture)

Cracks in concrete patio

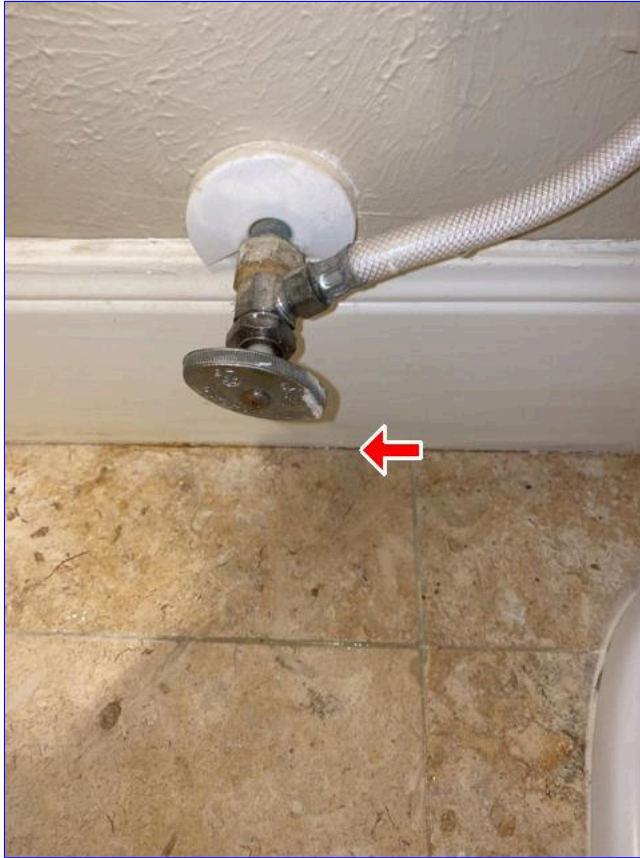
A. Item 4(Picture)

(6) Toilet is leaking at upstairs mother law suite bathroom

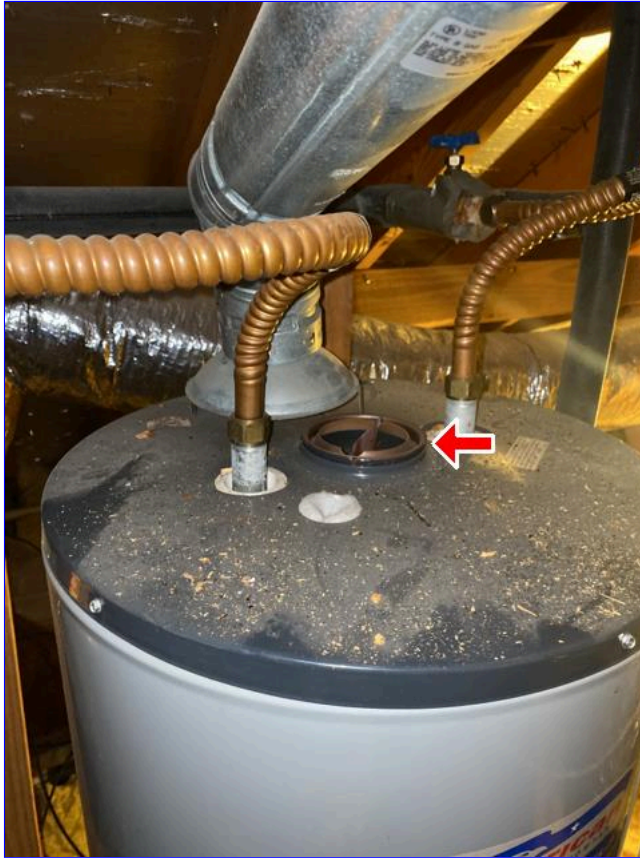
C. Item 16(Picture)

(4) Vent pipe collar is improperly installed at roof jack

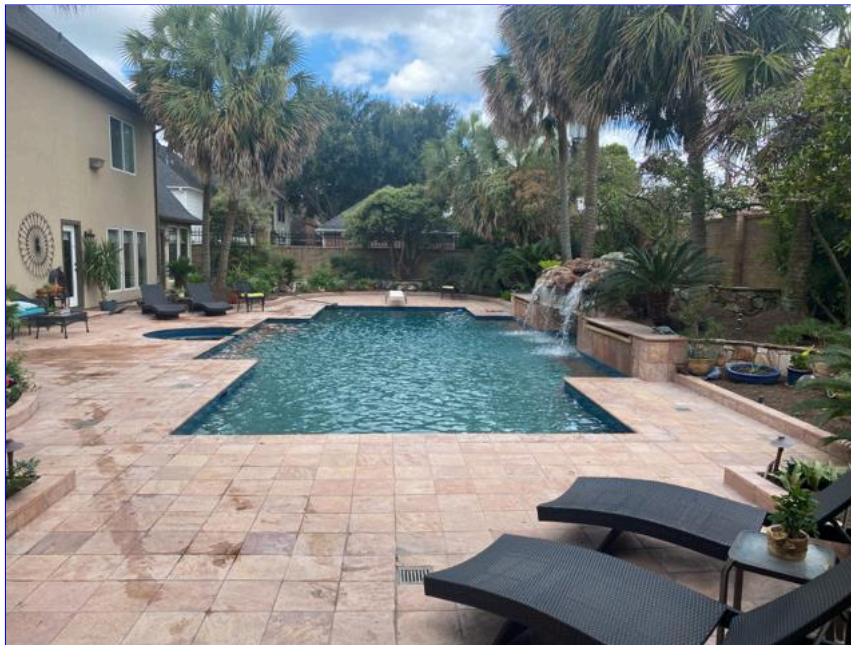
B. Item 2(Picture)

(2) Cracking on pool decking
