Inspection Report

Property Address:
161 Dogwood Blvd
Trinity Texas

PROPERTY INSPECTION REPORT

By: Joe Bradley 7310 TREC #7310 / Bradley Real Estate Inspection 10/6/2023

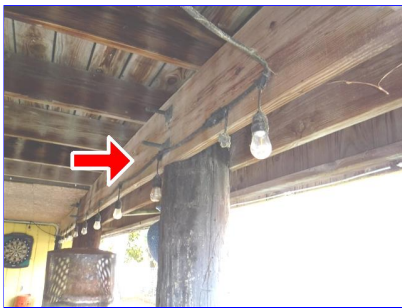
A. Item 1 (Picture) Foundation

In the opinion of the inspector nothing was noted that would indicate major differential movement or compromised structural integrity, foundation appeared to be within excepted tolerances. Foundation appeared to be performing as intended at the time of inspection. Inspector assumes no responsibility for geological faults.

Foundation checked with laser level. A reference point was established and measurements were taken around the room.

Foundation appeared to be within excepted tolerances and performing as intended at the time of inspection

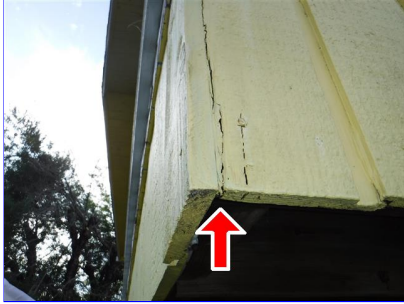
- Wood deterioration right front corner
- Wood deterioration siding along bottom rear
- Wood deterioration porch post trim
- Wood deterioration along garage roof gable.

E. Item 1 (Picture) Wood deterioration right front corner

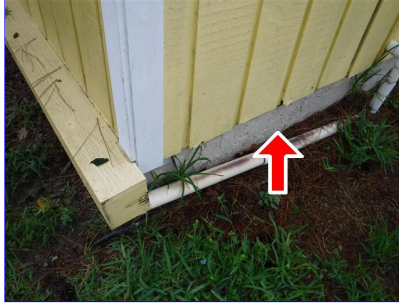
E. Item 2 (Picture) Wood deterioration along bottom rear

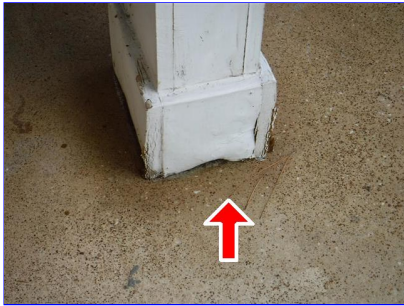
E. Item 3 (Picture) Wood deterioration post trim

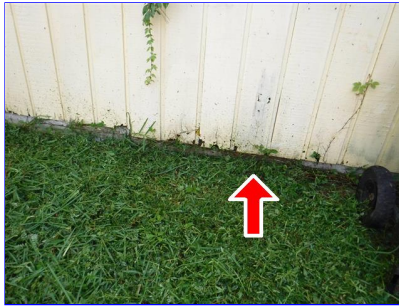
E. Item 4 (Picture) Wood deterioration along bottom rear

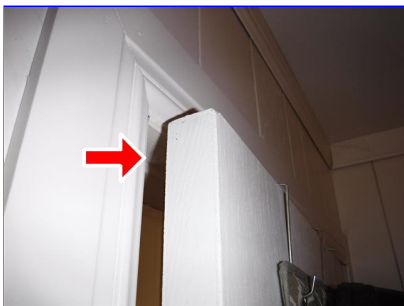
Bedroom door drags jamb

G. Item 1 (Picture) Bedroom door drags jamb

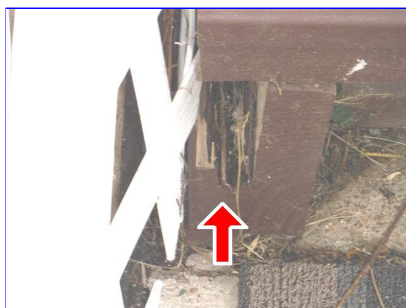
Wood deterioration stair stringers front.

I. Item 1 (Picture) Wood deterioration stair stringer

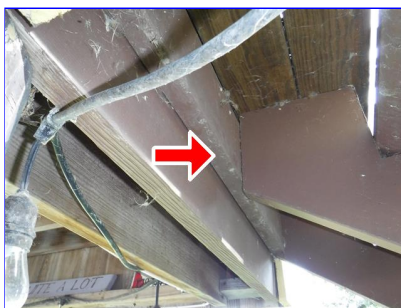
Missing hangers / pressure blocking at top of stairs.

I. Item 2 (Picture) Missing pressure blocking / hangers

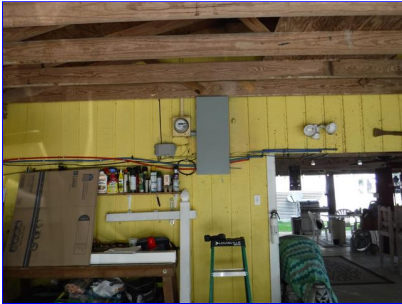
Pane mounted too high off ground.

A. Item 3 (Picture) Mounted too high

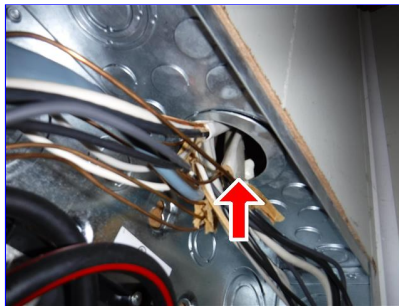
Missing wire bushings

A. Item 6 (Picture) Missing wire bushing

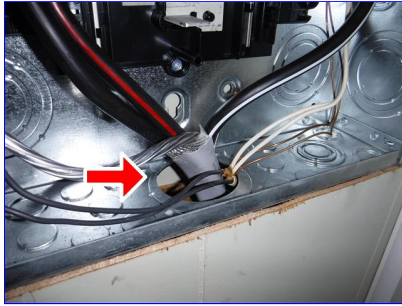
A. Item 7 (Picture) Missing wire bushings

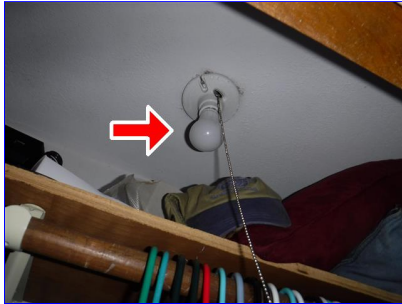
B. Item 1 (Picture) Un-covered light fixtures in bedroom closet

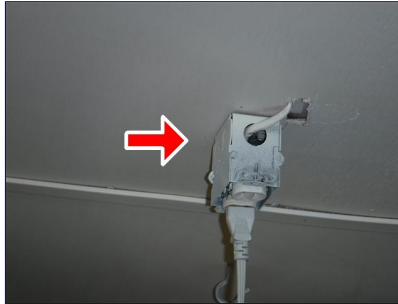
B. Item 2 (Picture) Missing plug cover storage room

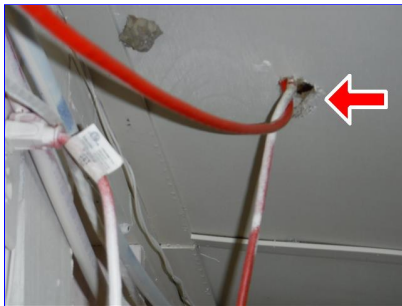
B. Item 3 (Picture) Extension cord run through ceiling storage room

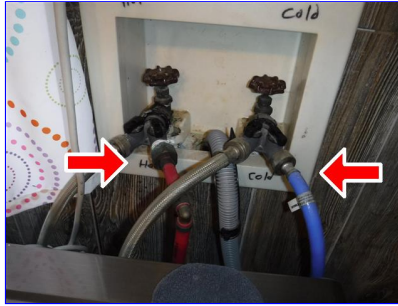
Downstairs shower plumbed to the washing machine valves

A. Item 2 (Picture) Water to downstairs shower plumbed to the washing machine valves

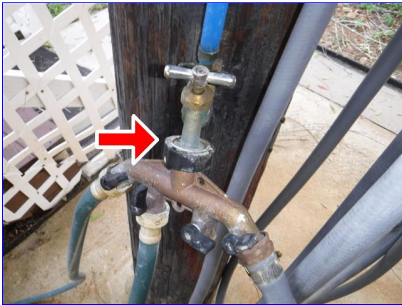
Missing anti siphon devices on outside hose bibs

A. Item 3 (Picture) Missing anti siphon devices on outside hose bibs

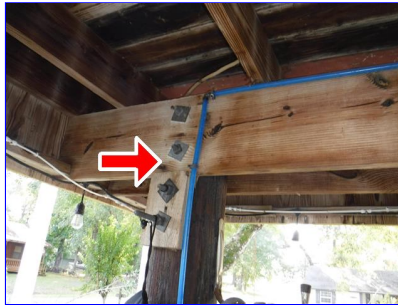
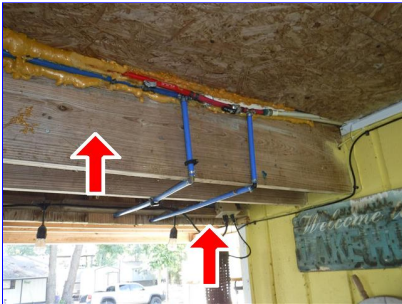
Un-insulated water lines in crawlspace

A. Item 4 (Picture) Un-insulated water lines in crawlspace

A. Item 5 (Picture) Un-insulated water lines in crawlspace

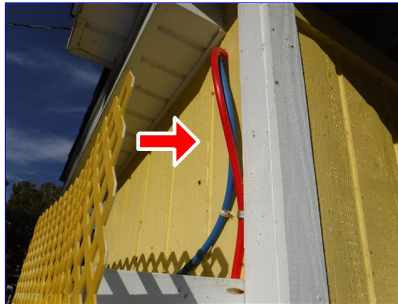
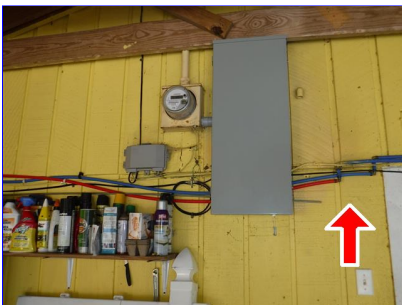
Un-insulated water lines left side

A. Item 6 (Picture) Un-insulated water lines on left side

A. Item 7 (Picture) Un-insulated water lines left side

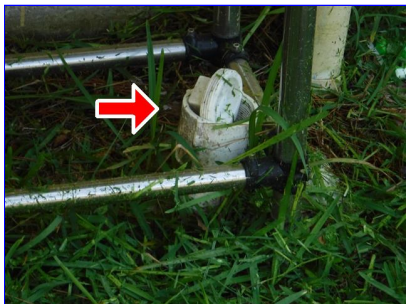
Cleanout cap off

B. Item 1 (Picture) Cleanout cap off

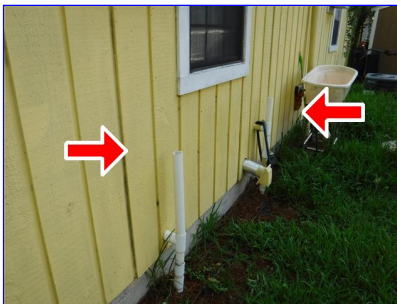
2 vent pipes rear terminate within 3 feet of an operational window

B. Item 2 (Picture) 2 vent pipes rear terminate within 3 feet of operational window
