Inspection Report

13722 Magnolia Manor Dr
Cypress TX 77429

Sunbelt Inspections

PROPERTY INSPECTION REPORT FORM

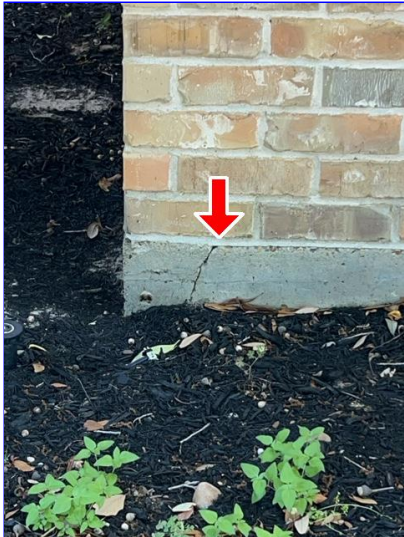
(1) Typical corner "pops" observed at foundation corners. This condition is cosmetic in nature and not structurally significant.

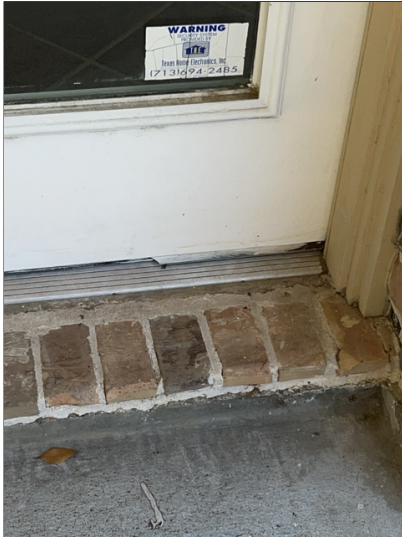
(1) The weatherstripping at the base of the exterior door to the carport area is damaged. Recommend correction.

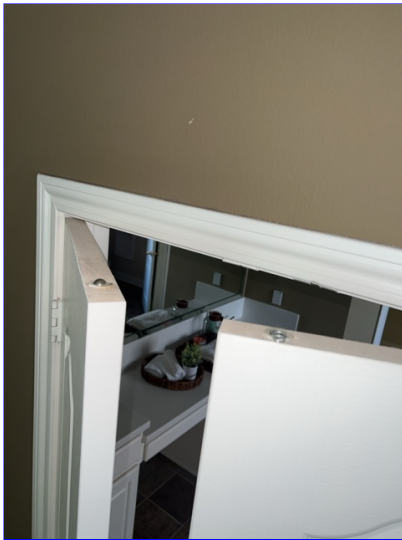
(2) The door hardware located on top of the double doors to the master bathroom or damaged and is in need of correction.

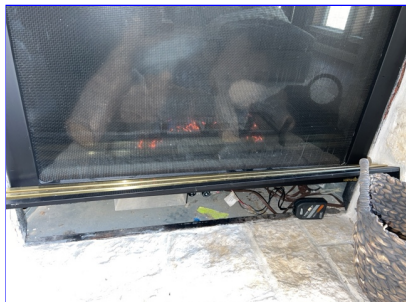
I was unable to locate the remote for the fireplace. I was able to turn on the fireplace using the controller under the unit.

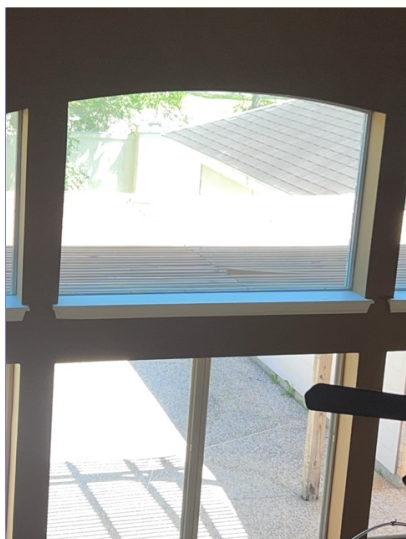
Several boards on top of the outdoor pergola have worked loose and are warped. Recommend correction.

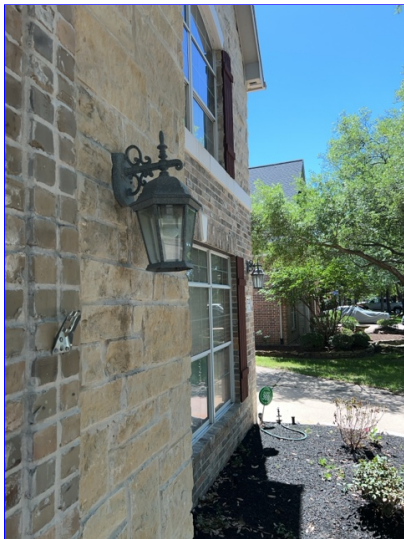
(1) The right side front porch Coach light did not turn on with the switch. The Coach light on the far right hand side of the house did not turn on as well.

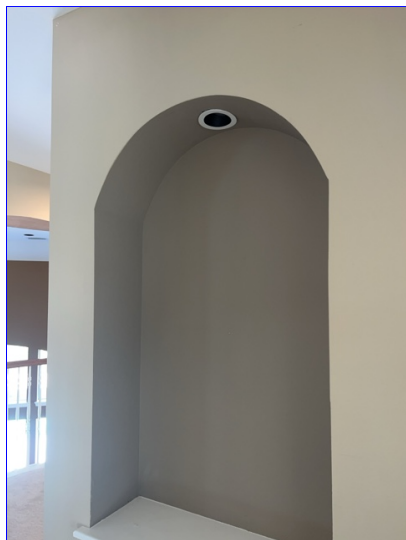
(7) The light in the upstairs art niche did not turn on with the switch. Recommend correction.

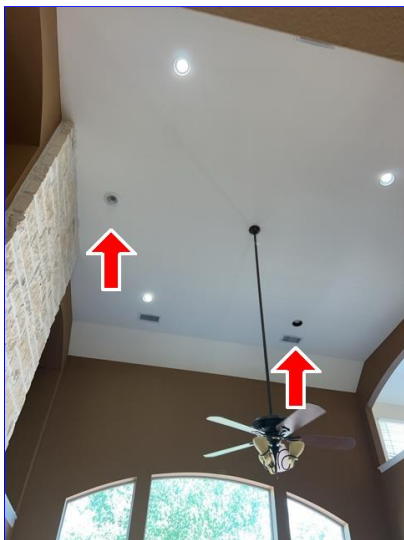
(9) Two lights in the living room did not turn on with the switch.

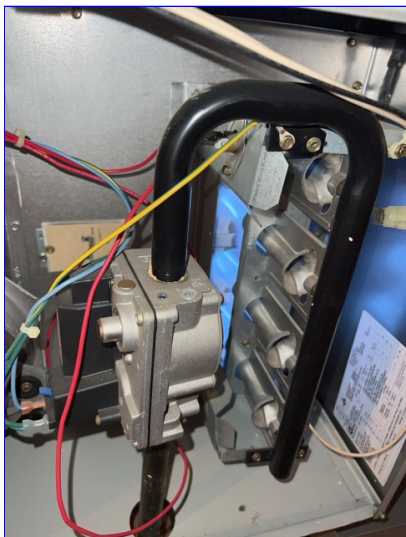
(1) The internal fan for the downstairs unit is defective and is making a lot of noise when it is running. The furnace was operating as intended.

(4) I recommend that you consult with a licensed, qualified, heating, ventilation and air conditioning professional to evaluate further, determine the best method for repair, estimate cost and perform the repair.

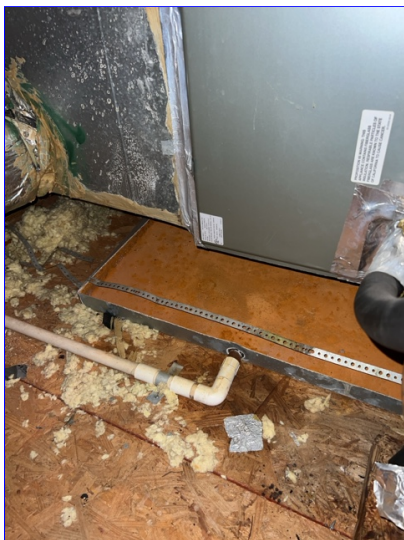
(2) The drain pan for the upstairs HVAC unit is rusted. Recommend recommend repair.

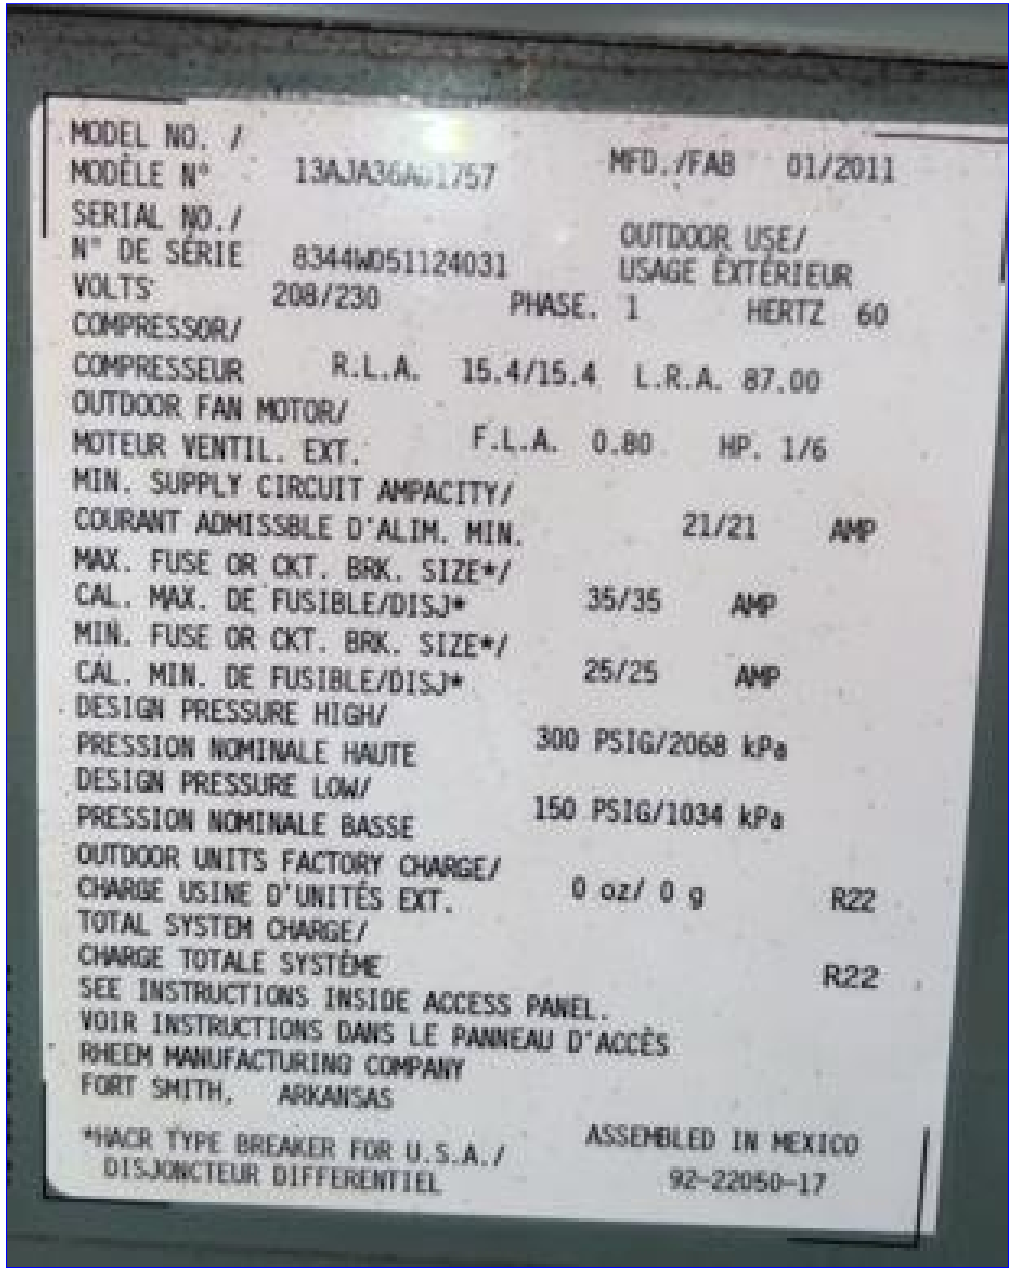
(2) Ambient air test was performed by using laser thermometer readings to determine if the difference in temperatures of the supply and return air is between 14 degrees and 22 degrees indicating that the unit(s) is(are) cooling as intended. The air temperature on the system(s) read:

Downstairs supply = 54 degrees, and the return air temperature was 71 degrees. Difference = 17 degrees. The low pressure line was cold to the touch at the condenser unit. With having a dirty Media filter in the attic, and it being double filtered, it can cause these numbers to read better than their actually performing.

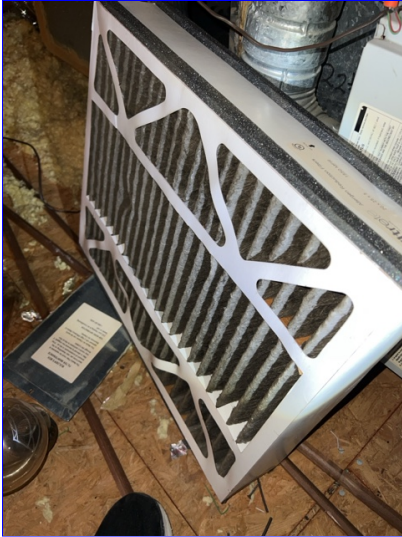
(1) The disposable filter is dirty & clogged. The filter needs to be replaced. I recommend replacement as needed.

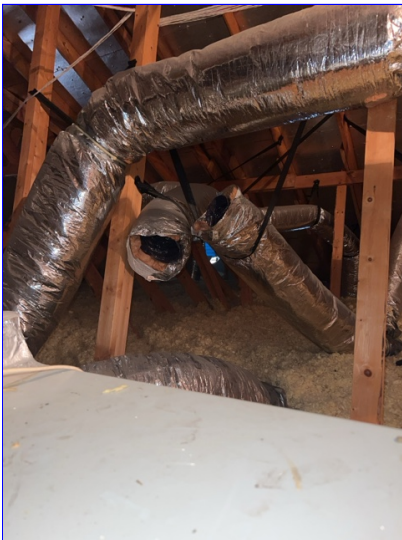
(2) Sections of ductwork in the attic have completely disconnected and are blowing conditioned air into the attic. Recommend correction.

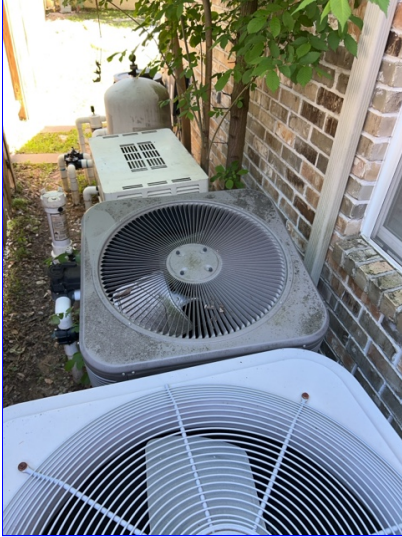
A air-conditioning unit was replaced in the past. The old air-conditioning unit is still on the side of the house. Recommend removal.

- A air-conditioning unit was replaced in the past. The old air-conditioning unit is still on the side of the house. Recommend removal.

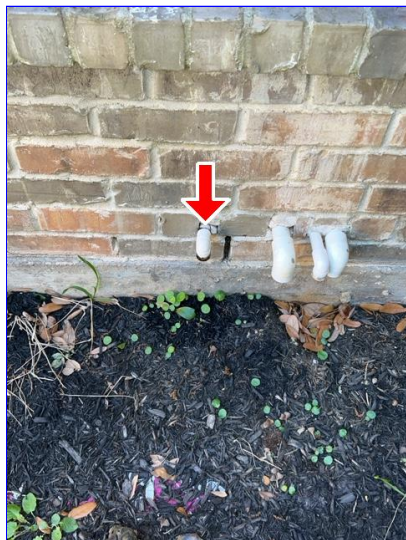
(1) The TMP valve for one of the water heaters is leaking. Water was dripping from the drain line at the front of the home.

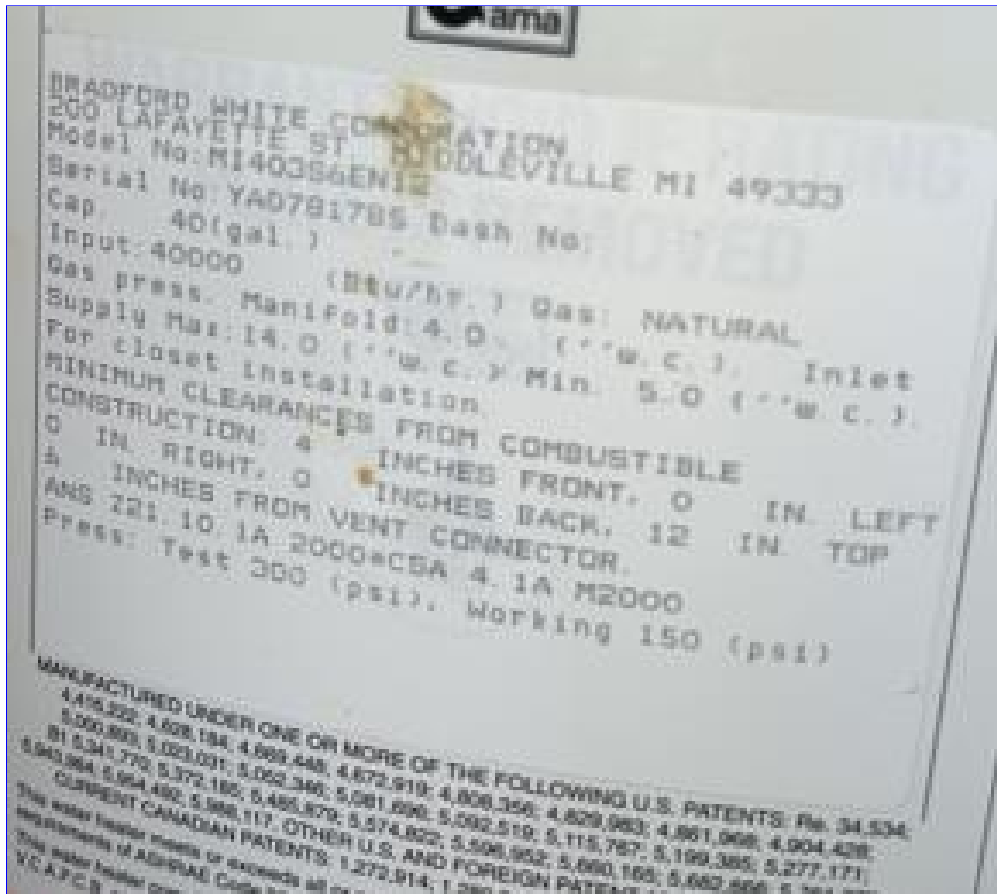
(2) Water heater service tag. This water heater was manufactured by Bradford White in 2002. The average age life expectancy of a water heater is 15 years. I recommend replacement of this unit.

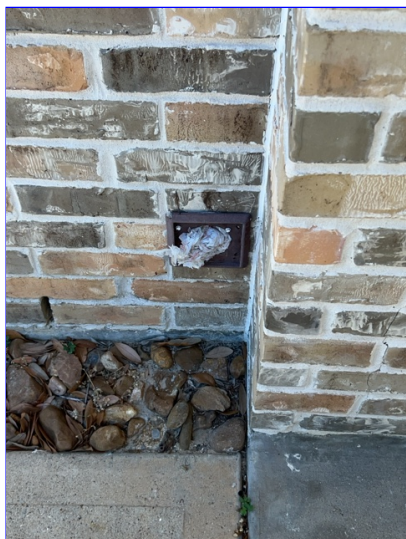
The dryer exhaust damper on the right side of the home is damaged. Recommend correction.
