Property Inspection Report

5515 Council Grove Ln, Houston, TX, 77088

*Inspector: Kory Knapp
TREC License: 25691
Agent: Cindy Raimon
Property Size: 2492
Property Age: 1974
Inspection Date: 3/7/2024
Inspection Time: 1:30 PM*

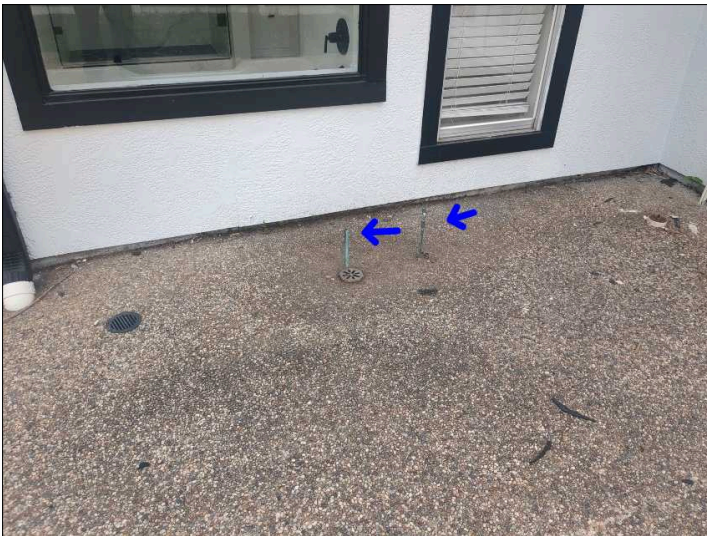
Copper tubing is noted to be coming through the spa deck in the left rear. Recommend removing to help prevent trip/fall hazard.

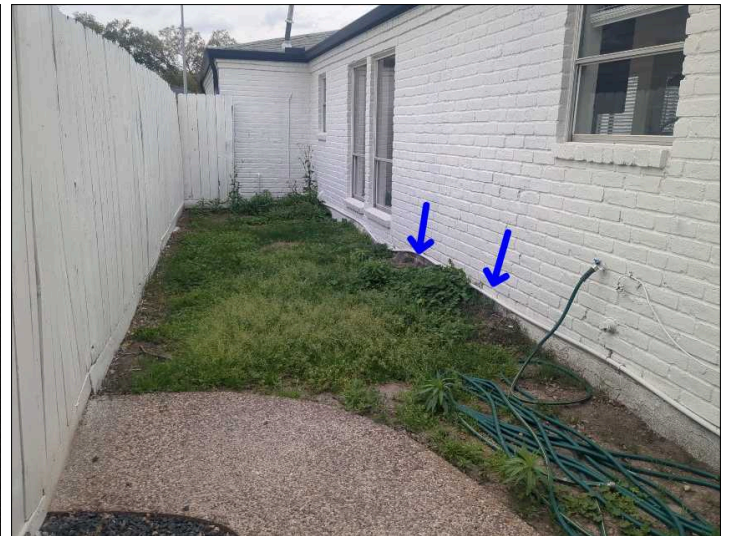
The soil or concrete is too high or footing is too low which does not allow proper exposure of the slab. This can cause conducive conditions for Wood Destroying Insects or water penetration usually if there is improper slope. Mainly at - right side rear

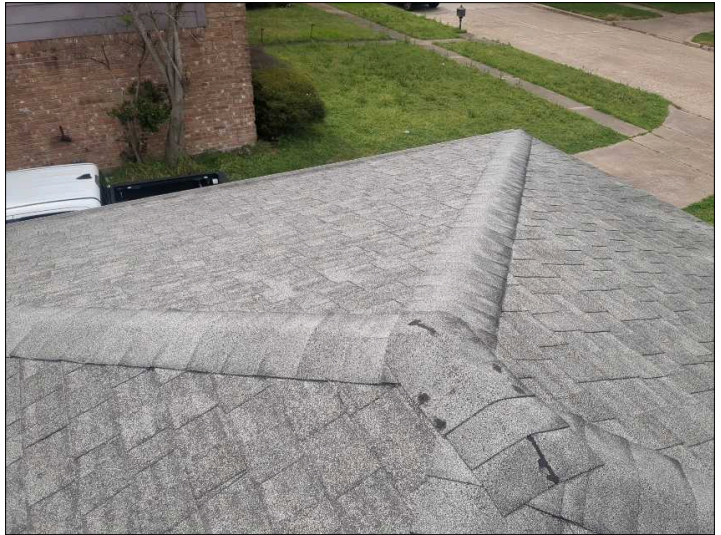
There were exposed nails noted on the roof. It is recommended that all exposed nails and fasteners on roof be sealed at all penetrations, ridges and roof to wall connections.

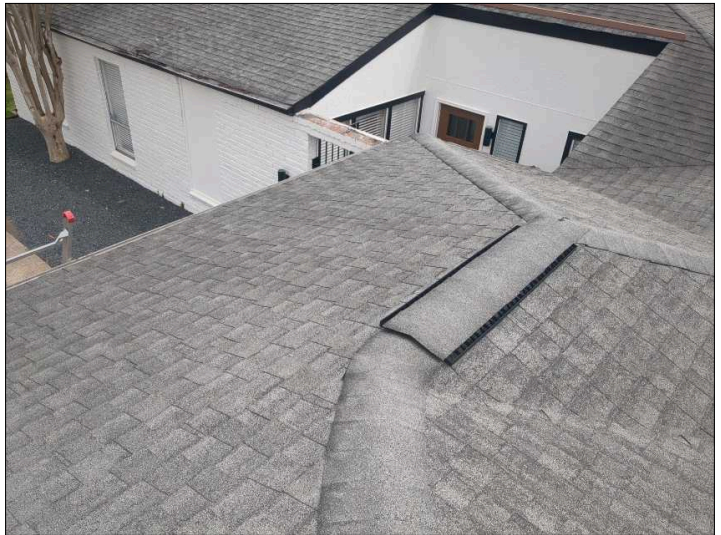
Some ridge shingles are cracked and or split on the roof, recommend repairs or replacement of damaged ridge shingles.

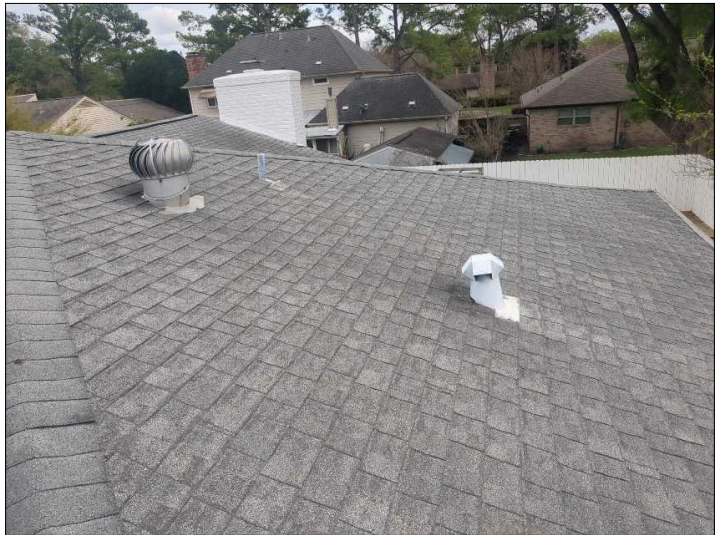
There are signs of rusted vents or flashing on the rooftop. We recommend painting or replacing all rusted or deteriorated vents or flashing as needed.

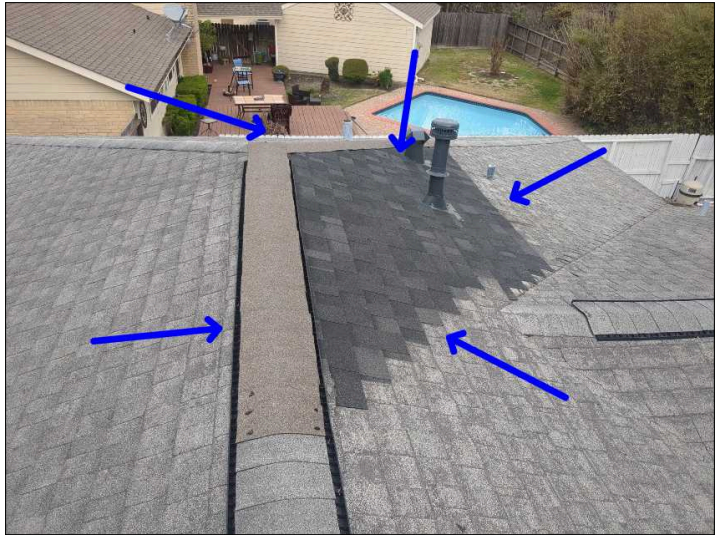
The decking is buckling on the roof, this is often caused by an improper gap for expansion of the decking materials, recommend consulting a roofing contractor for evaluation and repairs as needed.

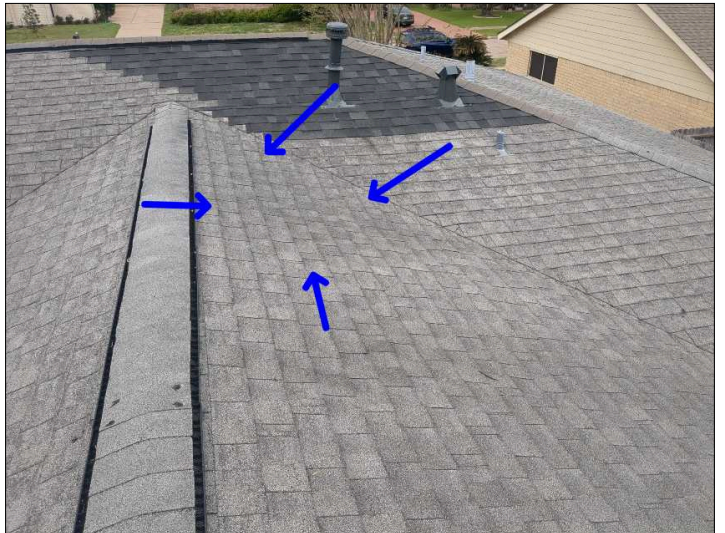
There are damaged or missing shingles on the roof, recommend repairs or replacement of damaged shingles.

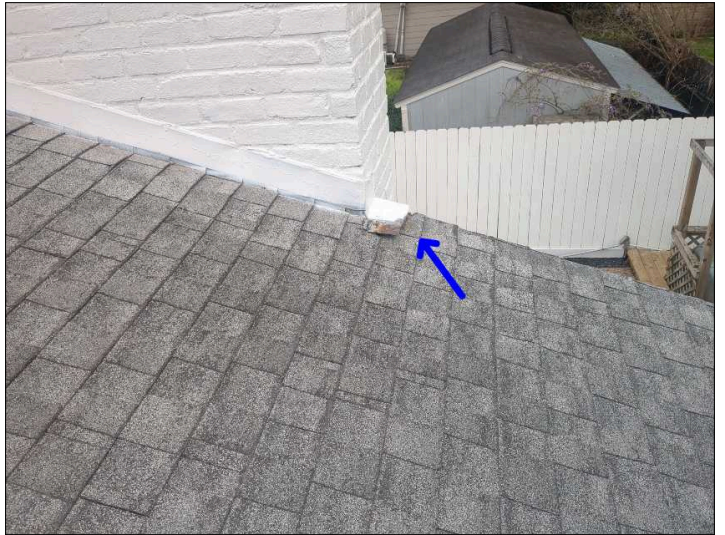
The roof flashing is lifted. Recommend securing all loose or lifted flashing and sealing nails to help prevent water penetration.

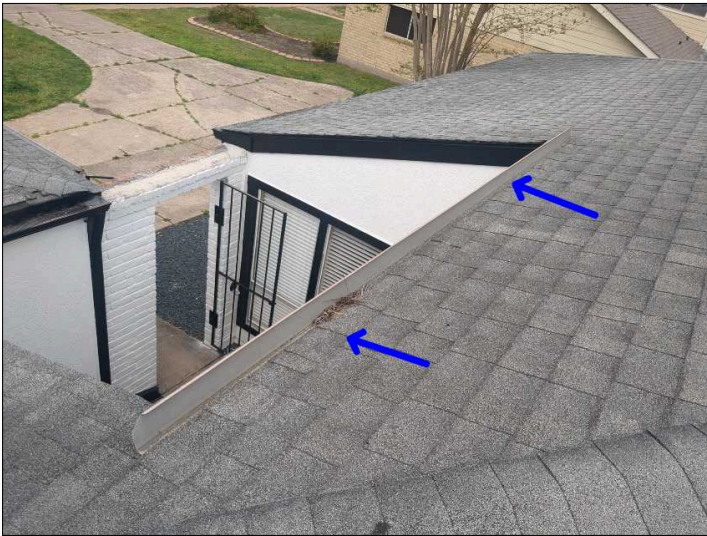
One or more of the vents and or flashing is unpainted, recommend painting all unpainted vents and flashing to help prevent damage due to UV rays or rust.

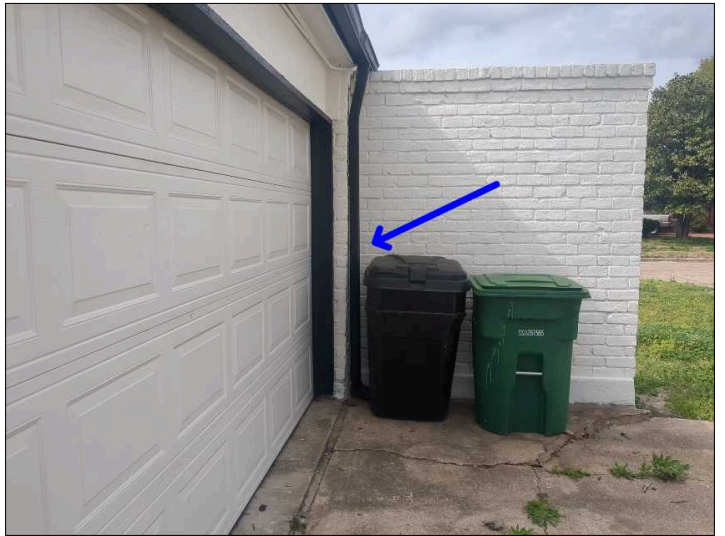
The gutters are sagging and/or loose. Attention to the gutters is required to keep them functioning as designed. Mainly at - front

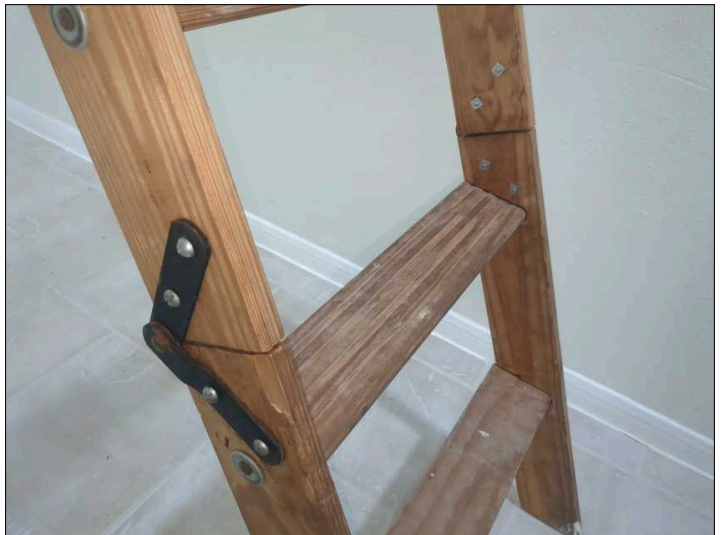
Attic stairway not cut properly to the floor, recommend cutting ladder so the ladder is a straight line when in the down position, otherwise it will put undue stress at the hinge and can cause ladder to fail.

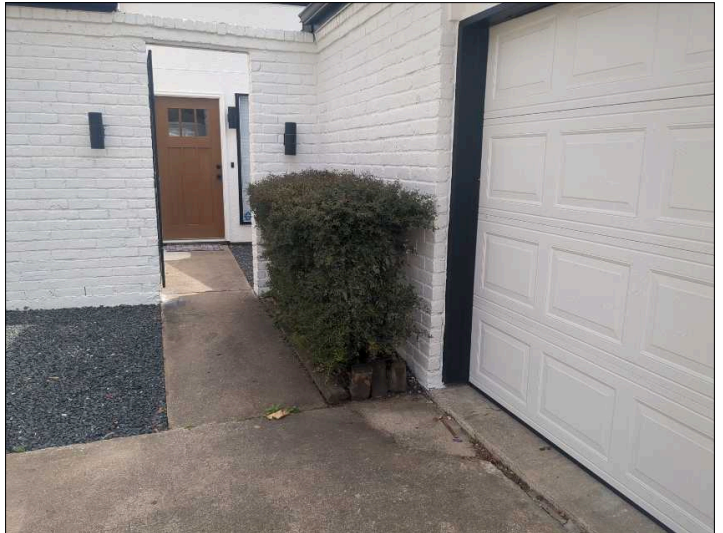
Recommend trimming vegetation so that it is not in contact with the house. Vegetation in contact with the structure can hold moisture against the structure and promote damage to building materials and conducive conditions for wood destroying insects.

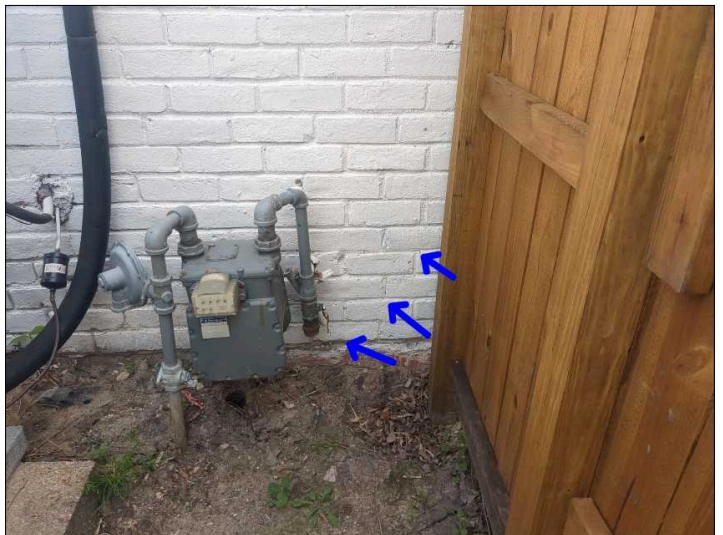
Settlement cracks were noted in the brickwork.
Mainly at - left side rear

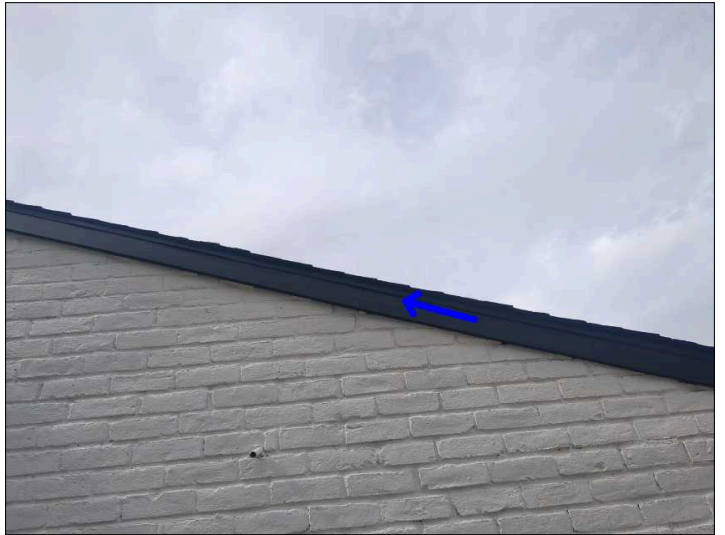
Recommend sealing trim to help prevent water penetration. Mainly at - rear

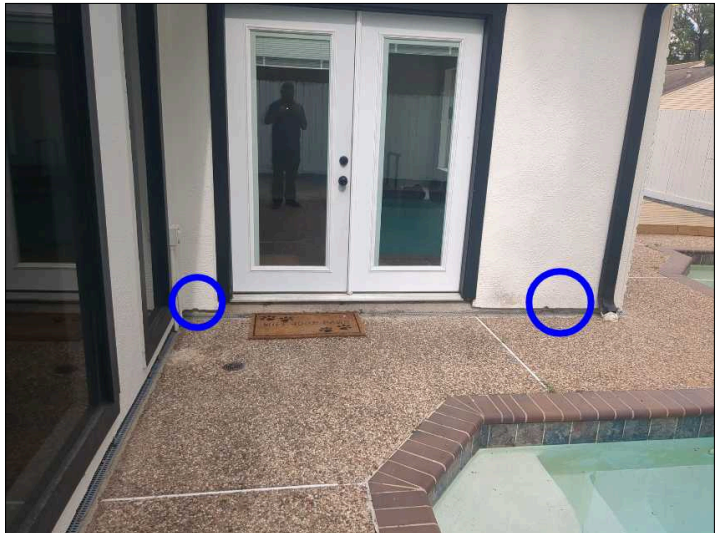
There is some damage to the exterior siding, recommend repair or replacement to help prevent water penetration. Unable to determine the condition of the underlying materials. Mainly at - rear right

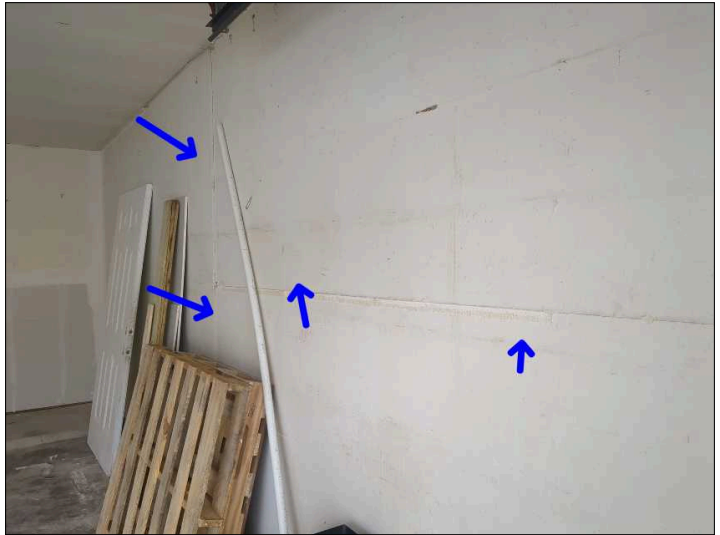
Settlement cracks were noted at the tape joint in the drywall. Mainly at - garage

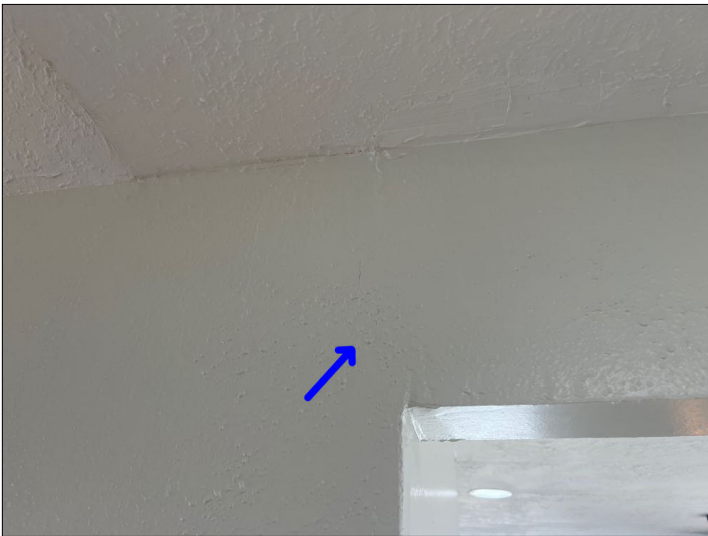
Settlement cracks were noted in the drywall.
Mainly at - front entry

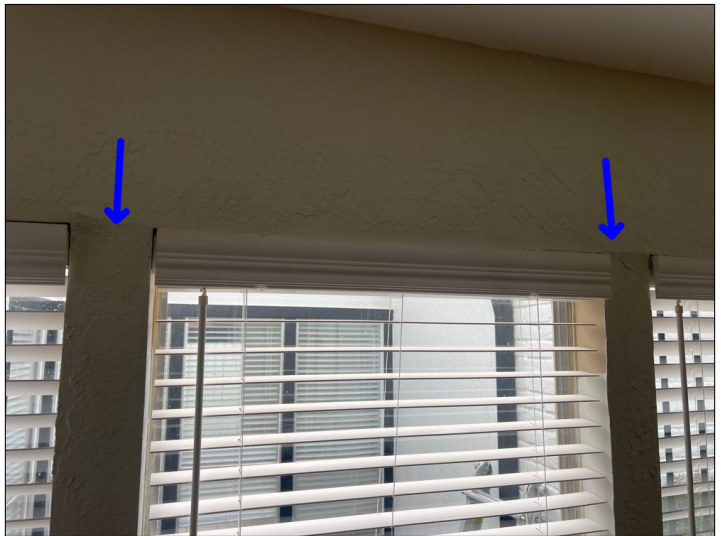
Settlement cracks were noted in the drywall.
Mainly at - front right bedroom

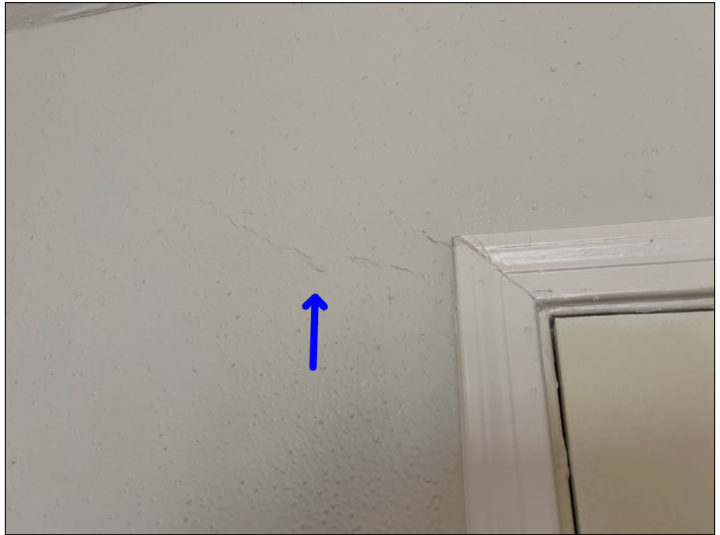
There is evidence of previous patch work and or painting on the interior finishes. Recommend contacting homeowner for more information.
Mainly at - primary bedroom

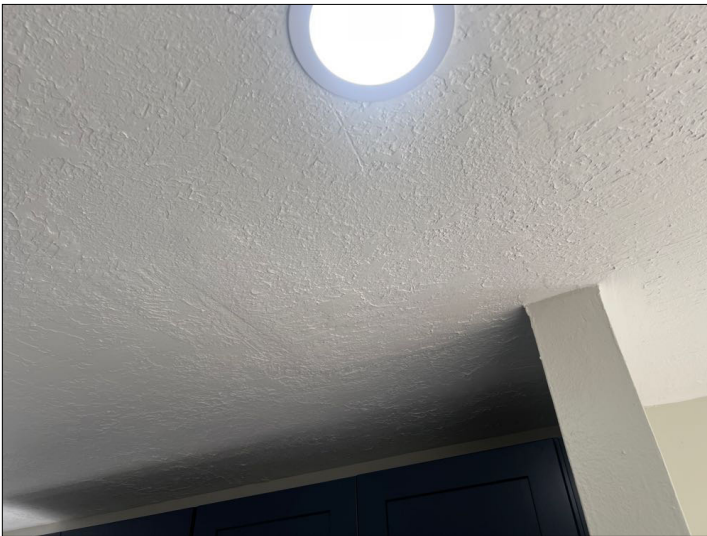
There is evidence of previous patch work and or painting on the interior finishes. This condition may limit the inspector's visual observations and ability to render accurate opinions as to the performance of the structure. Recommend contacting homeowner for more information. Mainly at - kitchen

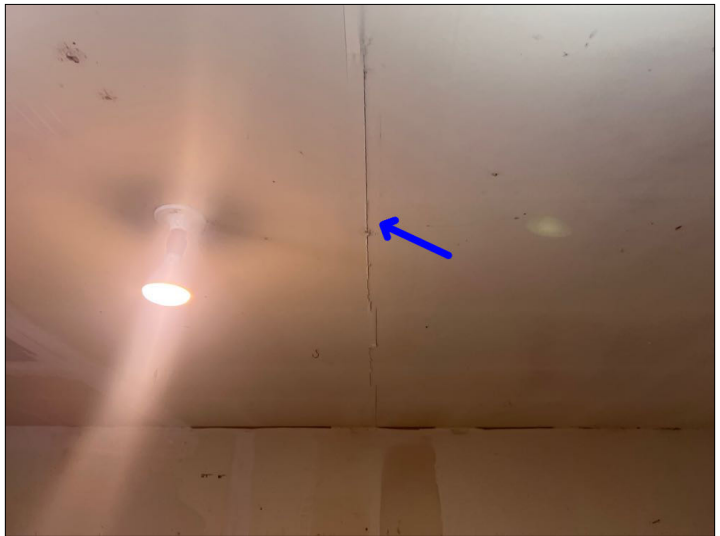
Settlement cracks were noted at the tape joint in the drywall. Mainly at - garage

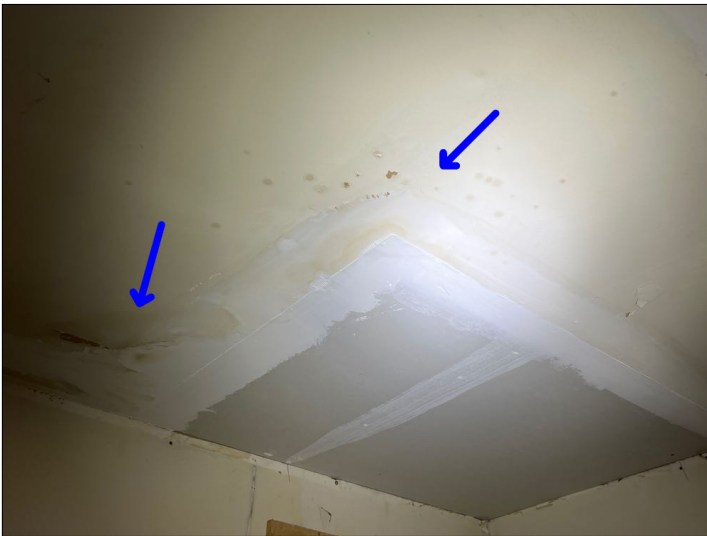
There are indications of water penetration to the ceiling evident mainly by staining. Unable to determine condition of the underlying materials. Mainly at - garage

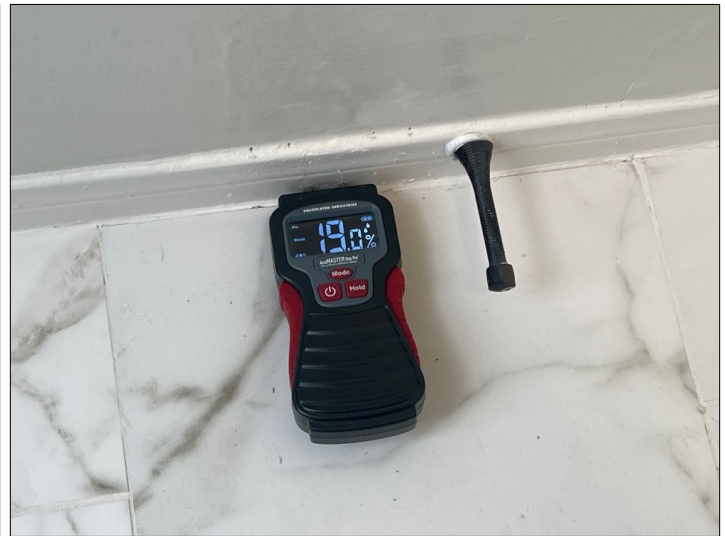
Checked water stain with a moisture meter and found it to be at a high moisture level. Unable to determine condition of the underlying materials. Mainly at - behind leaking primary tub spout

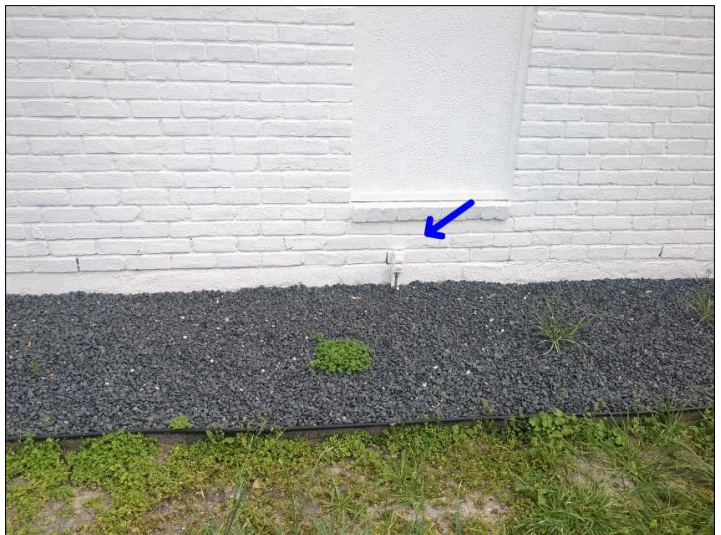
Electrical receptacle(s) are registering an open ground. Mainly at - front right exterior

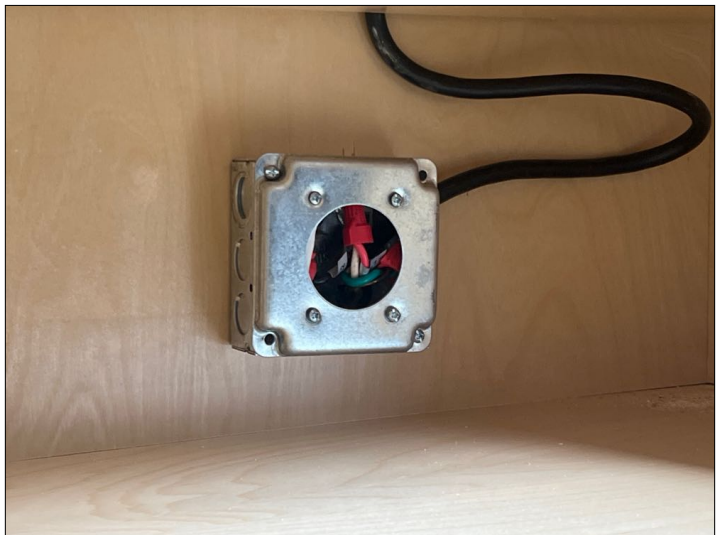
There are visible unprotected wiring splices. Recommend the wiring be properly enclosed. Mainly at - under cooktop

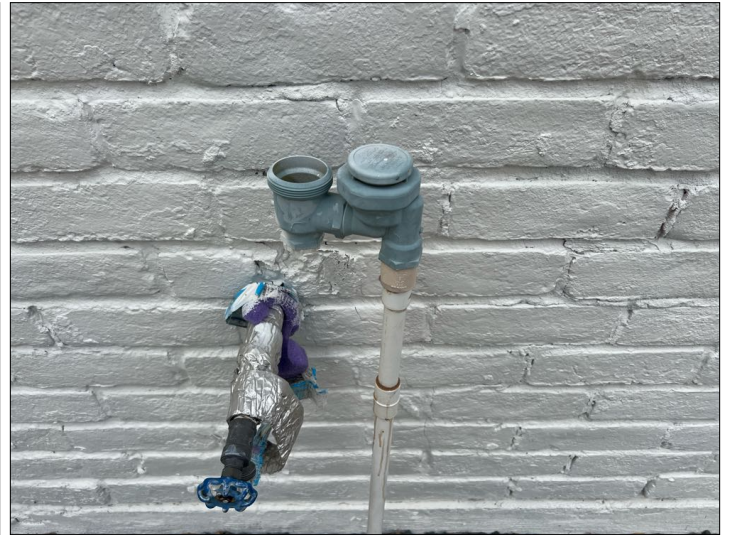
The swimming pool fill valve is disconnected and not properly equipped with a vacuum breaker.
