ENGINEER'S REPORT

4718 Menlo Park Drive
Sugar Land, TX 77479

Inspection No. 2020113S

Date of Inspection: May 6, 2020

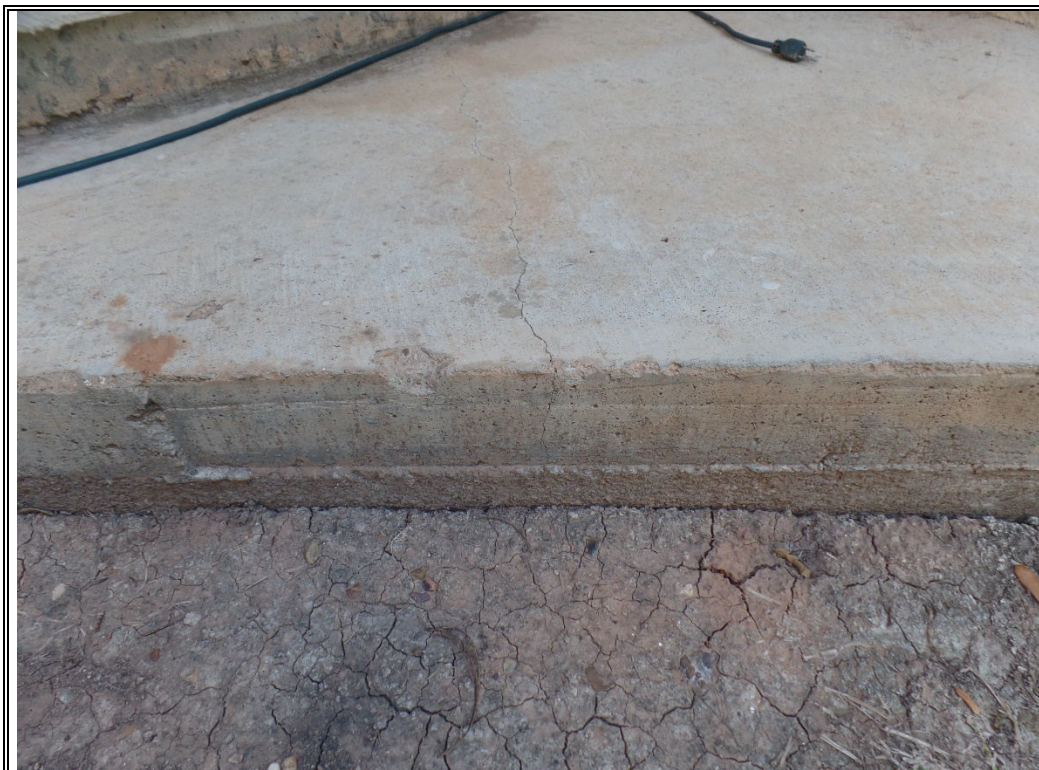
Photo Number
6

- **Where visible, we observed one hairline crack at the foundation perimeter grade beam at the front left side home.** There was no height differential from one side to the other, and no shearing movement along the crack. We were not able to determine the extent or if the crack continued any distance across the slab due to the floor coverings. Portions of the foundation perimeter were obscured and some other cracking may exist that was not viewable at the time of our inspection. It should be noted that many slab foundations develop cracks. In our opinion, the degree of visible cracking does not affect structural integrity.

Description:
Slab crack at
front left side

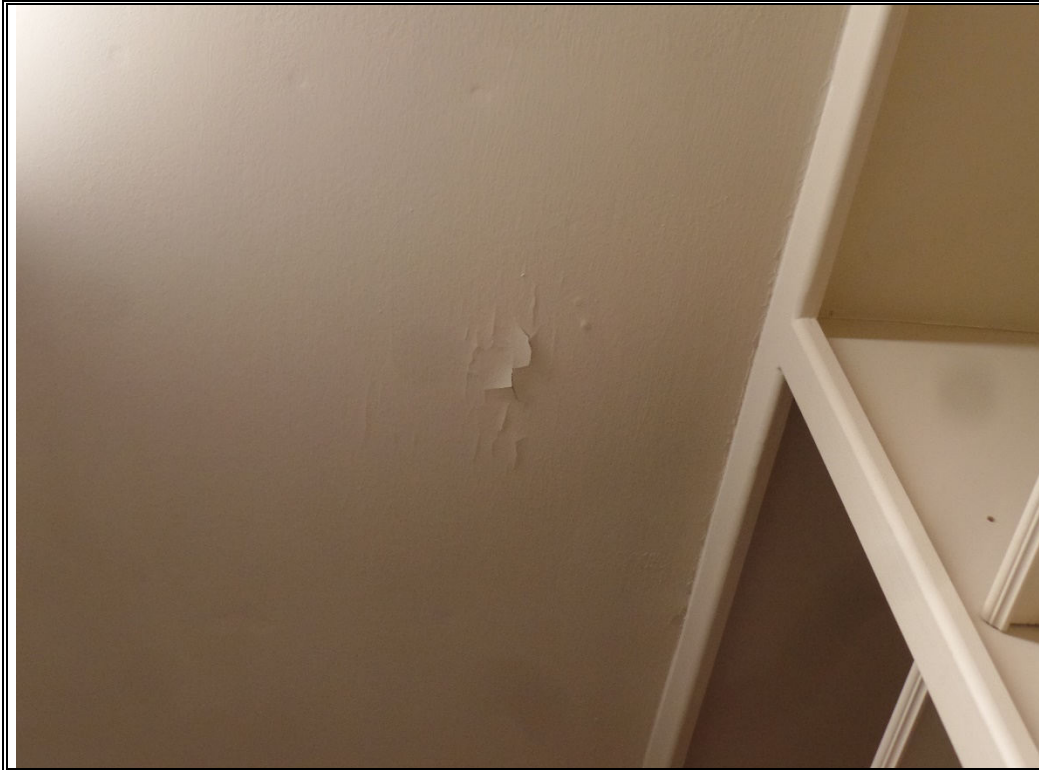
Photo Number
7

- **On the master (rear) closet ceiling. We noted that this location is directly below a roof vent.**
- **In the attic, at the living room fireplace chimney. Evidence of past leak repairs were noted in the chimney.**

Description:
Evidence of water damage on (rear) master closet ceiling

We recommend evaluation and repairs as necessary by a licensed roofing contractor. Any source of moisture accumulation should be eliminated and the area observed for any evidence of mold growth or moisture related deterioration.

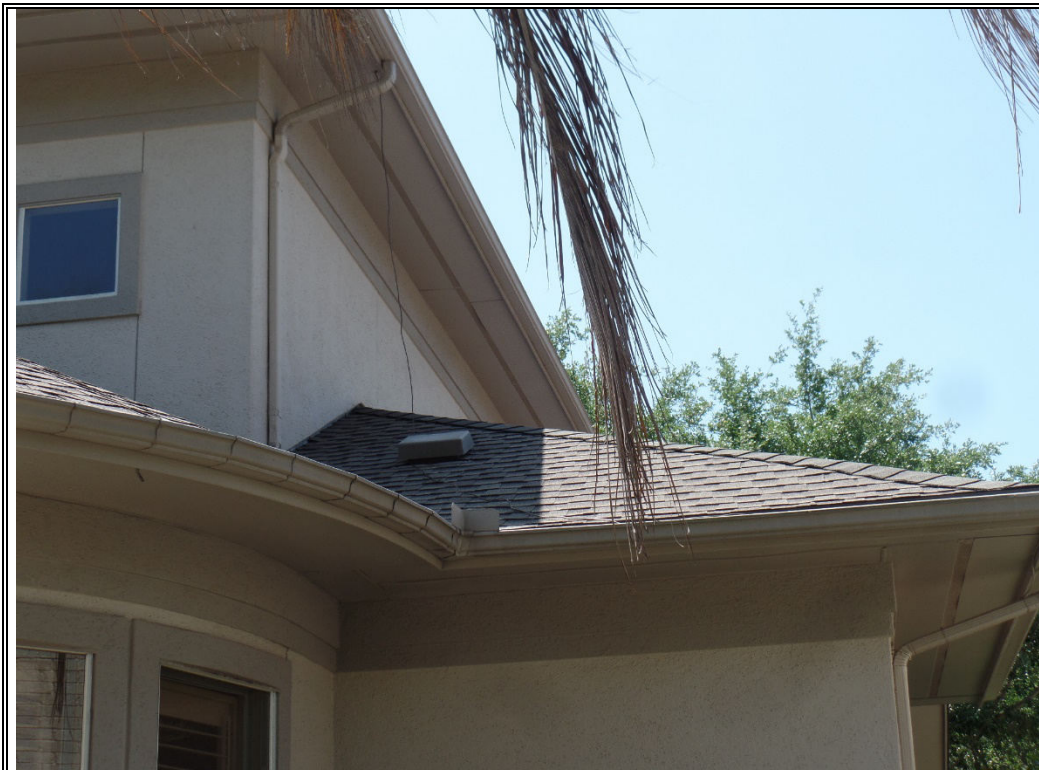
Photo Number
8

Description:
View of roof vent above master (rear) closet

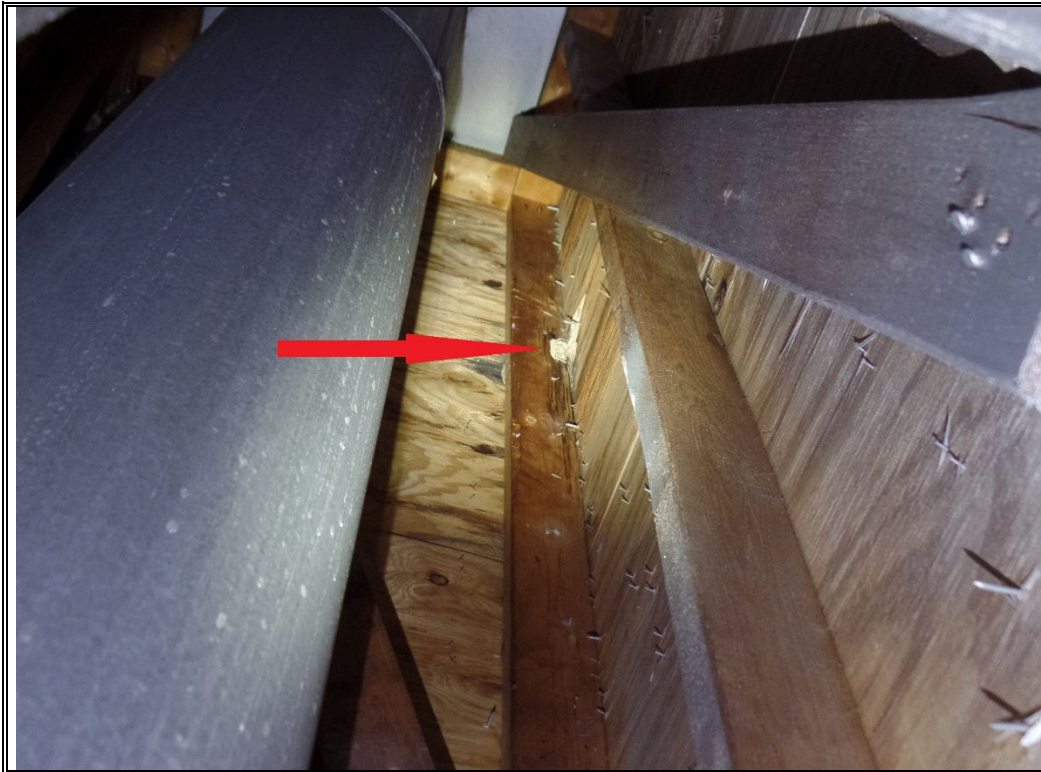
Photo Number
9

Description:
Evidence of past water leakage and repair at living room fireplace chimney

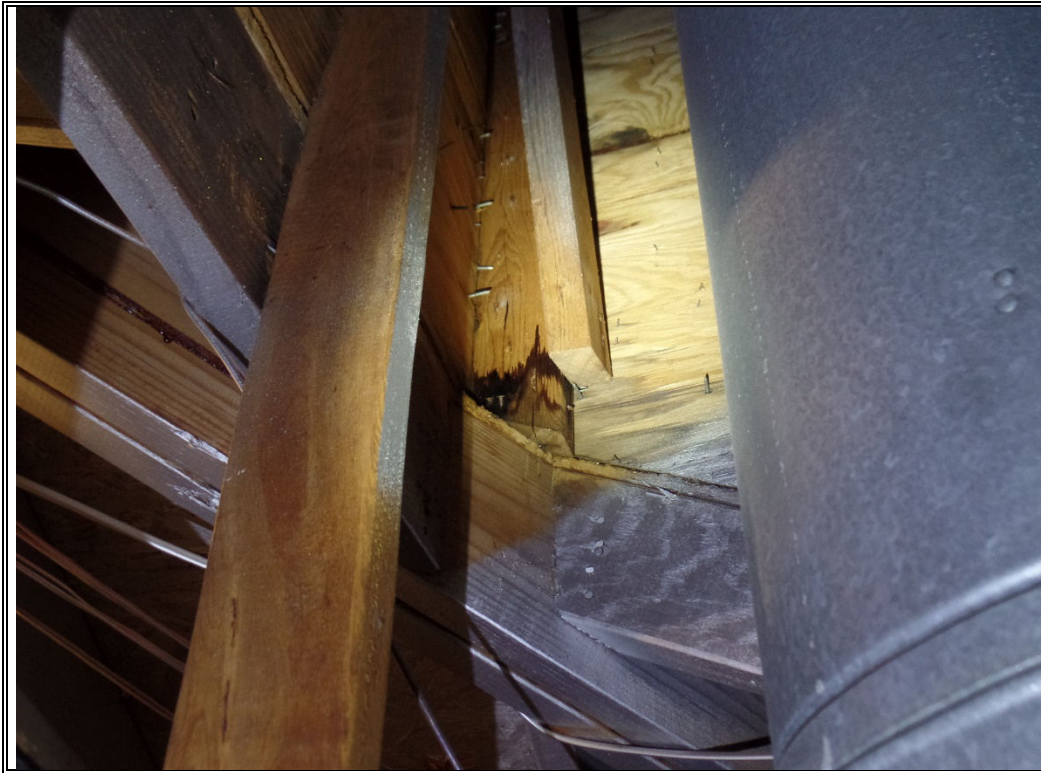
Photo Number
10

Description:
Evidence of past water leakage at living room fireplace chimney

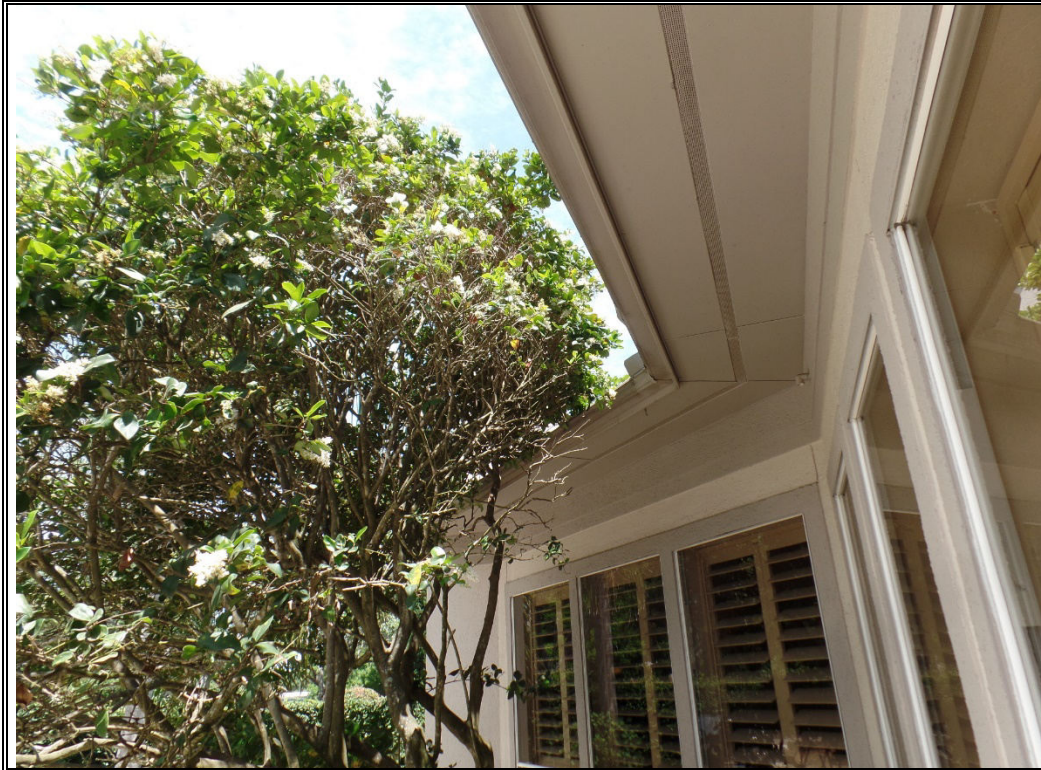
Photo Number
11

- **Tree branches were observed to be overhanging and/or in contact with the roof surface at the rear, which can lead to damage/premature aging of the roofing surface.** We recommend trimming back the branches away from the roof surface.
- **Accumulations of tree debris (leaves, needles, twigs, etc.) are present in the roof gutters.** You should anticipate frequent roof maintenance to remove these accumulations.

Description:
Tree limbs in contact with roof surface at rear

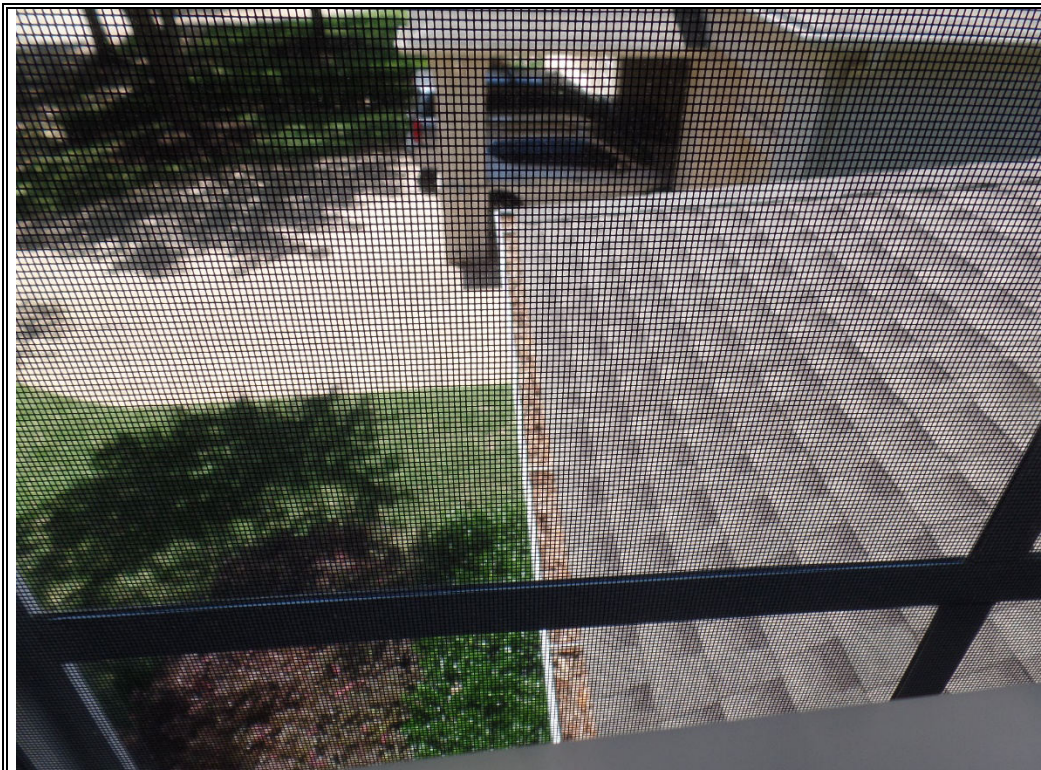
Photo Number
12

Description:
Tree debris accumulation in gutters

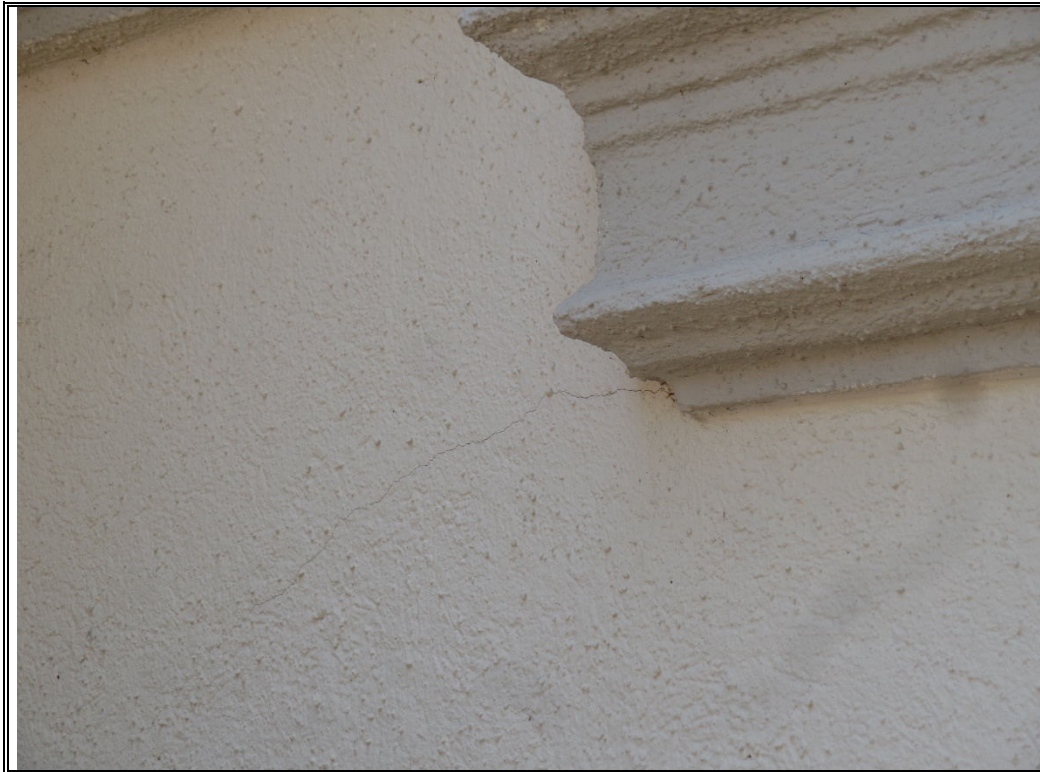
Photo Number
15

- **We observed hairline cracks in the stucco veneer in locations including the front right side, front left side, front left and at the front entry.** These cracks appear to be the result of seasonal temperature (expansion/contraction) changes and are not considered, in our opinion, to be due to any structural deficiency.
- **We observed a crack in the stucco veneer at the left side of the garage door.** Evidence of moisture penetration and corrosion of the wire mesh was noted at this location.

Description:
Hairline stucco
veneer crack at
front left

All openings, cracks, etc., in the exterior veneer or siding, or in any location on the exterior envelope of the building, should be caulked or otherwise sealed to prevent water or moisture from entering the building.

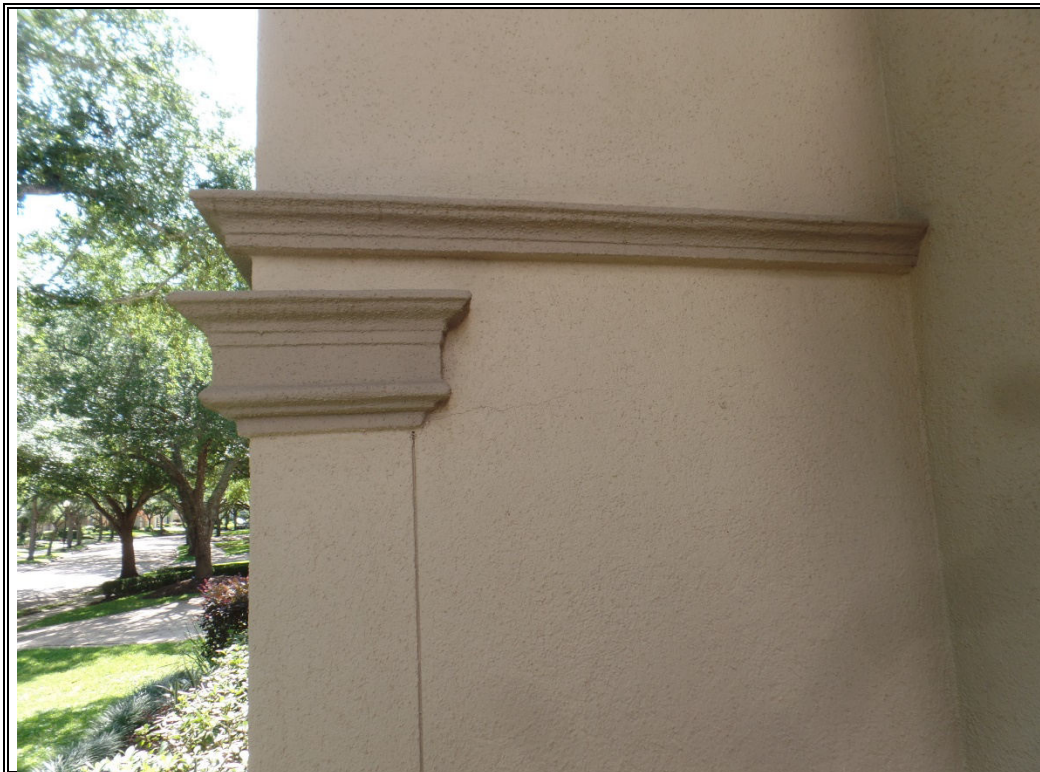
Photo Number
16

Description:
Hairline stucco
veneer crack at
front entry

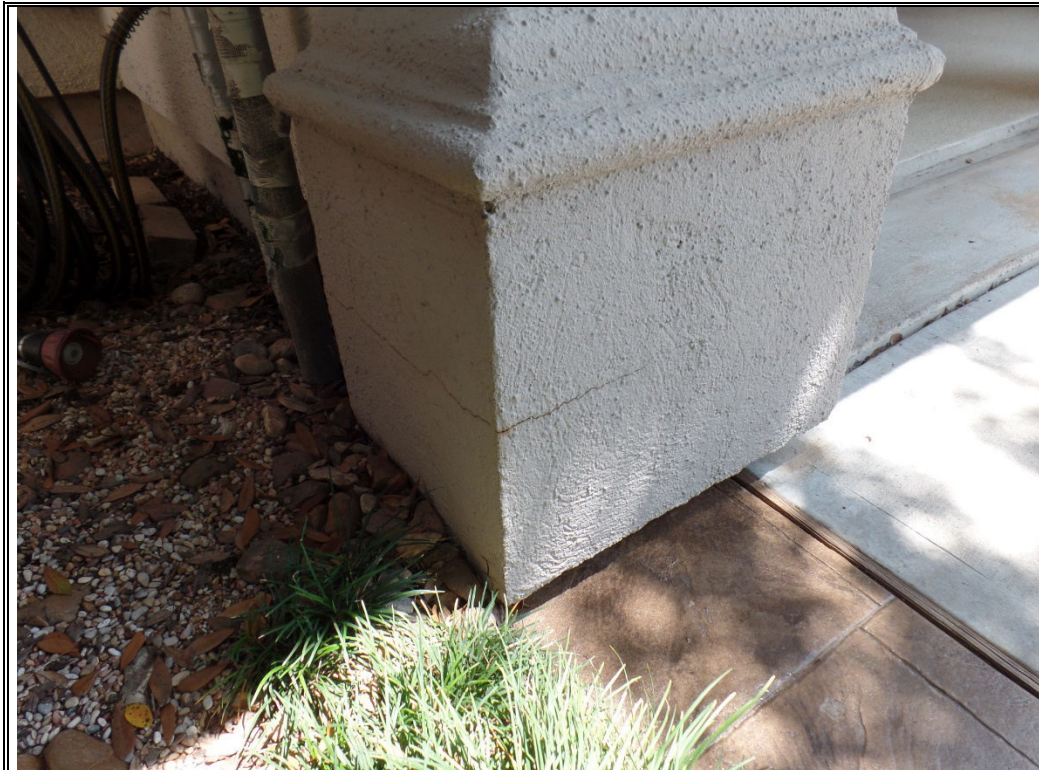
Photo Number
17

Description:
Stucco veneer
crack at front
left of garage
door

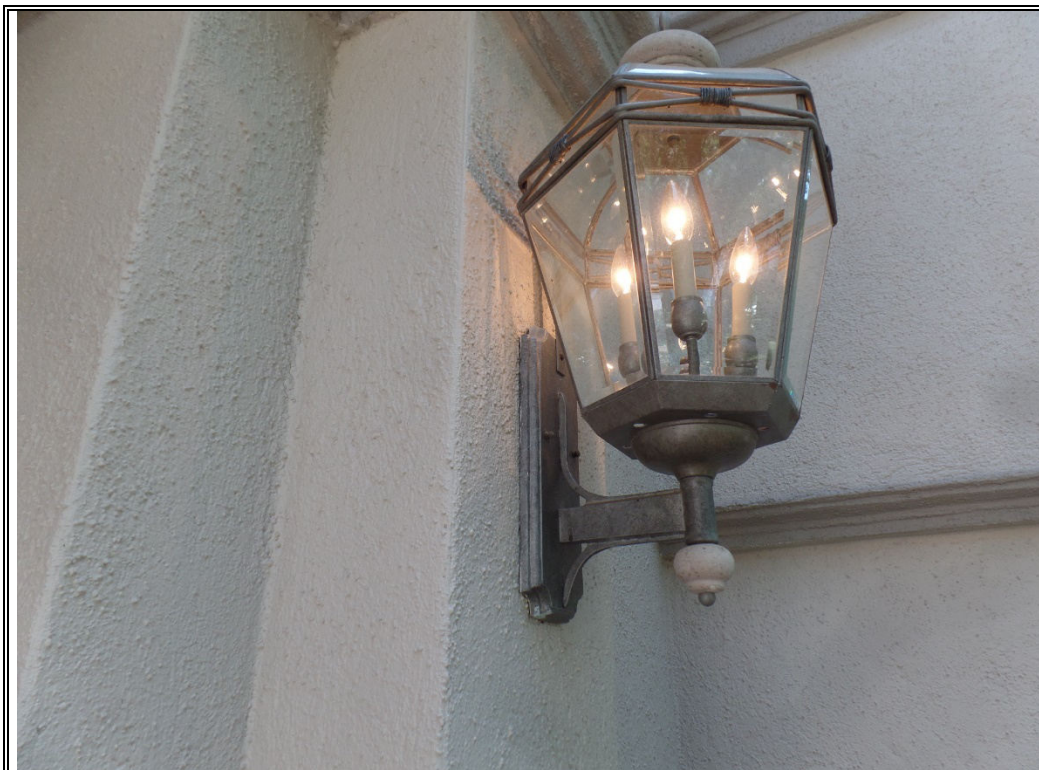
Photo Number
18

- **We observed exterior light bases and electrical boxes installed on the stucco veneer are missing caulking to seal**

Description:
Exterior light
bases missing
caulking to seal

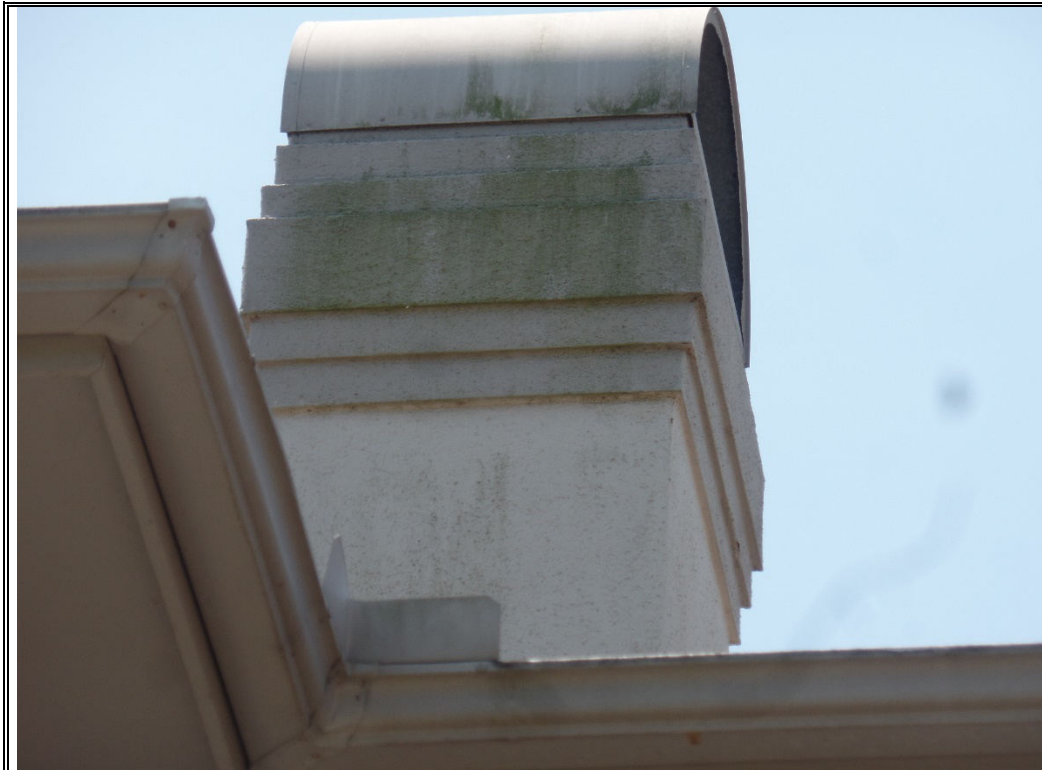
19

- **Mildew growth was noted on living room chimney exterior surfaces that receive less direct sunlight.**

Mildew growth
on living room
chimney exterior
surfaces

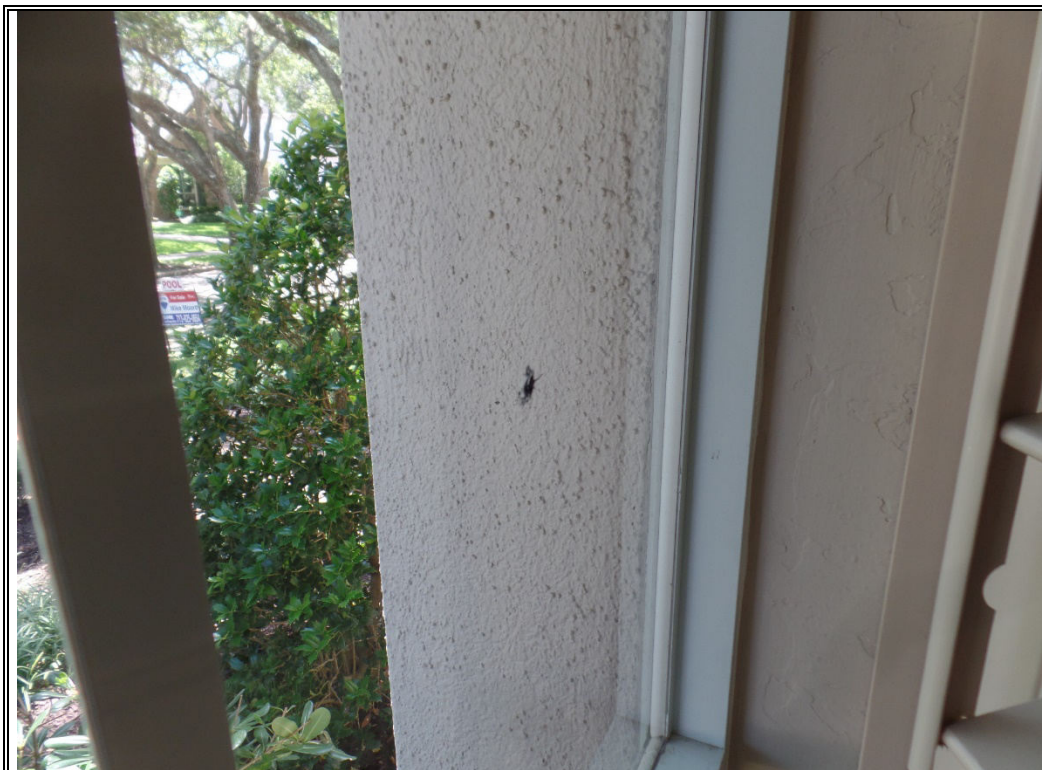
Dining room
window pane
chipped

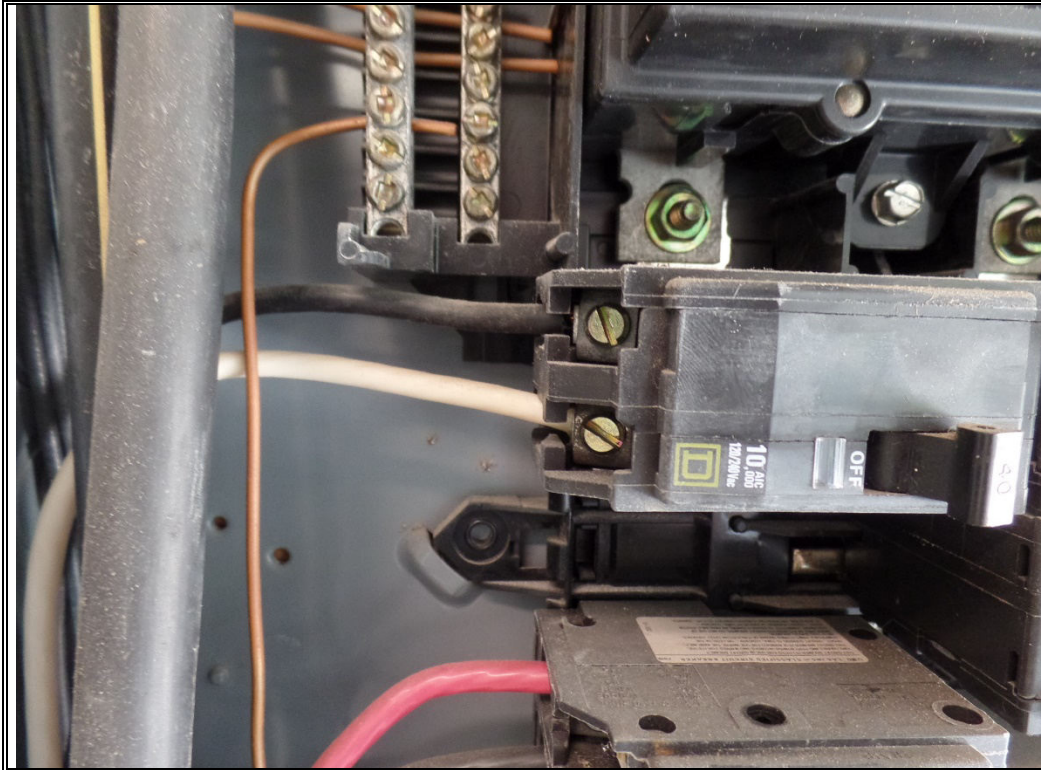
Photo Number
21

- **We observed white wires on 240 volt circuit breakers are not taped or marked black to indicate a hot leg.**
- **The service panel ground rod is severely corroded and requires replacement. The ground rod is the grounding electrode for lightning protection.**

Description:
White wires on
240V breakers
not marked
black to indicate
hot leg

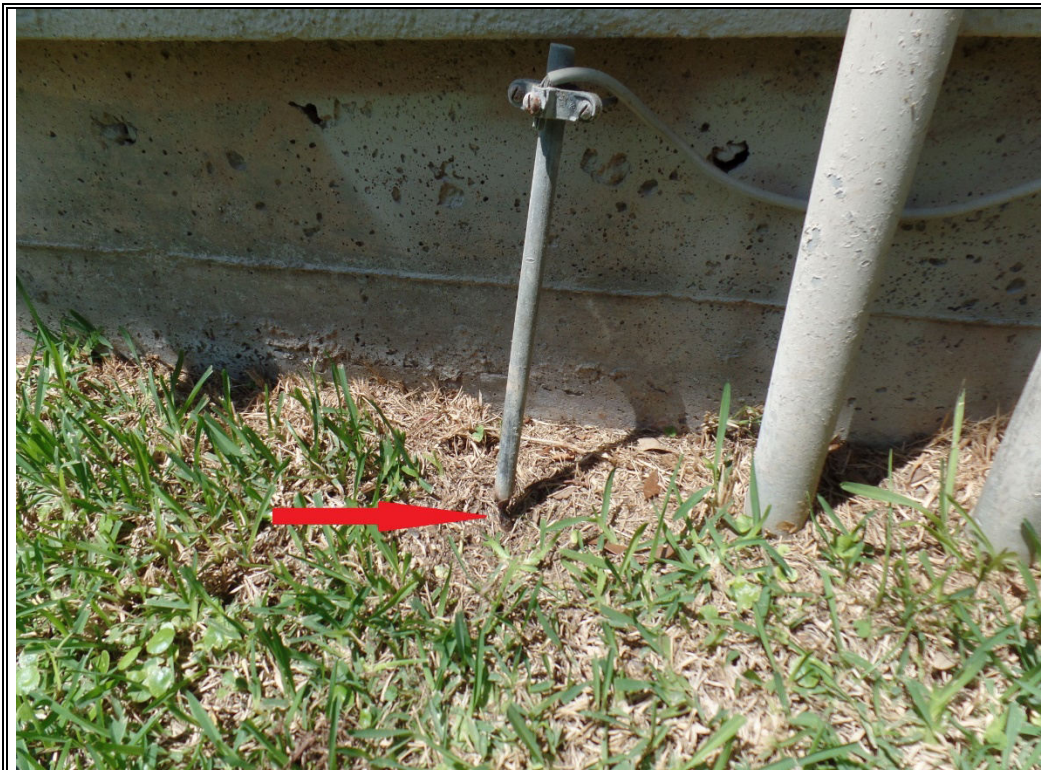
Photo Number
22

Description:
Service panel
ground rod
corroded

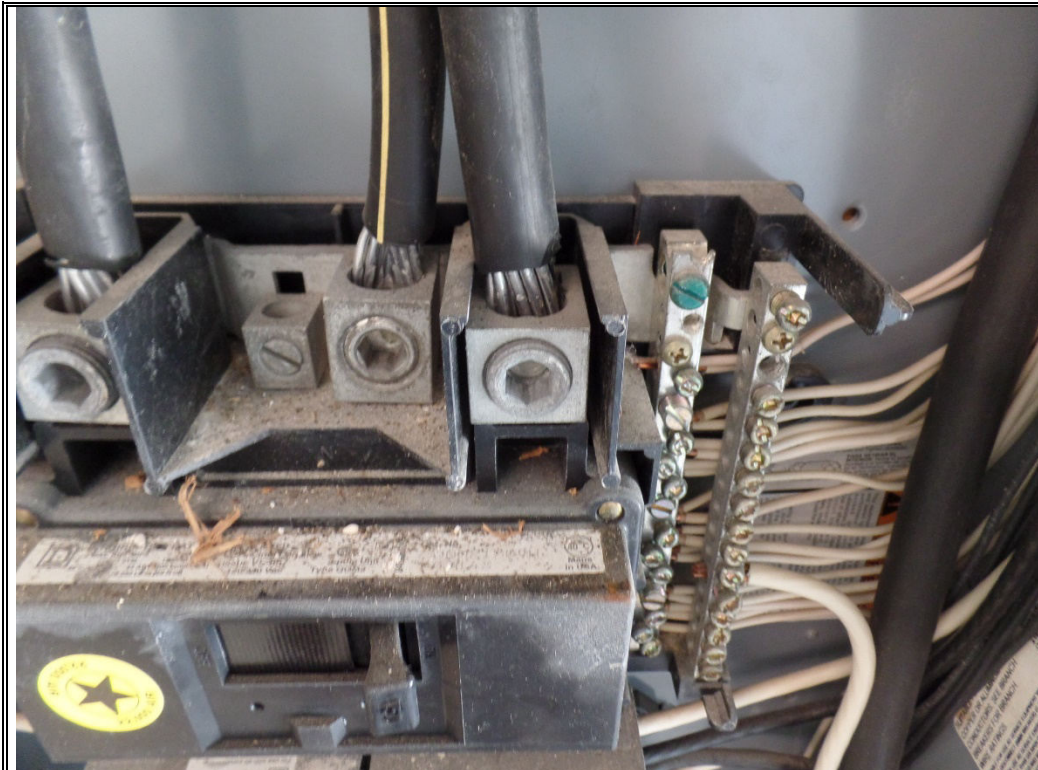
Photo Number
23

- **It would be wise to have each of the present circuits fully identified in each panel so you will know what electrical load is on each circuit.**
- **The aluminum service entrance wire connections in the service panel were not coated with an anti-oxidant. This can allow the conductors to oxidize, which can be a fire hazard.**

Description:
Aluminum service entrance wire connections in service panels missing anti-oxidant

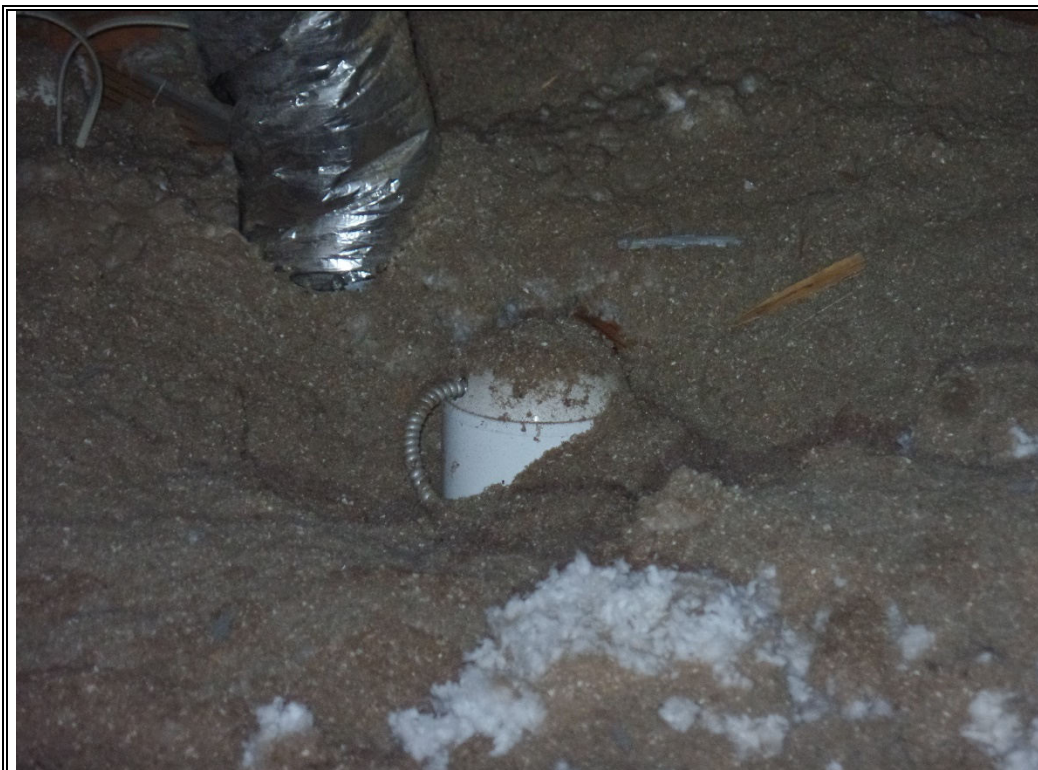
Photo Number
24

- **In visible locations of the attic, we noted insulation in contact with some of the recessed lights.** Only recessed light fixtures rated and marked “Type IC” can be covered with insulation. The acronym “IC” means “insulation contact”. Insulation must be at least three inches away on all sides of non-Type IC rated recessed light housings in order to prevent overheating. Overheated lights are a potential fire hazard. Some newer models are equipped with automatic shutoff components if overheating occurs. Note: The use of LED bulbs in these fixtures may prevent overheating.

Description:
Attic insulation in contact with Non IC type recessed lights (typical)

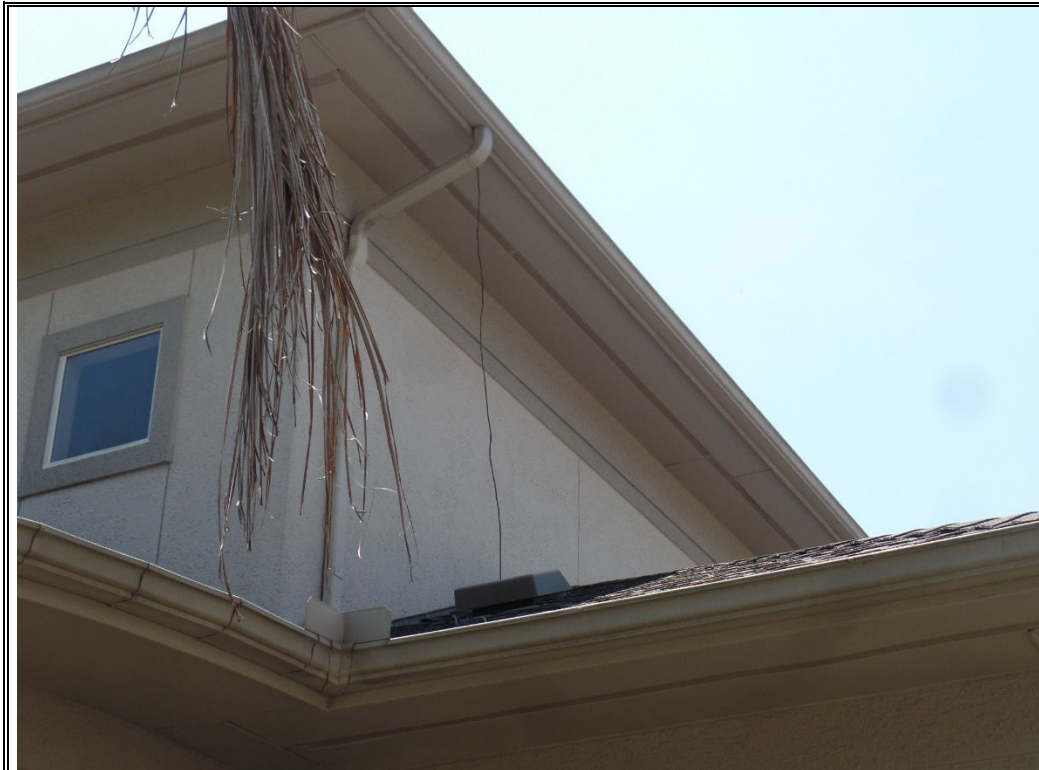
Photo Number
25

- **We observed an exposed/unsupported AC control wire run at left rear exterior to the AC compressor.**

Description:
Unsupported AC
wiring run at left
rear

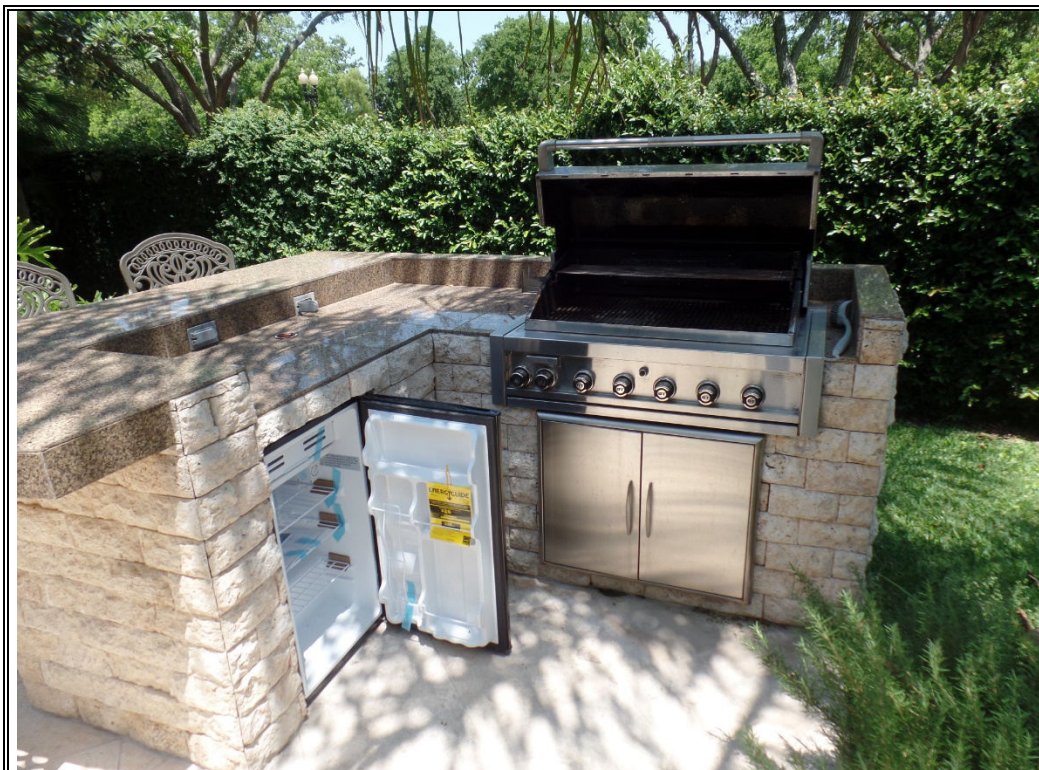
Photo Number
26

Description:
Outdoor kitchen
outlets not
operating at
time of
inspection

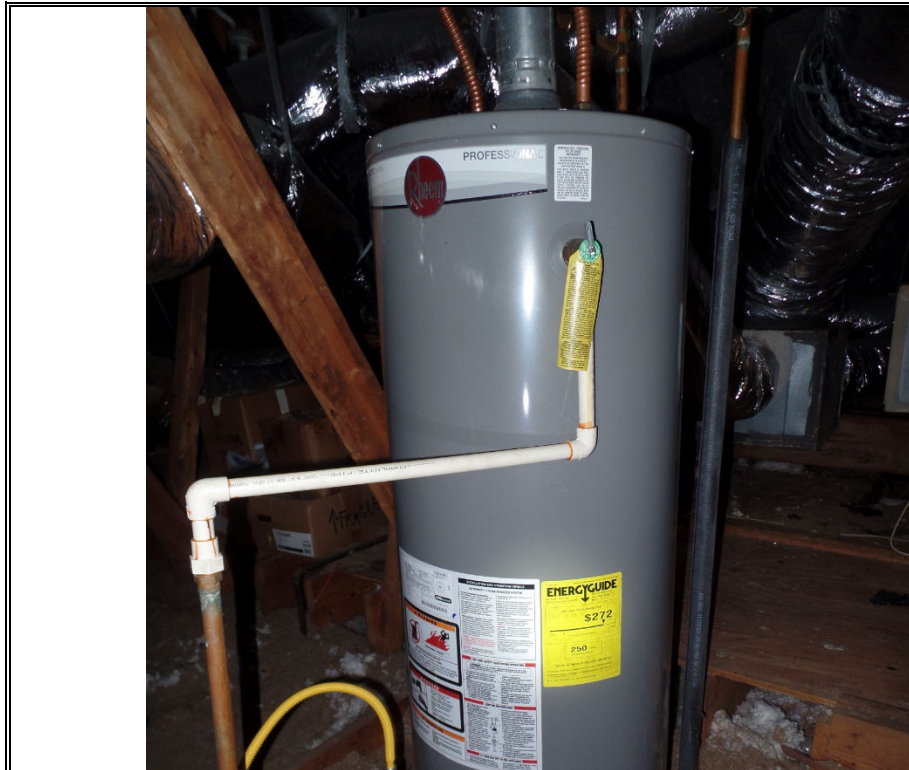
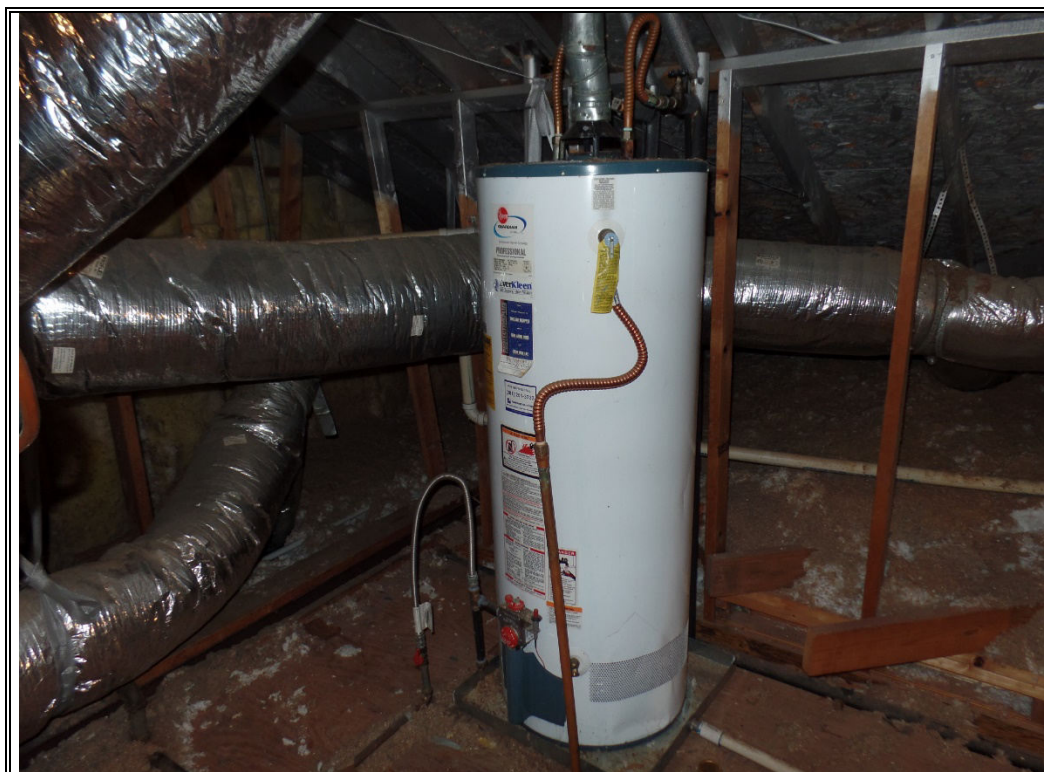
- **In general, water heaters can be expected to last about ten years. In our opinion, the 13-year-old water heater has reached the end of its expected useful life and should be replaced.**

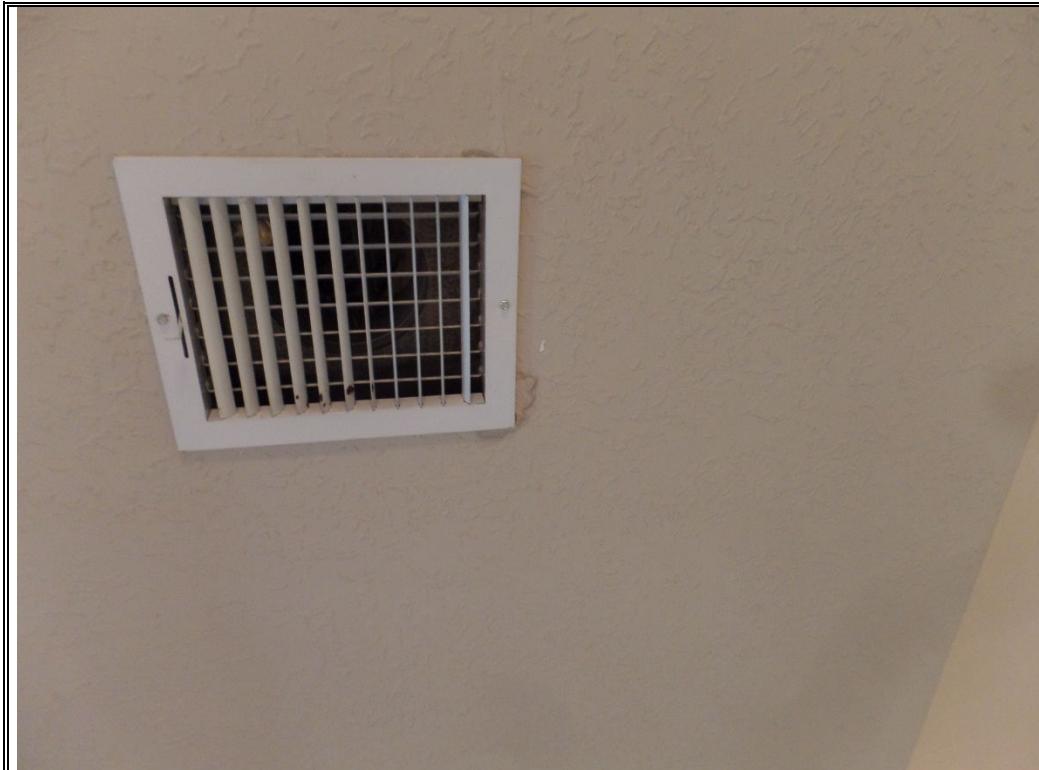
Photo Number
35

Description:
Evidence of condensation damage at HVAC register above 2nd floor walkway

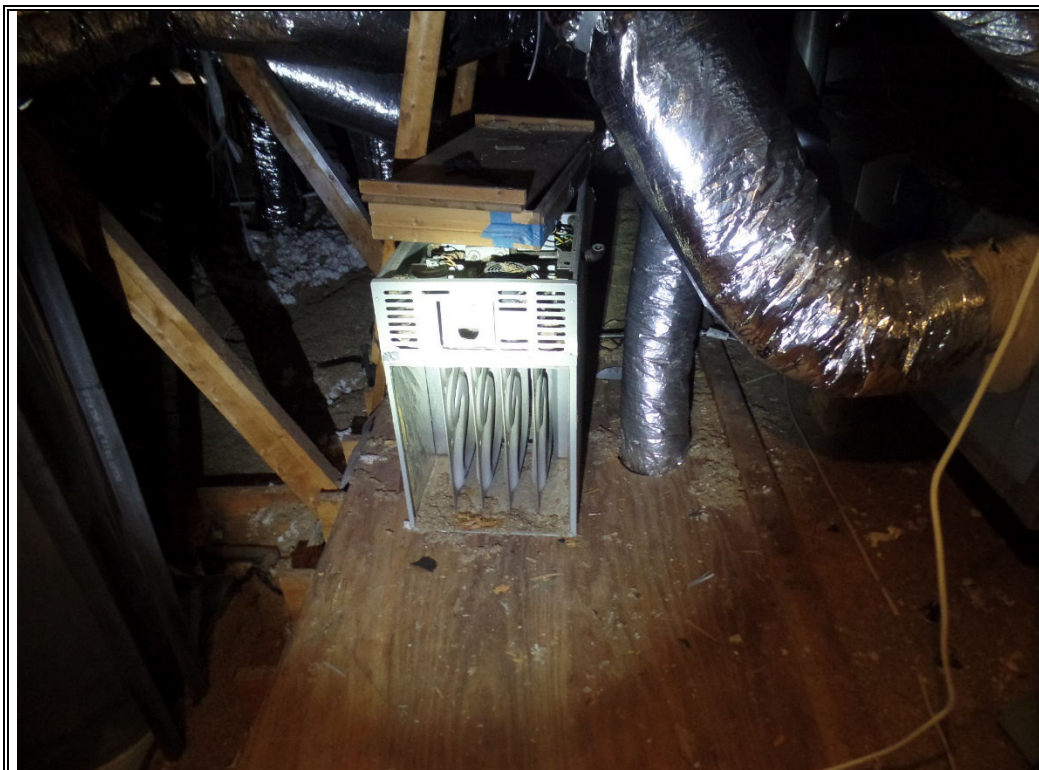
Photo Number
36

Description:
View of old HVAC equipment left in attic

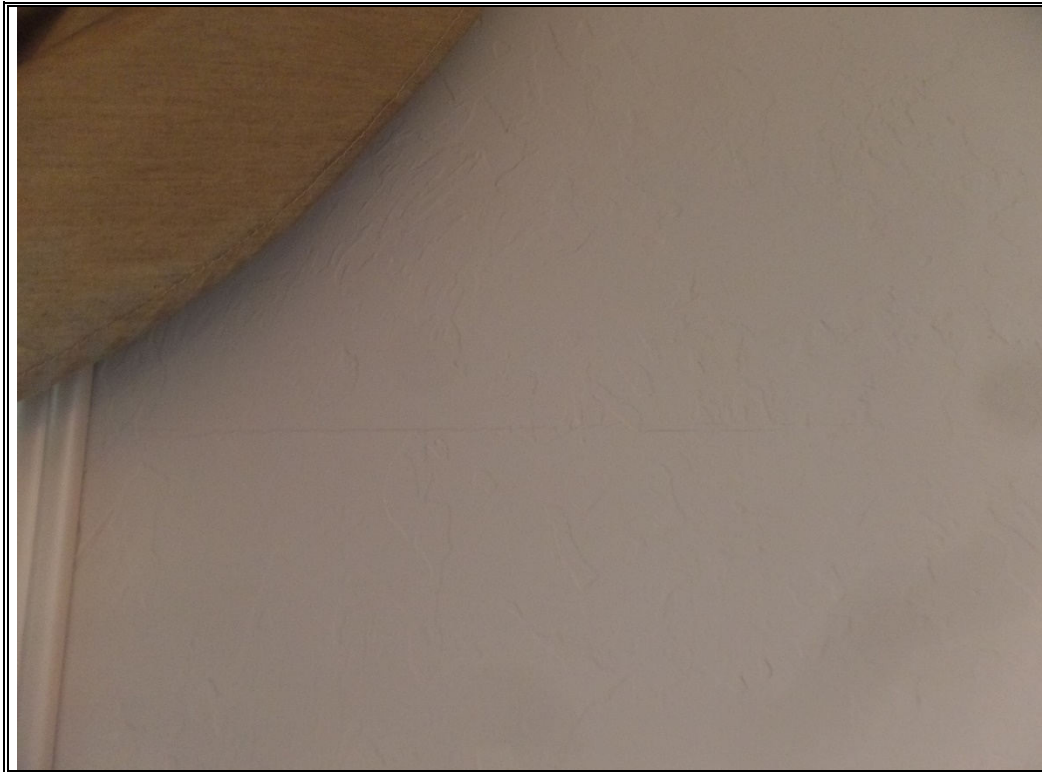
Photo Number
37

Description:
Hairline drywall
crack in dining
room

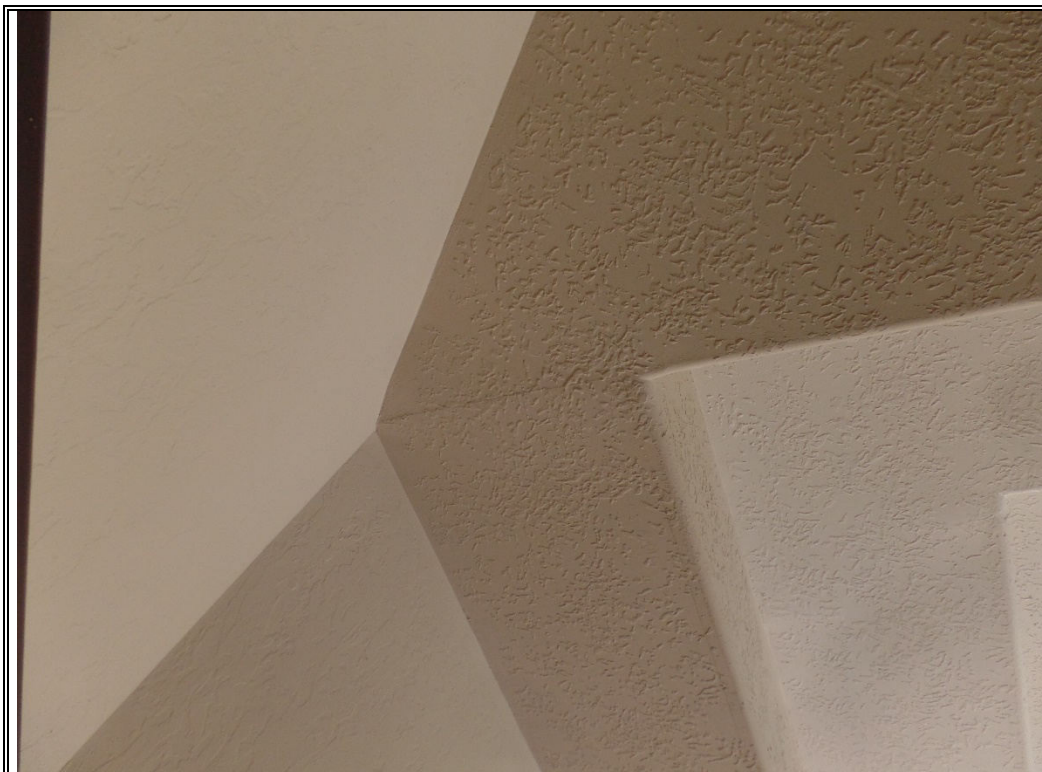
Photo Number
38

Description:
Hairline drywall
crack in master
bedroom ceiling
left

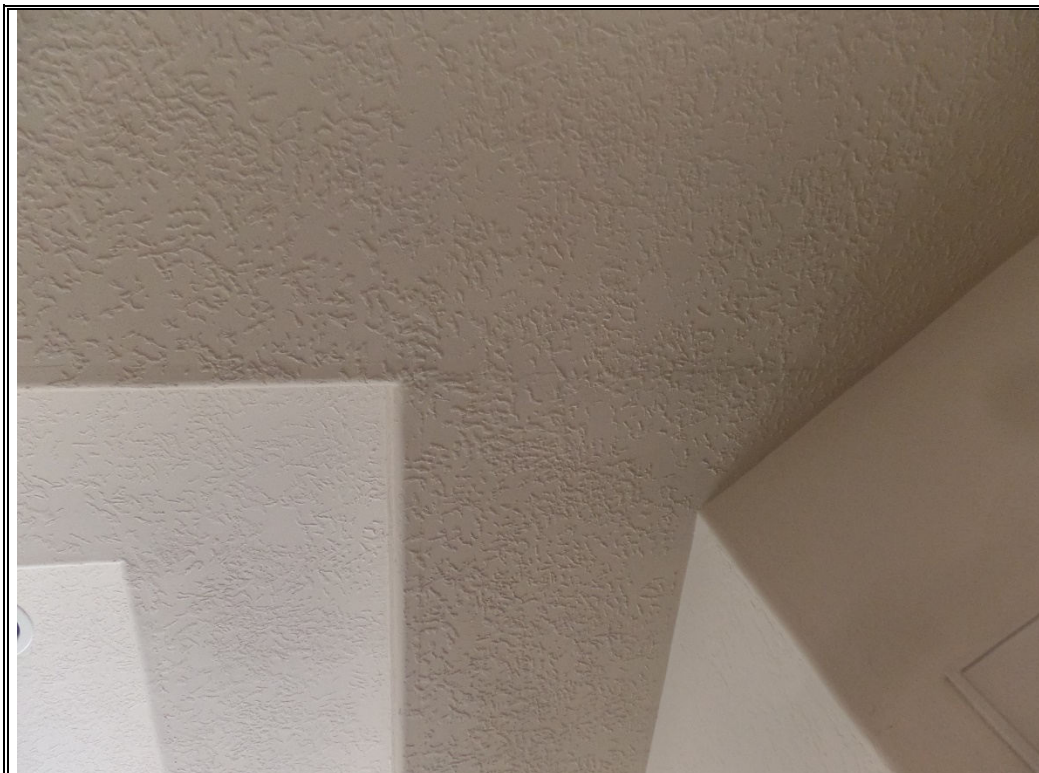
Photo Number
39

Description:
Hairline drywall
crack in master
bedroom ceiling
right

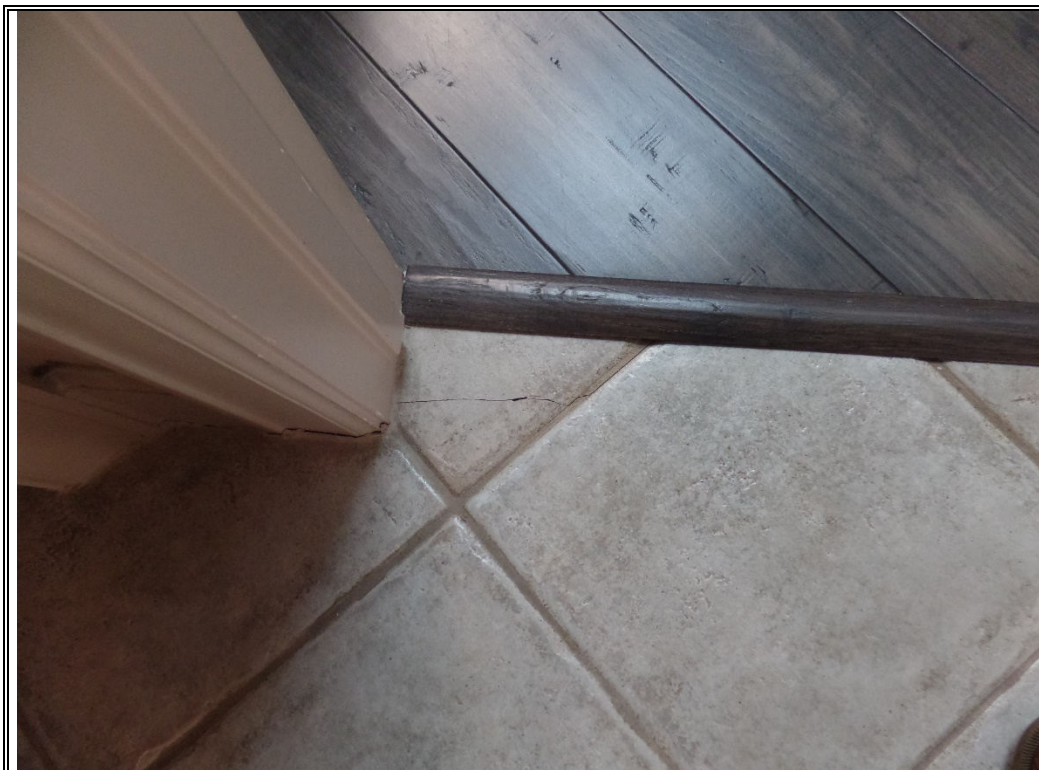
Photo Number
40

Description:
Floor tile crack in
master
bathroom
