ENGINEER'S REPORT

4718 Menlo Park Drive
Sugar Land, TX 77479

Inspection No. 2020113S

Date of Inspection: May 6, 2020

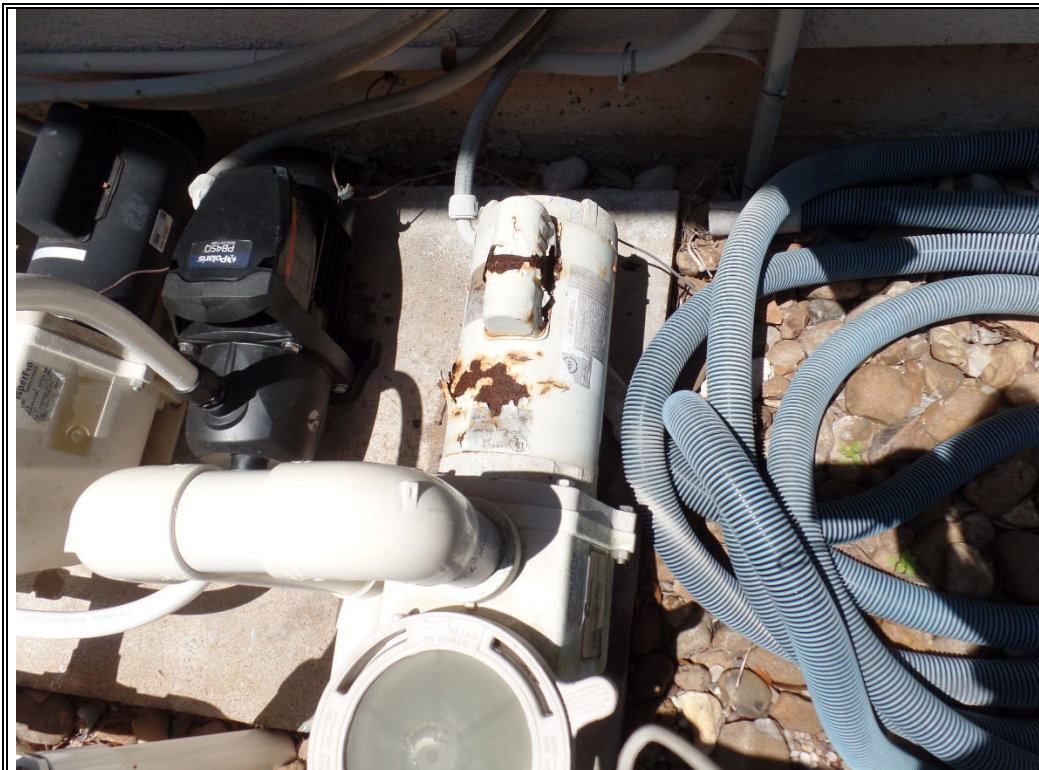
Photo Number
42

Description:
Pool pump
motor housing
corroded
