Inspection Report Repair List: 1311 W Bell , Houston, TX 77019

Re: 1311 West Bell Street, Houston, Texas

As requested, we are pleased to send you the attached report for the quality of workmanship inspection performed on the above property. The inspection includes: the structure, foundation, roof, load-bearing walls, ceilings, floors, potential and/or existing water penetration, plumbing system (excluding water wells, septic tanks, yard sprinkler systems, or foundation watering systems), electrical power system, heating and cooling equipment, and where applicable, the fireplace, built-in range, ovens, dishwasher, disposal, oven/range exhaust fans, and trash compactor. This inspection specifically excludes any hazardous gases or materials, such as asbestos, radon, etc. A leak test of the gas lines, if desired, should be made by a qualified plumber who has the equipment and time to install a pressure gauge and pressurize the system.

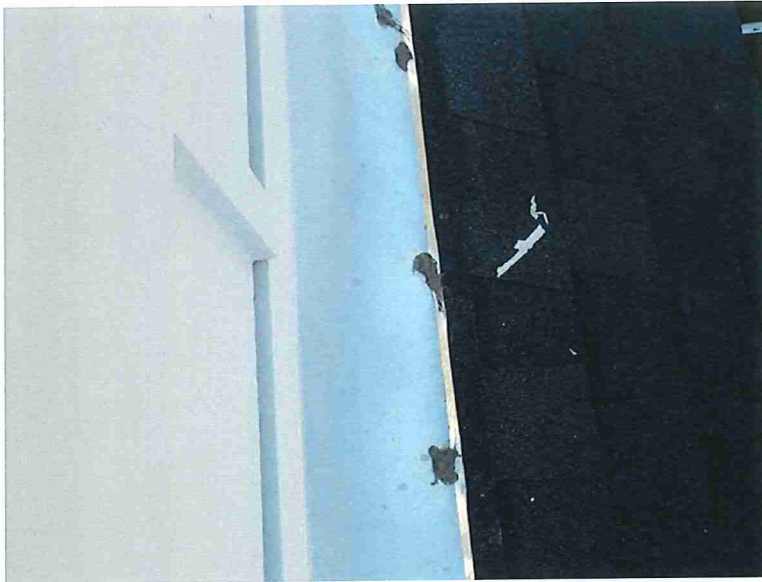
1. The roof head flashings had fasteners driven exposed in the lower surfaces to hold the flashing down against the roof. If the flashings had been properly constructed, there would have been no need for fasteners in the exposed surfaces of the flashings. As a minimum, the heads of the fasteners should be covered with a high quality caulk.

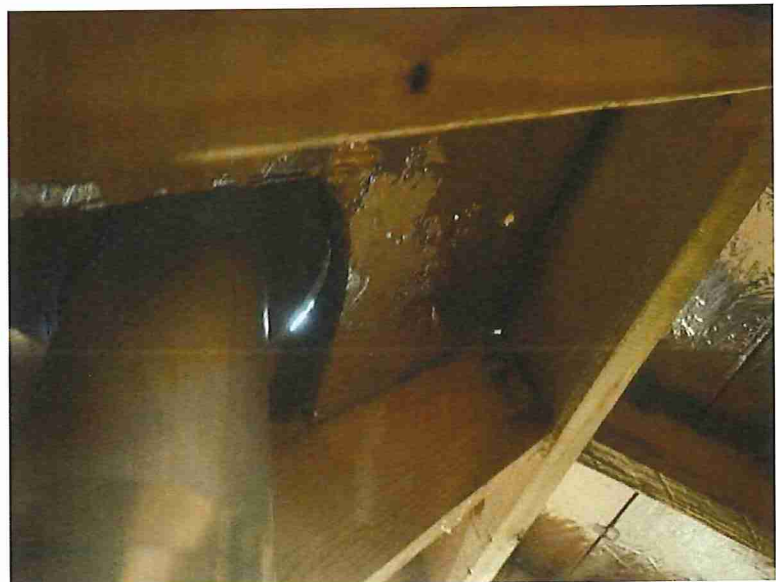
8. There appeared to be damage to the metal roof jack used at the furnace flue penetration at the attic, which could allow water penetration into the attic and should be replaced. Reference Photograph 2

2. There appeared to be damage to the metal roof jack used at the furnace flue penetration at the attic, which could allow water penetration into the attic and should be replaced.

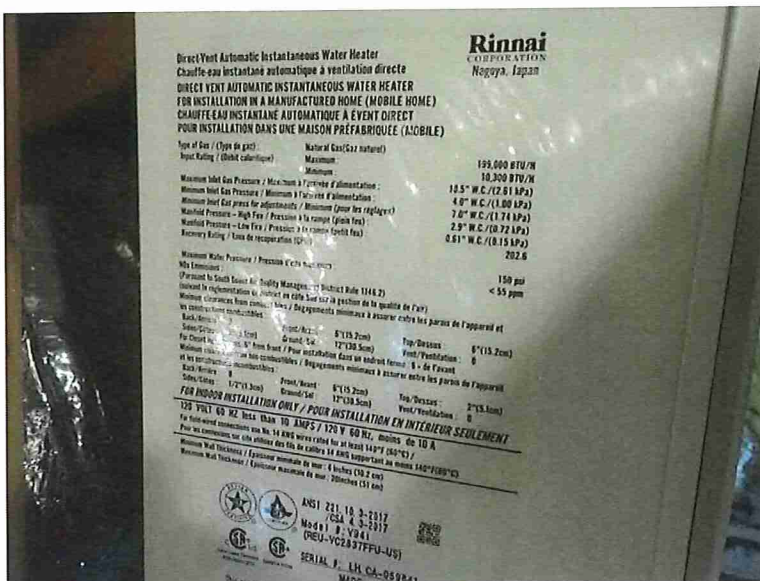
3. Hot water for the building was provided by a single on-demand gas-fired water heater having a maximum input capacity of 199,000 BTU/hr. Determining the adequacy of the water heater was beyond the scope of this inspection and should be designed based upon the maximum flow anticipated and the required temperature rise for an on-demand water heater. The equipment appeared to be of a size typical {...full text in report}

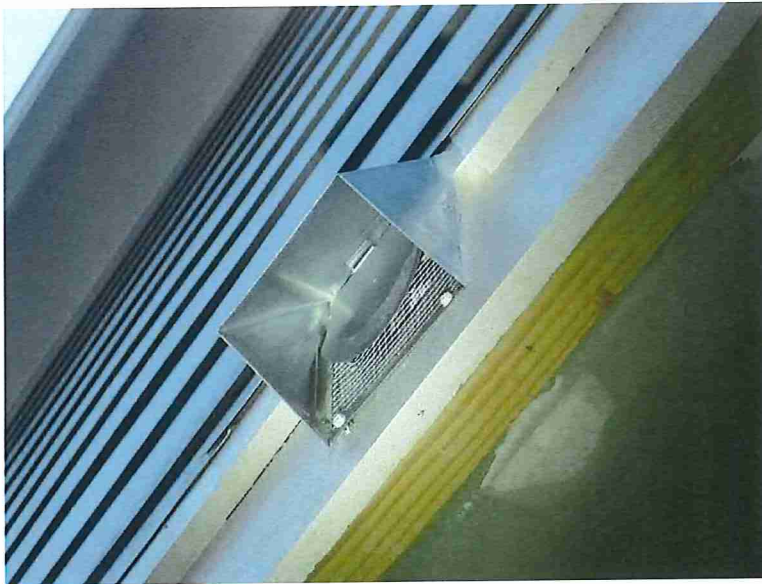
4. The 1/2 bathroom ventilator fan outlet had a bent damper and did not close tightly against the damper, and the vent flue was not flashed to the water-resistant barrier. Because the hood is not flashed to the water-resistant barrier, this increases the potential for water entry and may result in energy loss since the damper does not close tightly.

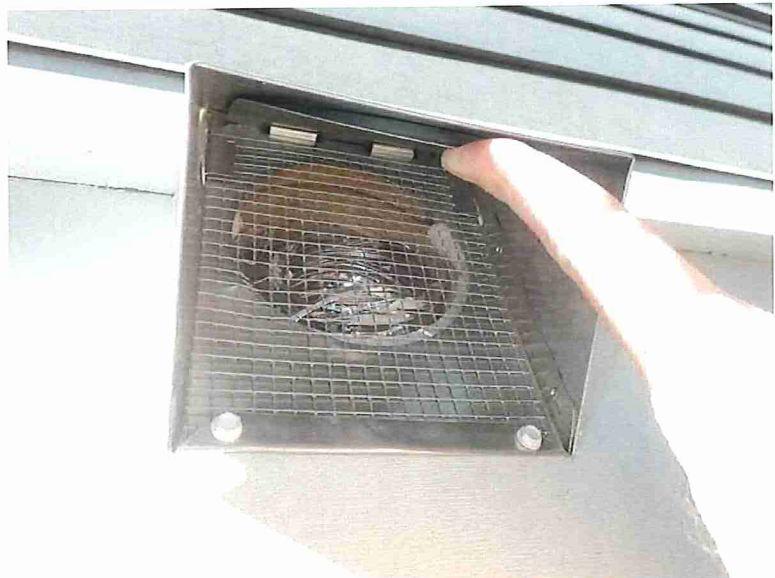
11. The area vent for the 1/2 bathroom did not appear to fully penetrate through the exterior wall, as observed at the vent hood opening. Reference Photograph 5

5. The area vent for the 1/2 bathroom did not appear to fully penetrate through the exterior wall, as observed at the vent hood opening.

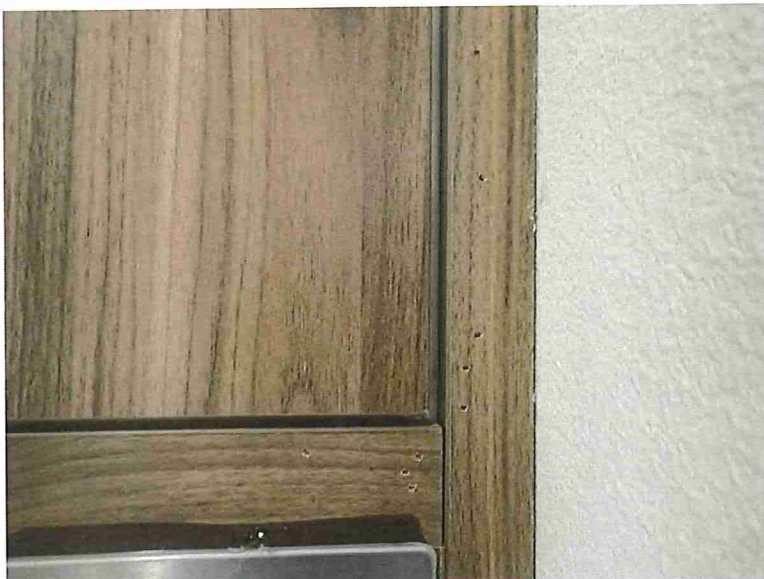
15. Cabinet facings around the oven and microwave oven had been installed with fasteners driven through the face of the facings that were prefinished. This creates an irregular appearance that may not be repairable without replacement of the facings. Reference Photograph 6

6. Cabinet facings around the oven and microwave oven had been installed with fasteners driven through the face of the facings that were prefinished. This creates an irregular appearance that may not be repairable without replacement of the facings.

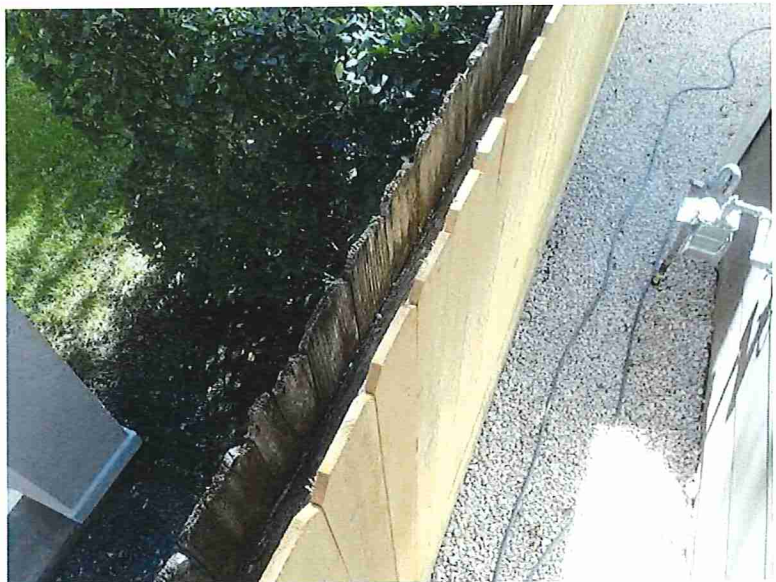
25. It appeared pickets at the east fence were applied to old fencing. It is possible that the fence frame may deteriorate before the pickets. Reference Photograph 8

8. It appeared pickets at the east fence were applied to old fencing. It is possible that the fence frame may deteriorate before the pickets.

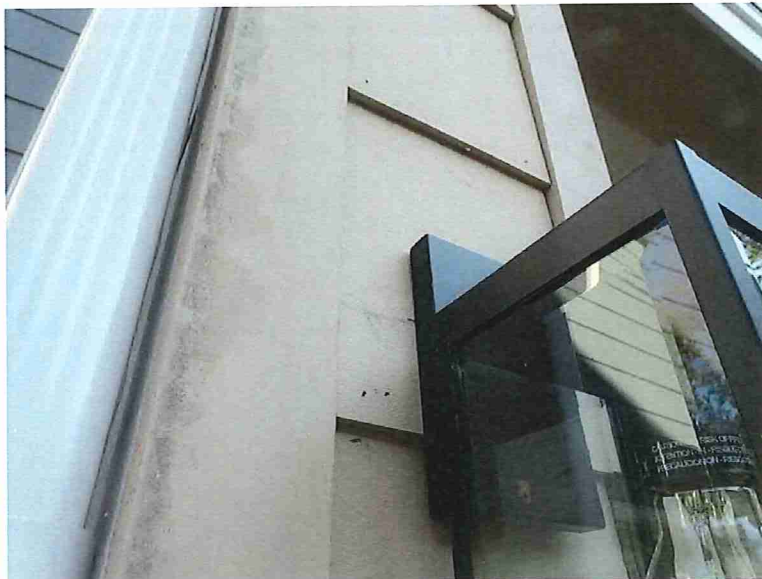
9. It appears finish nails had been used to secure some siding at the south side of the building. Nails could be observed at other locations. Finish nails are not considered an acceptable fastener for securing siding.

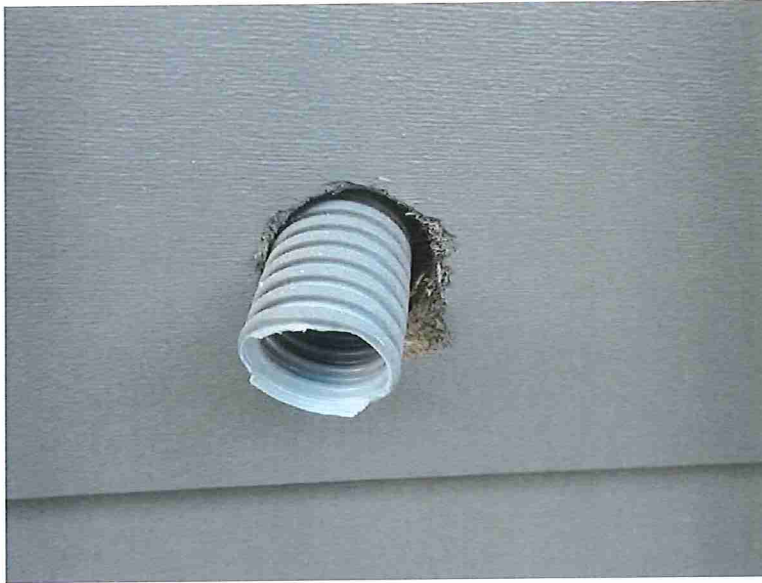
10. Penetrations through the fiber cement siding visible along the east side of the building were apparently made without adequate flashing to the water-resistant barrier behind the siding. The rough edges of the sheathing were visible around some penetrations. This increases the potential for water entry and is generally difficult to properly repair without removal of siding materials.

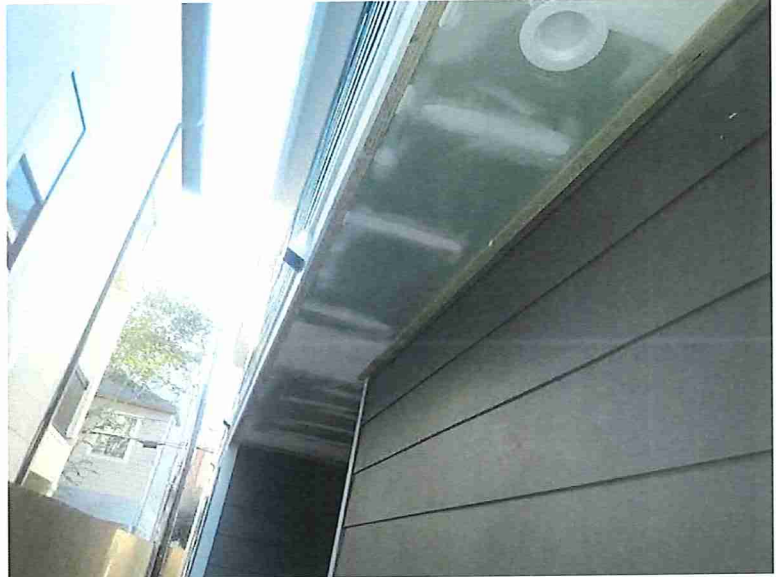
11. Soffit finishes were incomplete at the front porch and rear porch areas. The drywall ceiling covering at the rear porch appeared to be a mix of fire-rated sheetrock and exterior-rated sheetrock rock. Exterior-rated sheetrock is normally used at exterior locations.

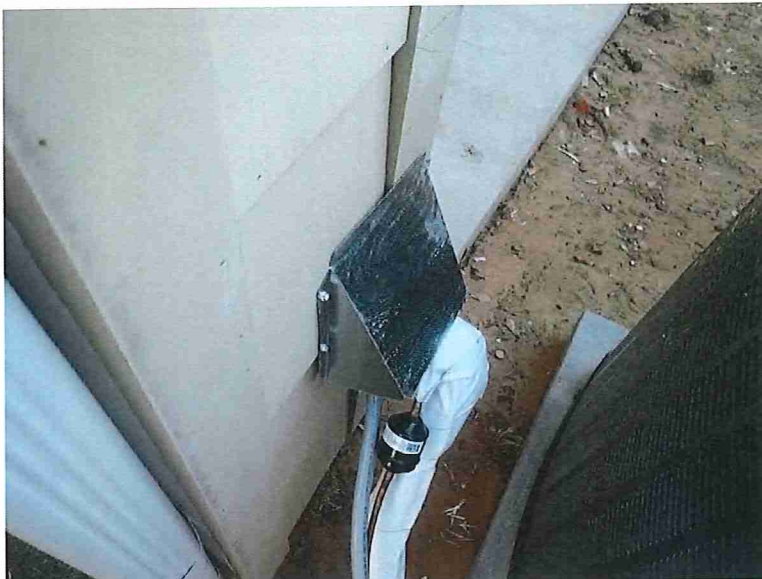
12. The air conditioning flashing hood did not extend behind the siding to the water-resistant barrier. This could leave the opening without adequate flashing that could allow water entry to the wall structure at the condensing unit.

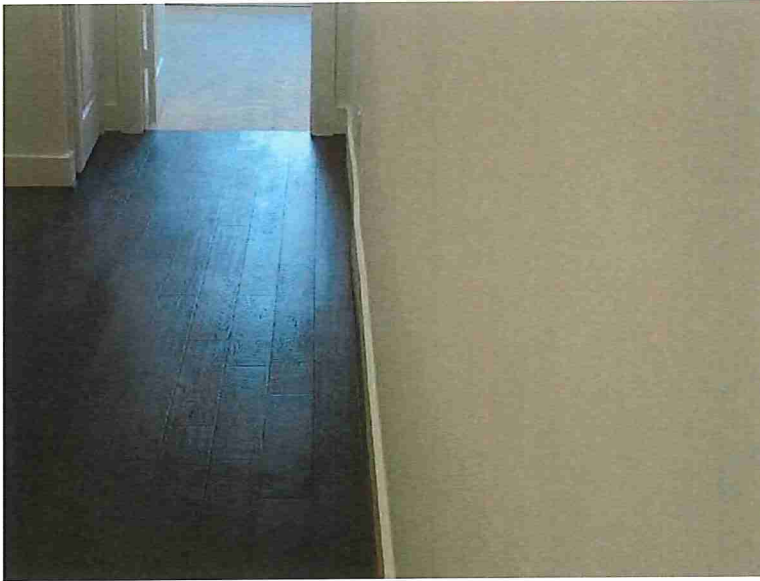
- 13. The base trim was uneven along the east side of the upstairs hall adjacent to the master bathroom, creating a poor appearance.

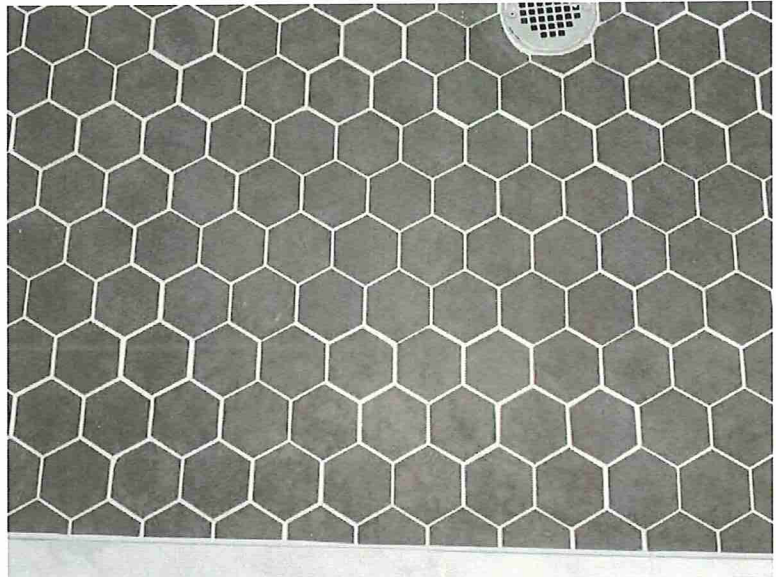
- 14. The fit of the floor tiles at the master bathroom shower enclosure was poor in appearance, where there were irregular tile joints and poorly cut tiles.

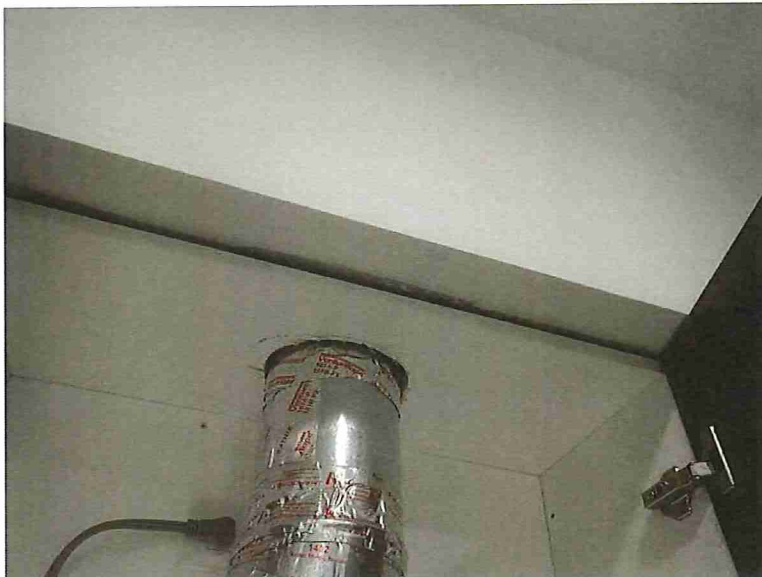
- 15. The furrdown finish was incomplete over the cabinetry at the upper cabinets at the kitchen. It appears that a valance may be missing or that the cabinets may have been installed too close to the furrdown since the cabinet doors dragged the furrdown. There may be a need to reset the cabinets lower with a valance to improve the performance and appearance.

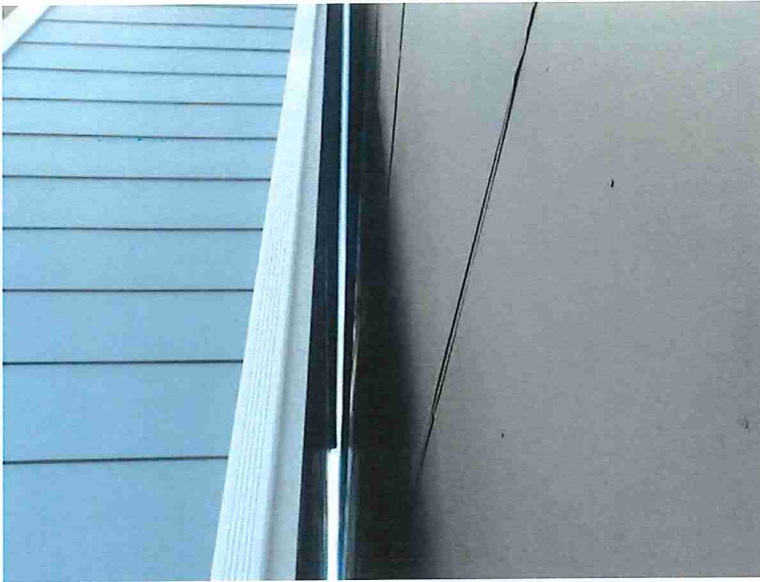
16. The gutter system at the west side of the building adjacent to the upstairs hall bathroom area was partially crushed, apparently due to a lack of adequate clearance to the adjacent unit. This will reduce its cross-sectional area and increase the potential for it to become clogged. This may increase the need for cleaning. Access to the gutters appears to be only from the roof and will be difficult.

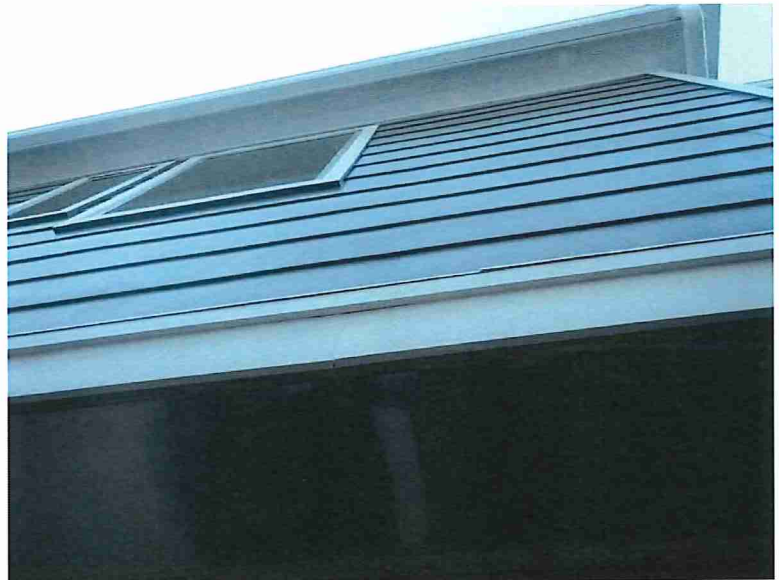
17. The joint cuts in the siding trim components were not made at 45-degree angles, typically intended to maintain alignment and create a good appearance. Because the cuts were made at 90 degrees, they were uneven at some locations around the building, creating a poor appearance.

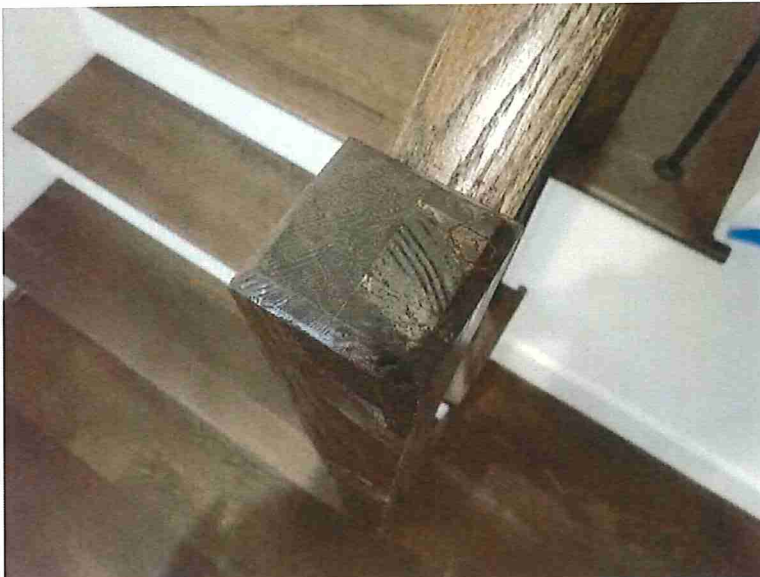
18. The newel posts at the base of the stairs had a poor quality finish, where it appears filler was used, creating an irregular appearance.

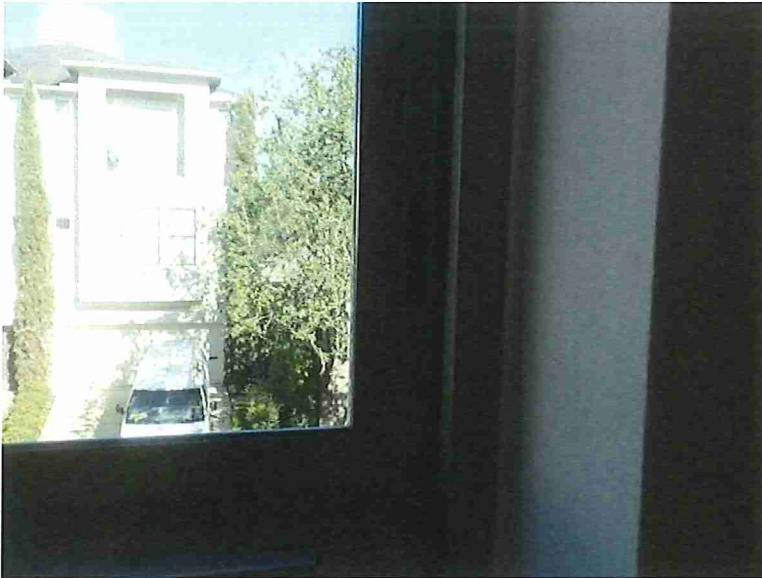
19. The window stop was missing at some windows, including at the master bedroom. The window stops are intended to prevent the windows from fully opening to prevent persons from falling out of them.

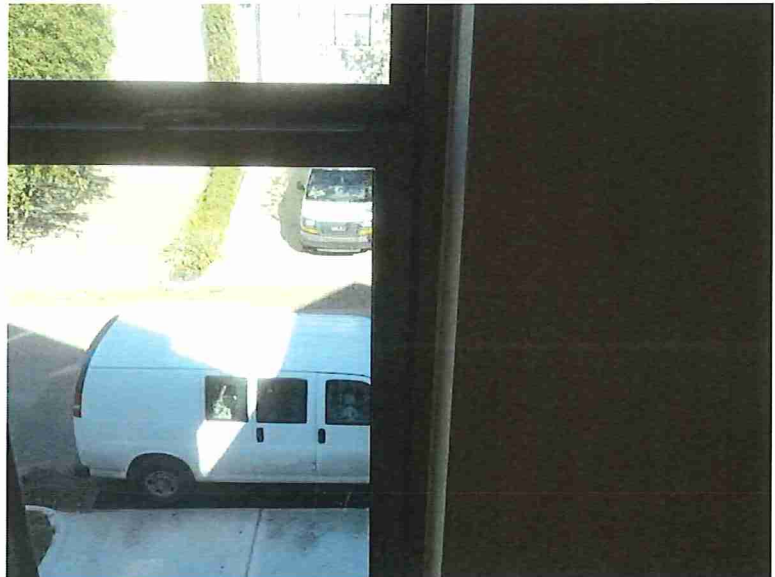
20. There was a poor fit at the vinyl window at the master bedroom, where a large gap existed between the sash and the frame of the window. This appears to be affecting the ability of the window to remain open and may be difficult to correct without rehang of the window.

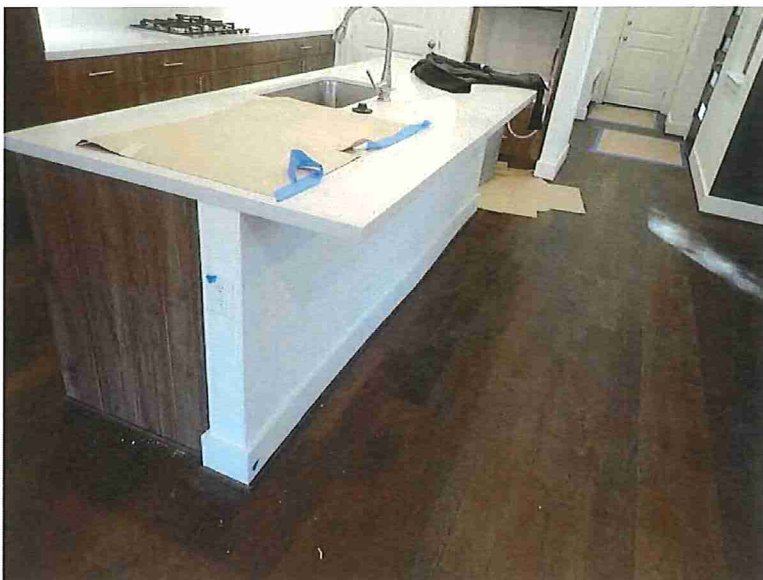
21. There was unevenness in the base trim at the base of the wall at the kitchen island, creating a poor appearance.

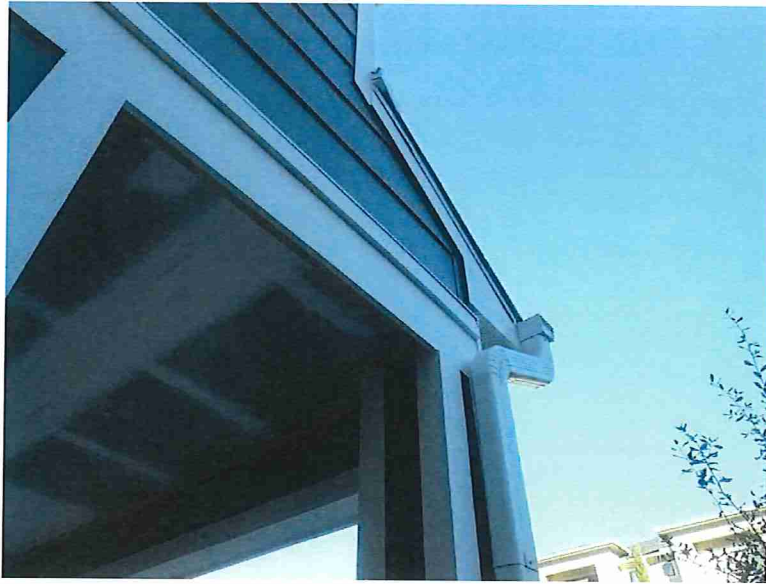
22. Trim at the east side of the carport extended past the upper trim without a flashing detail. This may allow water entry behind the trim components at the corners of the column and front wall.
