Wildcat Inspections

**107 Hillcrest Ln.
Livingston, TX 77351**

April 1, 2021

PROPERTY INSPECTION REPORT

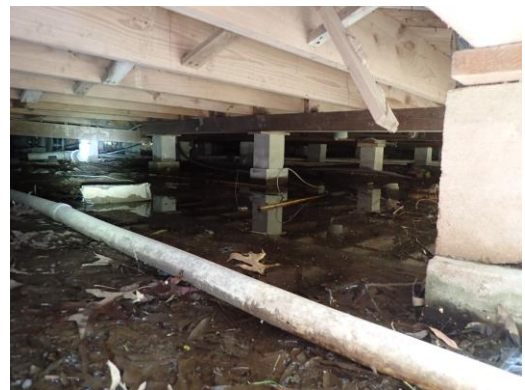
Surface water is traveling beneath the pier and beam structure in a manner that can cause excessive foundation movement. Water was observed to be standing beneath the building at the time of the inspection. The house was not constructed on a raised pad. A solution should be obtained to promote the flow of storm water away from the house.

There are several options for getting surface water away from a pier and beam foundation on rural property. Each must be examined for the best solution. Discuss options with a qualified dirt and landscape contractor. Regardless of the choice a good addition is to divert water away from the foundation with guttering when possible.

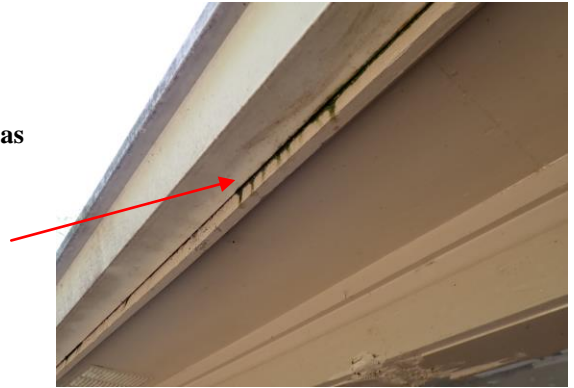
Evidence of water overflowing the gutters was observed. The gutters require cleaning and/or adjustment to prevent damage to the structural overhang.

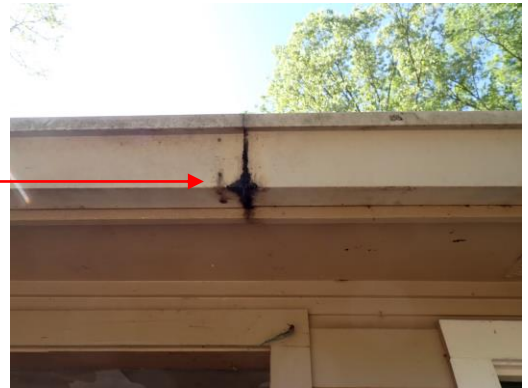
Gutter seams are leaky.

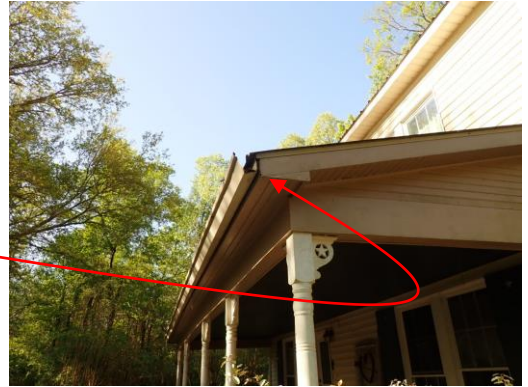
There were no ends on some of the gutters. This does not control the storm water away from the building.

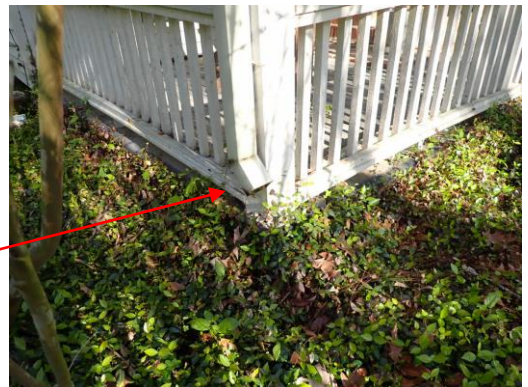
Downspouts discharge roof drainage less than 5-feet from the house and the effluent does not effectively flow away from the building. From the point of discharge effluent should be encouraged to flow steadily away from the foundation and off of the lot without standing.

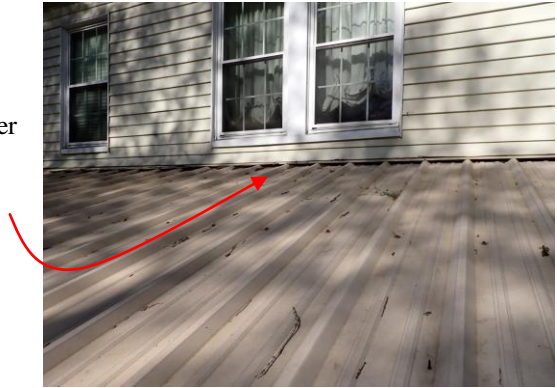
Closures are considered to be optional. Manufacturers recommend using inside closures at eaves to prevent water infiltration, insect or bird infestation at openings. Debris, insects and blowing rain can find easy access under the ridge cap, so solid or vented closures are often used to either completely or partially seal the openings. As a general principle the less steep the roof the more necessary the use of ridge closures.

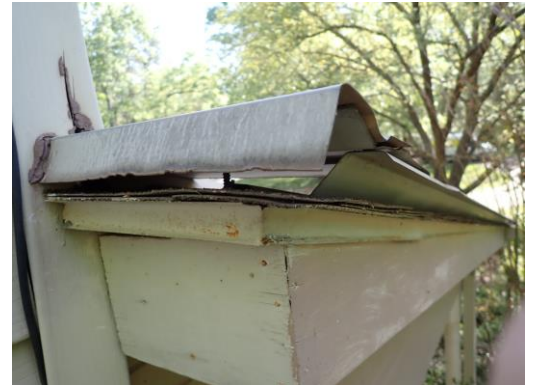
Loose flashing at the front porch should be secured and sealed.

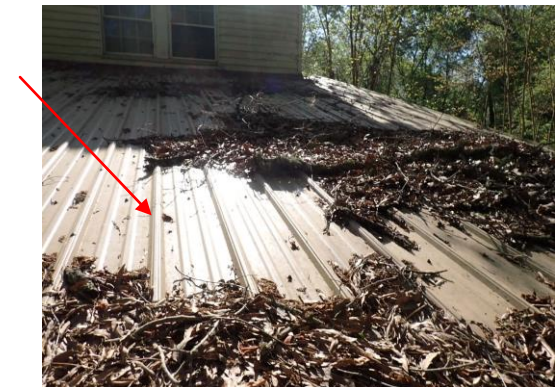
Lap screws were missing where panels overlap. Typical spacing for lap fasteners is 20 inches on center to help prevent wind damage.

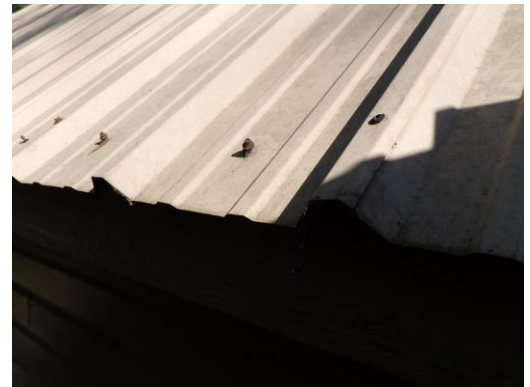
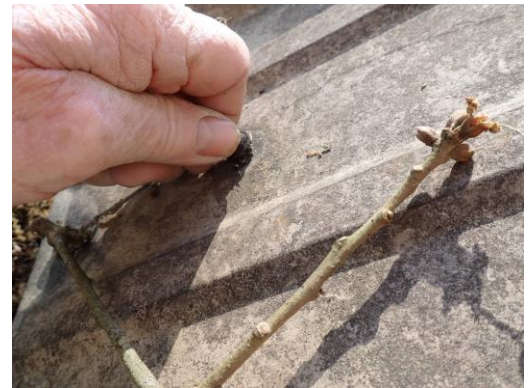
There were several fasteners that have backed out, some were loose and others could be turned by hand. These areas are prone to leakage and should be addressed promptly. Replacing loose and missing screws using larger fasteners is necessary in order to maintain the integrity of the roof system.

We recommend the use of ZAC "Long Life" screws. They cost a little more than the conventional TEK screws but the corrosion proof coating is often better and the rubber washers are covered when the screw is tightened so they last longer. The shape of the washer also prevents over tightening the washer, a leading cause of seal failure.

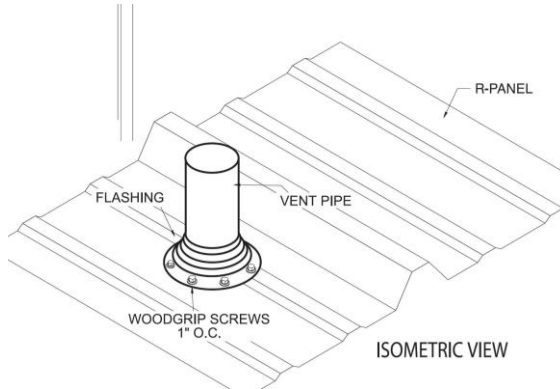
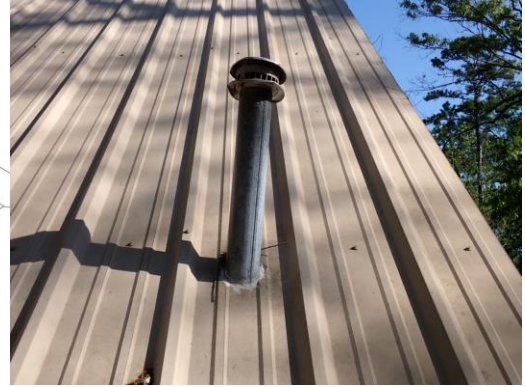
The water heater vent penetration through the metal roofing is not properly flashed. This should be repaired right away to prevent water damage. Suitable flashing will fit snugly to the pipe without the need for additional sealant and mold to the metal roofing. The flashing should be sealed to the roofing as required by the manufacturer. This is often achieved using a combination of sealant tape and metal roof-grade silicone sealant. A qualified metal roofing contractor should make these types of critical repairs.

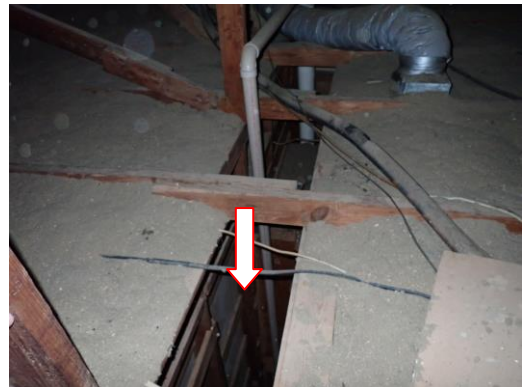
Adequate fire-blocking is not present within the attic near the access hatch. Although fire blocking (AKA fire stopping) has been a requirement of all major building codes even before it first appeared in the 1927 UBC (published by ICBO) it is often overlooked, especially outside the municipalities. Repairs are needed for safety against the spread of fire. Some of the greatest damage occurs to conventional wood-framed buildings during a fire when the fire travels unimpeded through concealed draft openings. Besides the fire safety aspect, properly installed fire-blocking can save energy where insulation is missing and shafts are open to non-conditioned attics.

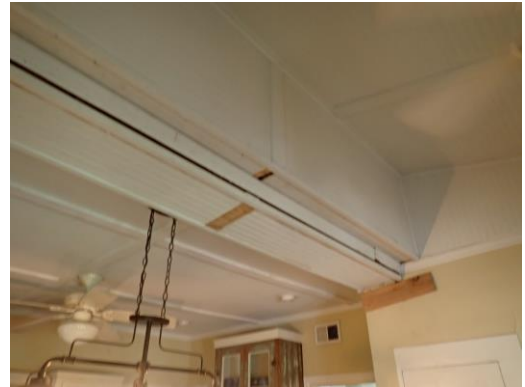
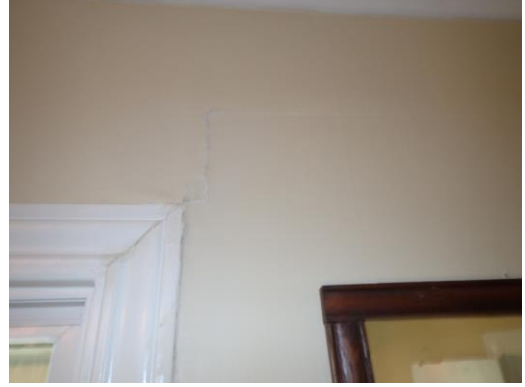
Extensive cracks and other defects in the drywall throughout the house at the lower and upper stories and garage were observed. This indicates greater than normal movement within the structure and potential structural problems. Further investigation by a structural engineer and/or a qualified structural repair specialist is recommended.

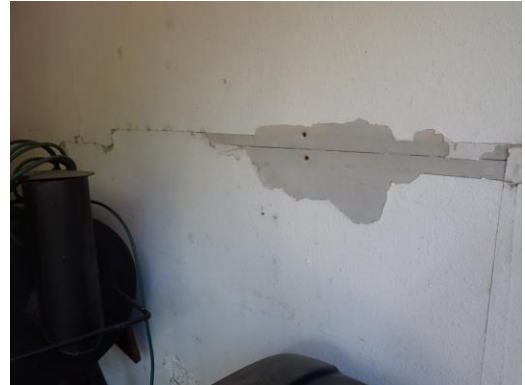
Damage to the drywall cladding in the garage appears to be a combination of structural movement and excessive moisture.

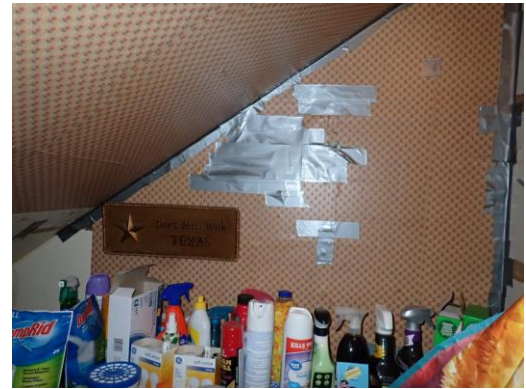
Repairs should be undertaken under the stairs to maintain fire resistant construction at that component of safe egress.

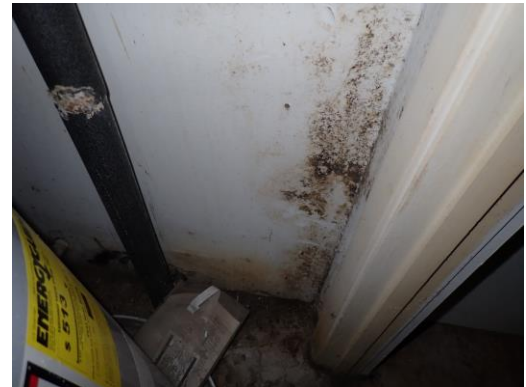
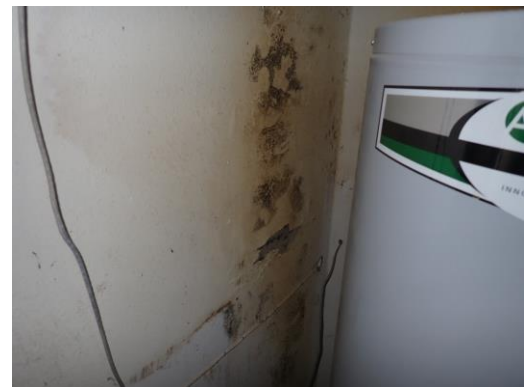
Water heater Closet

Staining that included probable organic growth was visible at multiple locations including in the water heater closet (all walls and ceiling), in the laundry room (wall and ceiling), under the cabinet for the laundry sink, in the stairwell (wall and ceiling) and in the garage (walls and ceiling). Immediate attention is needed. Type(s) of mold are not tested for or otherwise specifically identified during this type of inspection. The extent of damage to the unseen areas within the walls, ceilings, under flooring, behind cabinets and other wall coverings cannot be determined with a visual inspection such as this one. Further investigation of a destructive nature would be needed to determine the full extent of damage, if any. The affected areas are larger than 10 square feet therefore we recommend that a licensed Mold Assessment Consultant be contacted for further assessment and to develop a mold management plan or remediation protocol.

We recommend that a licensed Mold Consultant assess the conditions throughout the building and make recommendations for possible mold remediation by licensed remediators.

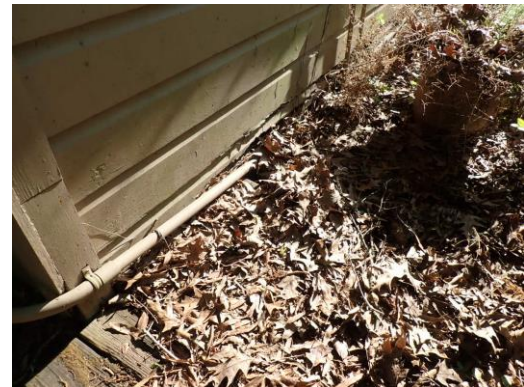
Localized rotting was observed at the exterior siding and trim. Rotted materials should be replaced or otherwise repaired promptly to prevent additional damage and reduce the risk of attracting insects. A qualified contractor should be contacted for an estimate to make repairs as necessary. This report is not intended to provide a complete list of all rotted materials. Some water damage may not be visible due to any previous partial repairs or recent caulking and painting.

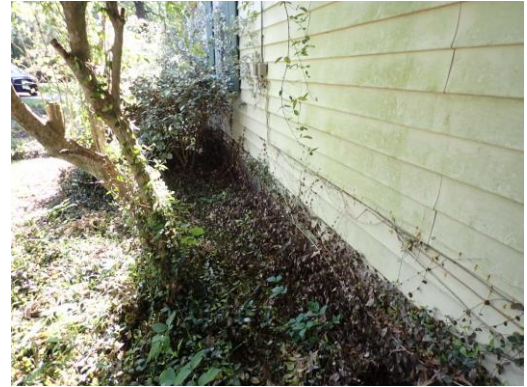
Vegetation should not be left growing against the exterior of the home where it can contribute to moisture concerns. Ivy, trees and shrubs brushing the walls and/or an accumulation of vegetation growing on exterior walls can cause elevated moisture within the wall cavities that can lead to unseen damage to the building structure. Insects can use the branches and limbs as a bridge into the house. All vegetation should be removed a safe distance from the structure. As a rule of thumb a person should be able to walk between the house and any vegetation. This will also allow for monitoring of the foundation and for signs of insect entry, such as tunnels and mounds.

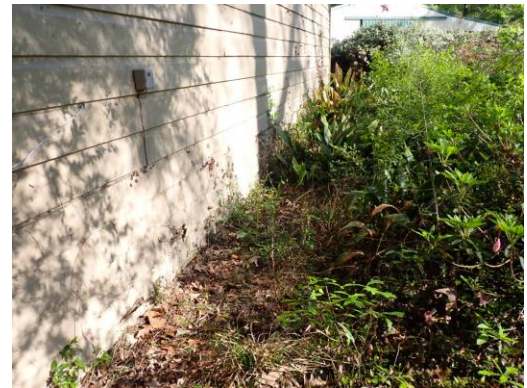
The clearance between the finish grade and the exterior cladding is inadequate. Soil, bedding, and other moisture retentive materials within 6-inches of the siding can result in moisture damage to siding. This also presents a possibility for excess moisture within wall cavities in those areas. Moisture can extend past the walls creating elevated humidity inside the house. In extreme circumstances flooring can be damaged as well. Excess moisture can contribute to rot, fungal growth, insect infestation and other concerns.

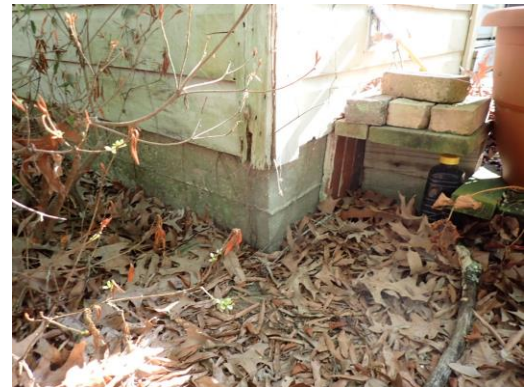
Items should be moved away from exterior walls. Building materials and other items next to a house can attract insects, rodents and promote moisture damage.

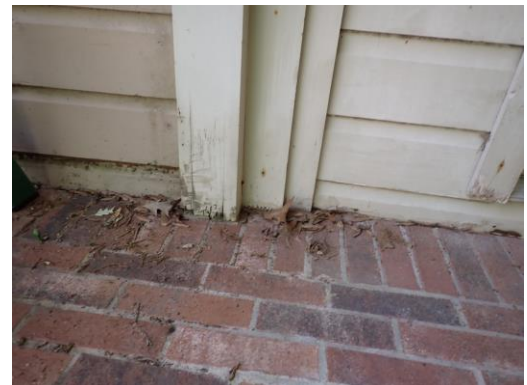
There was not an inch or more clearance between the bottom of the siding and trim and the brick placed on the patio. This can lead to moisture damage to siding and trap moisture in the wall cavities.

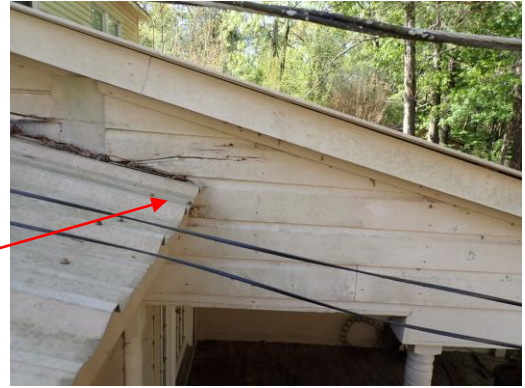
Kickout flashing was not installed at the sidewall/roof intersection. Kickout flashing is recommended to prevent water from flowing down the face of the wall and will help prevent damage to, paint, siding, etc. as well as fungal growth and elevated moisture in the wall cavities.

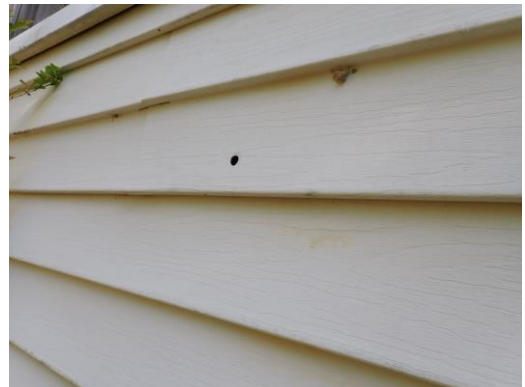
Holes in the exterior cladding should be repaired to prevent water migration and insect entry.

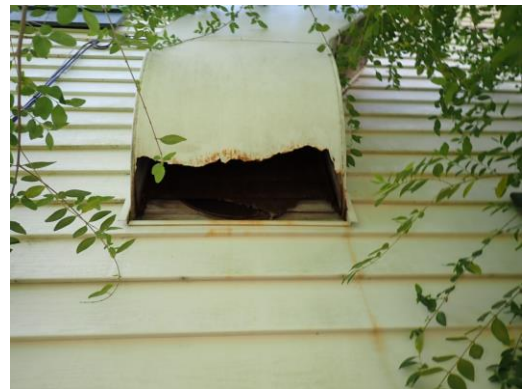
The abandoned kitchen vent is rusting and does not prevent moisture entry into the structure.

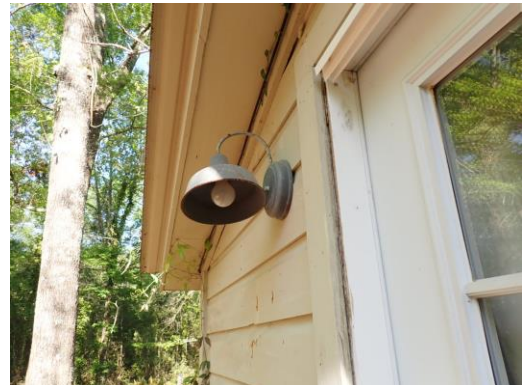
Water is able to enter the wiring compartment at the wall light box. This presents a possible electrical hazard and can cause water damage to the fixture. A better seal is needed. Caulking the perimeter of the fixture using approved material is the usual remedy.

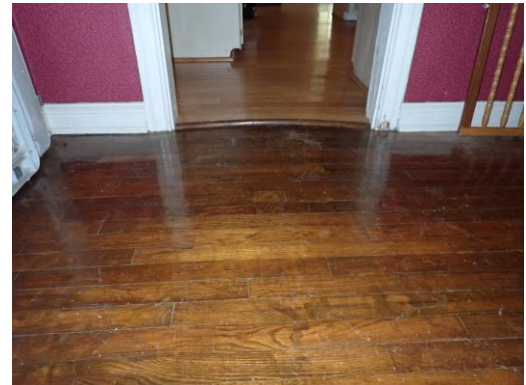
There was excessive sloping in the floor surfaces throughout the house. Most of the buyers that I have represented consider this degree of sloping to be uncomfortable. Pier and beam foundation repairs rarely make floor surfaces "level". Moisture evaporating from the crawlspace can affect the condition and performance of floor joists, subfloors and flooring due to cyclical wetting and drying. We recommend further investigation by a licensed structural engineer and/or qualified pier and beam foundation repair contractor of your choice to recommend a suitable course of action.

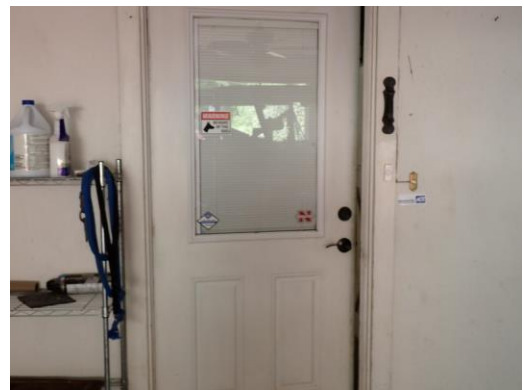
The door between the garage and the interior of the house is not rated to resist fire and is not self closing. Openings between the garage and residence must be equipped with solid wood doors not less than 1 3/8-inch thickness, solid or honey-comb-core steel doors not less than 1 3/8-inch thick, or 20-minute fire-rated doors, equipped with a self-closing device. These doors must be without a window, pet opening or other penetration between the house and garage. The Texas Real Estate Commission (TREC) recognizes the current condition to be deficient and considers the potential for injury or property loss from the hazards addressed in the Standards of Practice to be significant enough to warrant this notice. (For more information please see the [Texas Real Estate Consumer Notice Concerning Hazards or Deficiencies](#) found on page 3 of this report.)

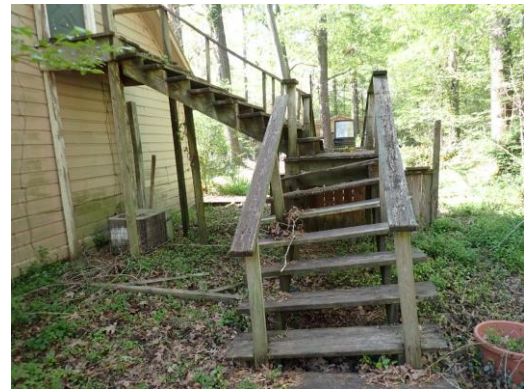
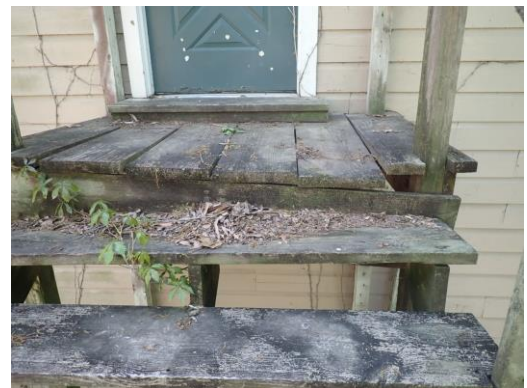
The exterior stairway to the room(s) over the garage is dilapidated. The life expectancy of a wood stairway is 10 to 15 years. That could be stretched to 20 years with regular maintenance and keeping it sealed with weatherproof coating. It is obvious that this maintenance on this stairway has been neglected. Given its condition and the advances made in safety requirements of stair construction over the years this stairway and landing should be replaced right away.

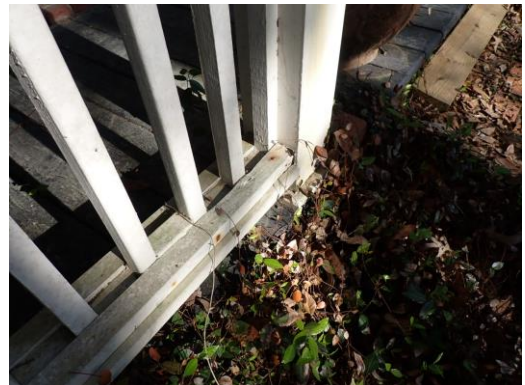
The porch rail shows evidence of rot. Replacement may eventually be desired. In the interim, localized repairs should be undertaken to insure safety. Rusted fasteners should be replaced.

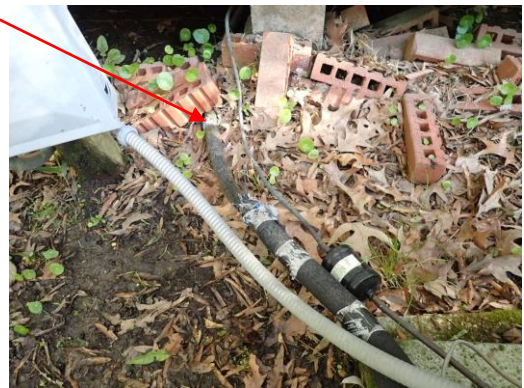
Insulation should be improved on the primary condensate line from the evaporator coils at the downstairs unit. Condensate lines should be insulated for the first ten feet from the equipment to prevent excess sweating of the pipe that can cause damage to the building.

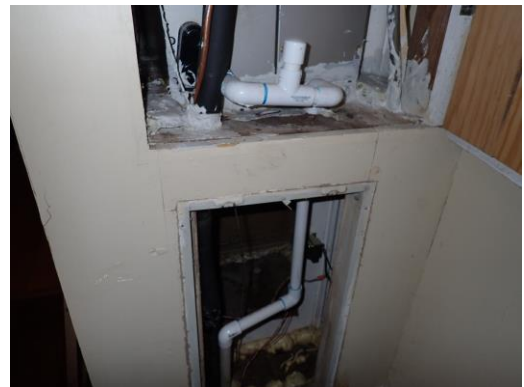
No emergency pan was installed and no visible means to manage condensate from the evaporator coil should the primary drain clog. This should be addressed to prevent property damage. Discuss options with a qualified HVAC repair contractor.

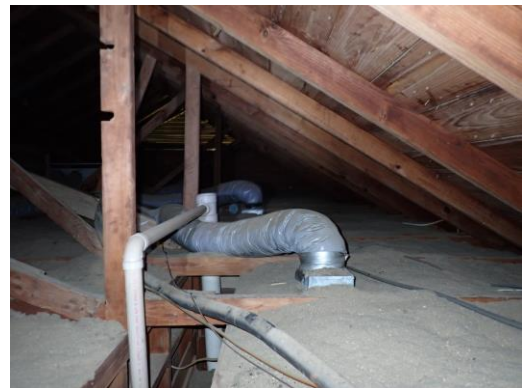
A large amount of dust staining was observed around ceiling diffusers. Cleaning is recommended.

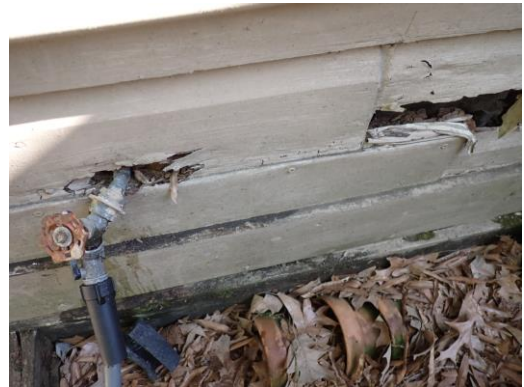
The copper pipe to a hose bib along the left side of the garage is damaged. This should be repaired to prevent a leak.

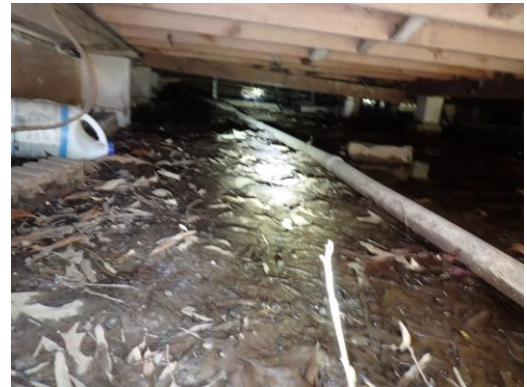
The waste piping under the home does not have sufficient slope for proper drainage. This condition should be repaired.
